Bat Survey Report

Survey Site: Cockgate Farm,
Bircher.
Leominster,
Herefordshire.
HR6 0BL

Report Reference: 022/19

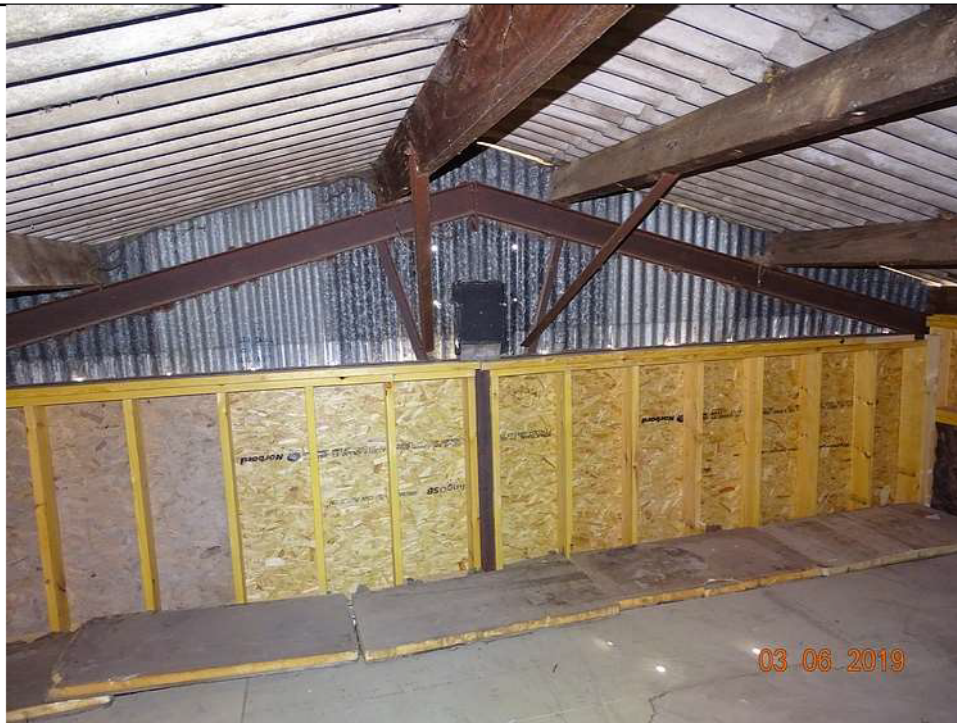
Fig 1. Southerly gable wall backing onto busy B4362 with Schwegler 1FF batbox that was removed from external position prior to original conversion.

- It is recommended that the Schwegler 1FF bat box currently within the bat loft is removed and attached to one of the mature trees in the boundary hedge. This will provide additional roosting opportunities for all species of bat recorded at the site during the emergence / activity survey. It should be attached as high as possible with open uncluttered access.

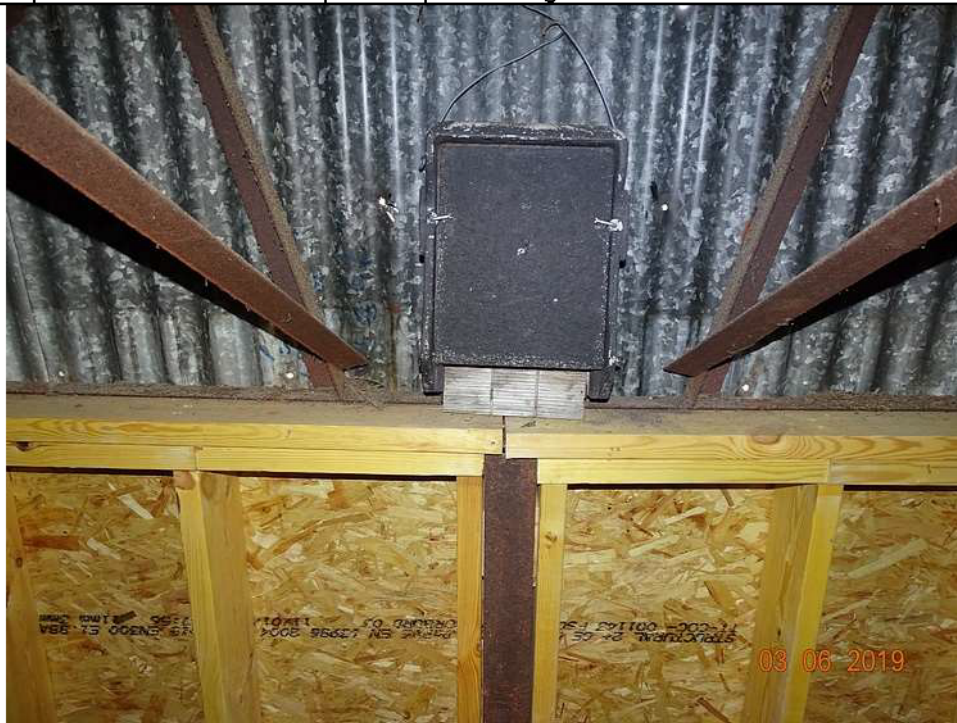
Fig 2. This 1FF Batbox was adjacent to the road and totally obscured by a small Ash tree that was growing in the roadside verge until owner advised to move it because it was very highly unlikely to be used by bats.

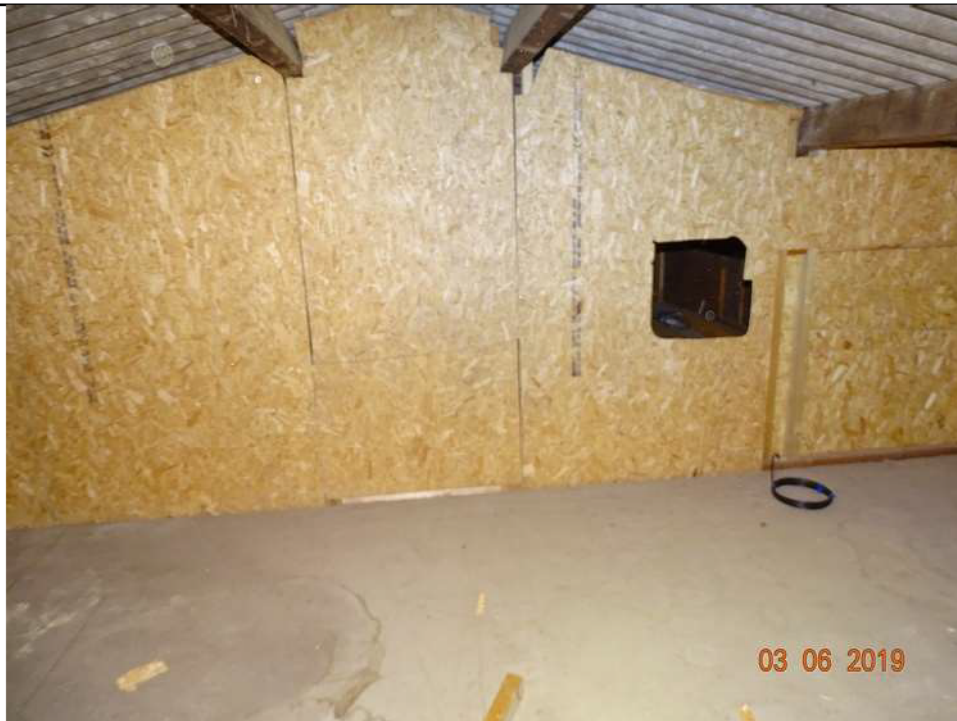
Fig 3. Looking at northerly wall in bat loft that separates it from the domestic living area that is still under construction.. Hatchway is entrance to bat loft.

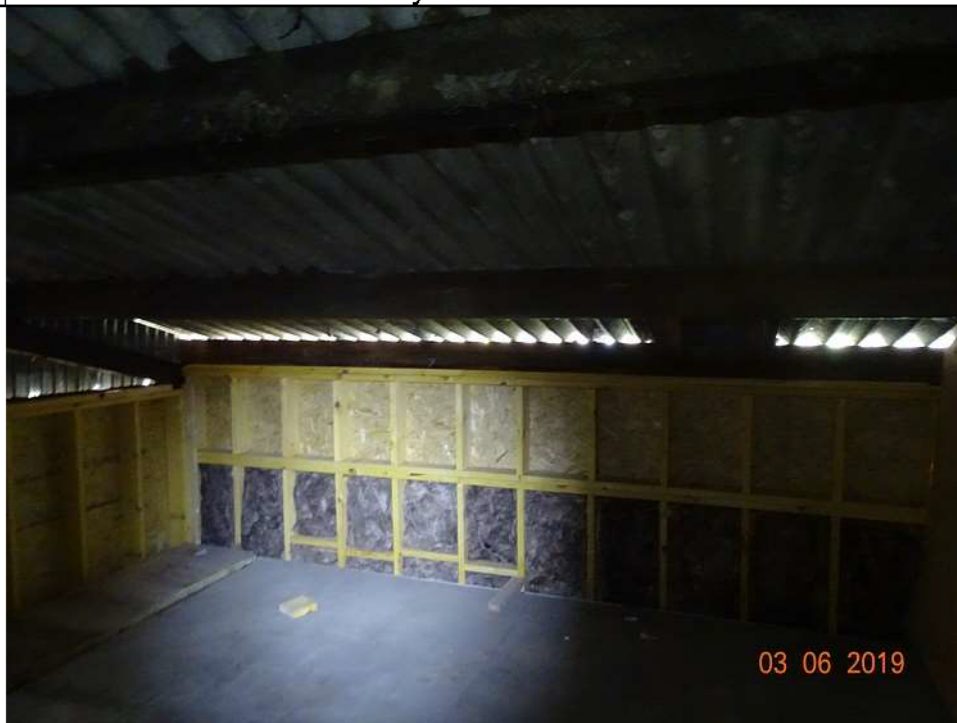
The existing bat loft is inappropriate with its dimensions, roof covering, and draughty conditions caused by gaps at eaves. Additionally, its location on the end of the building directly adjacent to the busy B4362 only allows access via eaves of building.

Fig 4. Describing the amount of light entering loft from eaves.

- Entrance to the new bat loft will be via a 'hopper style' opening. This will allow open access for all species of bats that might be found in the local area and be weatherproof, draught resistant and significantly reduce potential light penetration. (example with approximate dimensions at appendix 6.)

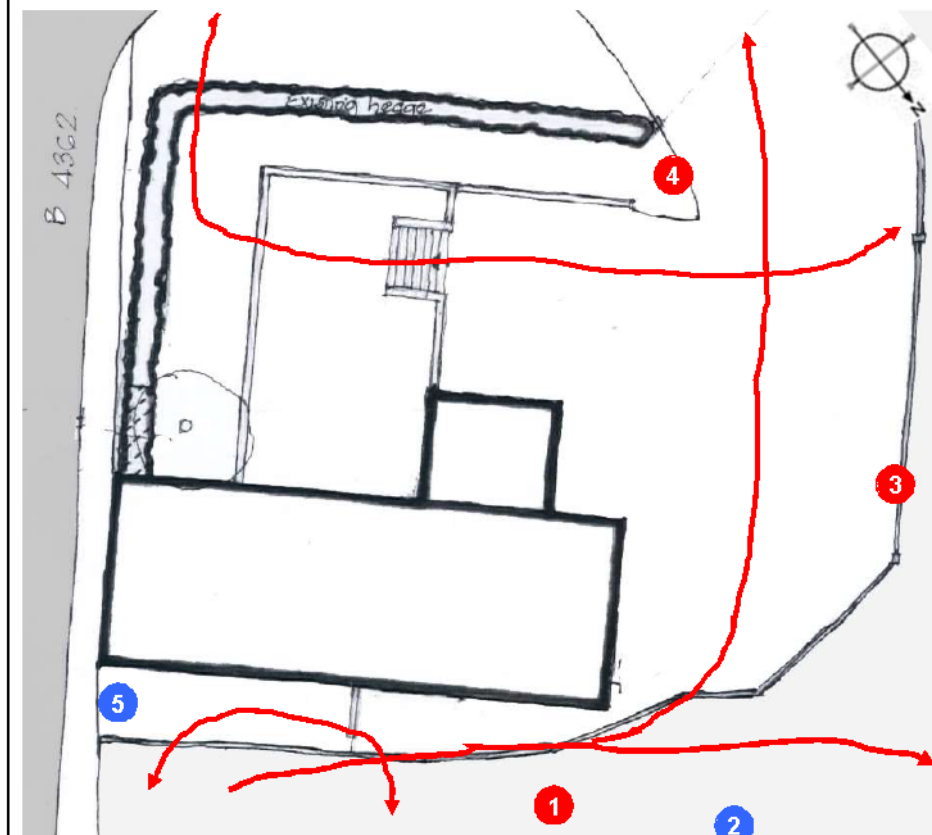
Table 1
Activity survey layout

No bats were observed to exit the building. All activity appeared to originate from the east and north where there are several buildings and open parkland with mature trees and boundary hedge on the Croft Castle Estate.

Position	Total Passes	Species in order of recording – predominant species underlined
1	41	<u>Ppip</u> , Nn, Ppyg
2	50	<u>Ppip</u> , Nn, Ppyg, Paur
3	37	<u>Ppip</u> , Nn, Ppyg, Paur
4	24	Nn, <u>Ppip</u> , Ppyg
5	36	<u>Ppip</u> , Nn, Ppyg
5	= Static Anabat	
1	= Observer with Anabat	
→	= flight routes of bats

All flight routes are Ppip

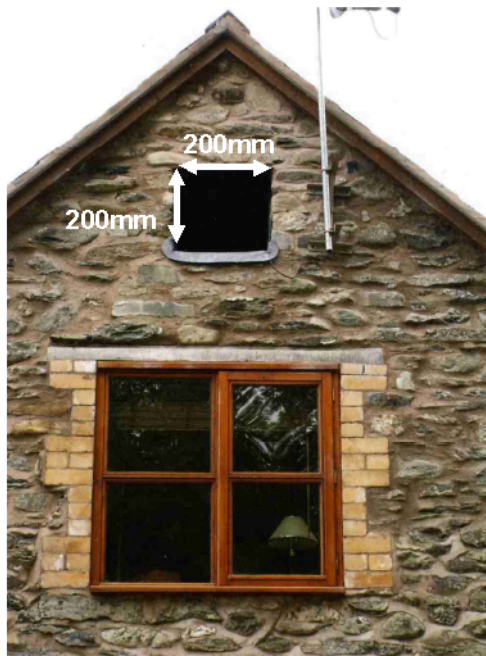
Hopper Entrance (photograph describe larger entrance)

Hopper constructed from studwork and (say 22mm or similar OSB or plywood).

Slope & sides to be covered in metal so that birds cannot gain purchase and make entrance weather proof. Lead suitable but anodised aluminium or stainless steel better as more 'slippery'

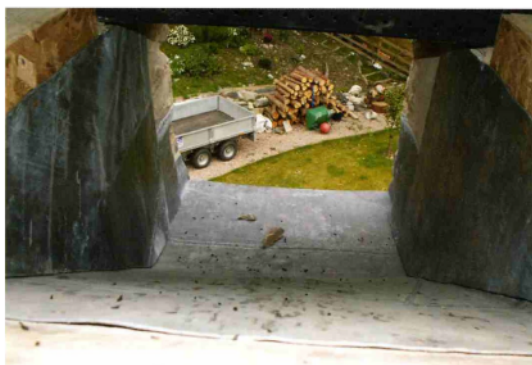
View looking down hopper to outside. Droppings visible on lead.

Angle sufficient for drainage and unsuitable as ledge for birds to gain purchase or nesting.
