Initial Bat Survey: Bodenham Manor, Bodenham, Herefordshire, HR1 3JS.

Report Reference: BM/1377/14.1

On 23rd February 2015, 21st March 2015 and 6th April 2015 an Initial Bat Survey was carried out on Bodenham Manor, Bodenham, Herefordshire, HR1 3JS.

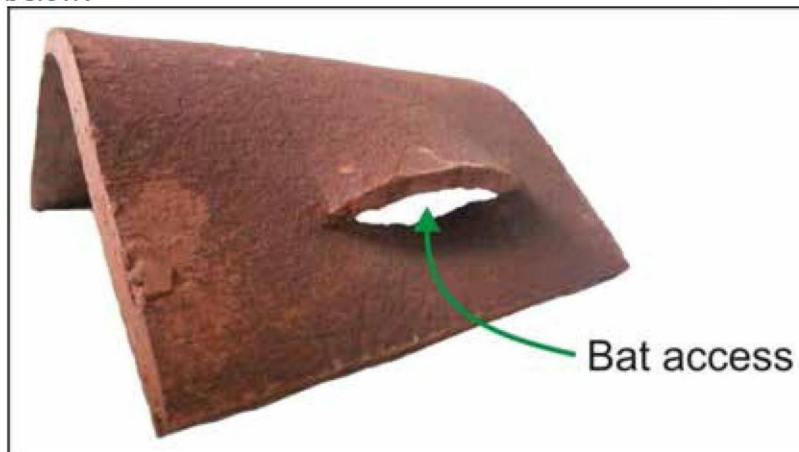
A picture of the Tudor Roof Co. Limited purpose-made ridge tile bat roost is shown below:

Purpose-made ridge tiles with bat-access openings are available commercially. For example, the handmade 'bat access ridge tile' produced Tudor Roof Tile Co. Limited, Dengemarsh Road, Lydd, Kent, TN29 9JH.

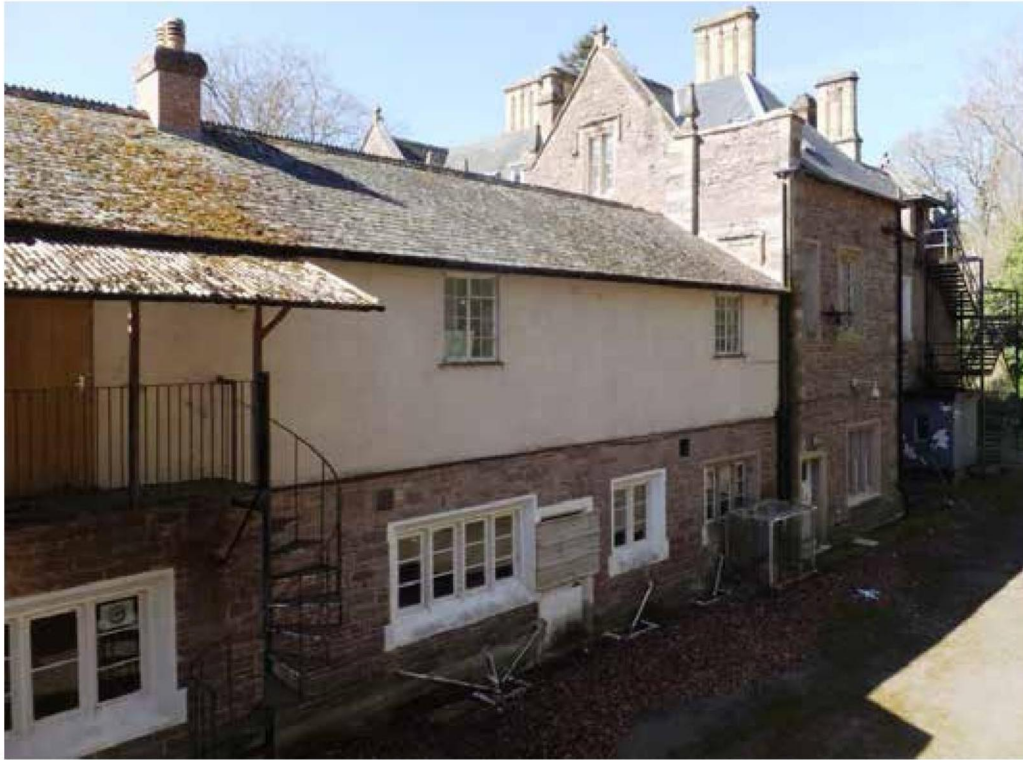
Bodenham Manor. Exteriors.

Left and centre: part of the Northeast elevation of Section B.
Upper centre: part of the Southeast elevation of Section A.
Right: Northeast elevation of Section A.

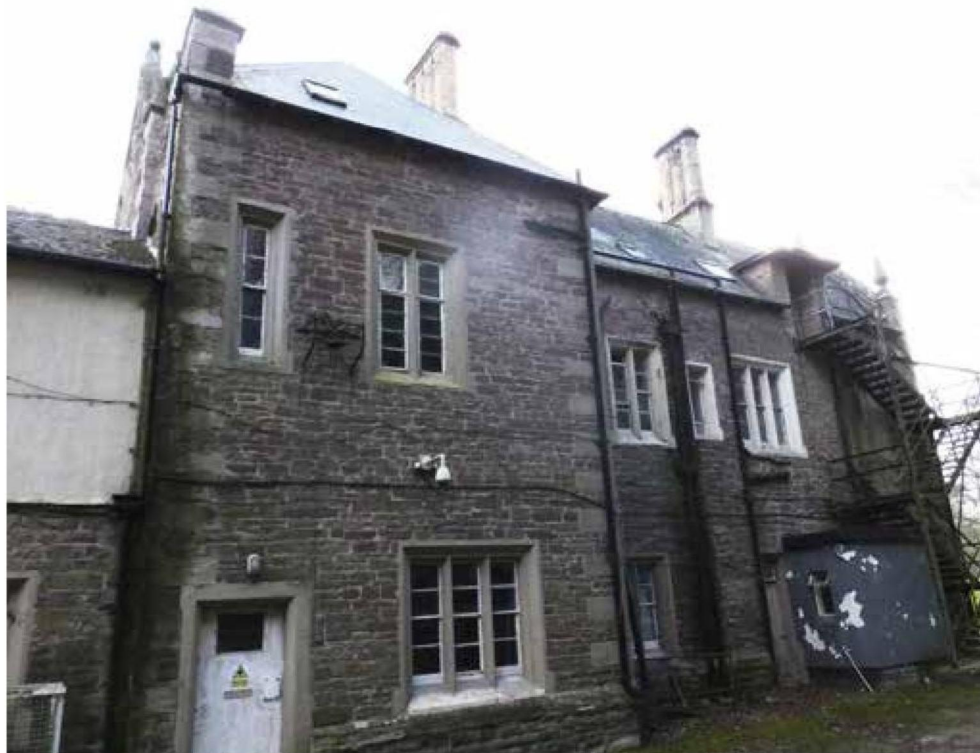
Bodenham Manor. Exteriors.

Extreme left: part of the Northeast elevation of Section B.
Centre and right: Northeast elevation of Section A

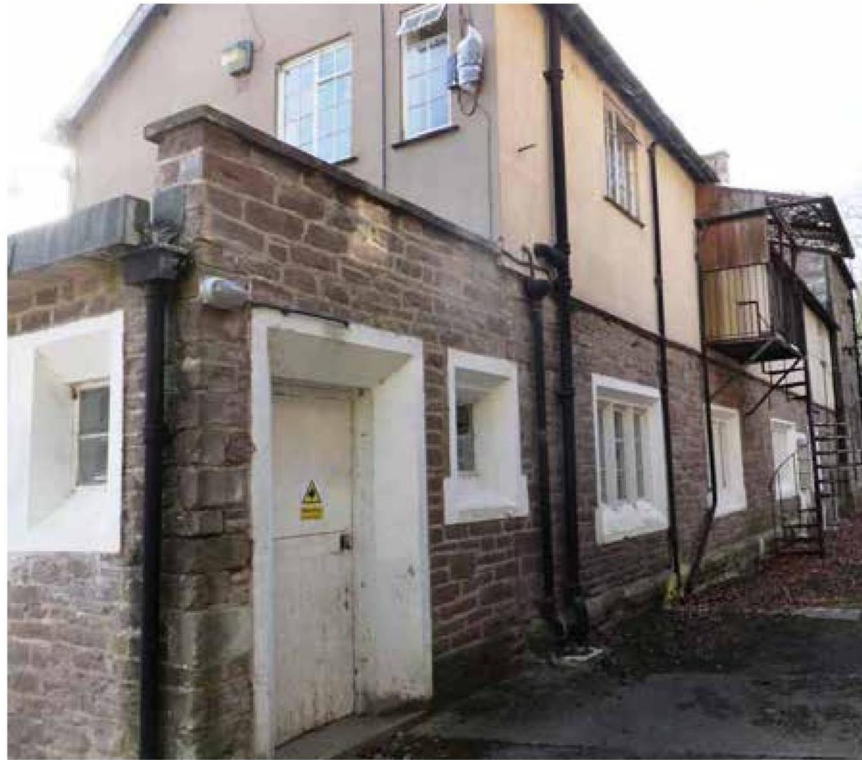
Bodenham Manor. Exteriors.

Lower left: part of the Southeast elevation and the Northeast elevation of single-storey structure at the southeast-end of Section B.

Upper left: Southeast elevation of the main, two-storey, part Section B.

Right: Northeast elevation of the main, two-storey, part of Section B

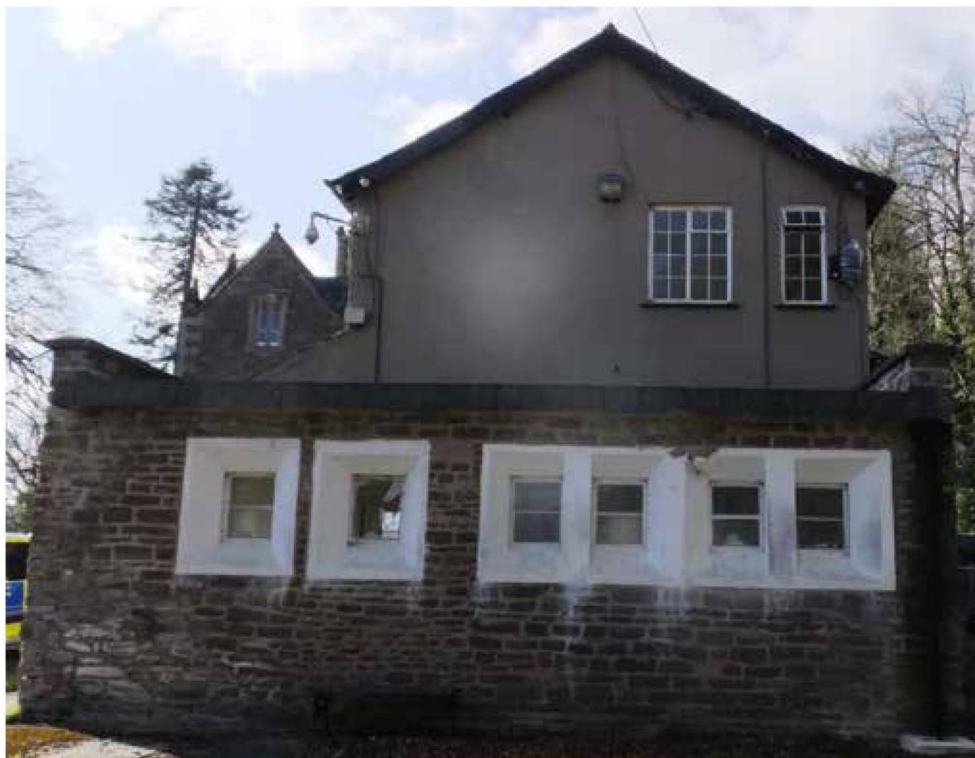
Bodenham Manor. Exteriors.

Upper left: part of the Southeast elevation of Section A.

Main picture: Southeast elevations of Section B.

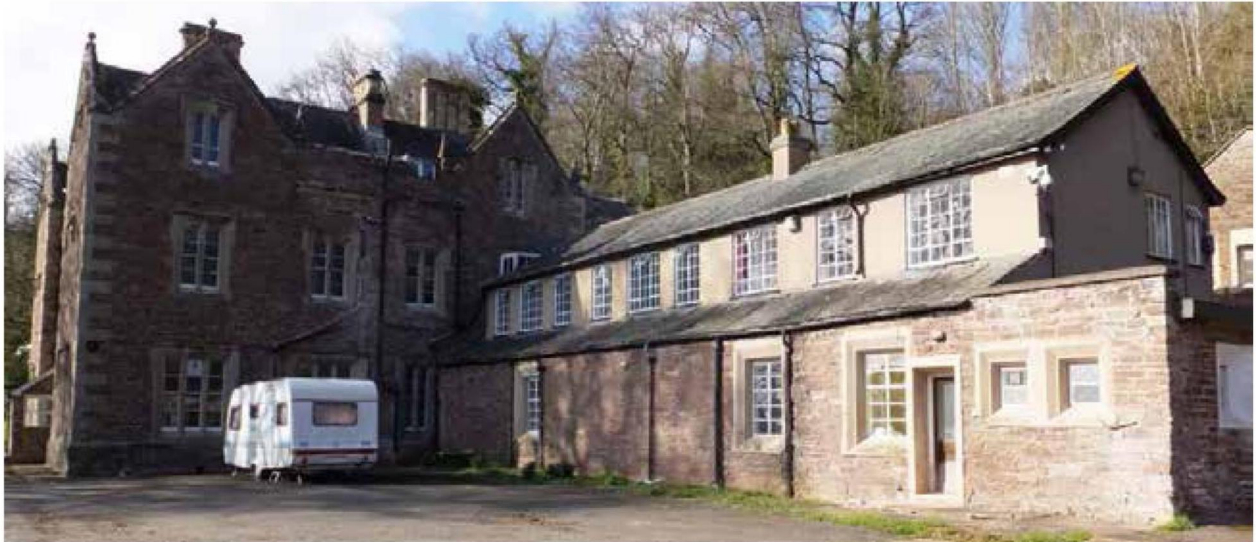
Bodenham Manor. Exteriors.

Extreme left: Southwest elevation of Section A.

Right: Southwest elevations of Section B.

Extreme right: Southeast elevations of Section B.

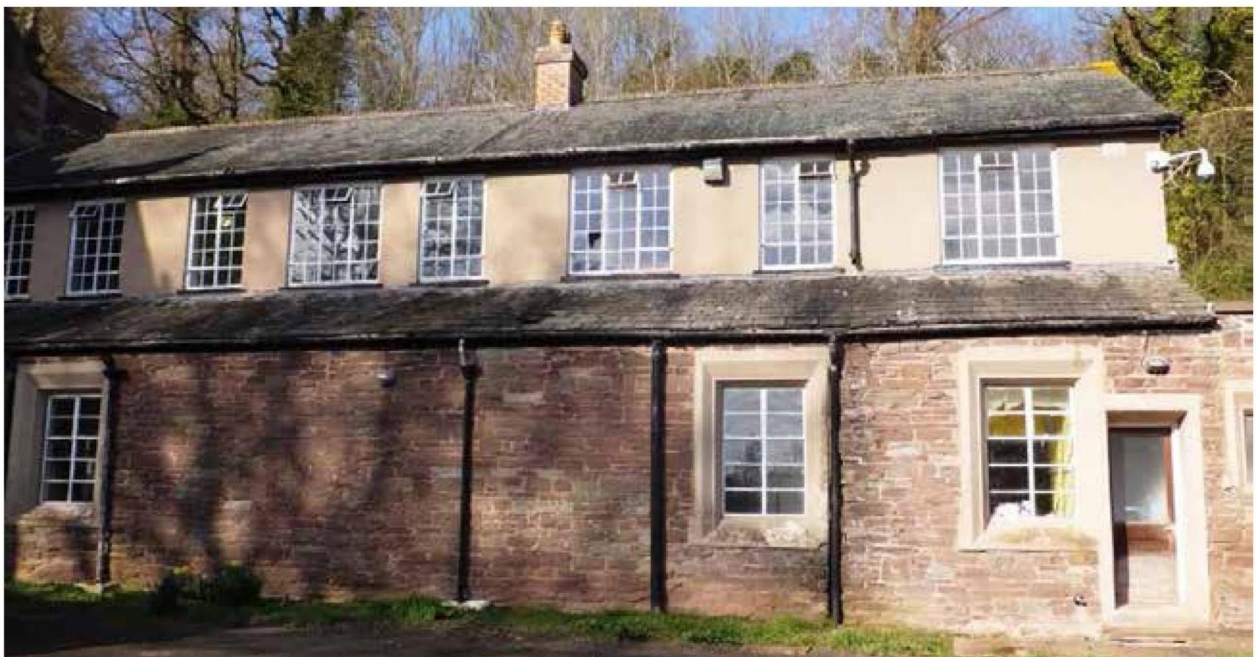
Bodenham Manor. Exterior.

View of part of the Southwest elevation of Section B.

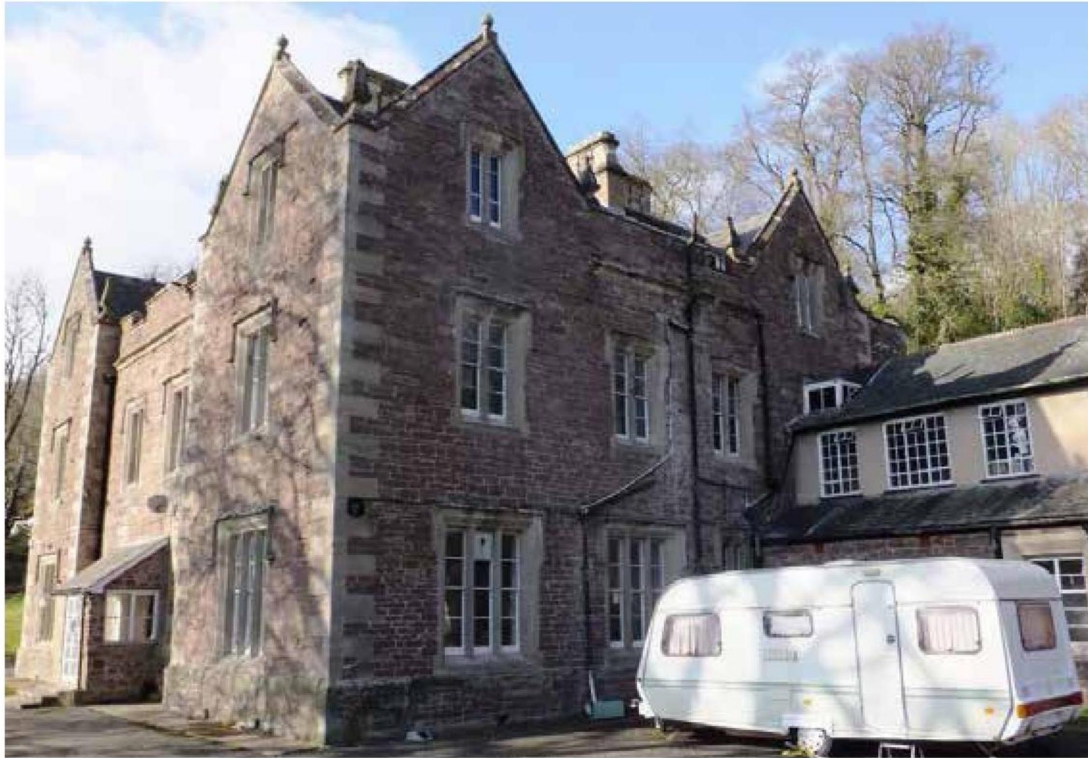
Bodenham Manor. Exterior.

Left: Southwest elevation of Section A.
Centre: Southeast elevation of Section A.
Right: part of the Southwest elevation of Section B.

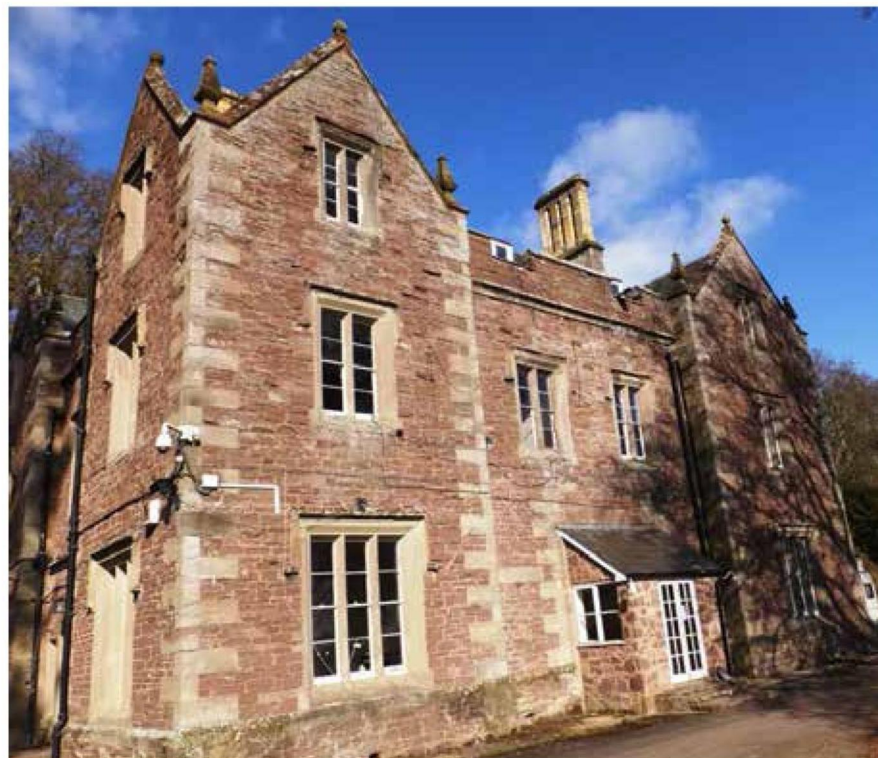
Bodenham Manor. Exterior.

Extreme left: part of the Northwest elevation of Section A.
Main picture: Southwest elevation of Section A.

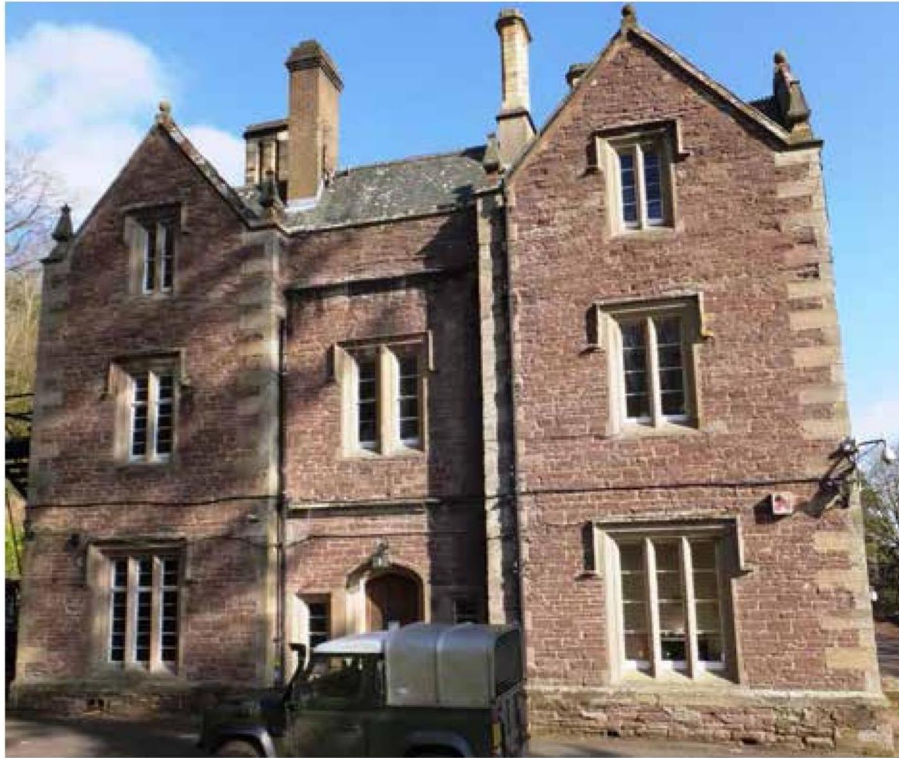
Bodenham Manor. Exterior.
Northwest elevation of Section A.

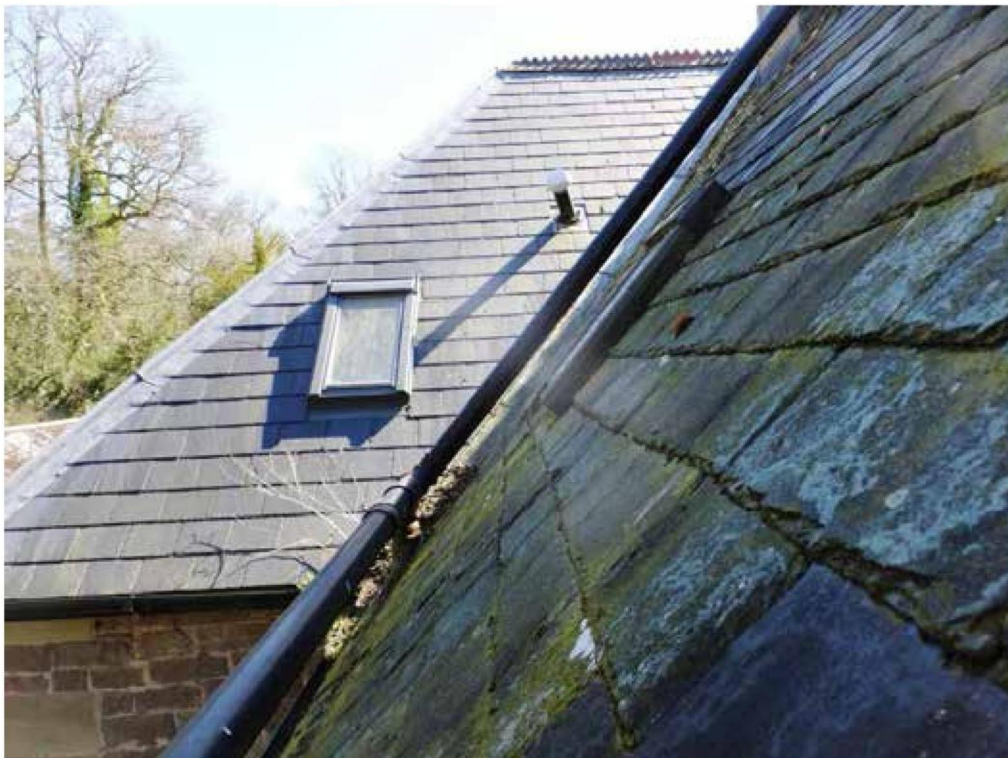
Bodenham Manor. Exterior.
View of part of the Northeast elevation roof structure of Section A.
Left: part of the 'recently' re-covered hipped roof.
Right: part of the main Northeast elevation roof-slope.

The lead ridge cover over the ridge of the hipped section of the roof of Section 1 (above Roof-space 3) is intact, close-fitting and in 'new' condition.

Lead hip ridges are intact and close-fitting and in 'new' condition.

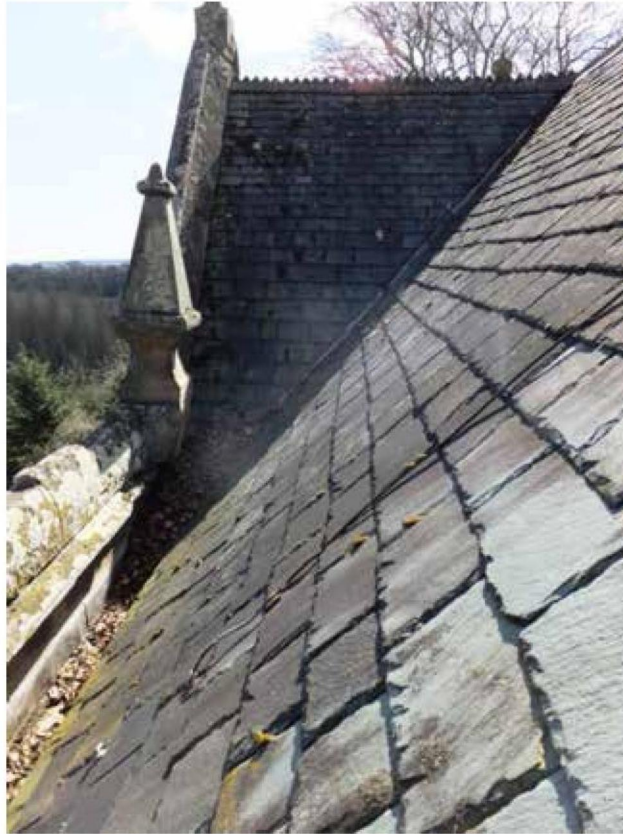
Bodenham Manor. Exterior.

View of the main Southeast elevation roof-slope of Section A.

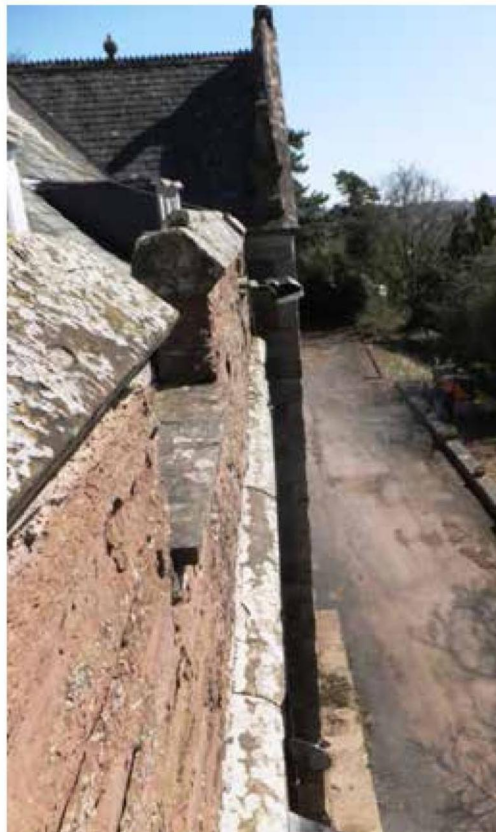
Bodenham Manor. Exterior.

View of part of the Southwest elevation parapet wall of Section A.

There are two missing-mortar holes/crevices within the southwest elevation wall of Section A. The holes/crevices are within approximately 0.40m of the base of the parapet and are too-shallow to be used by bats for roosting purposes. Furthermore one of the holes/crevices appears to be subject to water ingress caused by water moving through the base of the parapet - due to the failure of the parapet gutter.

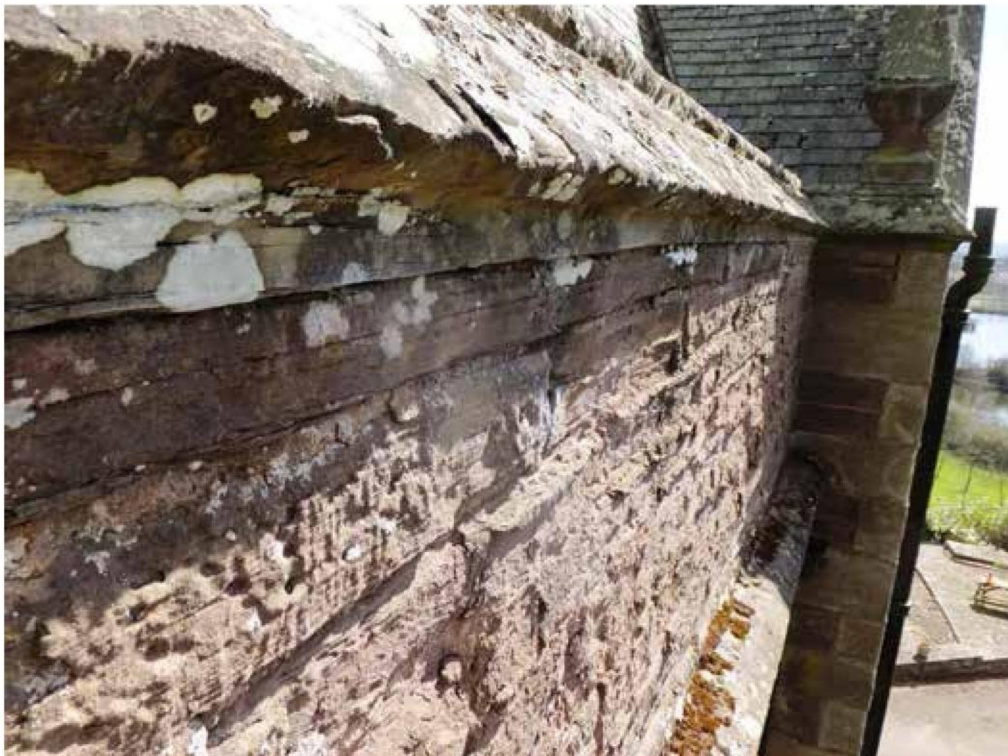
Bodenham Manor. Exterior.

There are no missing-mortar crevices within the parapet wall structure which may be used by for roosting purposes. Where missing-mortar crevices are present they are on/within the interior faces of the wall and are too-shallow for use by bats and/or full of debris and/or subject to water ingress (as the crevices are usually within the area of the parapet gutter).

View of part of the Northwest elevation parapet wall of Section A.

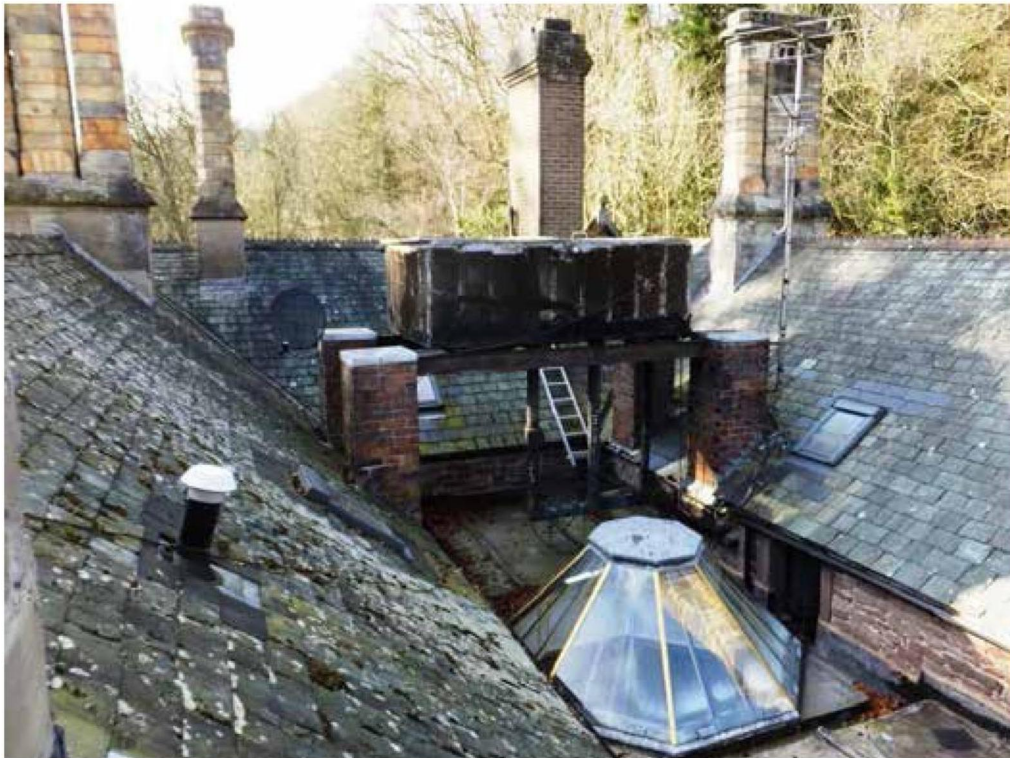
the 'flat' roof. The internal second-floor roof gutter is blocked and full of leaf debris which may have contributed to the blocking of the water collection hopper. In any event the wall crevices are either too shallow for use by bats for roosting purposes and/or full of algae and/or moss. Consequently, none of the missing-mortar wall crevices are considered to provide bat roosting potential.

Bodenham Manor. Exterior.
View of the central roof area of Section A.
Looking northwest from southeast.

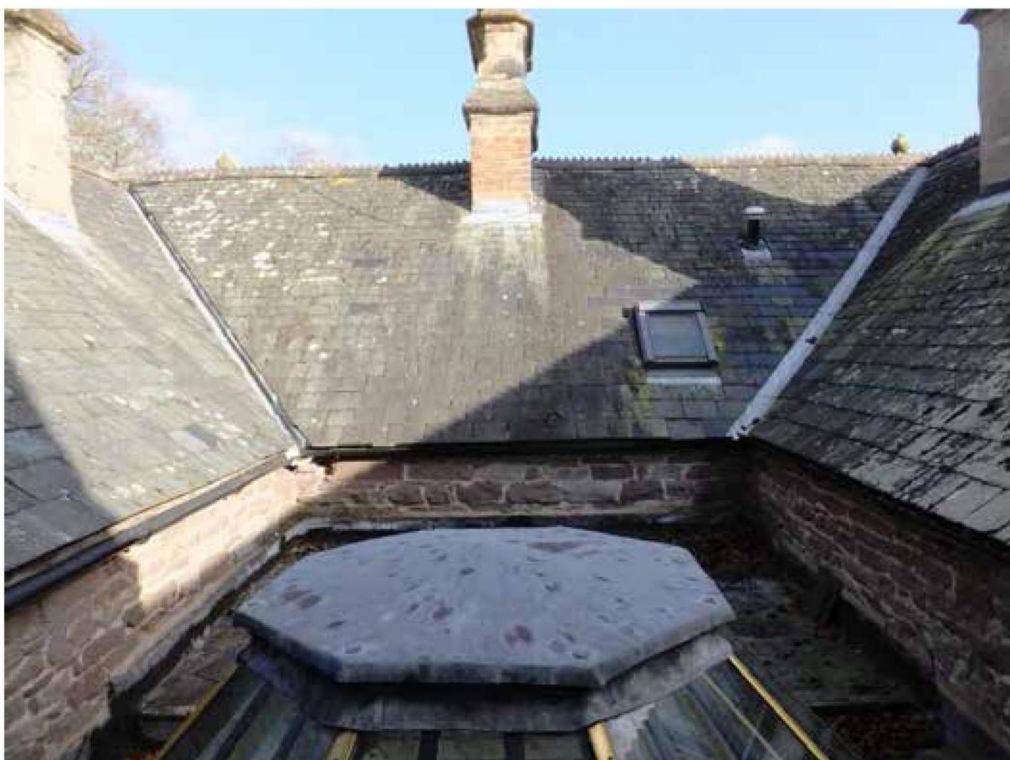
Bodenham Manor. Exterior.
View of the Southeast part of the central roof area of Section A.
Looking southeast from northwest.

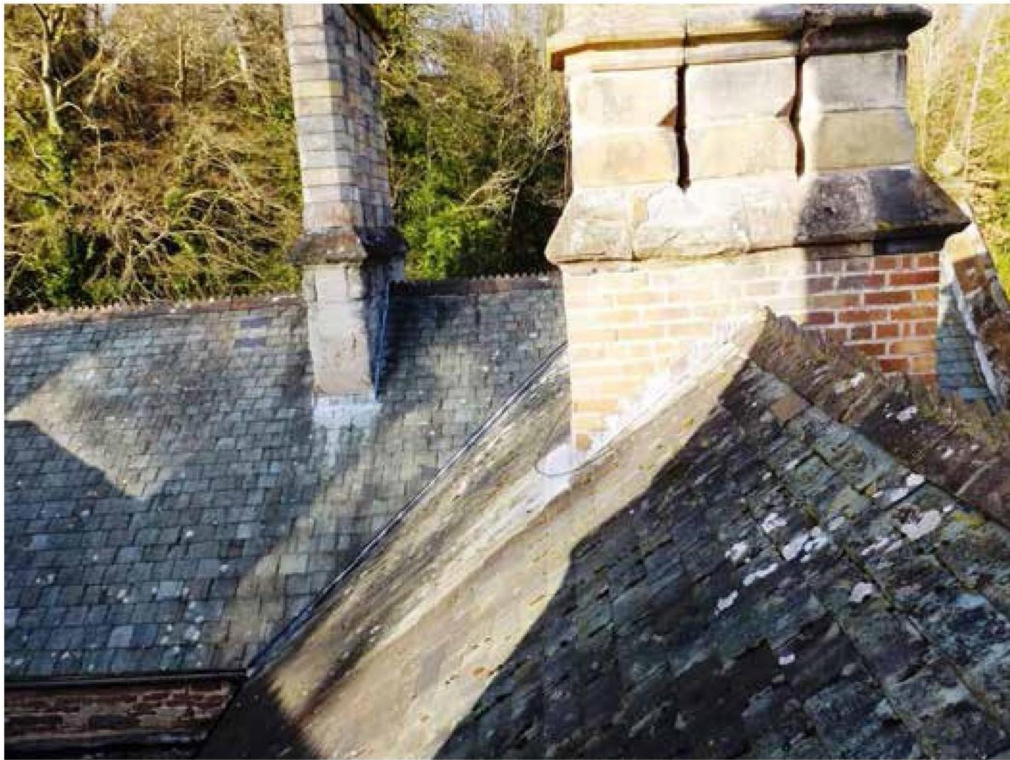
Bodenham Manor. Exterior.

'Typical' view of the apex roofs and chimney abutments of the Section A roof structure.

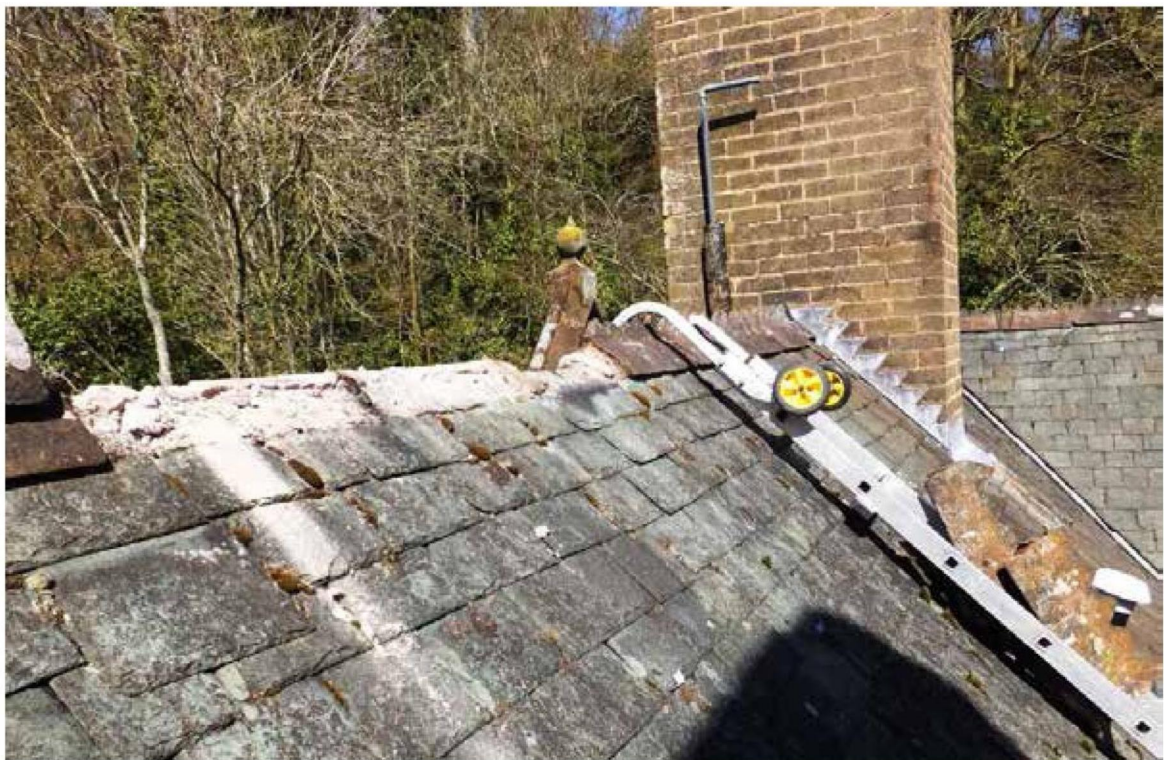
Bodenham Manor. Exterior.

Example of the temporary removal of ridge tiles from apex roofs of Section A to allow the inspection of the undersides of the tiles for physical evidence of bats.

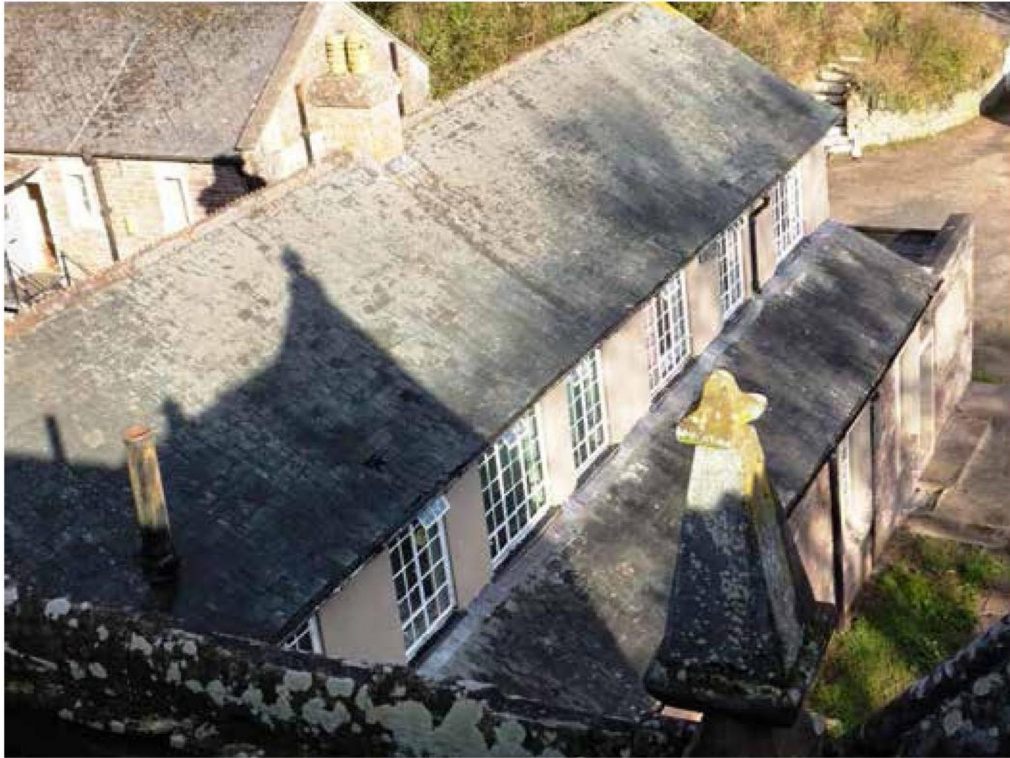
Bodenham Manor. Exterior.

View of the Southwest elevation roof-slopes of Section B.

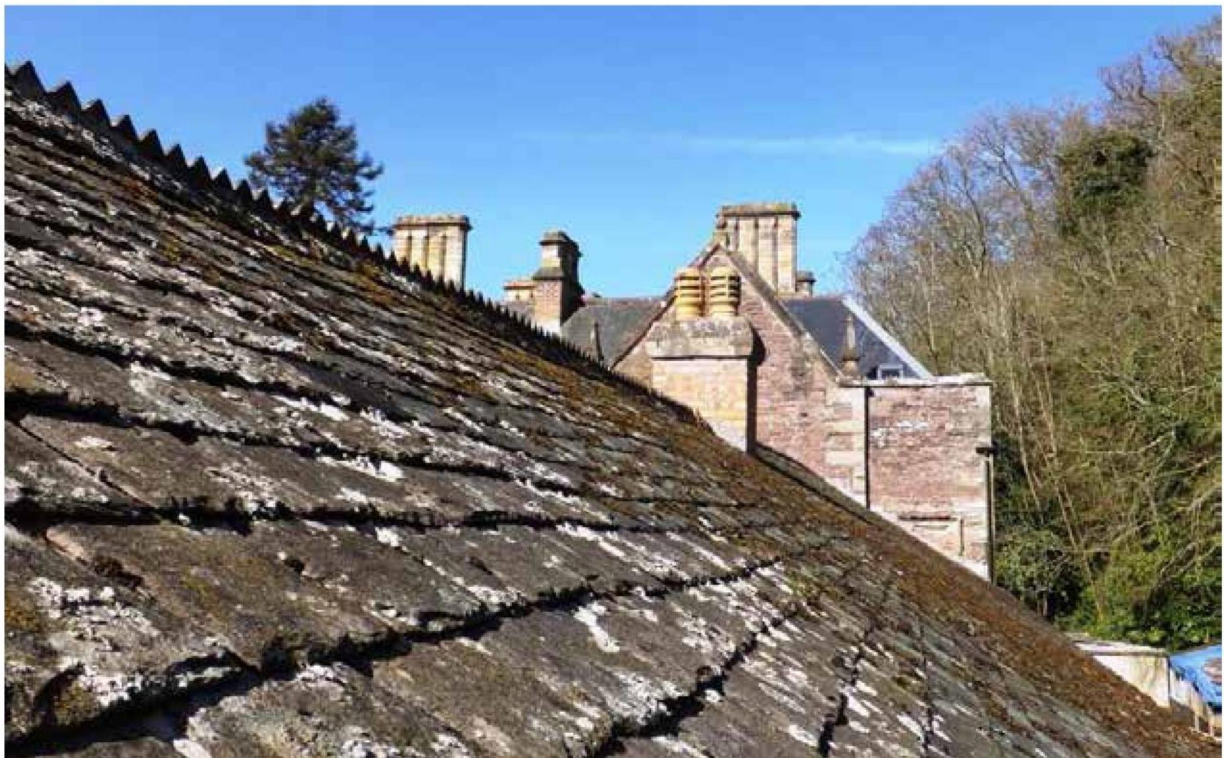
Bodenham Manor. Exteriors.

Left, centre and lower right: view of the Northeast elevation roof-slope of the main, two-storey, part of Section B.

Upper right: part of the Southeast elevation of Section A.

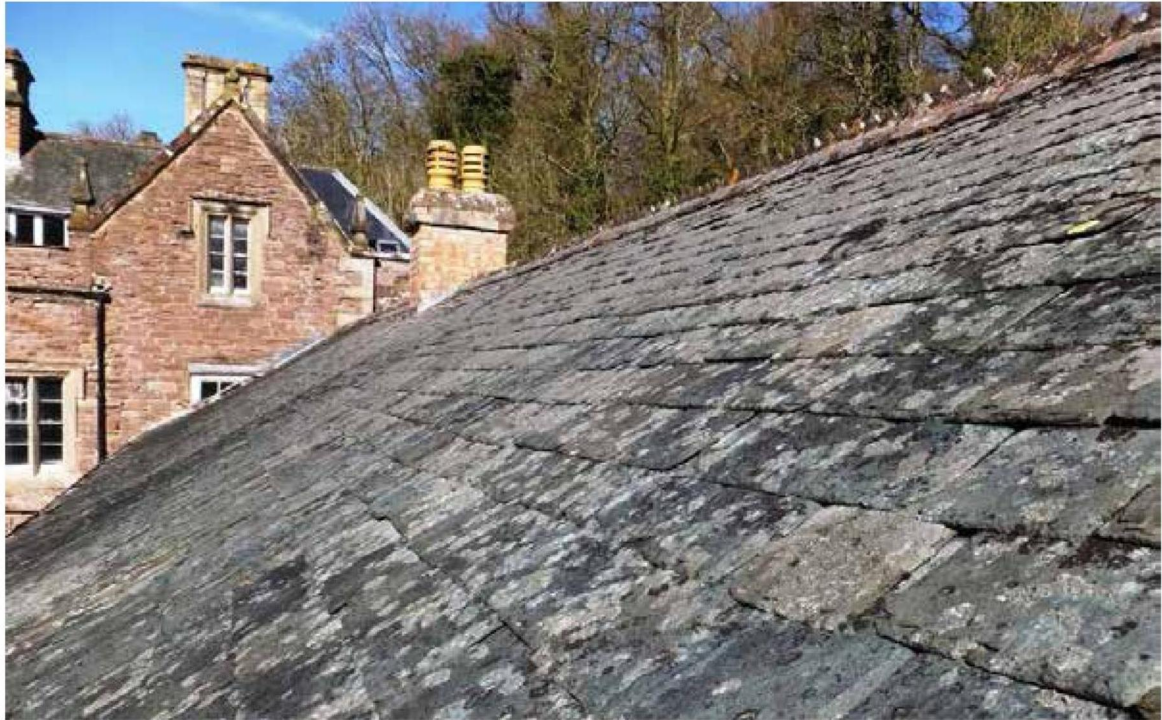
Bodenham Manor. Exterior.

Upper left: part of the southeast elevation of Section A.
Lower left, centre and right: Southwest elevation roof-slope of the main, two-storey, part of Section B.

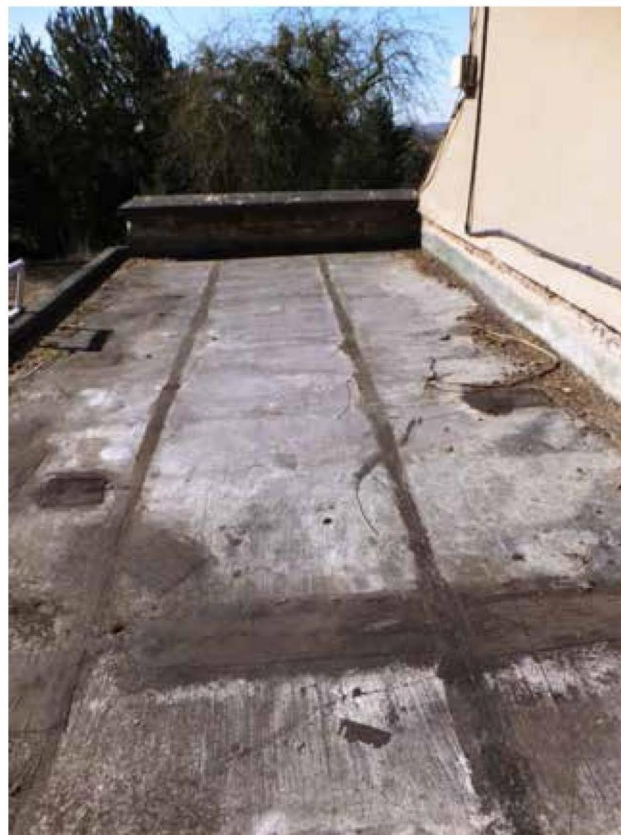
Bodenham Manor. Exterior.

Centre: view of the 'flat' roof of the single-storey structure at the Southeast-end of Section B.

Upper right: the Southwest elevation of the single-storey structure at the southwest of Section B and part of the Southwest elevation of the main, two-storey, part of Section B.

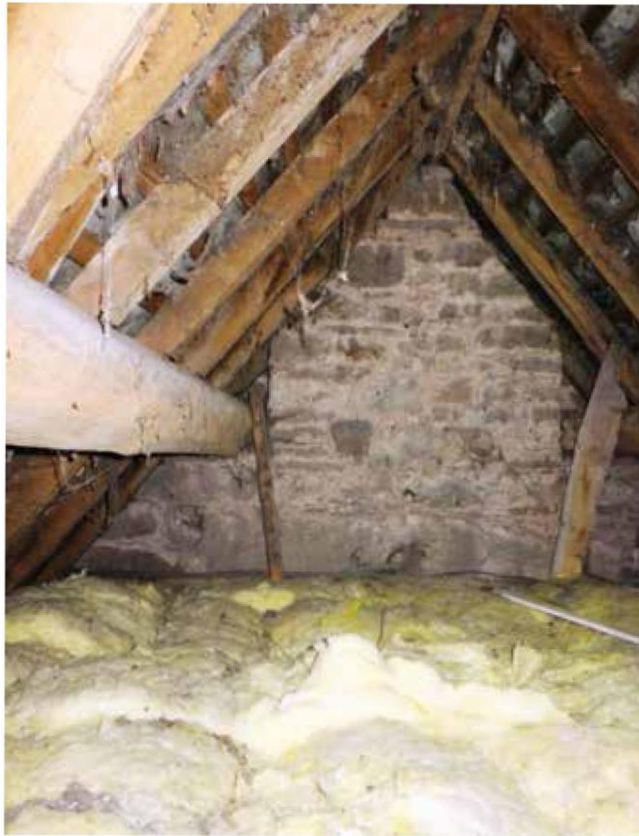
Bodenham Manor. Interior.
A view of part of Roof-space 1.

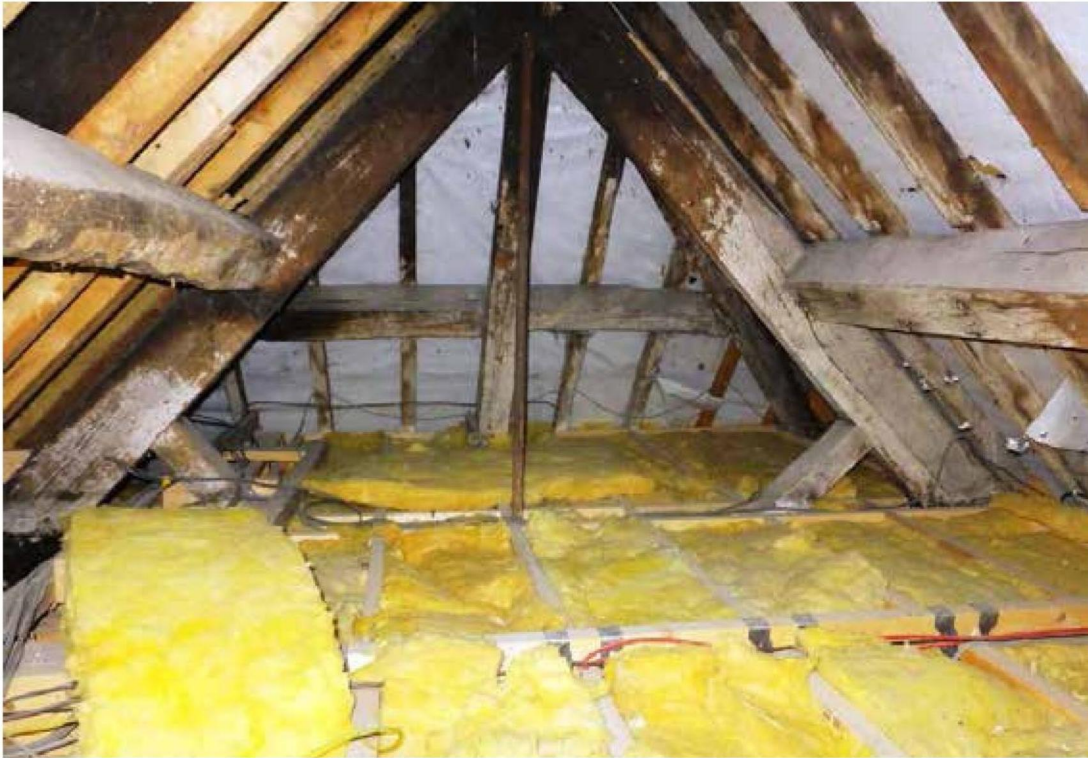
Bodenham Manor. Interior.
A view of part of Roof-space 3.

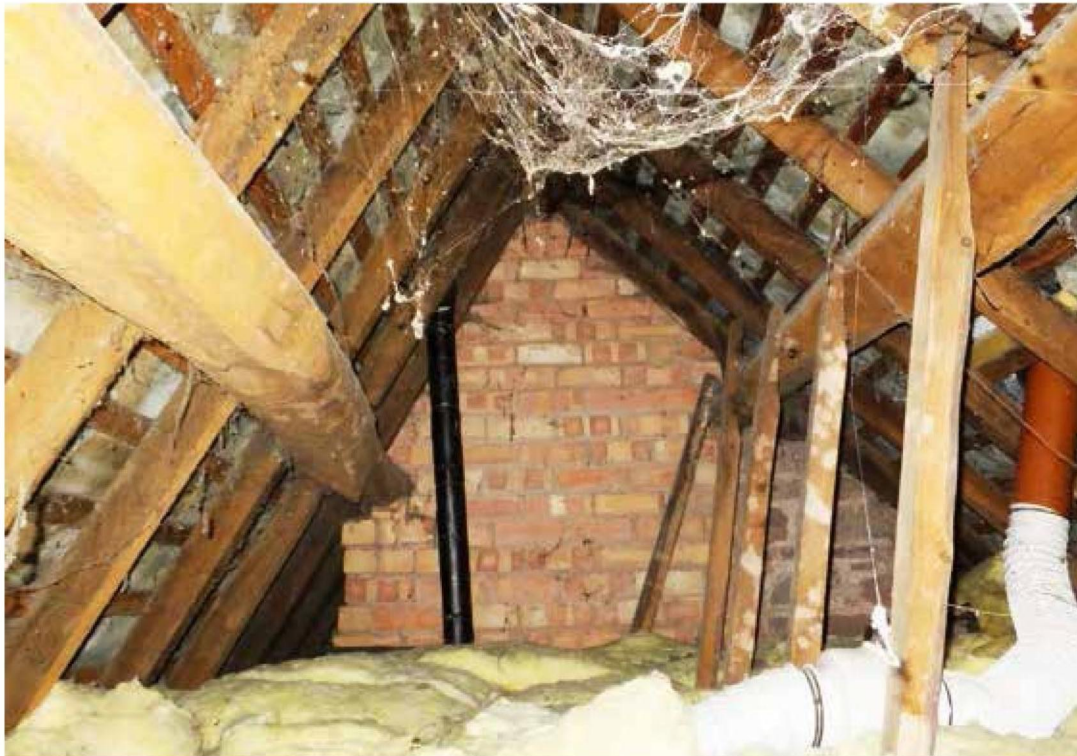
Bodenham Manor. Interior.
A view of part of Roof-space 4.

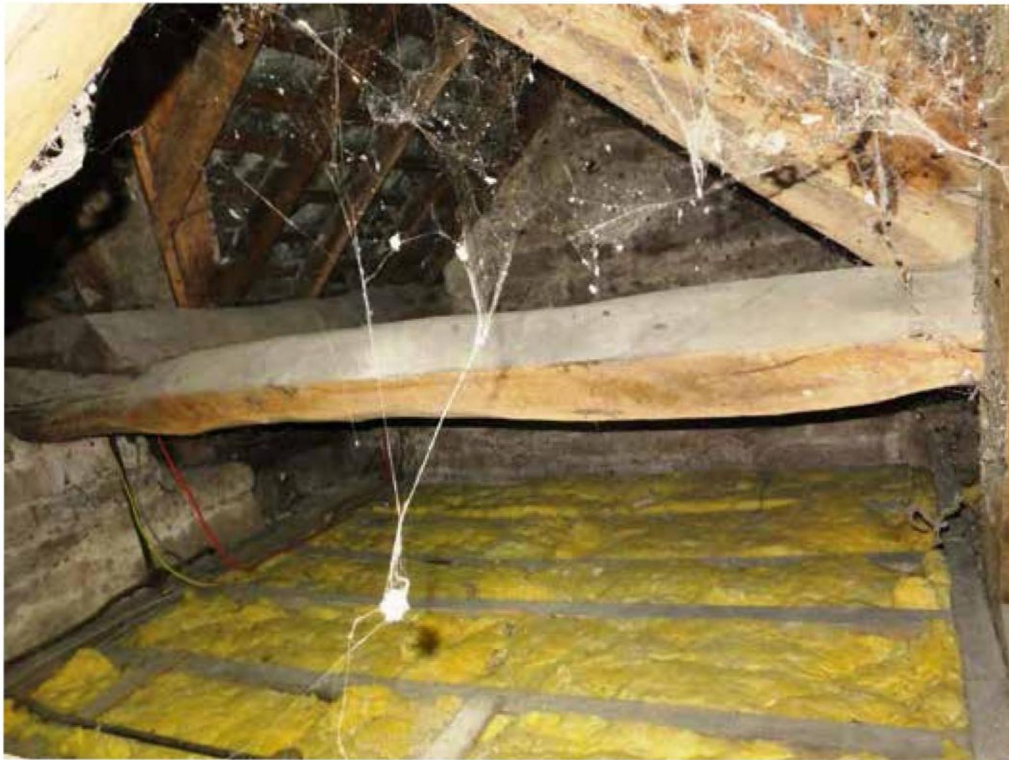
Bodenham Manor. Interior.
A view of part of Roof-space 5.

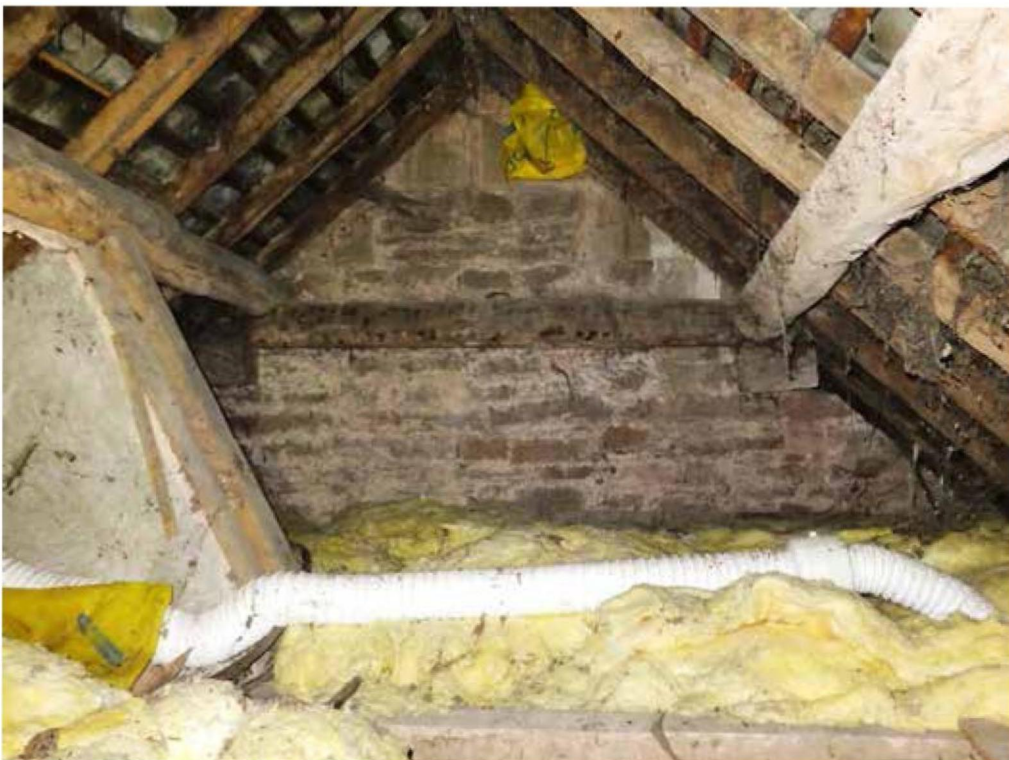
Bodenham Manor. Interior.
A view of part of Roof-space 6.

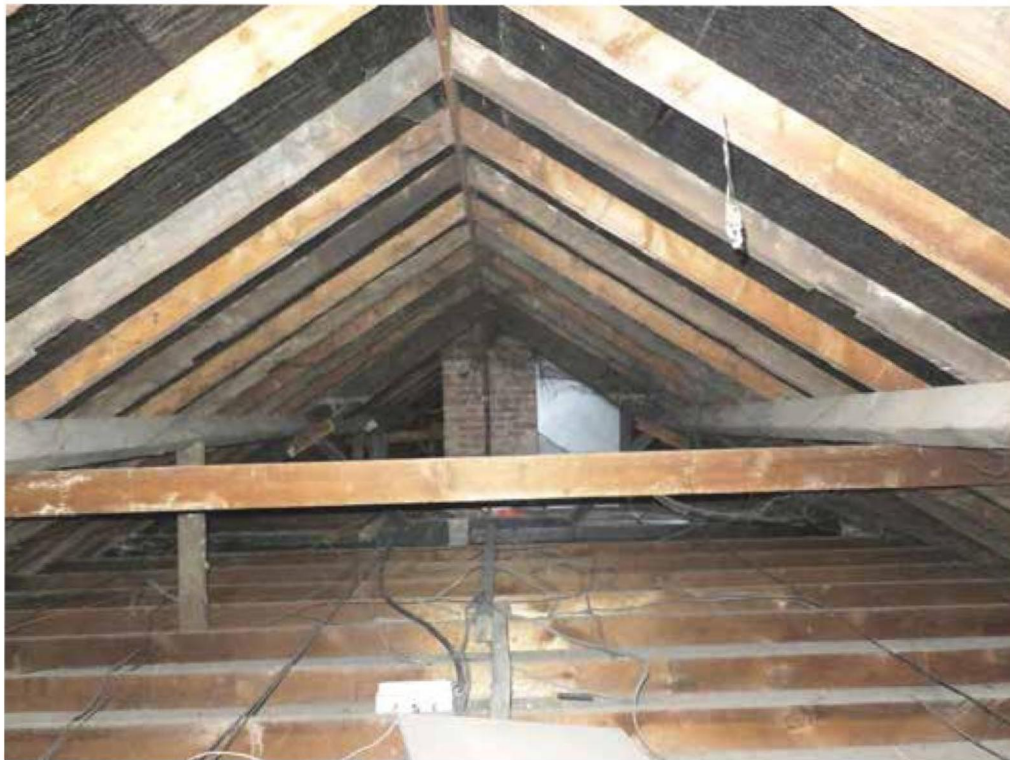
Bodenham Manor. Interior.
A view of part of Roof-space 8.

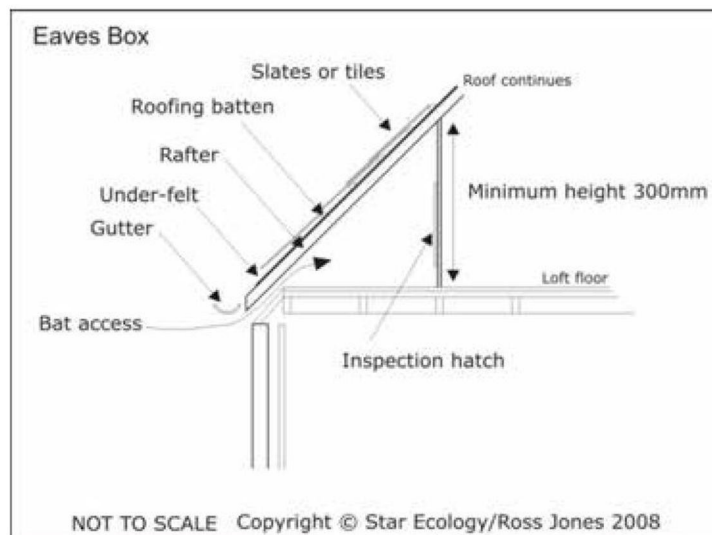
Cross section of Eaves Box.

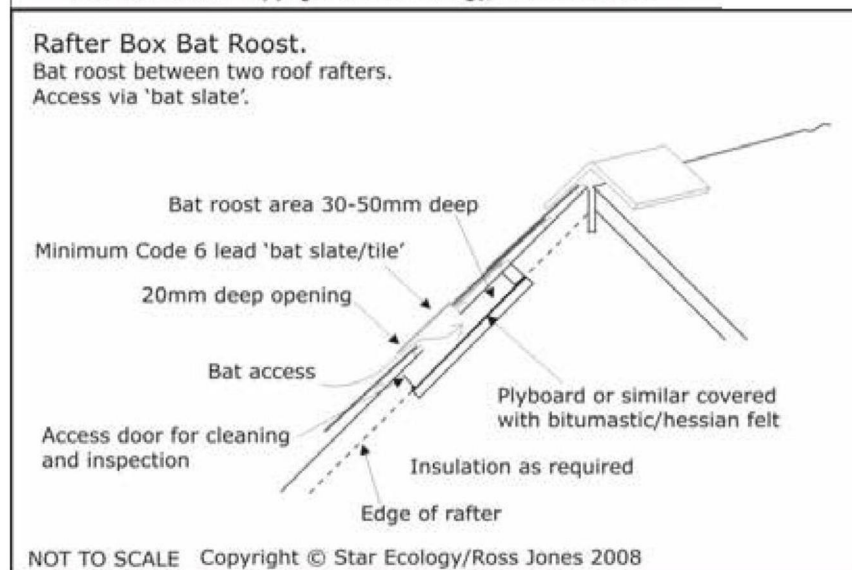
Rafter Box.
Midway on roof slope.
Access via lead 'bat slate' or 'tile'.

Rafter Box.

Bat roost between two roof rafters.

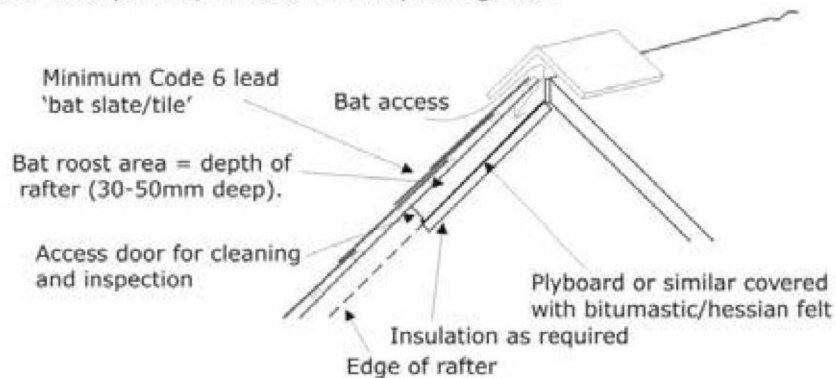
Rafter Box.

Access via ridge tile.

Exterior Common Rafter Crevice with roost cavity on top of gable wall.
