Initial Bat Survey: Bodenham Manor, Bodenham, Herefordshire, HR1 3JS.

Report Reference: BM/1377/14.1

On 23rd February 2015, 21st March 2015 and 6th April 2015 an Initial Bat Survey was carried out on Bodenham Manor, Bodenham, Herefordshire, HR1 3JS.

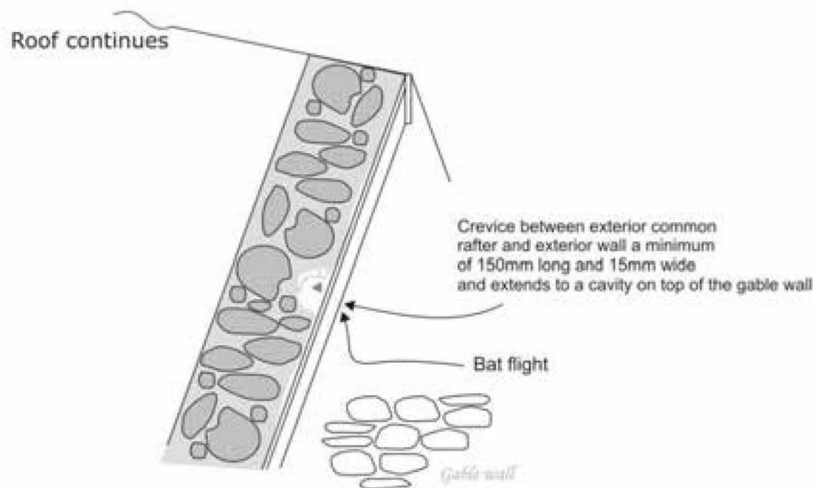
Exterior Common Rafter Crevice

leading to a roosting cavity on the top of a gable wall.

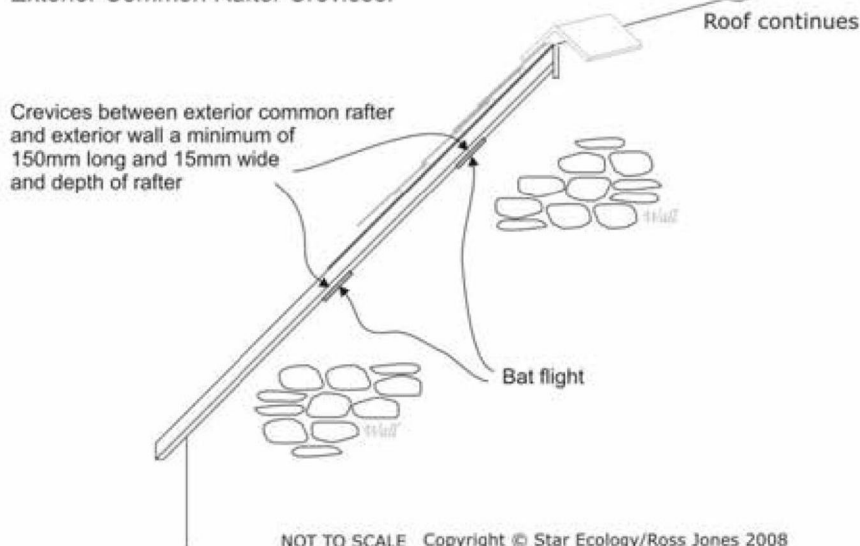
Exterior Common Rafter Bat Crevices

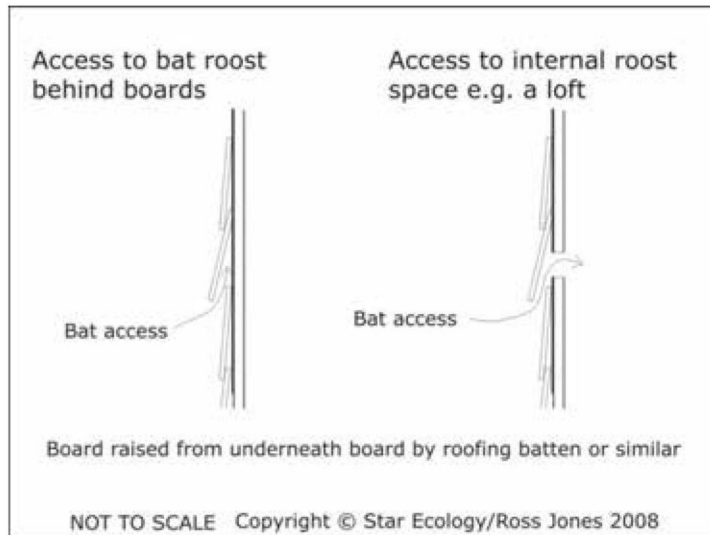
Bat roost access via external timber weatherboarding.

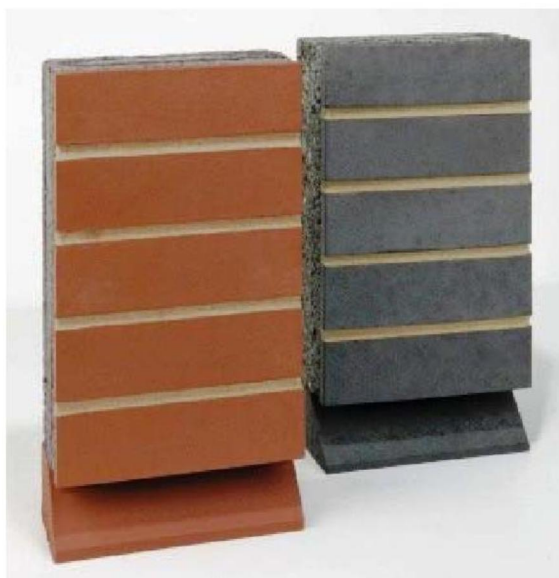
The **Wienerberger Ecosurv** Bat Box.

Boxes may be purchased with brick fascias to match those of existing walls or those of proposed new walls.

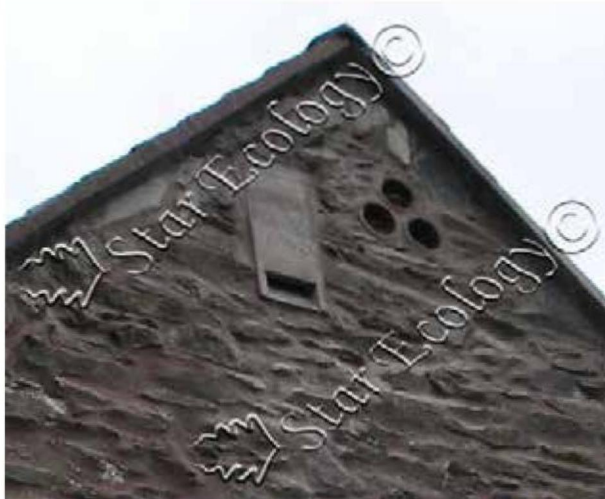
Schwegler 1FR Bat Tube built into stone gable wall.
Hay loft ventilation pipes have been retained for potential use by small birds for nesting.

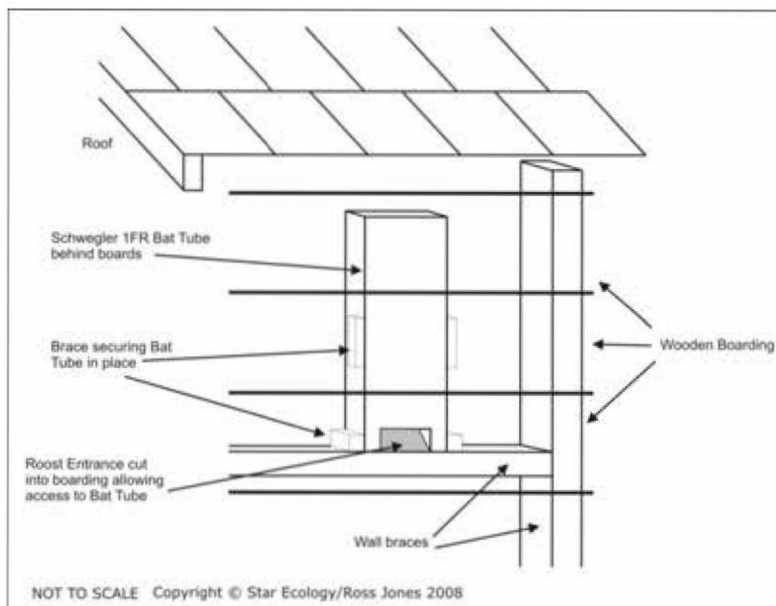
Schwegler 1FR Bat Tube incorporated into building structure of timber framed building, behind external wooden boarding.

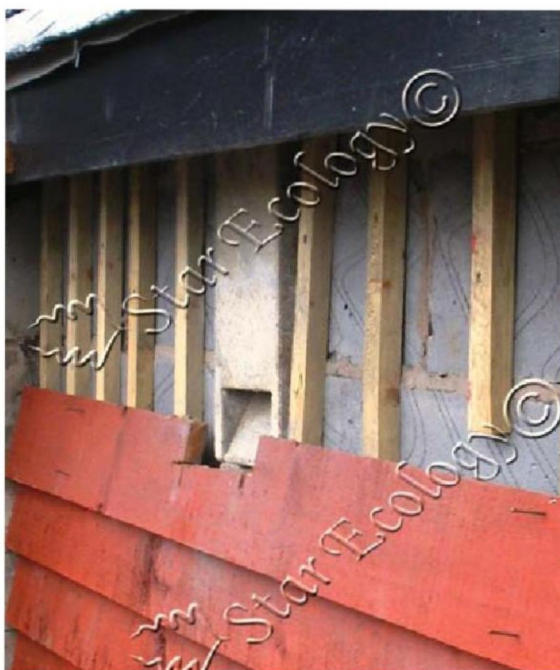
Schwegler 1FR Bat Tube built into thermalite® building block wall.
Weatherboarding will cover the Bat Tube, leaving access permanently open for bats.

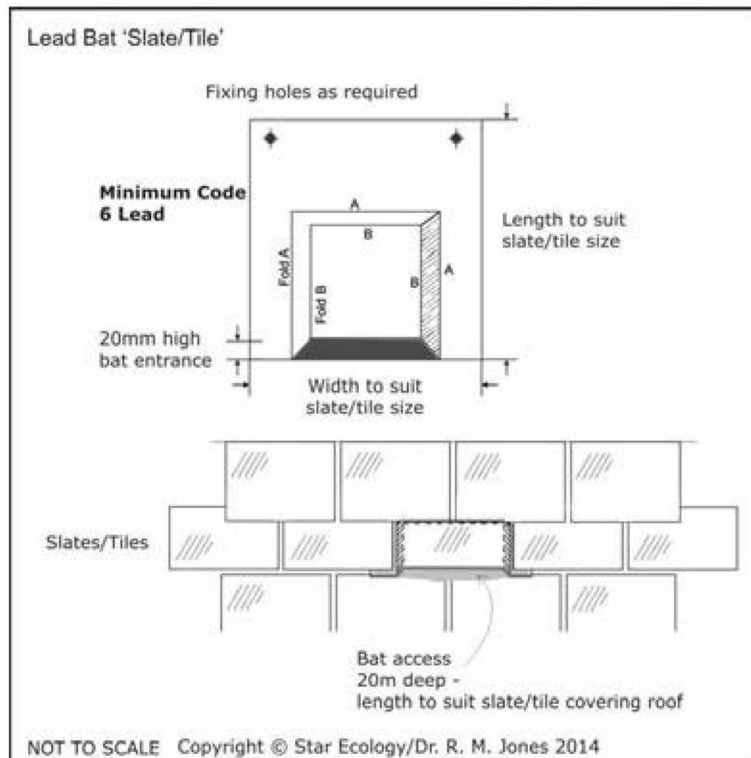
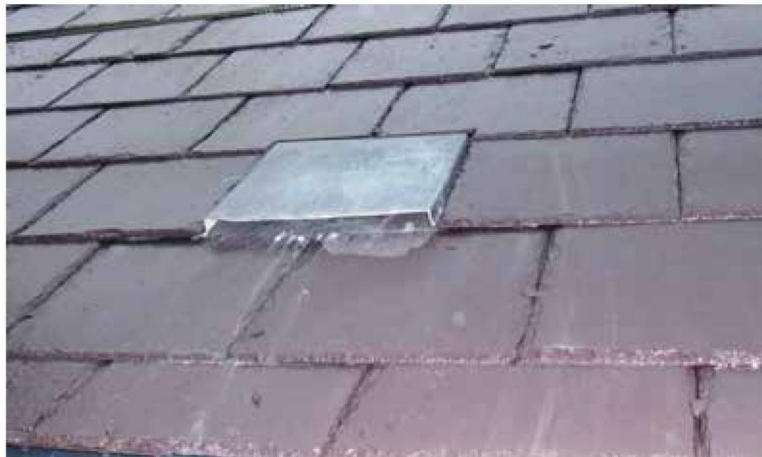
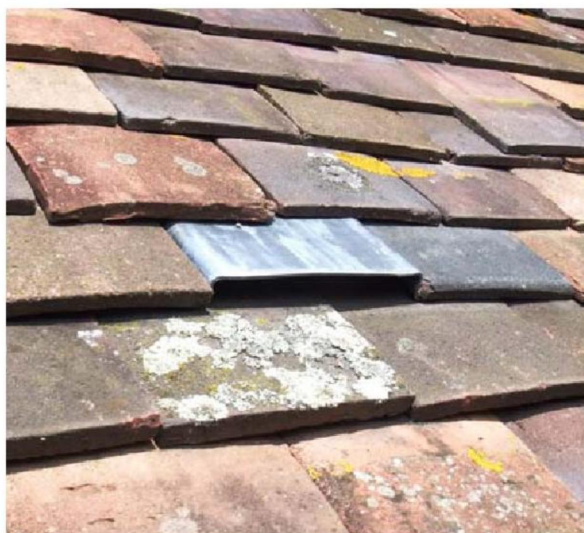
APPENDIX 4 – Lead Bat 'Slate/Tile' Plan and Photographs

Slate-line Bat Vent

The Bat Vent comprises of an exterior vacuum formed weathering cow! let into the body of a slate to allow entry and is combined with an injection moulded base which includes a factory applied non slip surface facilitating easy access for the bats into the roof space
