Appendix C

Principles of Environmental Risk Assessment

Appendix F

Photolog

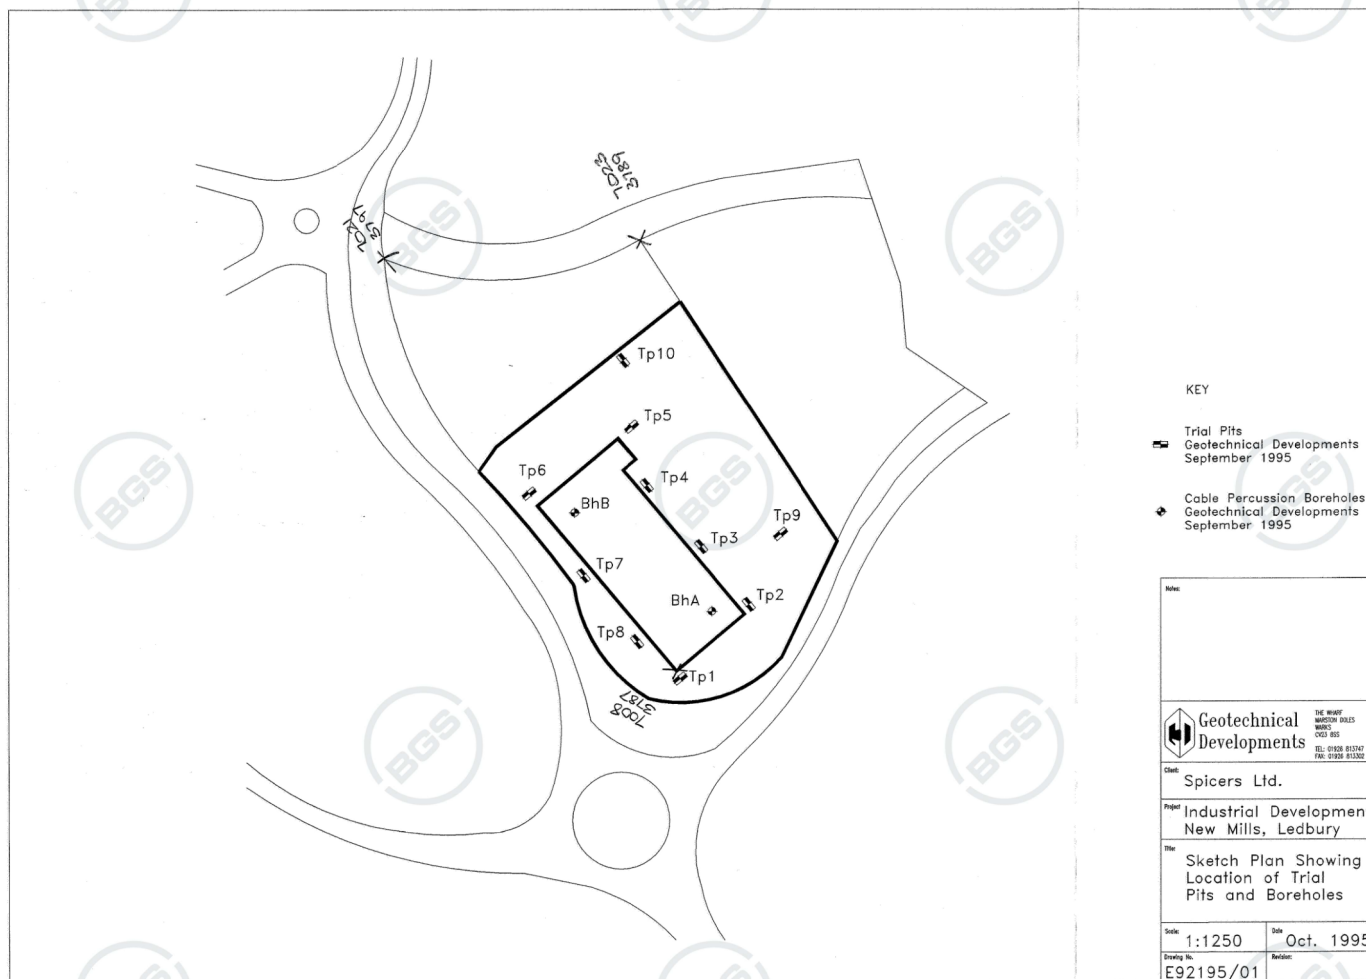
GEOTECHNICAL DEVELOPMENTS						BOREHOLE LOG			
GEOTECHNICAL INVESTIGATION SERVICES						Borehole B			
Telephone (01926) 813747. Fax (01926) 813302.						Sheet 1 of 1			
Method Cable Percussion		Date 05/09/95		Site Industrial Development New Mills, Ledbury					
Dia mm 150		Coord 370000E 237800N		Ground Level m.OD		Client Spicers Ltd. Ledbury			
Soil Samples/Tests		Field Records		OD Level m.	Depth m.	Description of Strata	Legend		
Type/Test	Depth m.								
B1	0.00 - 0.50					Topsoil above silty CLAY (TOPSOIL/HEAD) (0.50)			
B2	0.50 - 1.00				0.50	Very stiff silty gravelly CLAY (HEAD) (0.40)			
S1 N=54	1.00 - 1.45	,17/14,14,13,13			0.90	Very dense/dense orange/red brown slightly sandy silty fine to medium GRAVEL (TERRACE DEPOSIT) (2.10)			
B4	1.45 - 2.00								
S2 N=47	2.00 - 2.45	,16/11,12,12,12							
B6	2.45 - 3.00	Strike							
S3 N=49	3.00 - 3.45	,16/11,12,12,14			3.00	Dense to very dense orange brown fine to coarse slightly sandy fine to medium GRAVEL. (WEATHERED RAGLAN FORMATION/TERRACE DEPOSIT) (1.40)

B8	3.45 - 4.15								
S4 N=83	4.15 - 4.60	,20/12,13,25,33			4.40	Very dense/hard/moderately weak red brown gravelly silty MUDSTONE/clayey SILTSTONE (RAGLAN FORMATION) (1.60)			
B10	4.40 - 5.55								
S5 N=115	5.55 - 6.00	,23/17,21,34,43			6.00				
Remarks Water encountered at 2.50m bgl. Depth of casing 2.50m bgl. Sealed at 4.60m bgl. Standpipe installed at 5.85m bgl. See installation drawing for details.						Logged by JCE	Scale 1:50	End Casing Depth m.	Job No. E92195
						Sample/Test key: U () U100 sample (blows) D () Disturbed sample B () Bulk sample W () Water sample - Progress & Day

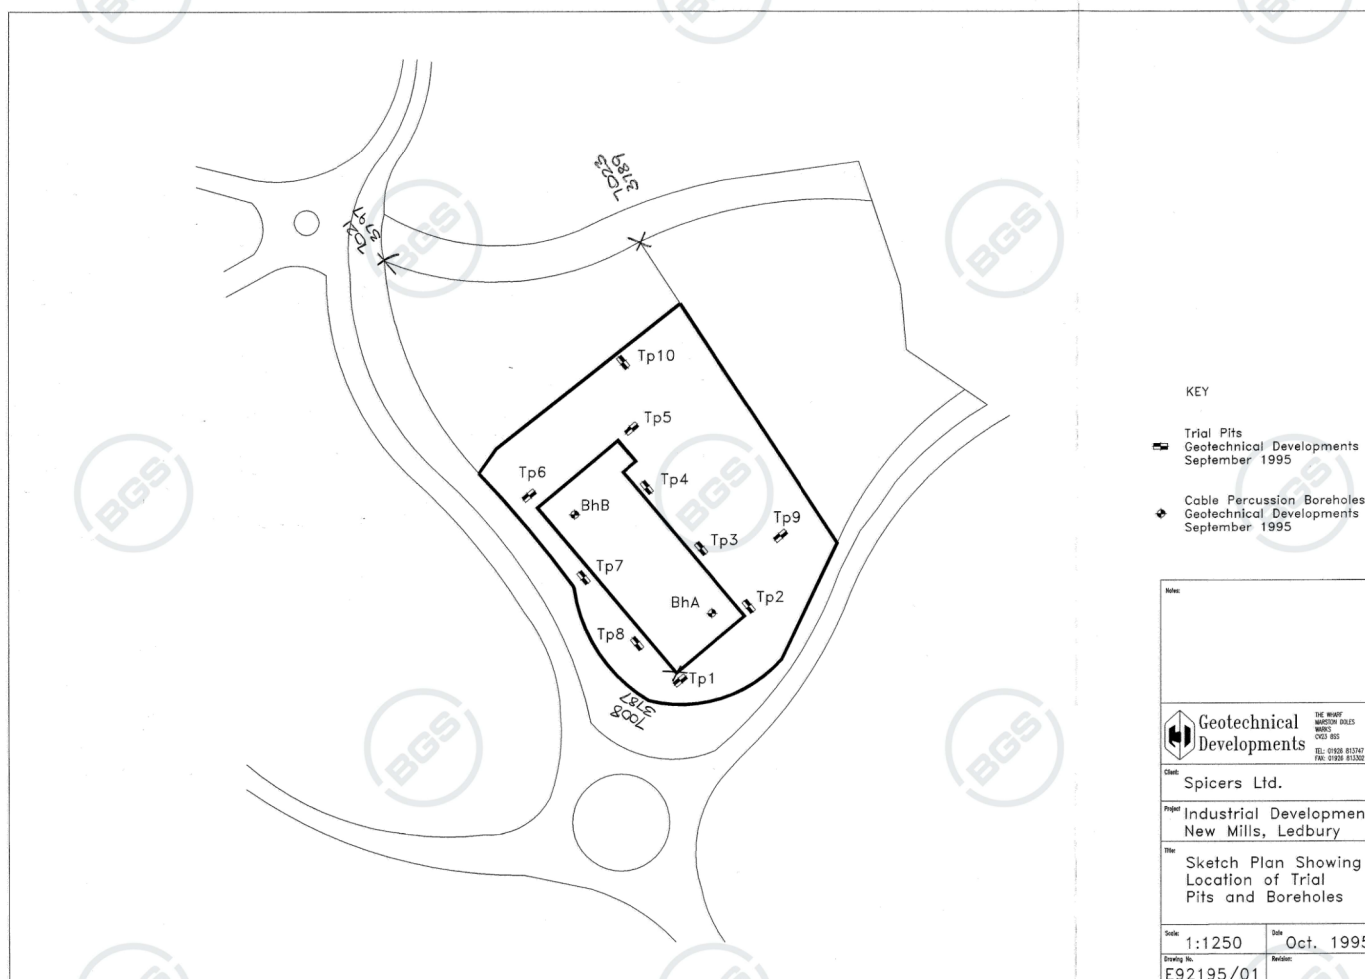
GEOTECHNICAL DEVELOPMENTS					TRIAL PIT LOG	
GEOTECHNICAL INVESTIGATION SERVICES					Trial Pit 02	
Telephone (01926) 813747. Fax (01926) 813302.					Sheet 1 of 1	
Method JCB-3CX Sitemaster		Date 04/09/95		Site Industrial Development New Mills, Ledbury		
Dia mm		Coord 370000E 237800N		Ground Level m.OD Client Spicers Ltd., Ledbury		
Soil Samples/Tests		Field Records		Description of Strata		Legend
Type/Test	Depth m.			OD Level m.	Depth m.	
D1	0.40				0.30	Hard fissured gravelly/clay TOPSOIL with many roots. (0.30)
B1	0.80 - 1.80				0.70	Very hard, fissured red/orange brown gravelly silty sandy CLAY. (HEAD) (0.40)

2.10	Very dense/dense, orange brown mottled green grey fine to coarse angular to well rounded sandy GRAVEL with occasional cobbles of angular sandstone/siltstone. (TERRACE DEPOSIT) (1.40)
D2	2.30				2.70	Loose to medium dense orange/red brown fine to coarse angular silty slightly clayey SAND with occasional cobbles of sandstone/siltstone. (TERRACE DEPOSIT) (0.60)
		Rapid ingress.			3.20	Very dense/Coarse uniformly graded/angular GRAVEL of siltstone/fine sandstone. (TERRACE DEPOSIT) (see note) (0.50)
Remarks Sides of trial pit stable. At 3.2m bgl intact rock, unable to identify/sample due to water ingress. Rapid water ingress at 2.9m bgl.				Logged by JCE		
				Scale 1:25		
				End Casing Depth m.		
				Job No. E92195		
Sample/Test key: D Disturbed sample Hv Hand Vane (KPa) B Bulk sample P Penetrometer (kg/cm ²) W Water sample - Progress & Day

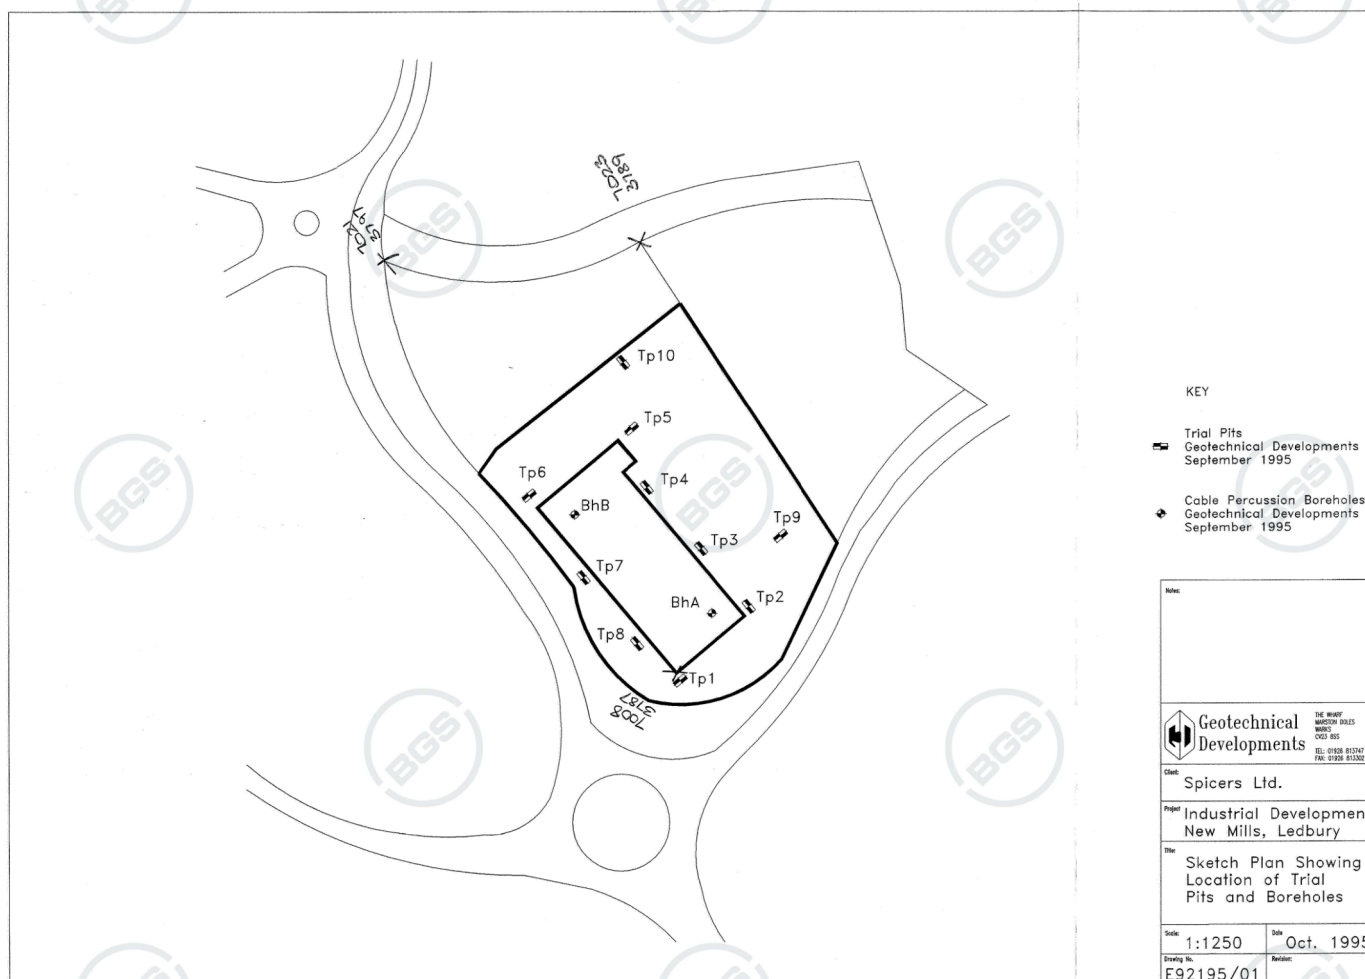
GEOTECHNICAL DEVELOPMENTS GEOTECHNICAL INVESTIGATION SERVICES Telephone (01926) 813747. Fax (01926) 813302.						TRIAL PIT LOG Trial Pit 03 Sheet 1 of 1	
Method JCB-3CX Sitemaster		Date 04/09/95		Site Industrial Development New Mills, Ledbury			
Dia mm		Coord 370000E 237800N		Ground Level m. OD		Client Spicers Ltd., Ledbury	
Soil Samples/Tests		Field Records		OD Level m.	Depth m.	Description of Strata	
Type/Test	Depth m.					Legend	
D1	0.50				0.30	Topsoil - very sandy silty CLAY with many fine roots. (0.30)

1.00	Firm/stiff orange/red brown very sandy silty CLAY with occasional cobbles/gravels of sandstone/siltstone and fine roots becoming sandy gravel below 0.5m. (HEAD) (0.70)	
B1	1.20 - 2.00				1.20	Very dense green/grey siltstone/fine medium sandstone GRAVEL with some fine to coarse angular sand. (TERRACE DEPOSIT) (0.20)

2.40	Medium dense/dense, red/orange brown medium well rounded/angular GRAVEL with some medium-coarse sand becoming very sandy with depth. (TERRACE DEPOSIT) (1.20)

3.20	Medium dense red brown fine-coarse gravelly SAND becoming very dense at 3.2m bgl (POSSIBLE WEATHERED BEDROCK) (0.80)	
Remarks		Sides of trial pit stable. At 3.2m bgl possible bedrock - unable to progress further due to water ingress and very dense formation. Rapid water ingress at 2.8m bgl. (Standing water level)					
Logged by JCE		Scale 1:25		End Casing Depth m.		Job No. E92195	
Sample/Test key: D Disturbed sample Hv Hand Vane (KPa) B Bulk sample P Penetrometer (kg/cm ²) W Water sample - Progress & Day

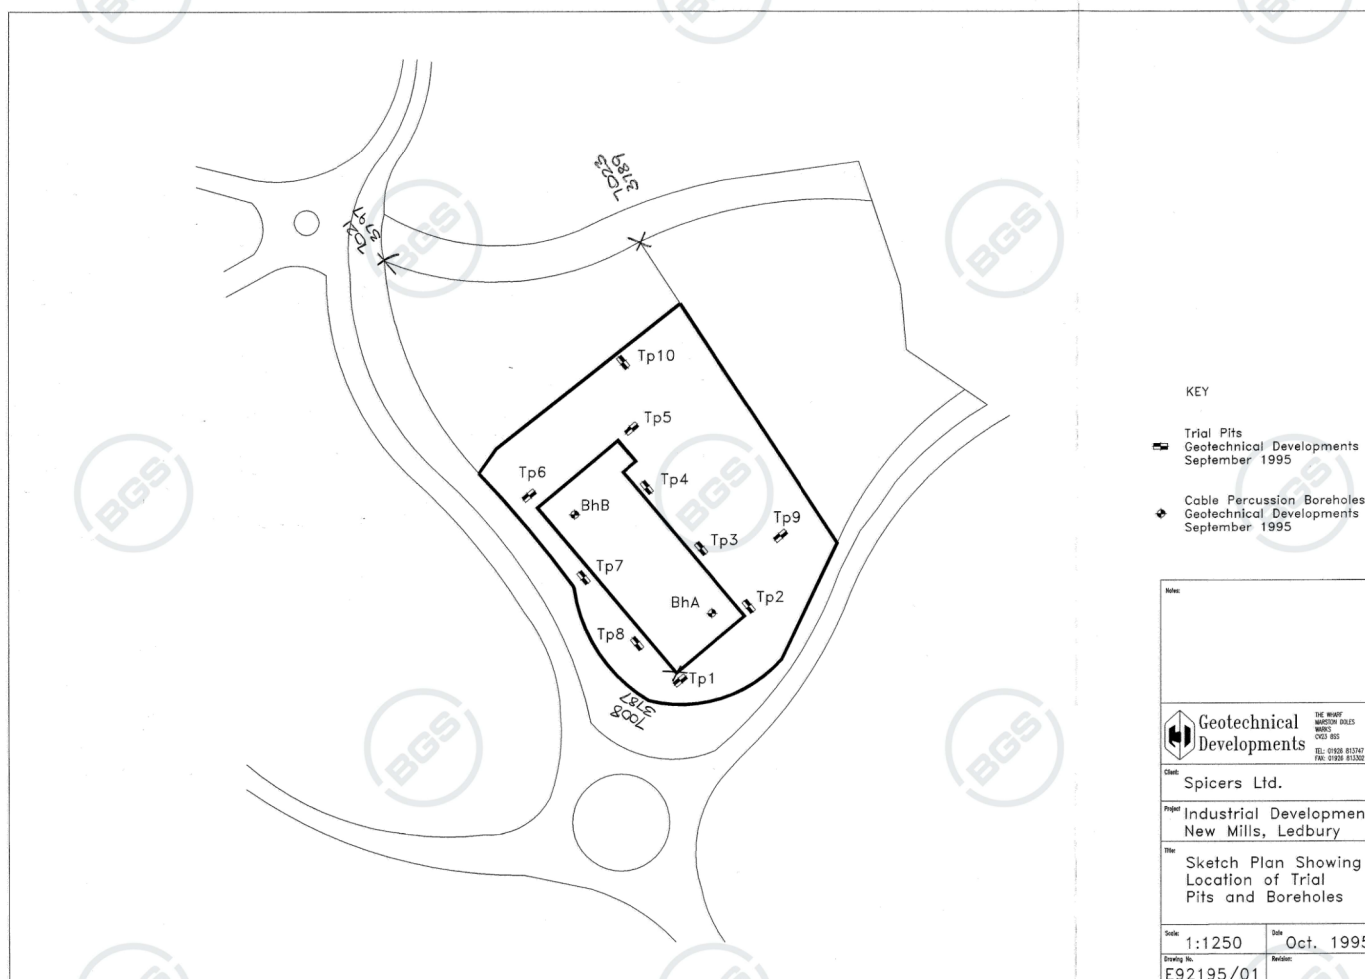
GEOTECHNICAL DEVELOPMENTS GEOTECHNICAL INVESTIGATION SERVICES Telephone (01926) 813747. Fax (01926) 813302.						TRIAL PIT LOG Trial Pit 09 Sheet 1 of 1	
Method JCB-3CX Sitemaster			Date 04/09/95		Site Industrial Development New Mills, Ledbury		
Dia mm		Coord 370000E 237800N		Ground Level m OD		Client Spicers Ltd., Ledbury	
Soil Samples/Tests		Field Records		OD Level m.	Depth m.	Description of Strata	Legend
Type/Test	Depth m.						
B1 D1	0.40 - 0.90 0.50				0.30	Topsoil - stiff sandy silty CLAY with many roots, highly dessicated. (TOPSOIL) (0.30)	[Pattern]

0.90	Stiff - hard red brown fissured very sandy silty CLAY with occasional fine angular gravel. (HEAD) (0.60)	[Pattern]
					2.10	Dense - very dense coarse angular sandstone/siltstone GRAVEL becoming orange/red brown very sandy slightly silty fine to medium rounded angular gravel. (TERRACE DEPOSIT) (1.20)	[Pattern]
Remarks Sides of trial pit stable. Dry.				Logged by JCE Scale 1:25 End Casing Depth m. Job No. E92195 Sample/Test key: D Disturbed sample Hv Hand Vane (KPa) B Bulk sample P Penetrometer (kg/cm ²) W Water sample - Progress & Day

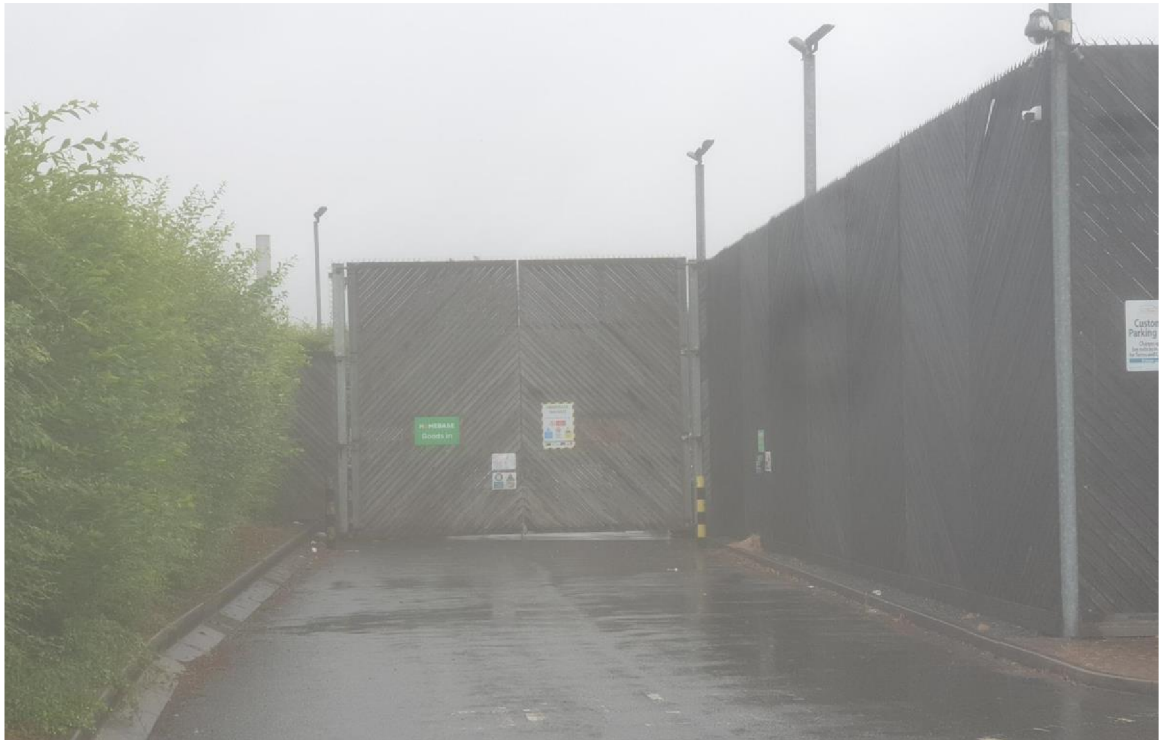
Photo 3: Gated access to the HGV loading bays located with the site (facing south east).

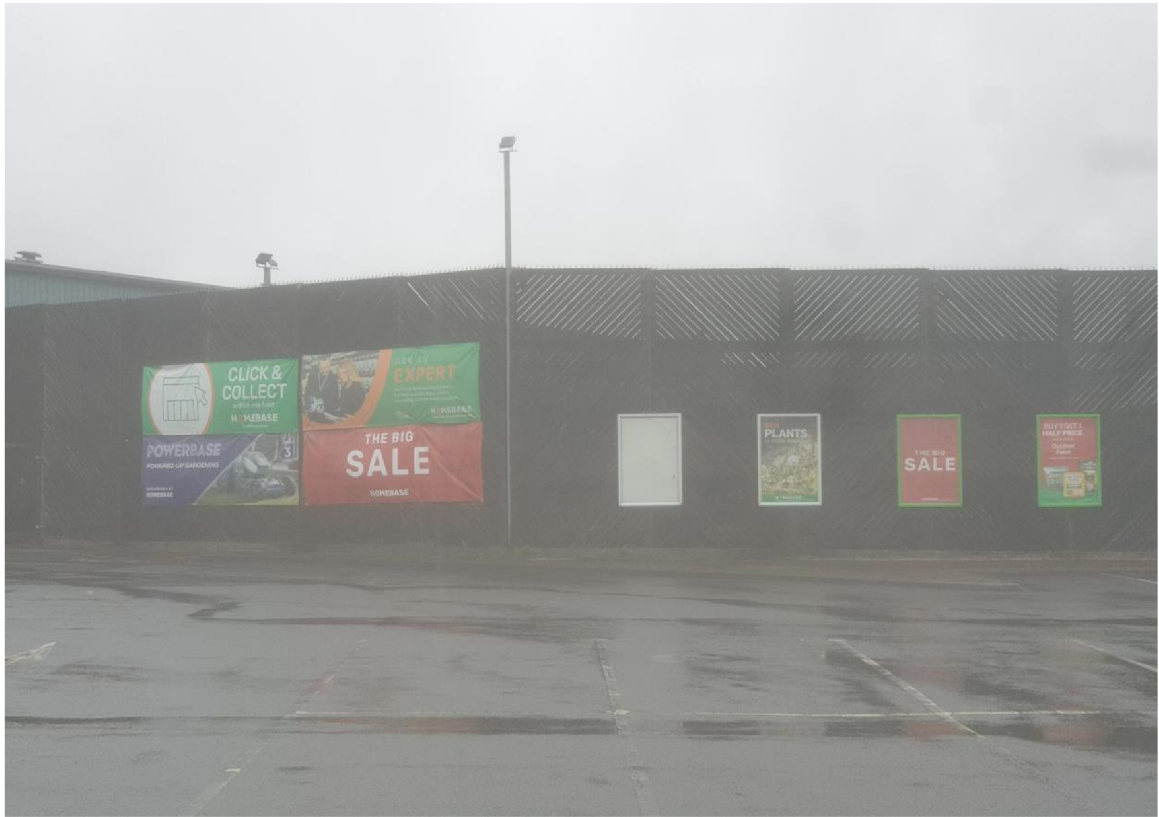
Photo 5: View of part of the Homebase buildings in particular the wall separating the car park from part of the garden centre section (facing south west)

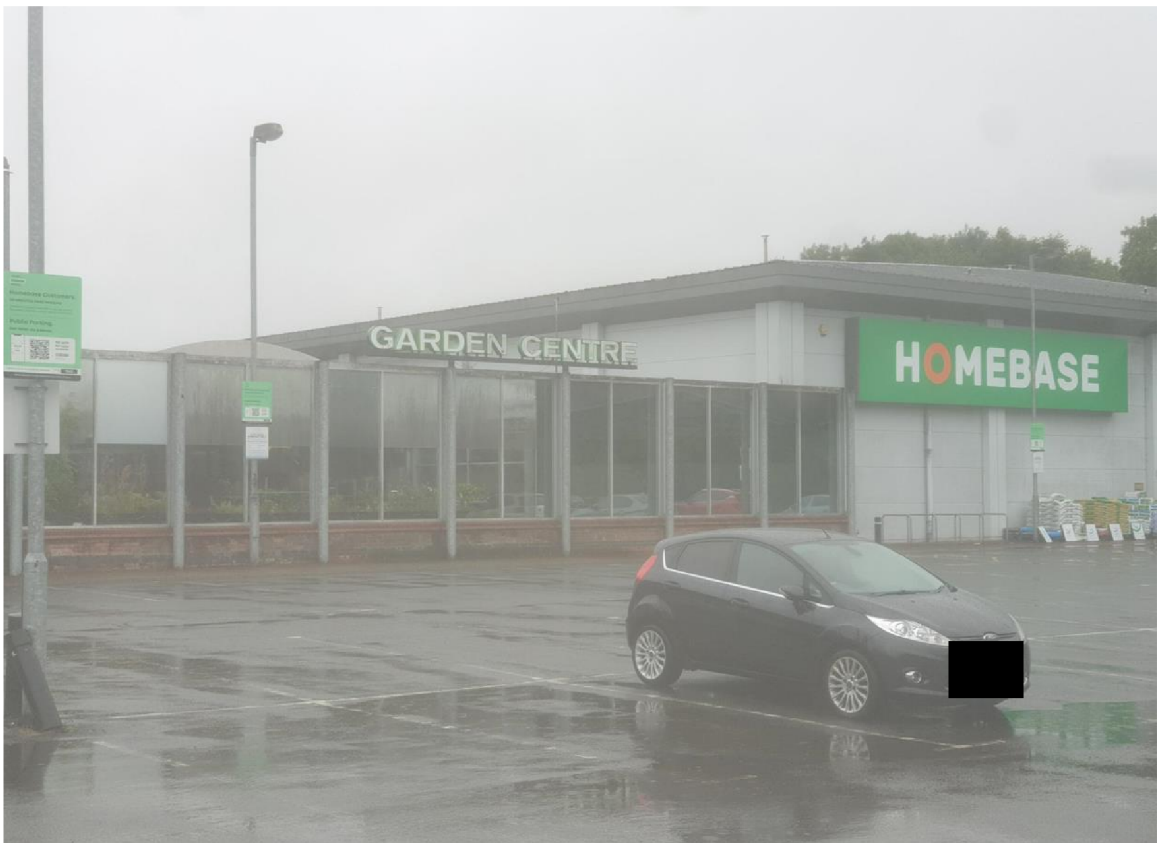
Photo 6: The other exterior wall to the garden centre section of the Homebase unit (facing south west)

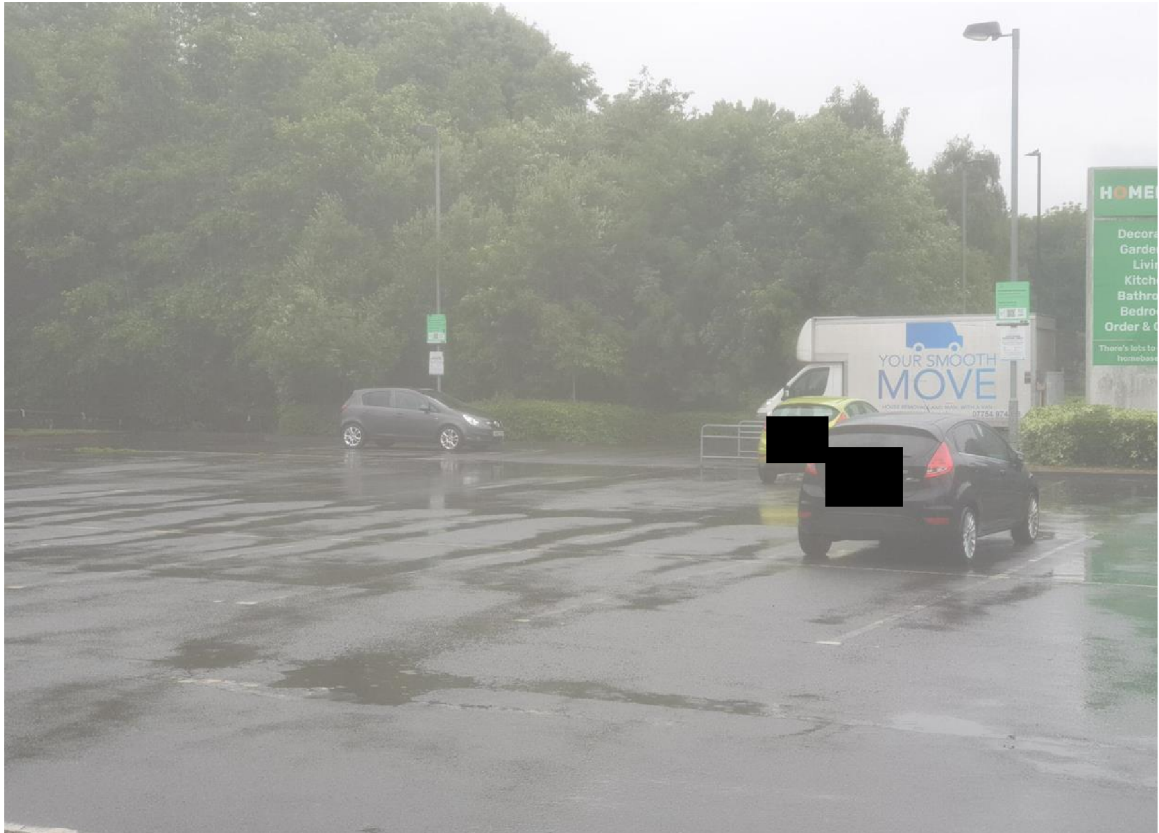
Photo 7: Car park area in good condition (facing north)
