## PHASE 1 SITE INVESTIGATION & PRELIMINARY RISK ASSESSMENT

Lidl Great Britain Ltd
Three Counties Hotel, Hereford

923.01.01 January 2022

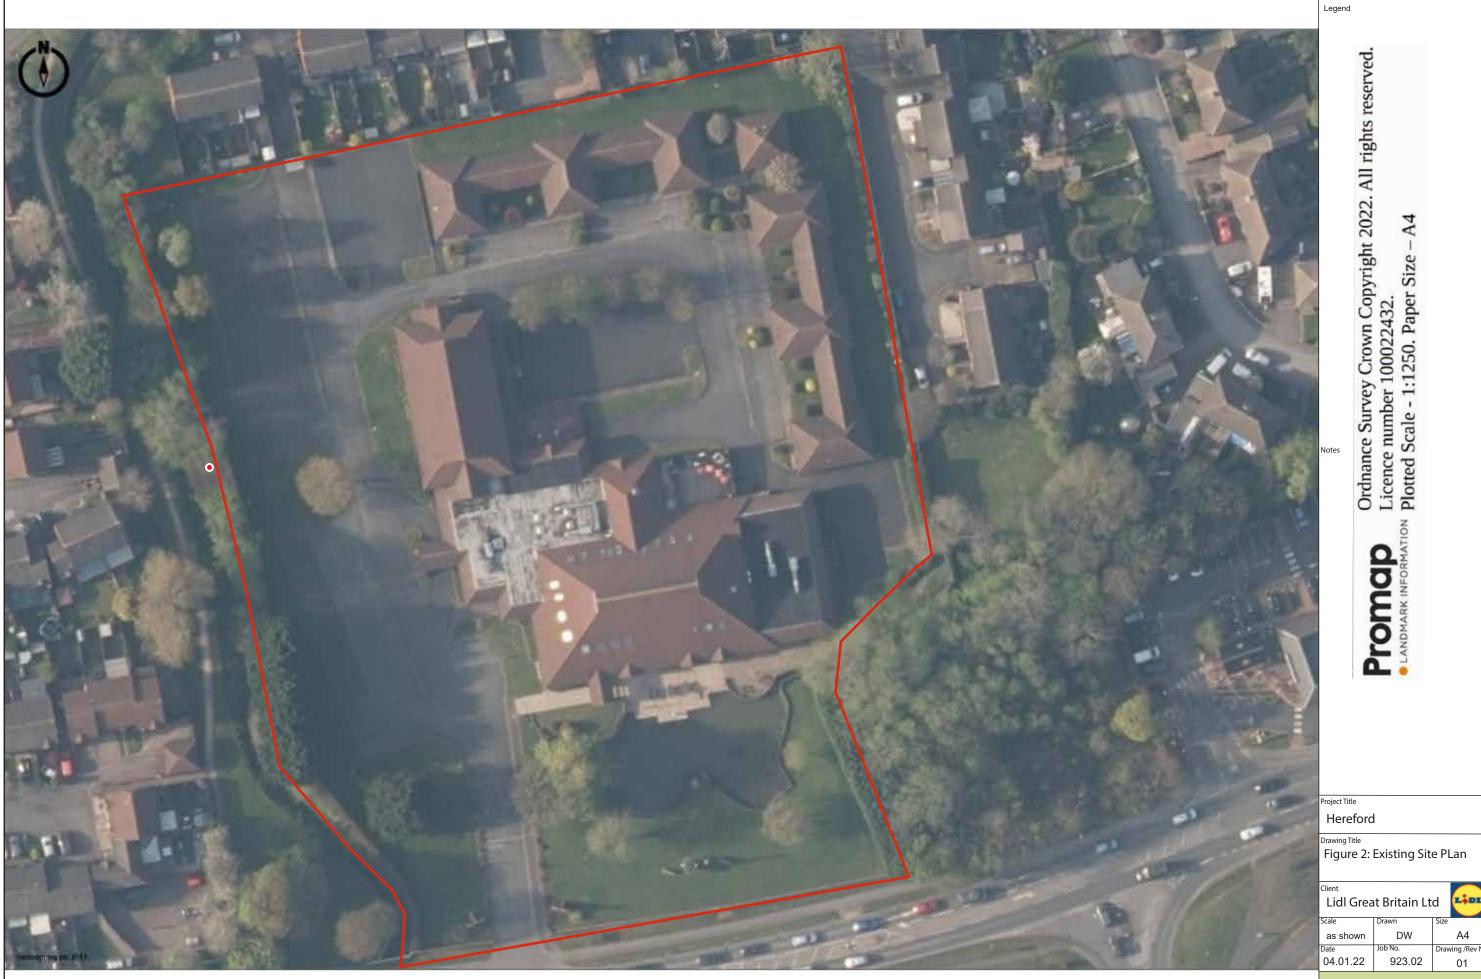
Figure 1 Site Location Plan Figure 2 Existing Site Layout

The site is currently occupied by the Tree Counties Hotel and car park which is an irregular plot to the north of Belmont Road as indicated in Figure 2. The hotel is split up into four separate buildings surrounding a central courtyard, the largest being the main hotel building/reception to the south and other smaller buildings just for accommodation to the north and east.

Site Description	The site is currently occupied by the Tree Counties Hotel and car park which is an irregular plot to the north of Belmont Road as indicated in <b>Figure 2</b> . The hotel is split up into four separate buildings surrounding a central courtyard, the largest being the main hotel building/reception to the south and other smaller buildings just for accommodation to the north and east.
	The proposed new store is to be located to the east, with the car park and soft landscaping to occupy the remainder of the site.
Area of Site	16800 m <sup>2</sup> .
Site Elevation	The topographic elevation of the site is 59m aOD (metres above ordnance datum).
National Grid Co-ordinates	349690, (E), 238590 (N)

The site is currently occupied by the Three Counties Hotel and car park which is an irregular plot to the north of Belmont Road as indicated in **Figure 2**. The hotel is split up into four separate buildings surrounding a central courtyard, the largest being the main hotel building/reception to the south and other smaller buildings just for accommodation to the north and east. The proposed new store is to be located to the east, with the car park and soft landscaping to occupy the remainder of the site.

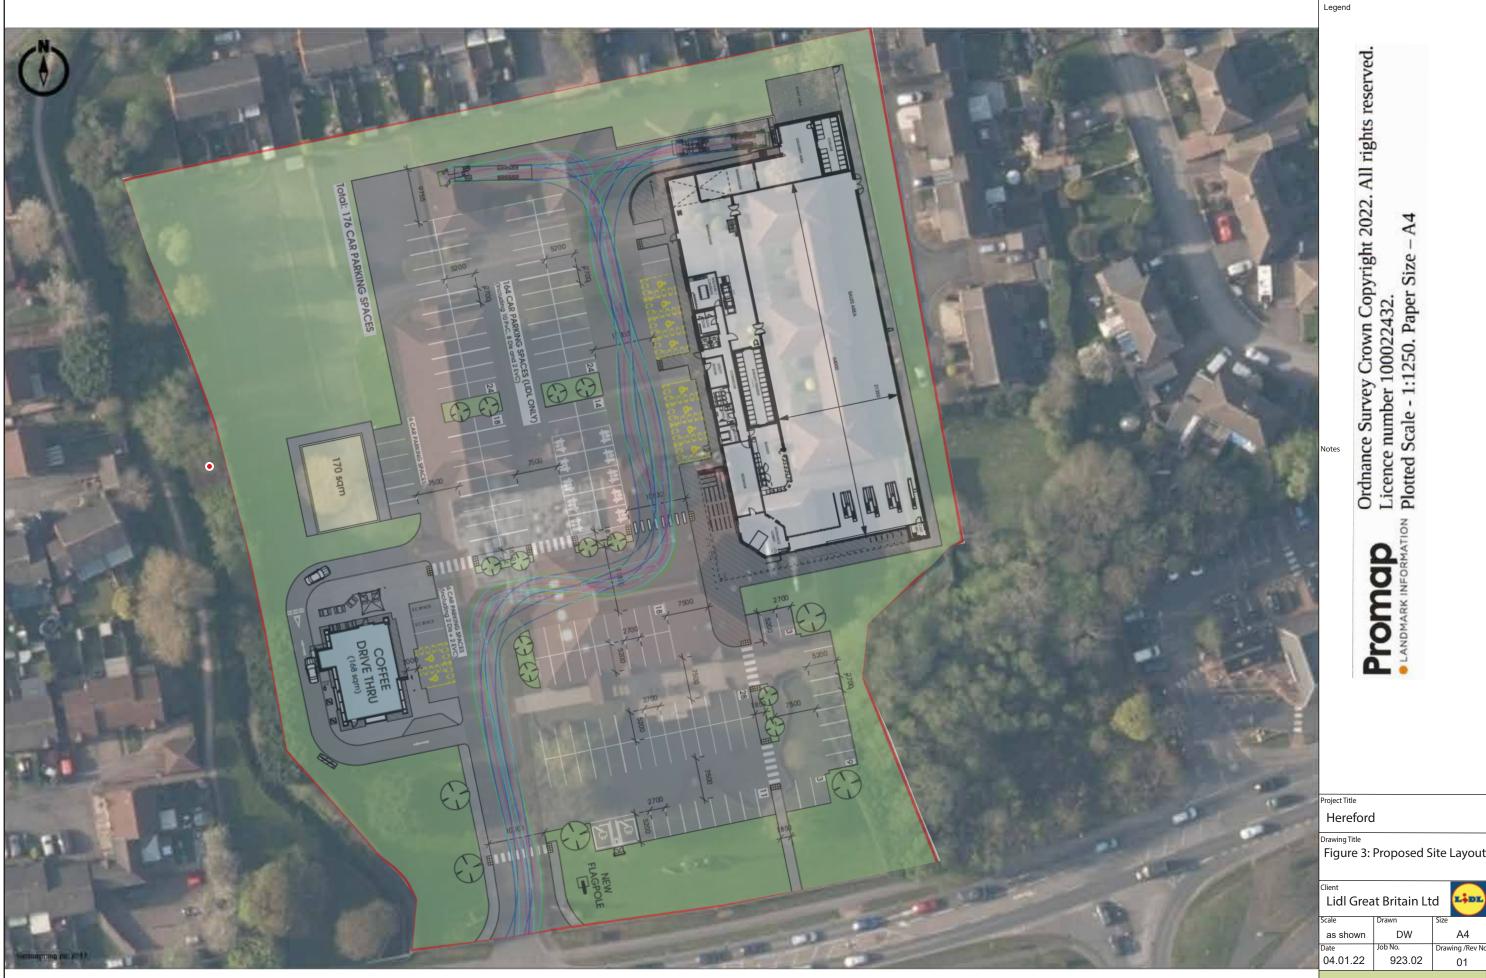
**Figure 3 Proposed Site Layout**

It is understood that the proposed site use for the majority of the site will be a Lidl retail store with associated car park and soft landscaping. This development will comprise a site area of 16800m<sup>2</sup> fronting onto Belmont Road as shown in **Figure 3**.

The proposed new store is to be located to the east, with the car park and soft landscaping to occupy the remainder of the site.

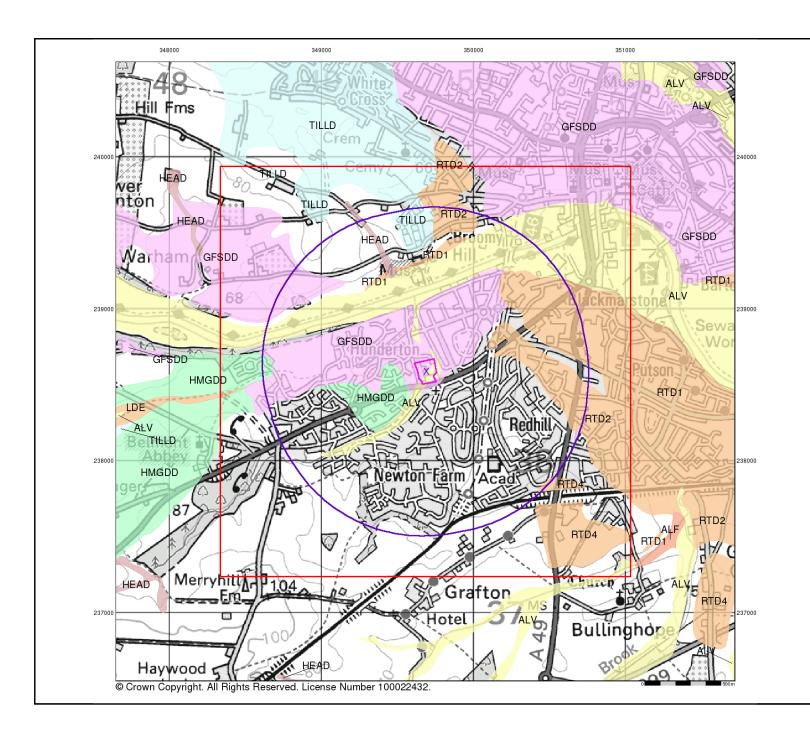
#### **Superficial Geology**

The superficial deposits underlying the site are indicated to comprise a mixture of Alluvium and Glaciofluvial Sheet Deposits. The BGS describe these as typically comprising 'soft to firm consolidated, compressible silty clay, but can contain layers of silt, sand, peat and basal gravel', and 'sand and gravel, locally with lenses of silt, clay or organic material; characteristic 'sandur' (sheet) and valley train form; of glaciofluvial origin' respectively.

The superficial deposits are designated as a Secondary Aquifer - A (ref Envirocheck Appendix B).

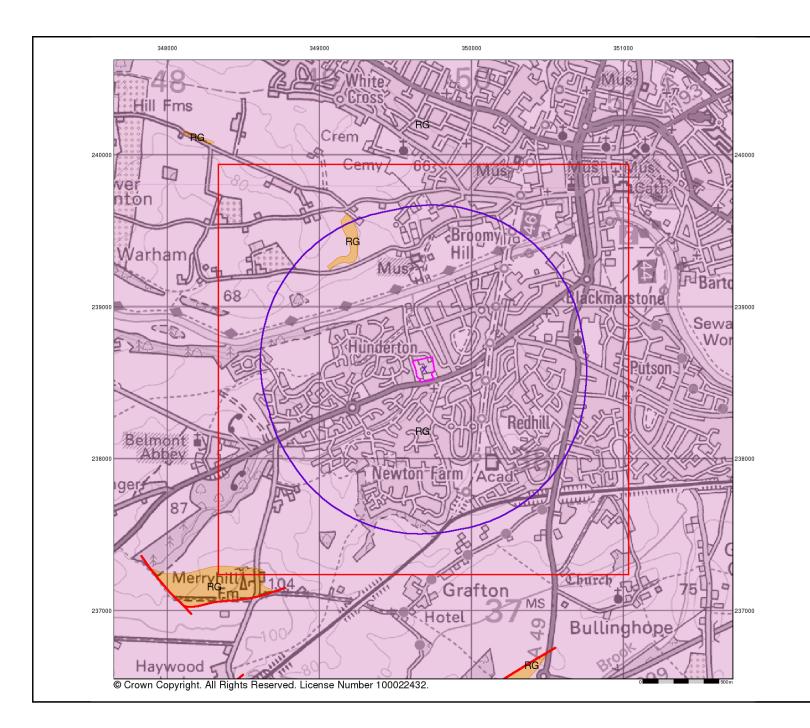
#### **Bedrock and Faults**

The bedrock directly underlying the site is formed of the Raglan Mudstone Formation. The BGS describes this Formation as typically comprising 'Red mudstones and silty mudstones with calcretes and sandstones'

The bedrock is designated as a Secondary Aquifer - A (ref Envirocheck Appendix B).
