CATHEDRAL SCHOOL SPORTS HALL
East Street
Hereford

Rapid Historical Research

December 2006

Historical Research

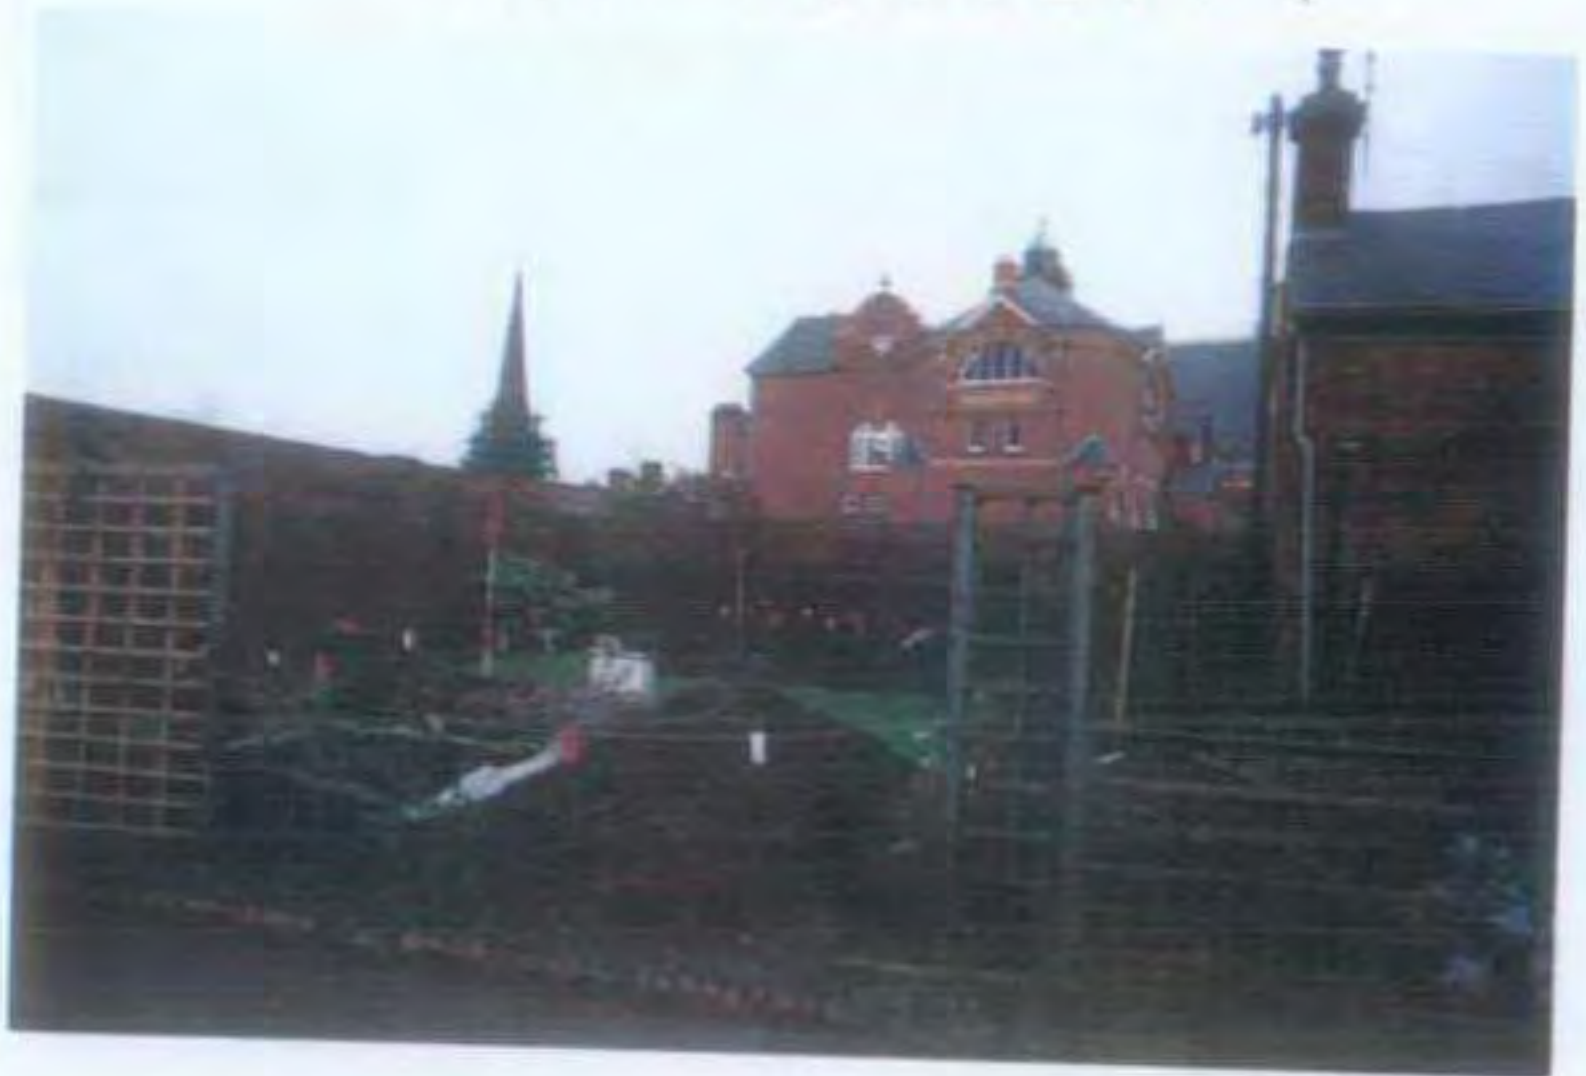
The evaluation excavations from the south. Trenches B and C are in the foreground; trench A is close to the boundary wall. Part of 77 East Street is on the right.

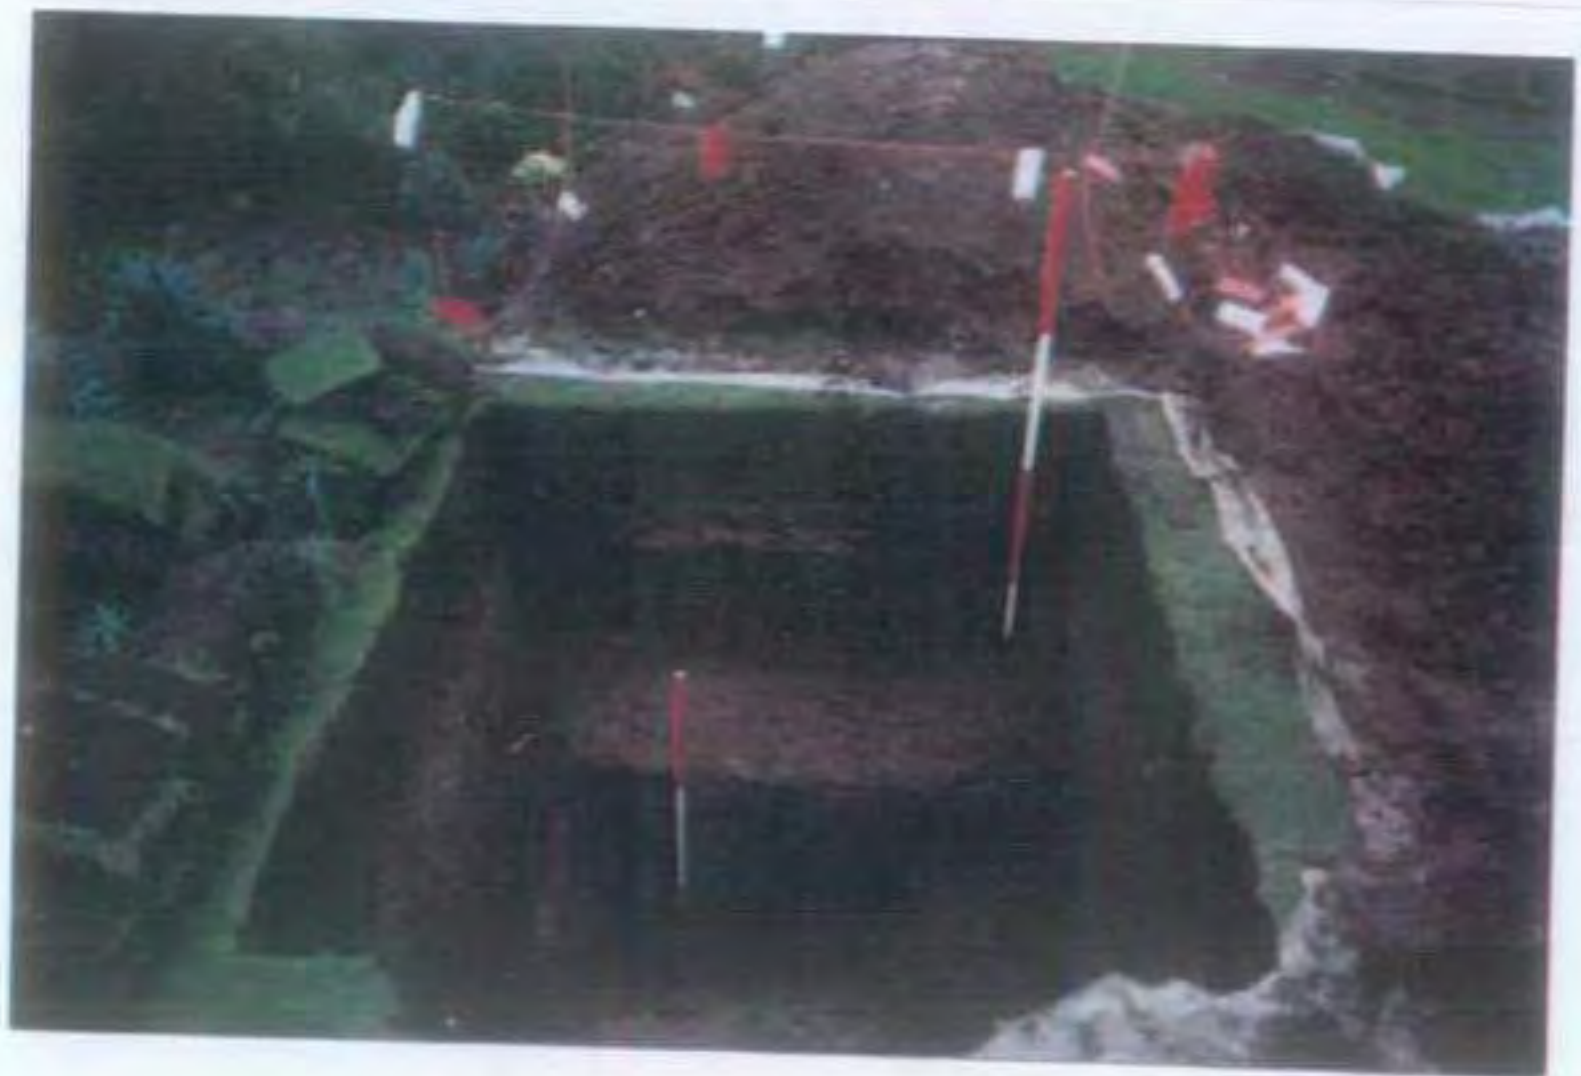
Trench A from the north-west on completion.

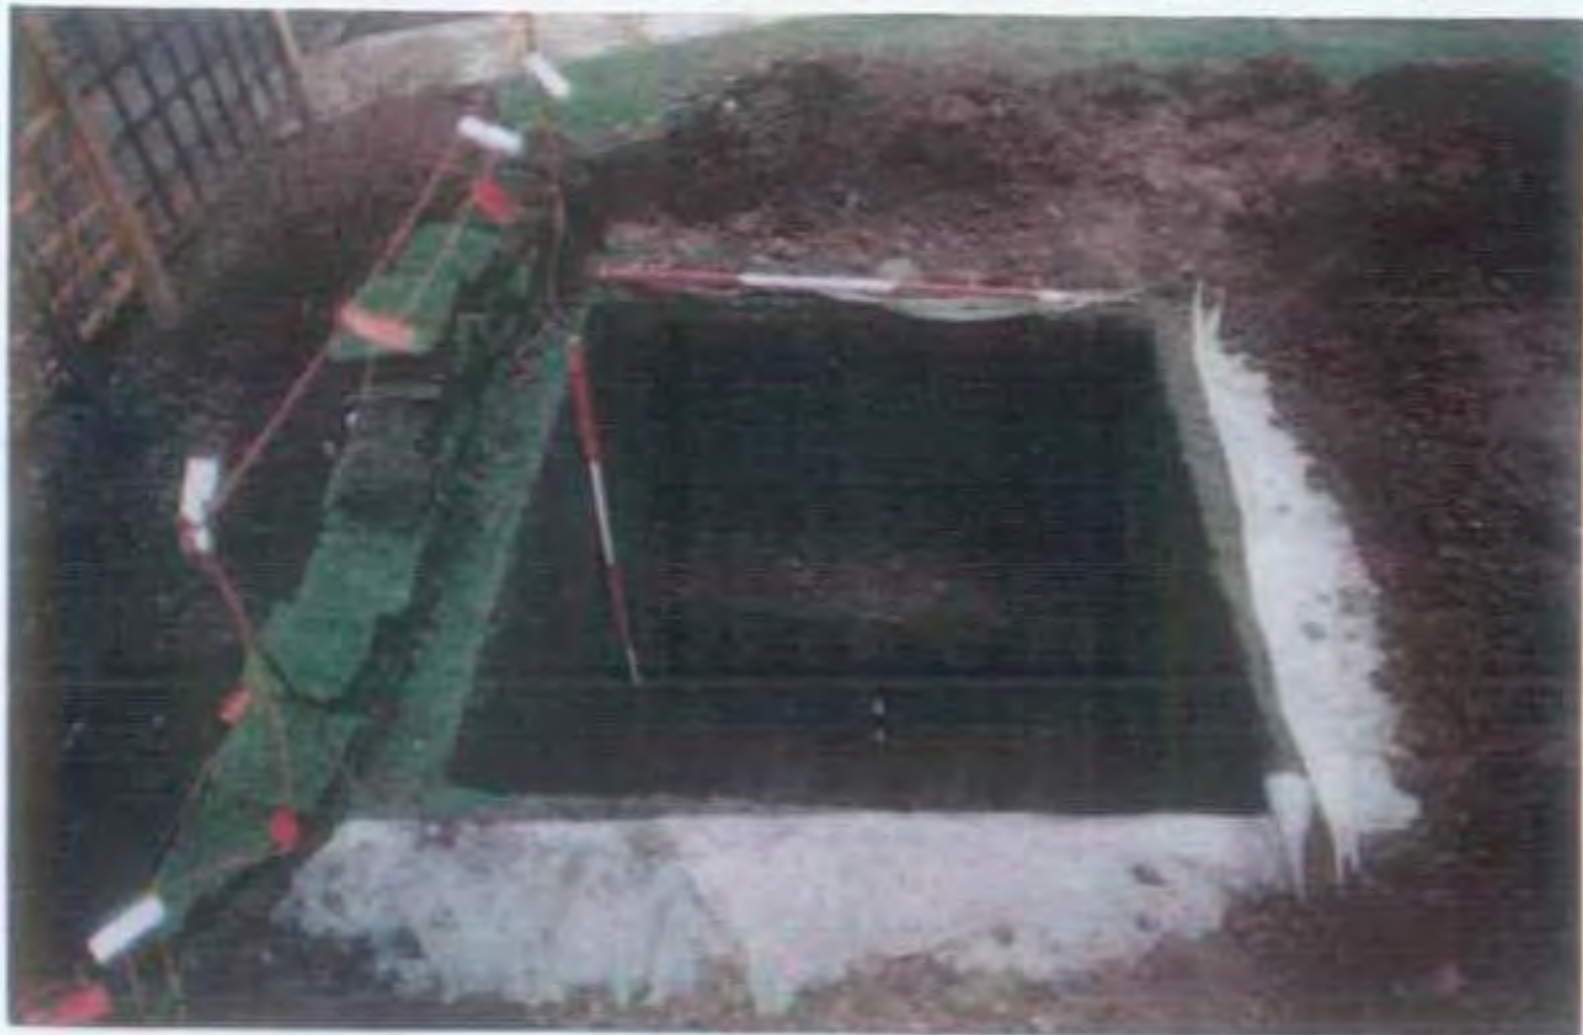
Trench B from the south-east. The small Saxon ditch is indicated by the lower scale.

Undisturbed natural deposits were encountered in Trench A at 54.30m OD and at 54.63m OD in Trench B. Cutting the natural at the base of Trench B was a 0.20m deep gully running parallel with the alignment of the late Saxon rampart located to the north. The ditch was filled and sealed by a light brown silty soil (7 on the section of Trench B, Fig. 2), which was also observed

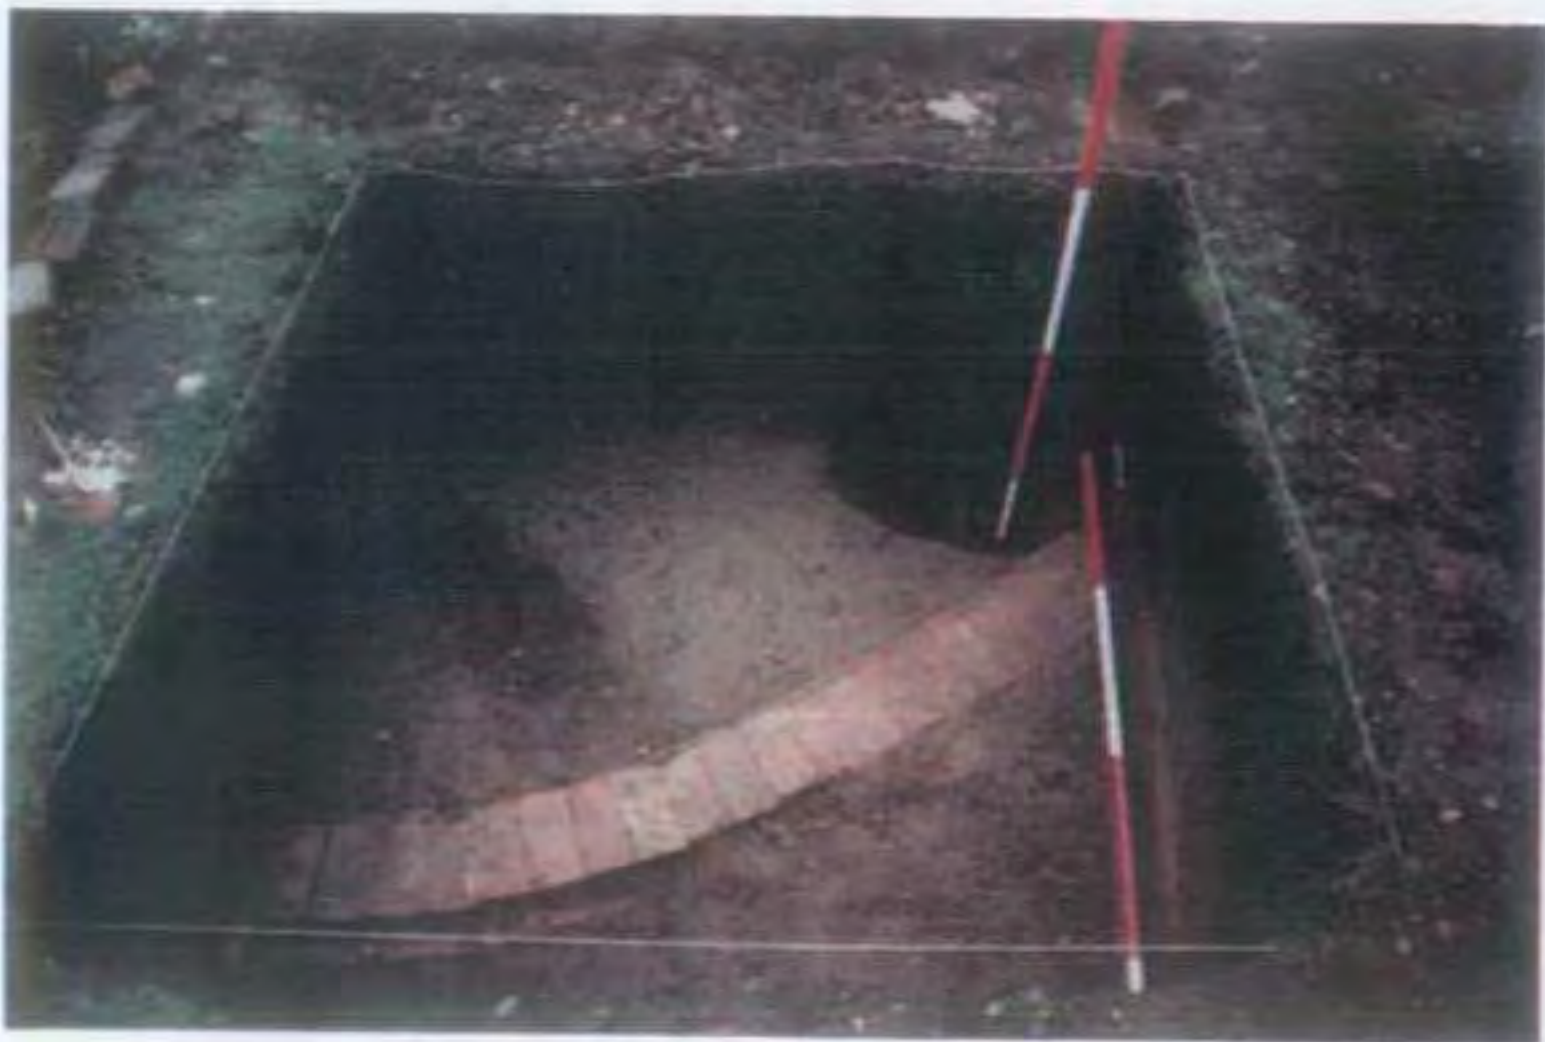
Trench C from the south-east at the level where excavation ceased.

This comprised three trenches, each 2m square (Figs. 1-4). Excavation of Trench C ended at a depth of 1.20m owing to disturbance by a modern drain and a 19th-century pit, but the other trenches were excavated to depths of 2.20m below modern ground surface. The surface area at the base of these trenches was much reduced by "stepping in" for Health and Safety reasons.
