Project  
Hereford Museum and Art Gallery  
Client  
Herefordshire Council

Drawing Title  
**Heritage Plans Third Floor Exhibition 4  
(Sheet 2 of 2)**

Project Originator Zone Level Type Role Number  
**10265 - ART - XX - 03 - DR - A - 16031**

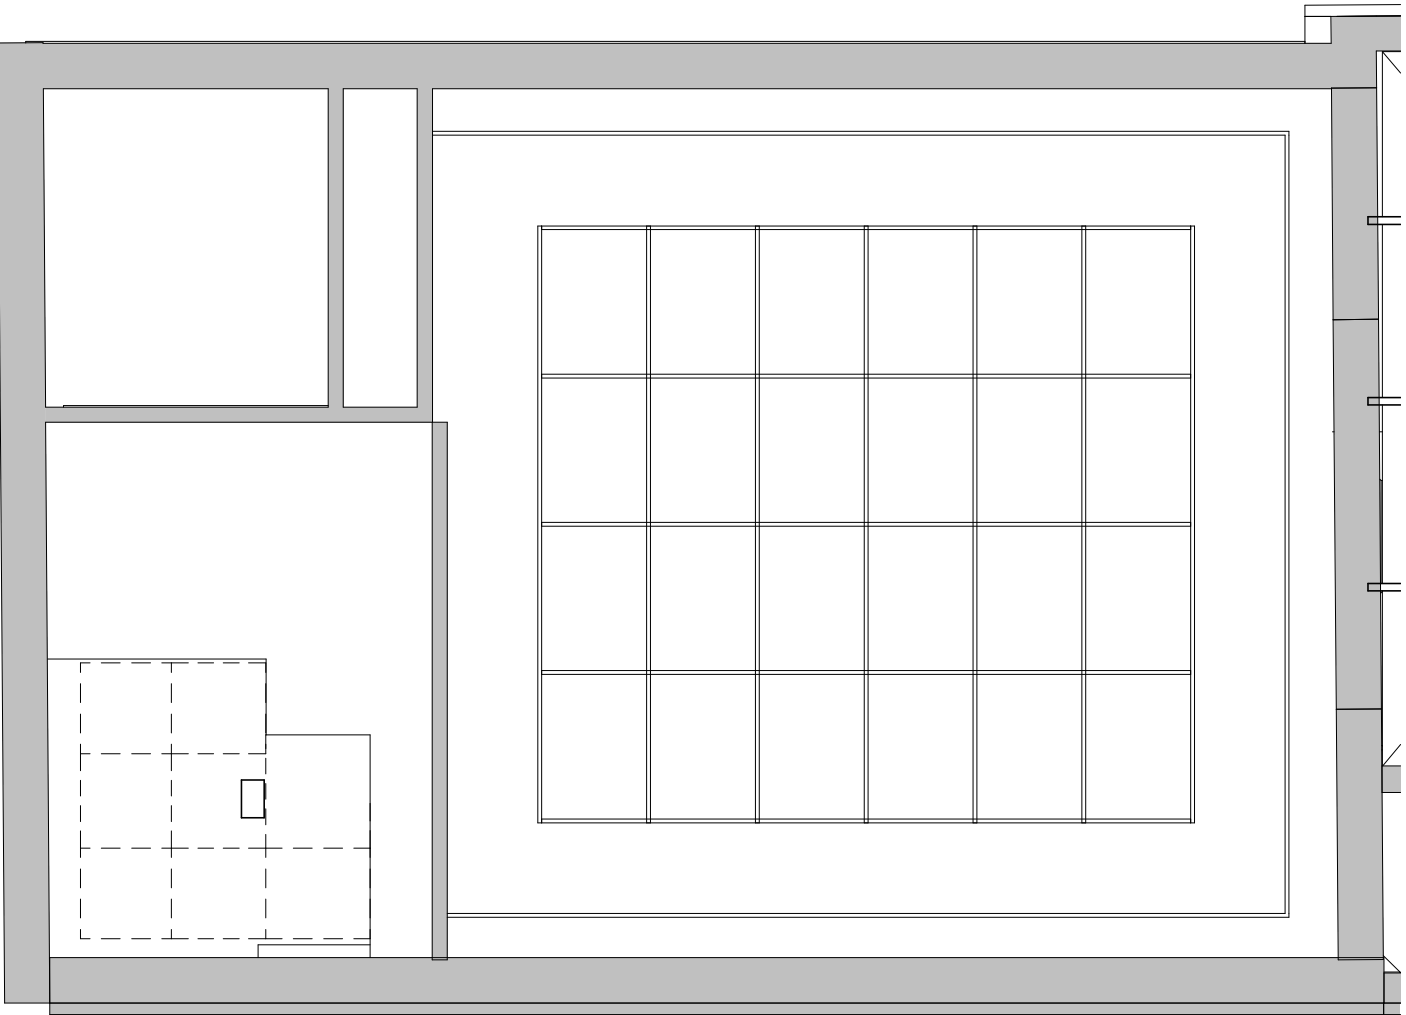
6 Exhibition 04 - Proposed Reflected Ceiling Plan  
1 : 100

The proposed ceiling to the gallery space expresses no detail, it is a simple intervention, one that allows the existing historic features prominence. The diffused light ceiling grid references the original top lit space and sits away from the existing cornice which defines where the new intervention begins. The ceiling, offset from the perimeter of the room and the cornice also assists in the discreet installation of the required ventilation diffusers at high level. At low level the space under the plinth bench is utilised for the ventilation ductwork, this ensures that the space can be environmentally conditioned and retains the historic essence of the original art gallery. Consideration was given to referencing the existing ceiling through the insertion of a vaulted ceiling however, retaining the existing cornice limited the height available. The proposal of a simple yet contemporary ceiling insertion is of its time yet subordinate to the retained historic features of the space.

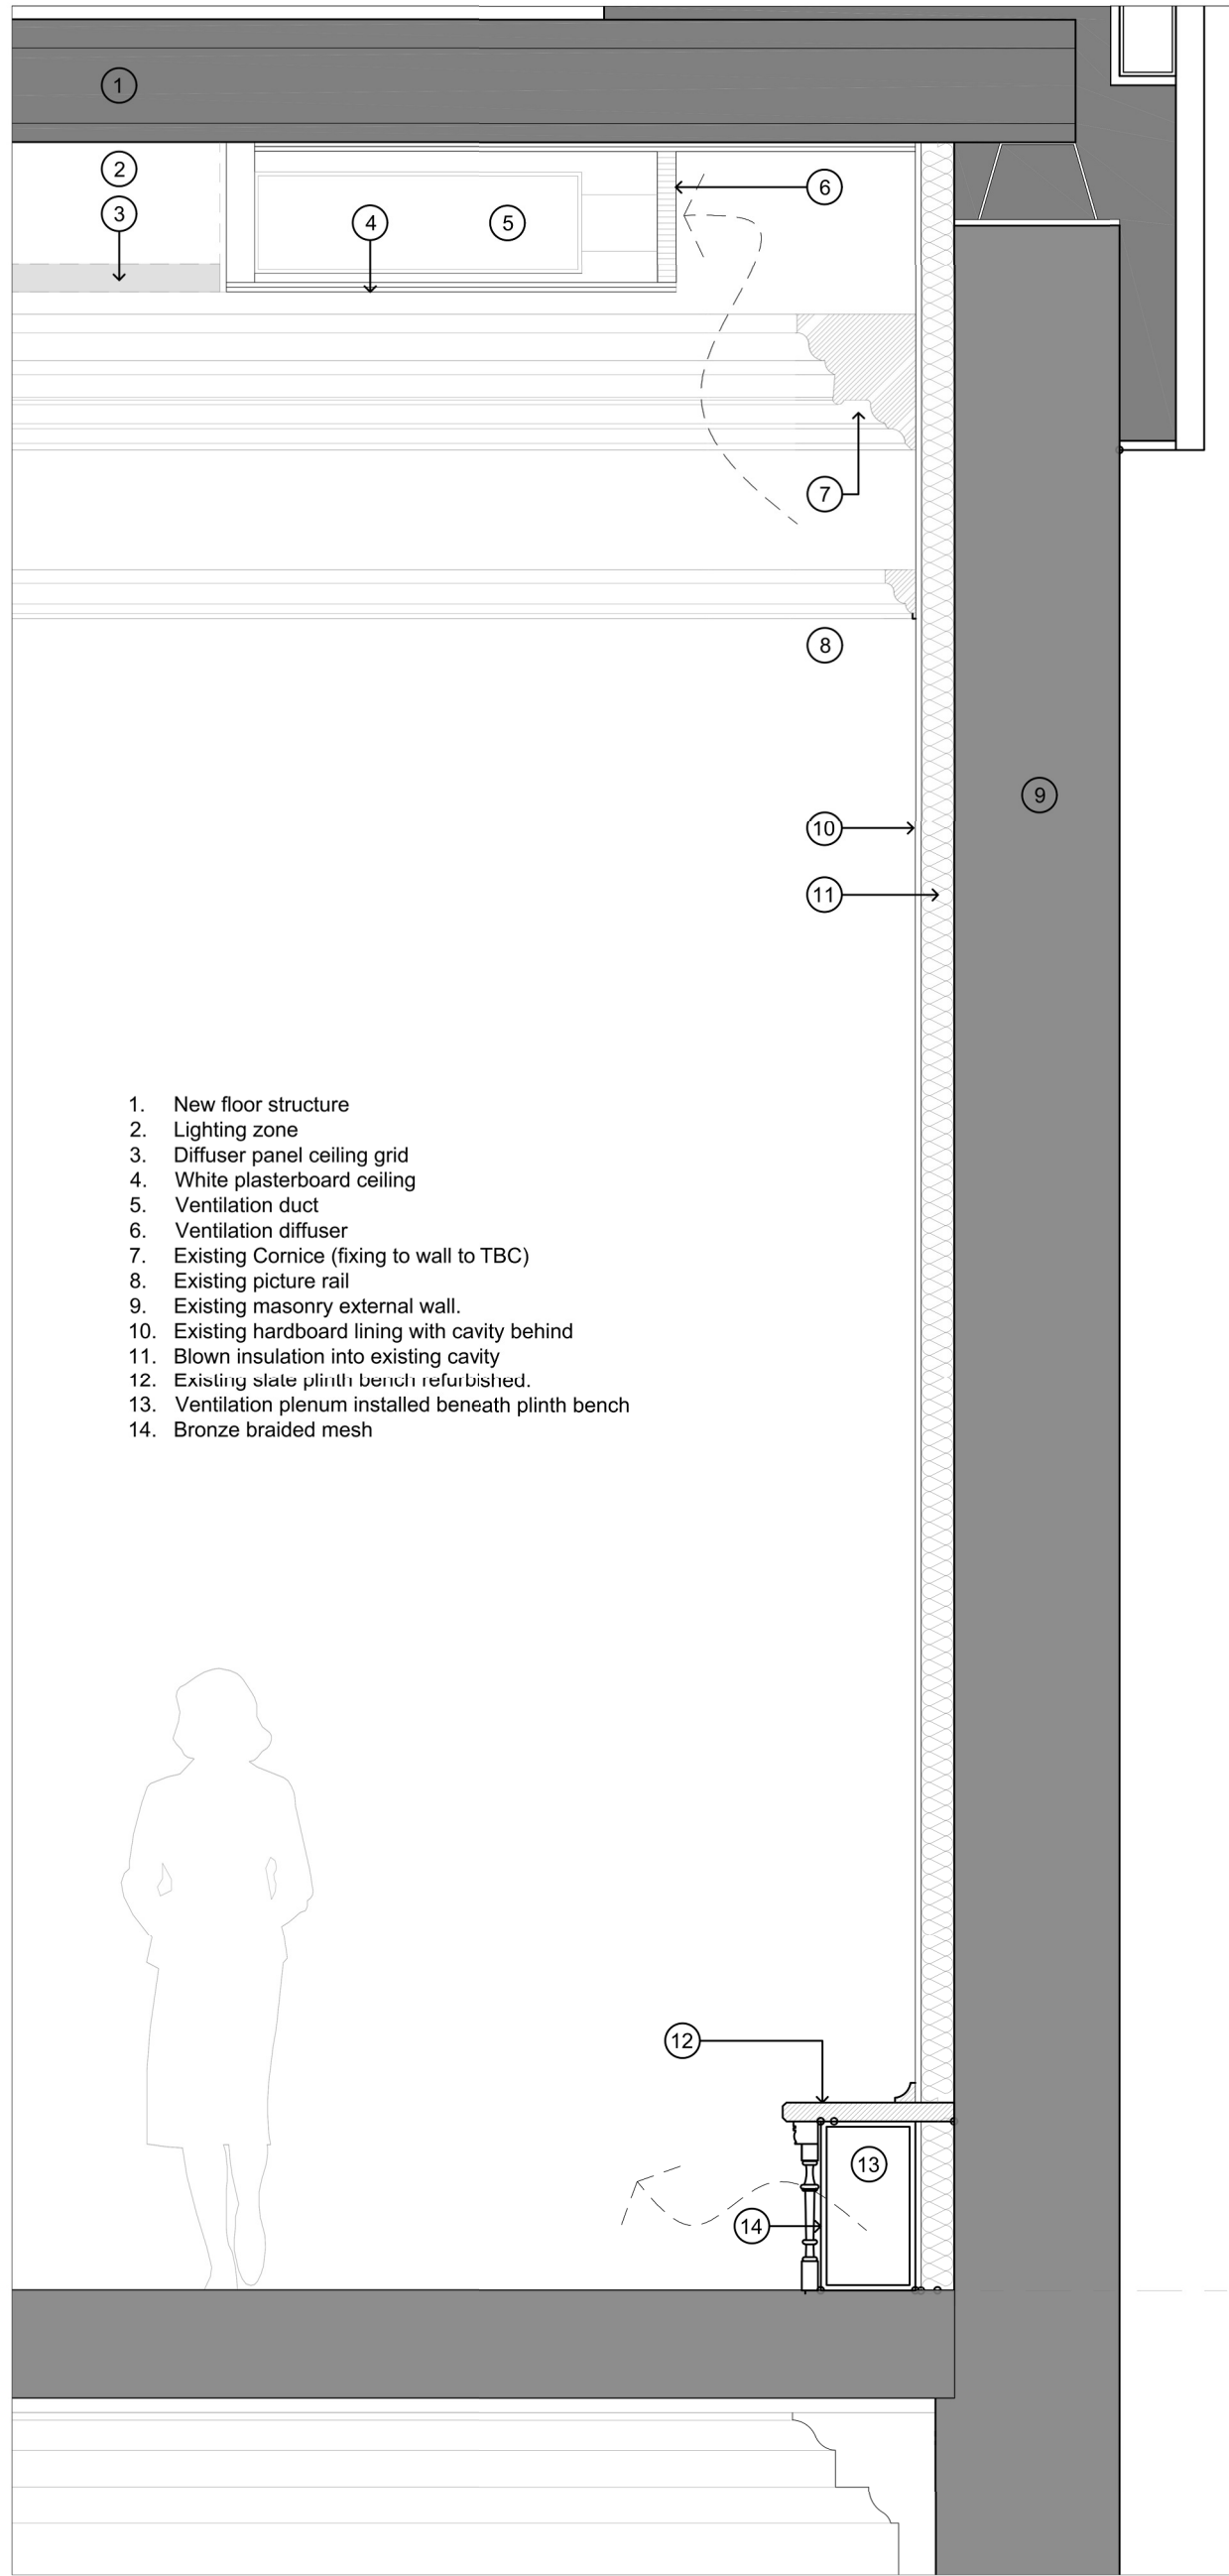
Proposed detail section of Exhibition 04

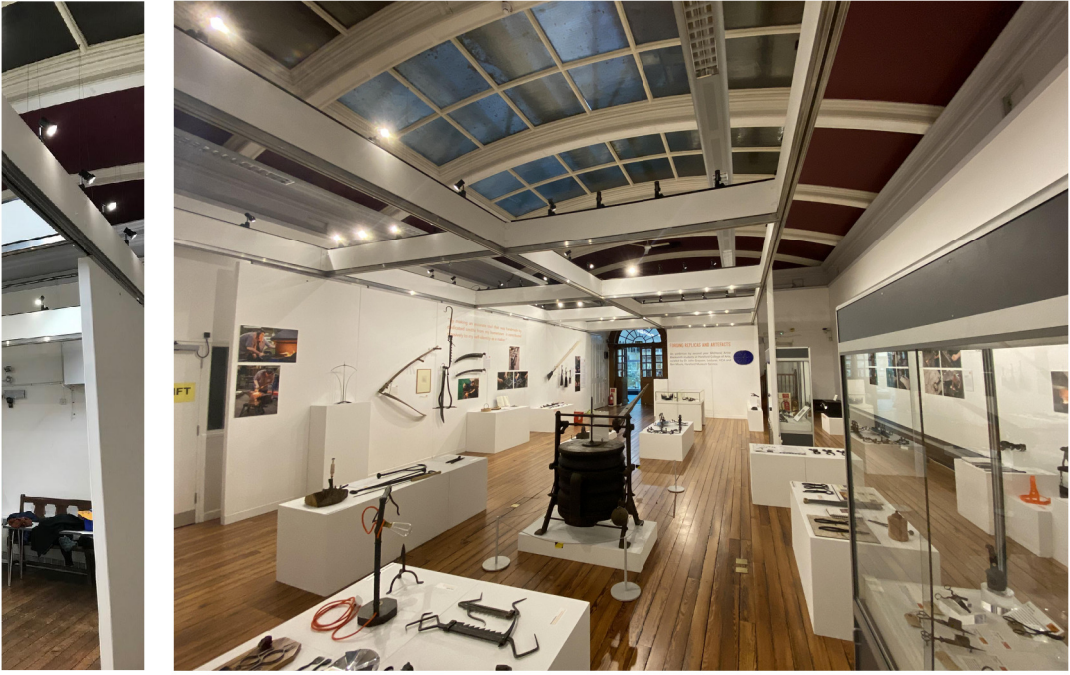
Art Gallery looking through to Museum

Art Gallery looking North-East

This gallery space was added as part of the 1912 extension and has regional heritage significance as an example of Edwardian gallery construction and the primary art gallery space of the county. The walls are lined with softwood to provide a dry, flexible fixing backing for paintings, while there is a slate bench at the base which, combined with the heating pipes below, provided a gentle diffusion of heat. These features are being carefully retained and adapted to retain the history and maintain the appearance. The gallery ceiling has a gentle barrel vault with large glazed panels at the centre which would have previously lit the gallery with north light from the rooflight above. This has been blocked at some point in the past. The ceiling structure is hung from the iron truss roof above and is constructed of a combination of iron and timber forming an arch to which the plaster cornices are attached. Removal of the roof is planned for the new extension above and because it is suspended from it the 1912 ceiling will need to be removed too. Despite this not being the 1873 original building the removal of the ceiling is recognised as a significant loss for heritage impact and a wide range of alternative options were investigated throughout the design process, including with Historic England's structural engineer. However, the conclusion was that it is not possible to retain due to the likely flexing of the brittle ceiling structure, both during replacement of the supporting structure and with the new, structurally loaded extension above. This flexing would risk dangerously damaging the ceiling and sudden collapse of cast in-situ elements. As a result, the design shown includes for the replacement of the ceiling. This is justified by the museum business case report explaining the need for the new facilities enabled on the proposed floor above, to maintain the future of the museum and gallery on this site.

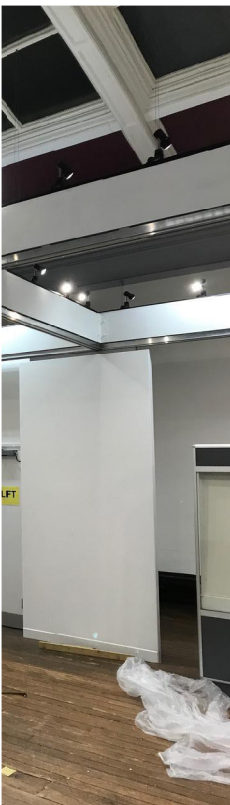
Lift in corner of room, to be removed

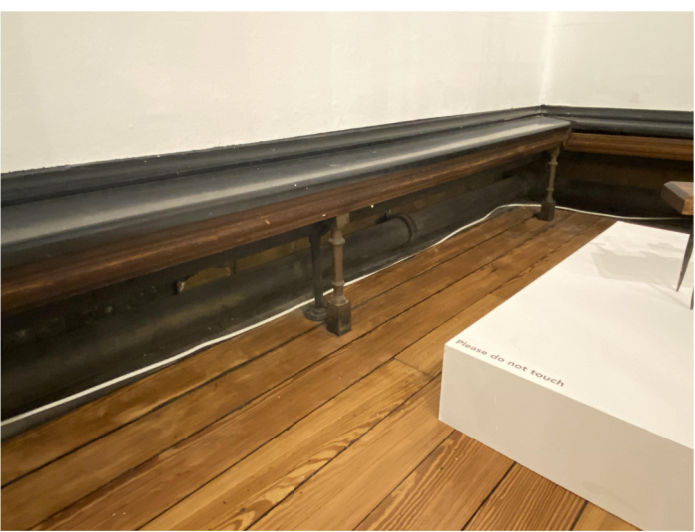
Slate bench, retained and used for services

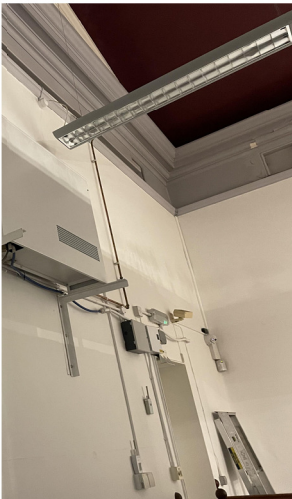
Modern mechanical and ventilation equipment to be removed

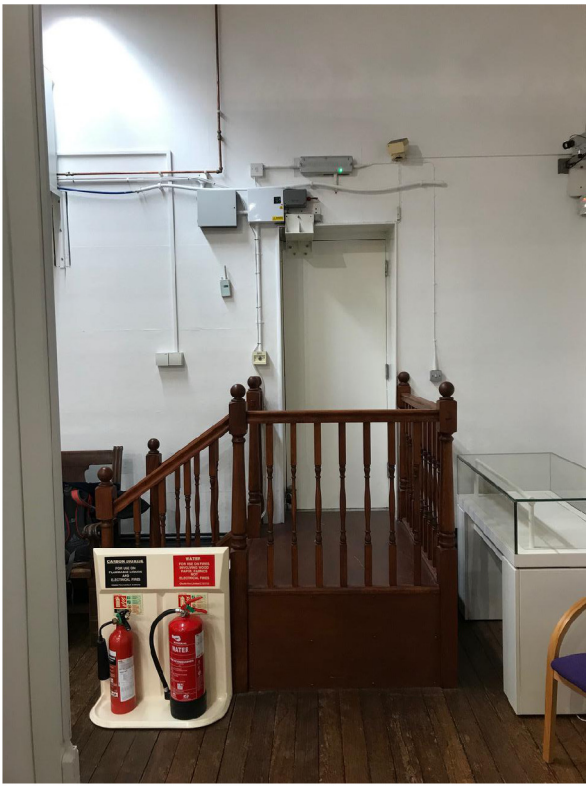
Modern step and exit to be removed
