Planning Application Submission:

Additional Drainage Details
for Barns:

Grove Farm, Sellack, Ross on Wye, Herefordshire HR9 6LZ

Change of Use of barns to form new residential dwellings.

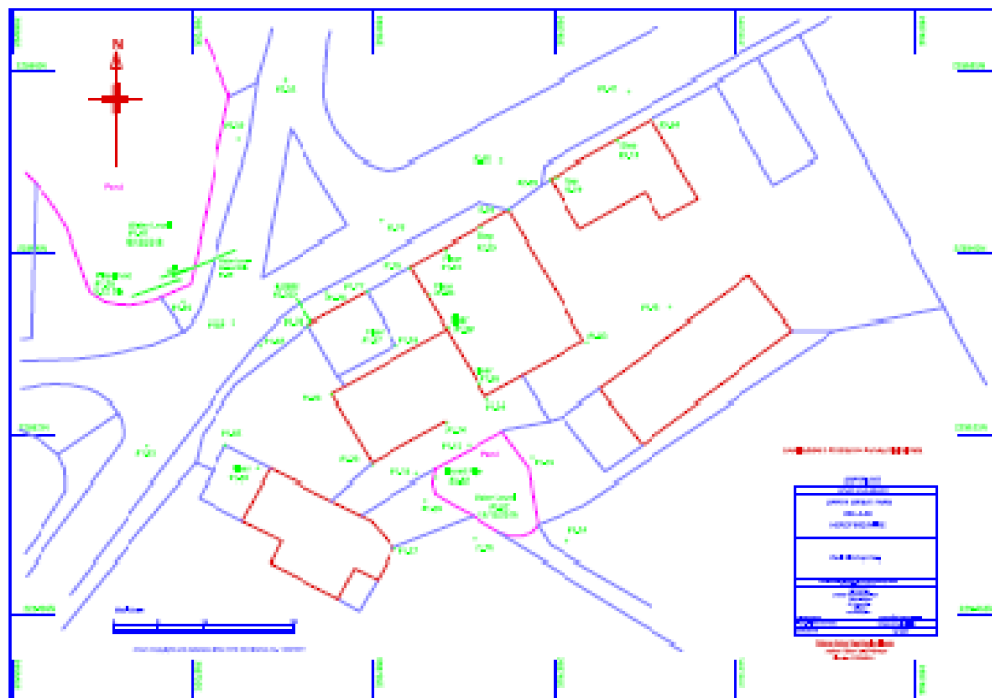
Drawing 19005/31:

- Drawing 19005/31 - Detailed site / drainage survey undertaken by Jonathan Tasker - Land Surveyor.
- Drawing 19005/19 - Drainage Plan (Barns B and D)
- Drawing 19005/30 - Drainage Plan (Barns A and C)
- Percolation Test Results and supporting photographs

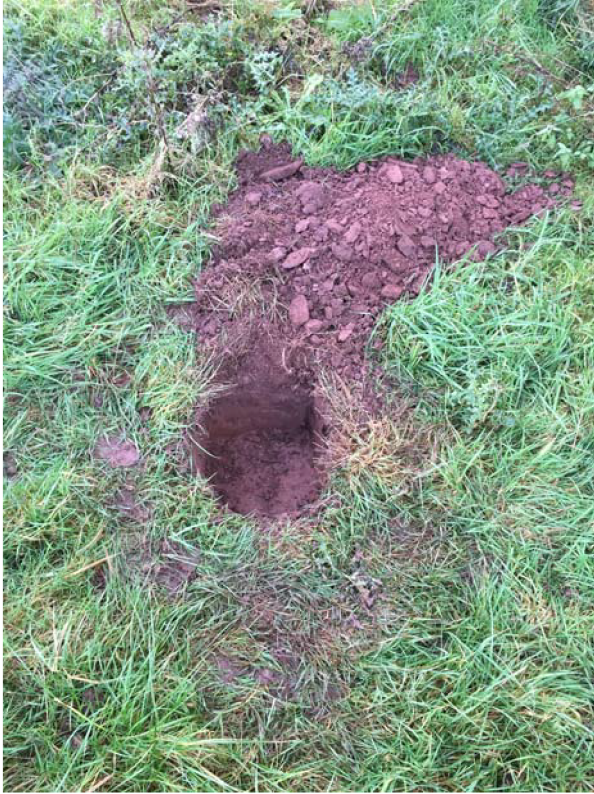
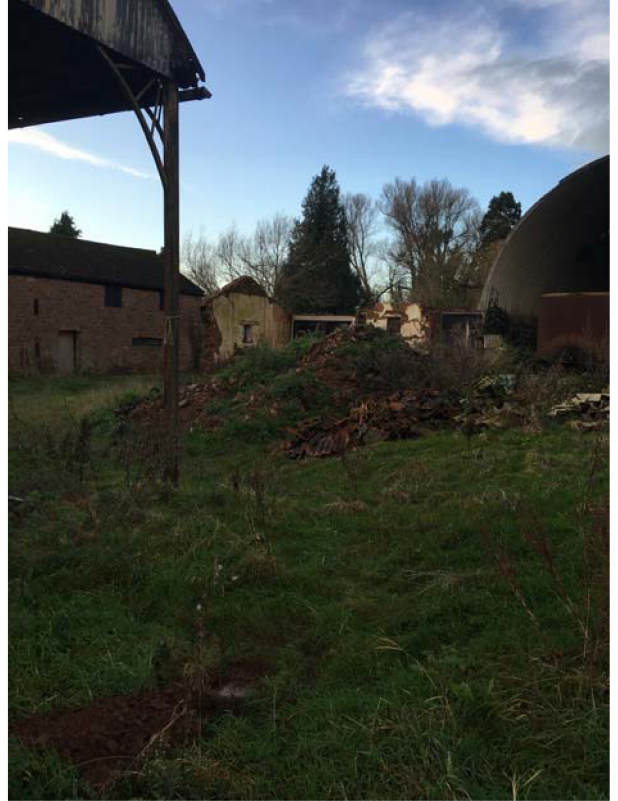
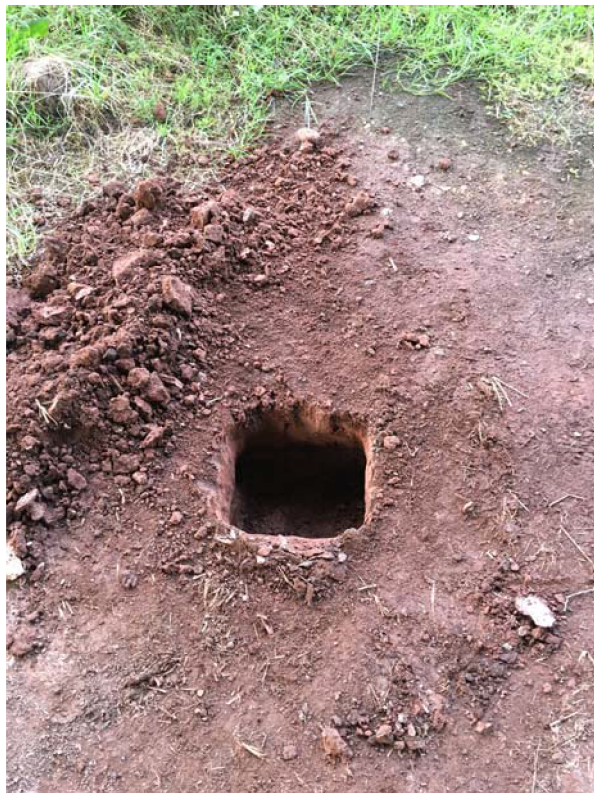
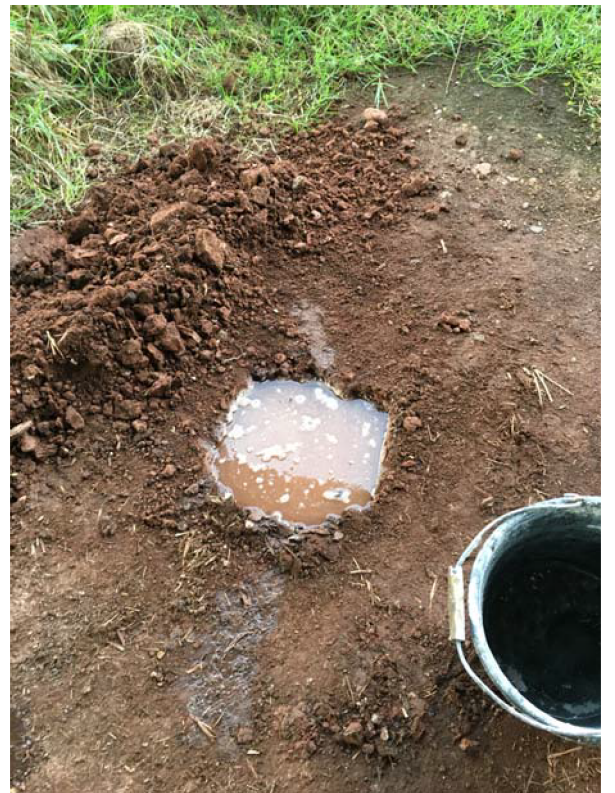
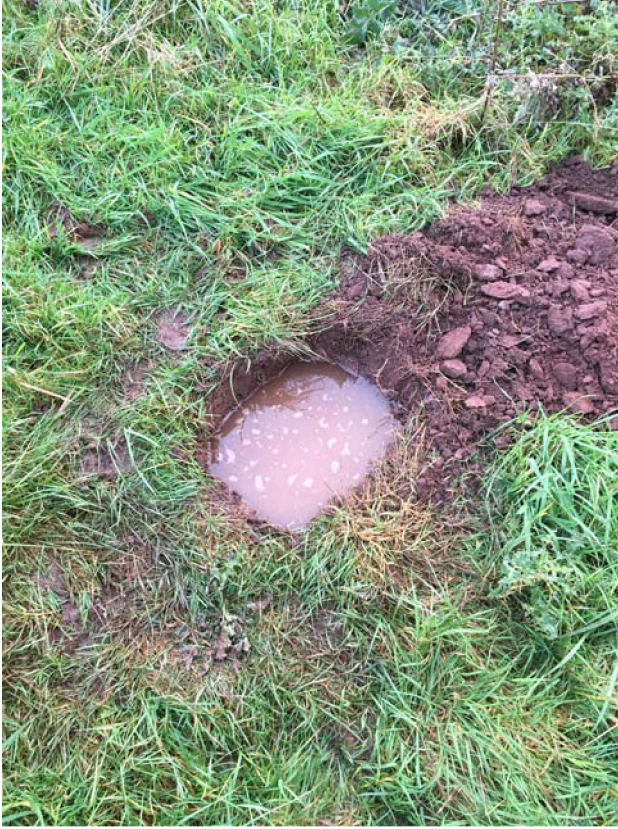
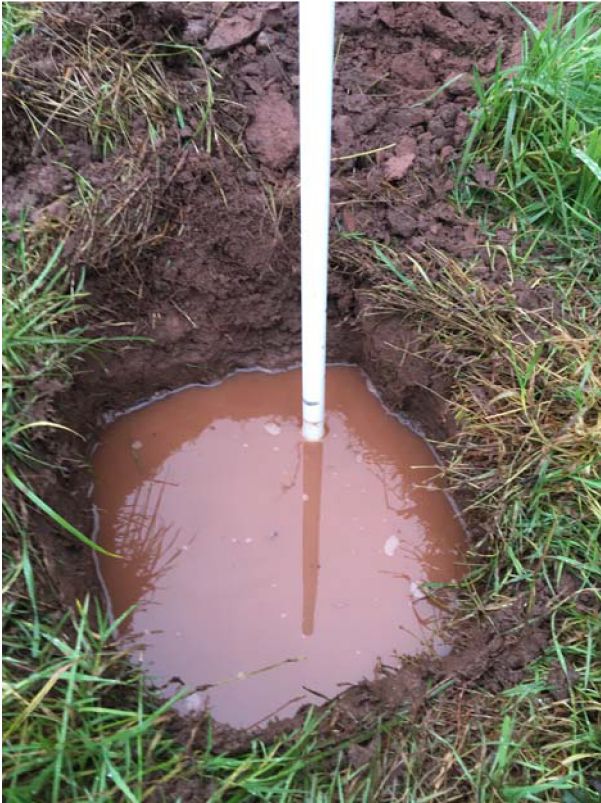
Percolation Test Photographs

- Excavate 2 percolation holes, not less than 5m apart, 300mm square to a depth of 300mm below the proposed invert level of the effluent distribution pipe. Where deep holes are necessary, the hole should conform to this shape at the bottom but may be enlarged above the 300mm level to enable safe excavation to be carried out.

- Fill the 300mm square section of the holes to a depth of at least 300mm with water and allow it to seep away overnight. It is important to saturate the soil surrounding the test hole to simulate day to day conditions in an operational drainage field.

- Next day, refill the test sections with water to a depth of at least 300mm and observe the time (T) in seconds, for the water to seep away from 75% to 25% full level.

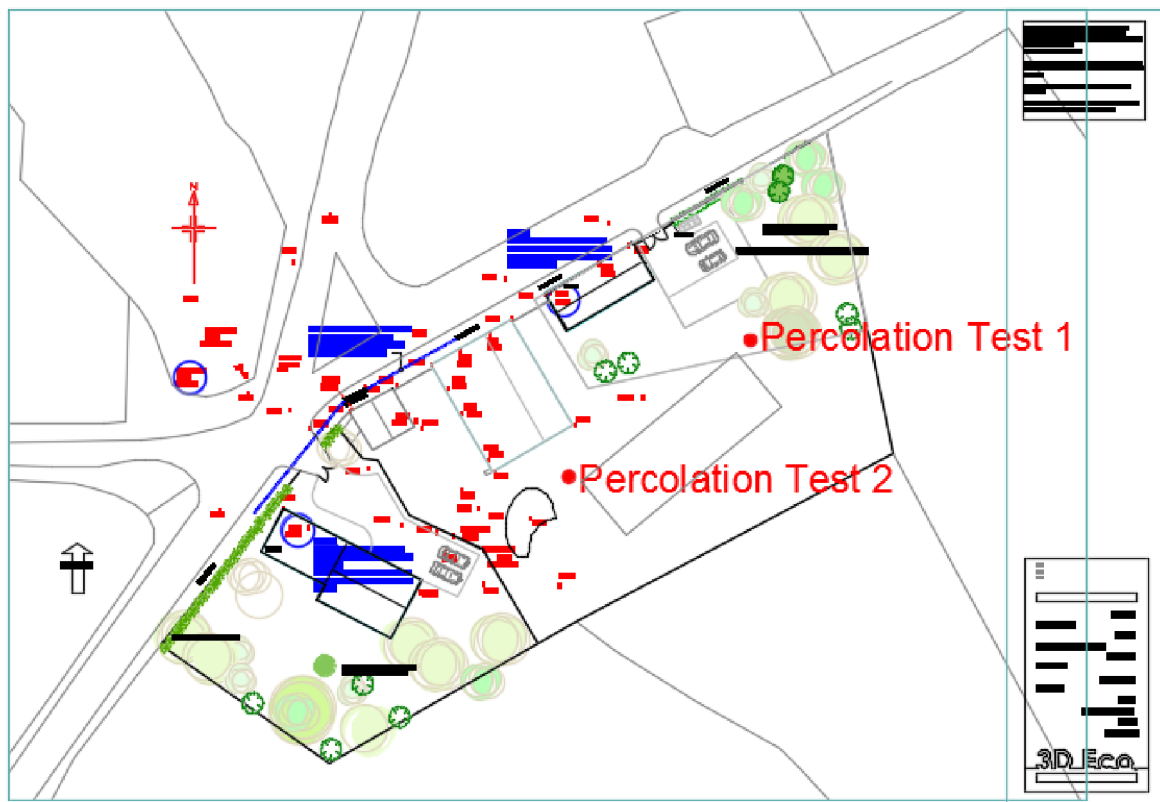
Percolation Test Locations

- These tests should be carried out within and be representative of, the proposed infiltration area which should be at least 5m from the intended building and any boundary.
