BAT SURVEYS AND MITIGATION PLAN

**Eyton Court, Leominster,
Herefordshire HR6 0AG**

**Report
1st August 2024**

Report reference:
C4147-2

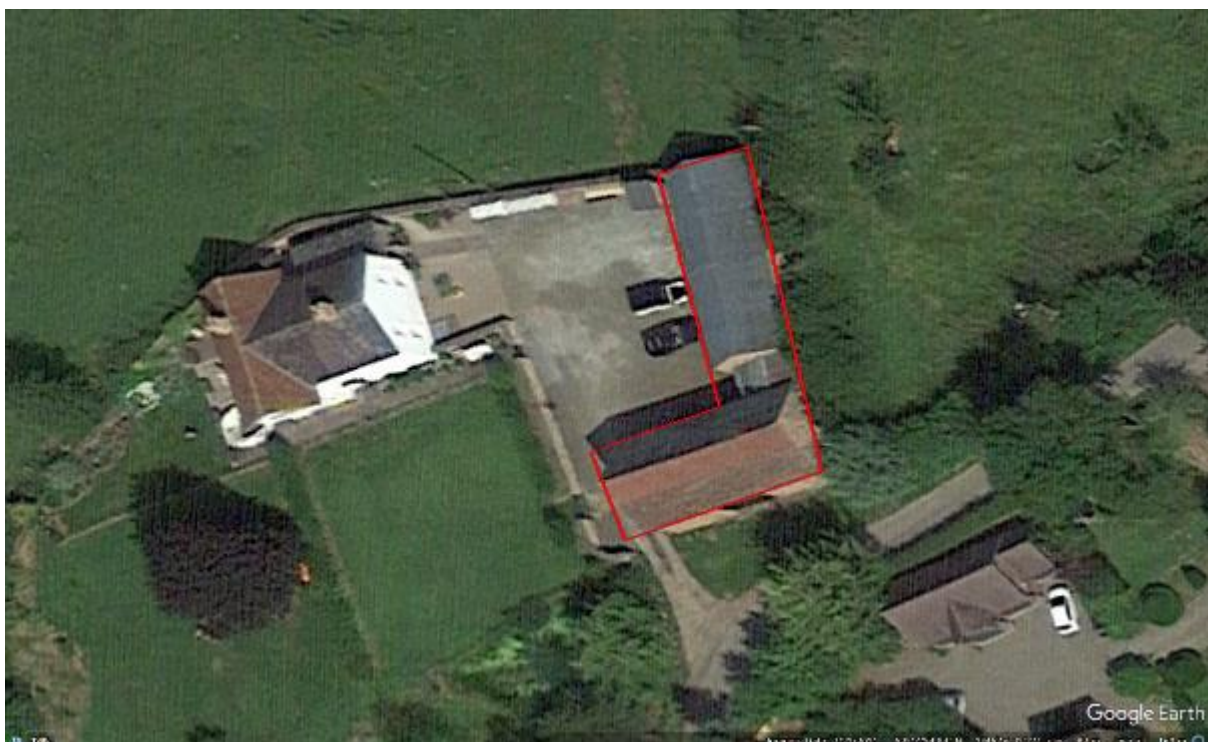
Figure 2: Aerial photo of Eyton Court, with the two barns outlined in red.

Weather conditions at the time of the survey are shown in Table 1. The survey covered the two barns and interlinking canopy as shown in Figure 2, Section 1. Adjacent habitats were briefly assessed for their value for bats, as shown in Figures 1 and 2, Section 1.

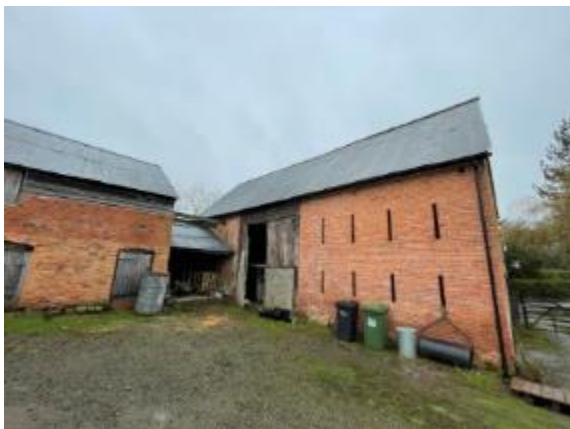
Plate 1. North elevation of the south barn, with the north barn partially visible on the left.

The building has numerous slitted, unglazed barn vents on all elevations (Plates 1-4); there are wooden timber lintels above the inner brick walling surrounding the slitted barn vents (Plate 11). The timber roof purlins extend from the gable ends, where there are also timber barge boards along the tile verges (Plate 3). The eaves are open, and the timber doors are poorly fitted, with various gaps (Plate 7).

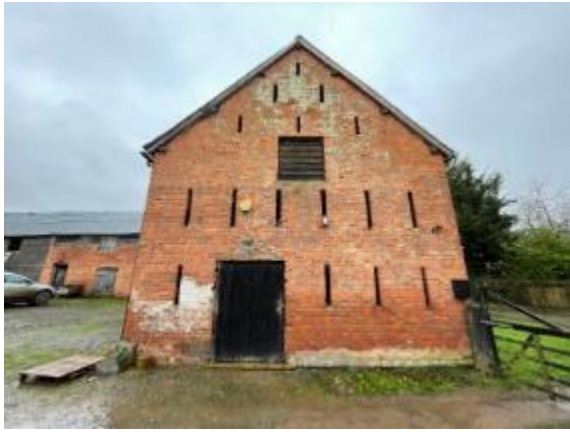
Plate 3: West gable of the south barn.

The elevation stone and brickwork is in reasonable condition, but there are several visible gaps around the extending timber purlins on the gable ends, and gaps/crevices within the eaves and gable wall tops, which could offer crevice-roosting opportunities for bats.

At 2119 a common pipistrelle emerged from below the barge board on the west elevation of the south barn, just above the middle purlin. At 2125 a soprano pipistrelle emerged from a crack in the tile verge on the west elevation of the south barn, at the bottom of the roof. At 2131 a second soprano pipistrelle emerged from a gap between the middle timber purlin and surrounding brickwork on the west elevation of the south barn.

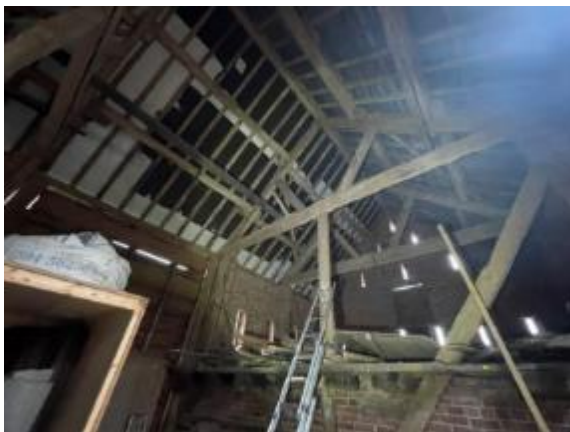
Plate 5: South barn interior, eastern end.

Internally the barn comprises one large room, with an open roof space, roughly 6.5-7 m from floor to ceiling in the central area, and raised platforms at approximately a third height (Plates 5 and 6) on either side. The north roof pitch is unlined (Plate 9) while the south roof pitch contains a combination of traditional roofing felt and breathable membrane (Plate 10).

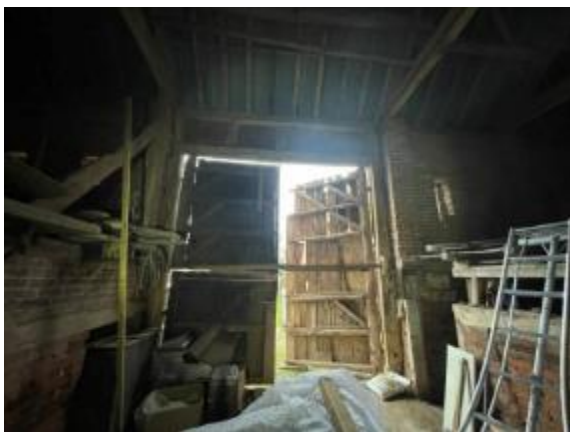
Plate 7: South barn north doorway.

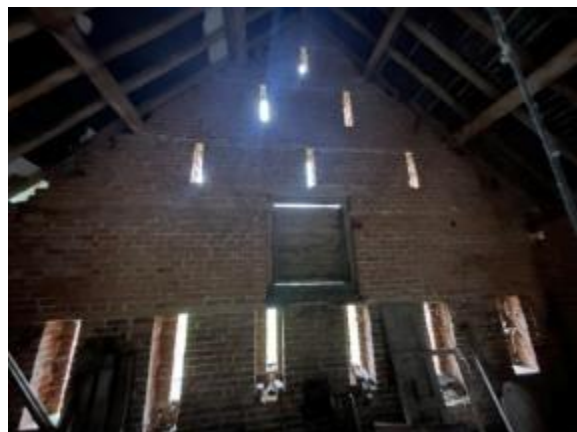
Plate 8: South barn, slitted brick vents.

The internal brick walls have few openings, cracks or crevices within the mortar suitable for roosting bats. However, the majority of the slitted barn vents contain timber lintels on the inner course of bricks; most of the lintels have gaps behind leading to deep cracks and crevices between the inner and outer course of bricks providing suitable opportunities for roosting bats.

Inspection of the gaps and crevices behind the vent lintels found no evidence of bats.

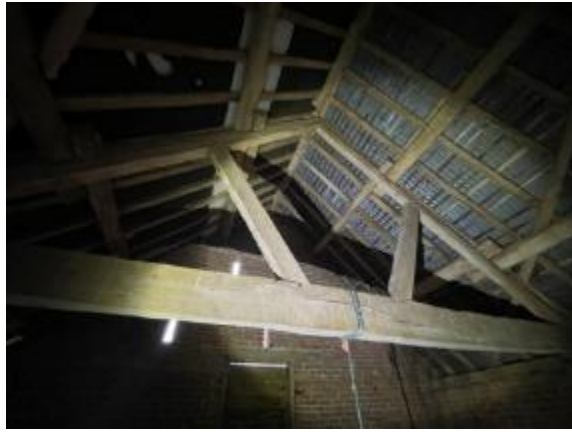
Plate 9: South barn, north roof pitch, unlined.

The north roof pitch is unlined and comprises corrugated metal panels; there are few opportunities to access the building between the roof panels (from above) and the unlined nature of this roof pitch makes it less likely to be used by bats. Conversely, the south roof pitch contains clay tiles; the more recently tiled upper half of the roof looks well-sealed while the older, lower half has various missing, slipped or broken tiles which may offer opportunities for bats to access spaces below the tiles; the south pitch is lined with a mixture of bitumastic felt and modern breathable membranes, and thus there are enclosed spaces between the tiles and lining which may be suitable for crevice-roosting bats.

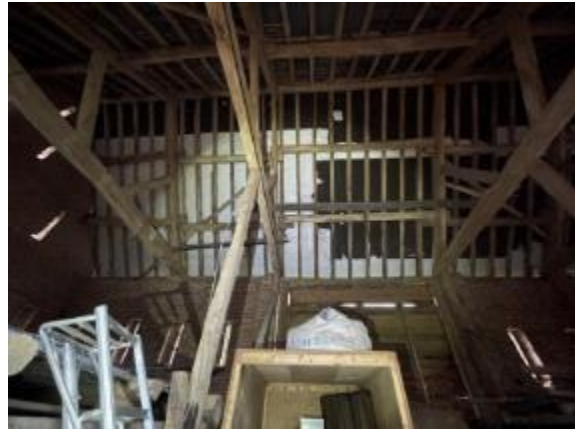
Plate 10: South barn, south roof pitch, with felt and breathable membrane lining.

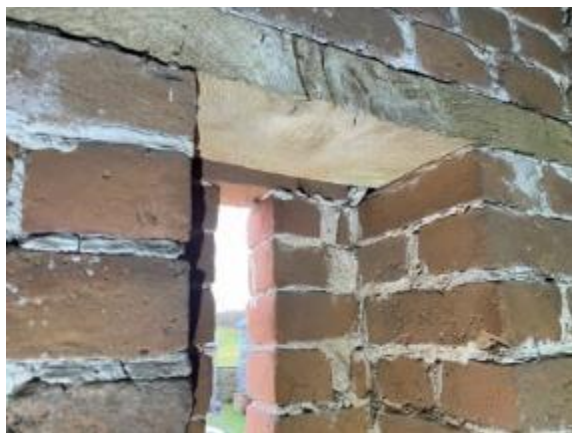
Plate 11: South barn, timber lintel within inner brick wall.

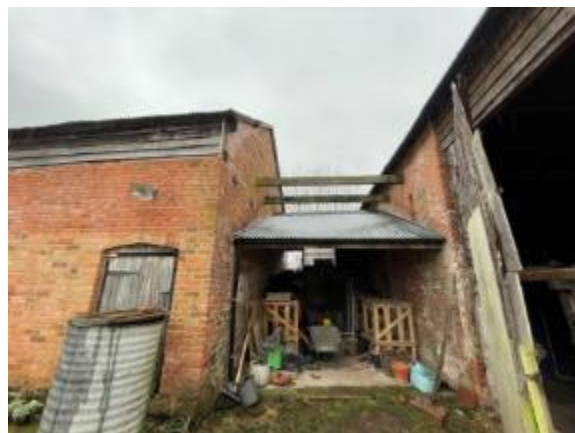
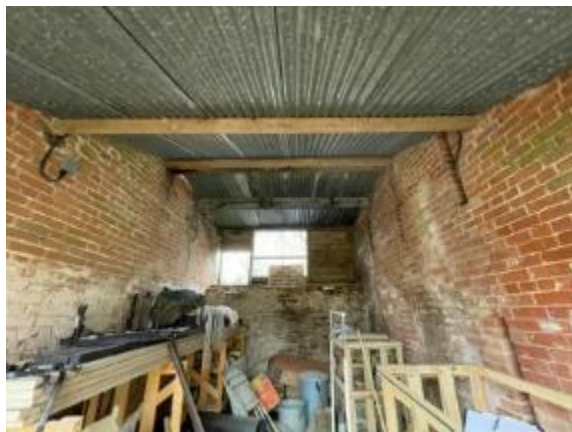
A small canopy links the south and north barns (Plates 12 and 13). This comprises timbers spanning the gap between the two barns and supporting corrugated metal roof panels; the roof is unlined. At the back (east side) of the canopy is a low stone wall to half-height, with unglazed window openings and timber cladding above. The west side is open to the courtyard.

Plate 12: Open-sided canopy between the two barns.

Plate 13: Canopy interior space.

No evidence of bats was found from external or internal inspection of the canopy between the two barns.

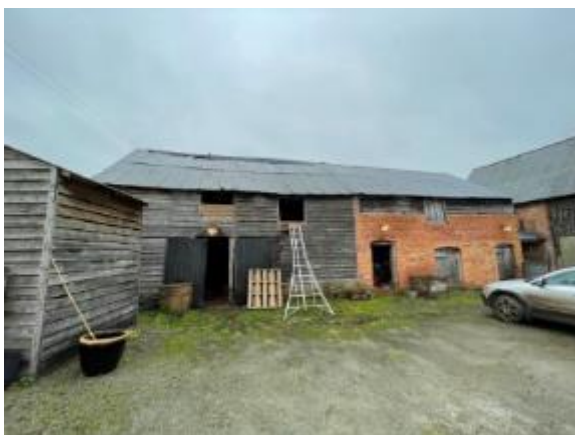
The timber cladding is in poor condition, with many sections of missing or broken cladding (Plates 15 and 17). The west elevation has a set of double doors and several unglazed window openings in the upper walling (Plate 14).

Plate 14: West elevation of north barn.

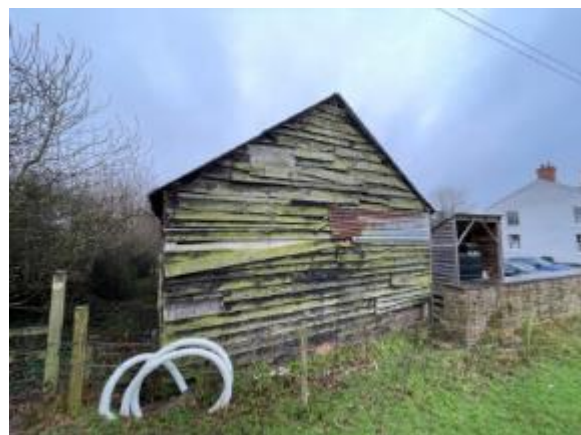
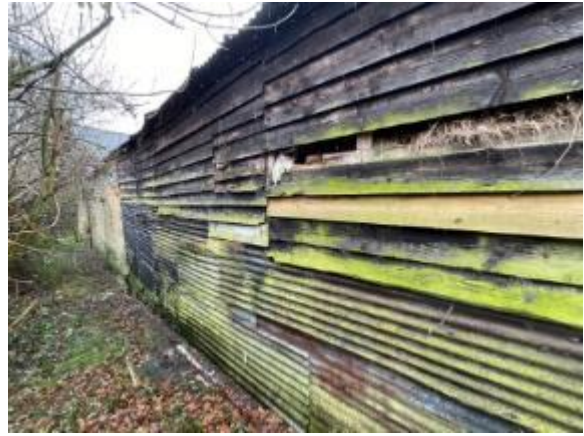
Plate 15: North elevation of north barn.

Plate 17: East elevation of north barn.

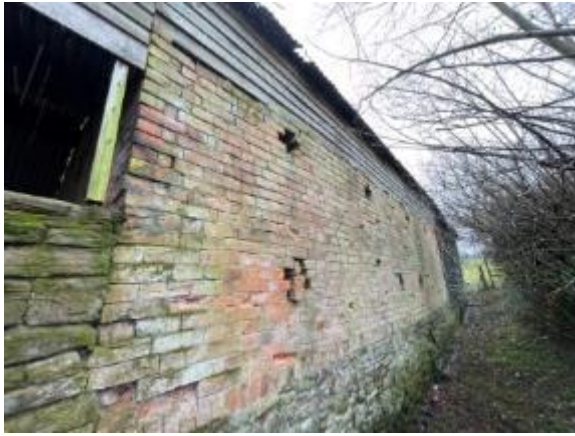
Plate 16: East elevation of north barn.

The southern brick-built section has some areas of stone plinth (to approx. 0.5 m) and upper areas of timber cladding (<1 m) (Plate 16). This half of the building contains one large room, open from the floor to the unlined metal roof (Plate 18). The brickwork is mostly old, with

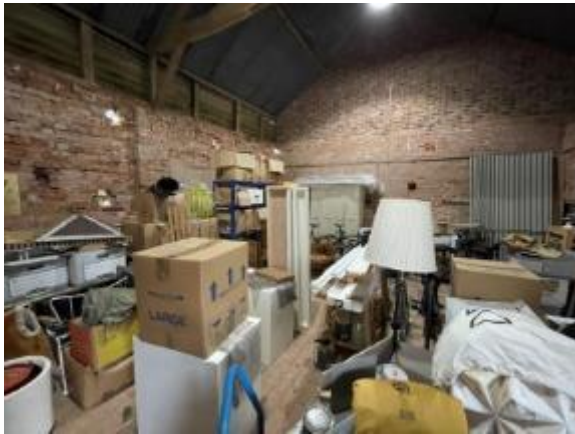
Plate 18: North barn, south room.

The south section contains electrical strip lighting and is used as a workshop and for storage (Plate 18). The upper internal north gable wall has an unglazed window opening directly into the roof space of the northern part of the barn (Plate 20).

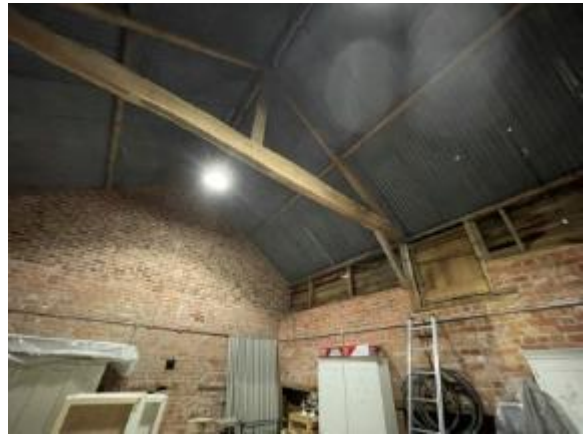
Plate 19: North barn, south room.

large gaps in places, but with the upper gables comprising more recent brickwork (Plate 20); the height of the building may have been increased when the metal roof was put on. The roof is supported by large timber purlins and a timber frame of King-post style construction (Plate 19). There are four timber doors on the west elevation of this section of the building, comprising three on the ground floor, with brick lintels, and one on the first floor (Plate 14). The east elevation has open ventilation gaps in the upper brickwork (Plate 16), and there are square holes in the north brickwork gable, probably where first-floor joists were once present.

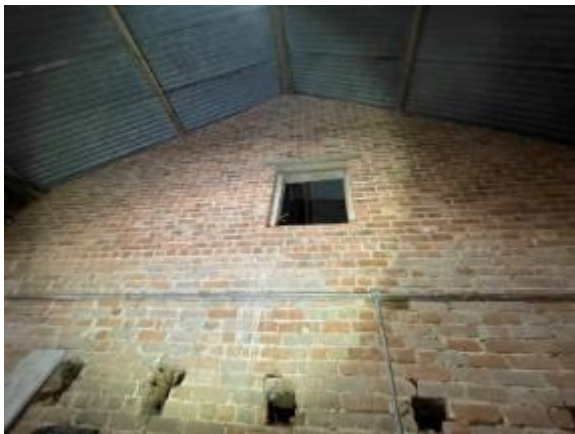
Plate 20: North barn, open window in internal gable wall.

A localised collection of bat droppings (c. 40-50), of various size, was present stuck to the central gable wall and on materials below the unglazed window opening, on the south side (Figure 5, Plates 20, 26 and 27); a sample of bat droppings sent for DNA analysis confirmed they were from brown long-eared bat, lesser horseshoe bat and serotine *Eptesicus serotinus*. The localised nature and location of the droppings may indicate use of the window by bats flying between the two parts of the barn, and potentially of roosting within the hayloft or south room (e.g. night roosting).

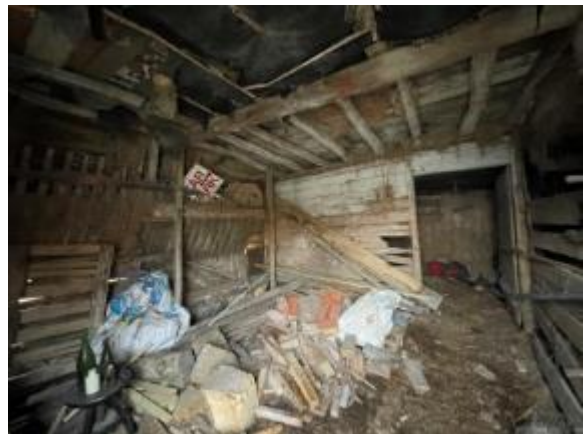
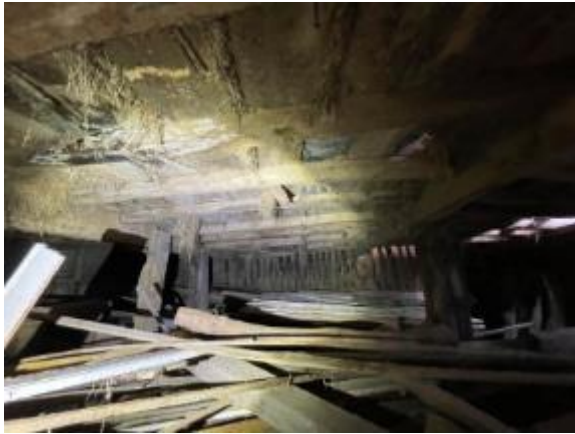
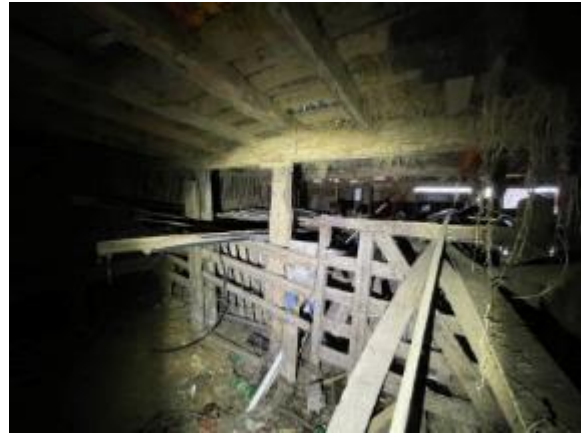
Internally the barn ground floor is compartmentalised into several livestock pens (now unused), covered in hay, below a timber ceiling/first floor (Plates 21-23); there are various gaps in the ceiling into the roof space above. The ground floor rooms have no electrical lighting and are relatively dark.

Plate 21: North barn, north livestock room.

Plate 22: North barn, north livestock room.

Plate 23: North barn, north livestock room.

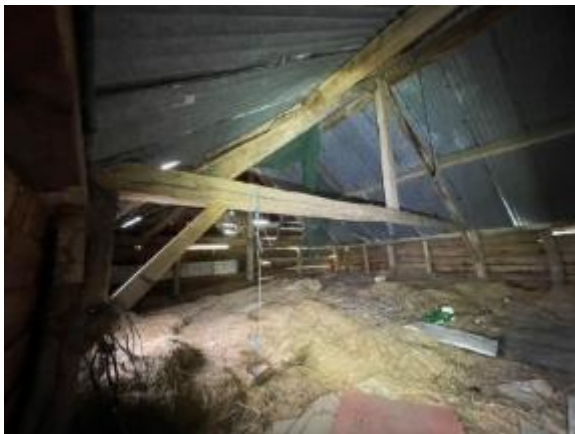
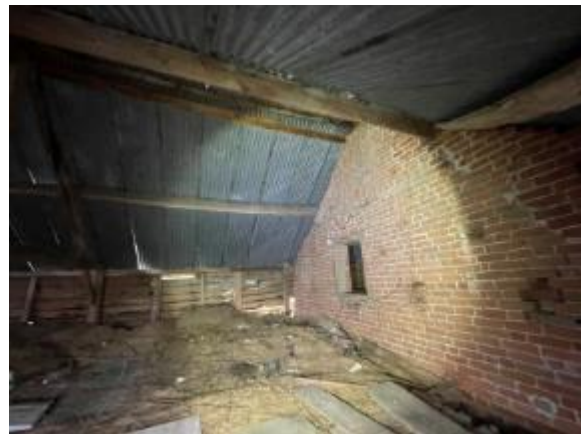
The roof space is relatively open and draughty from numerous gaps in the cladding (Plates 24 and 25). The roof is supported by timber purlins and a Kingpost (as in the southern half), while the floor is covered in hay. The internal south gable wall has various gaps in the brickwork where previous timbers may have once inserted (Plate 25).

Plate 24: North barn, north roof space.

Plate 25: North barn, open window into south room (as seen in Plate 20).

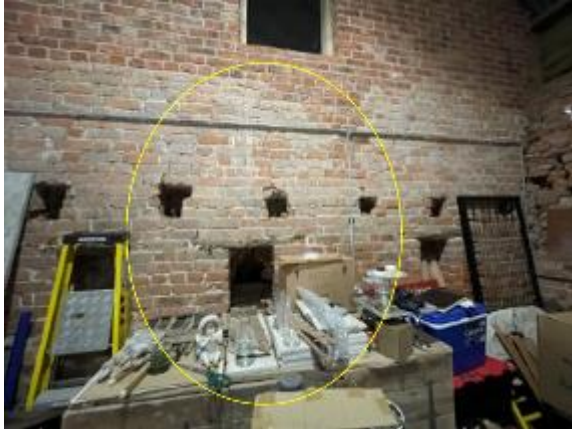
Plate 26: Area of localized bat droppings below wall opening

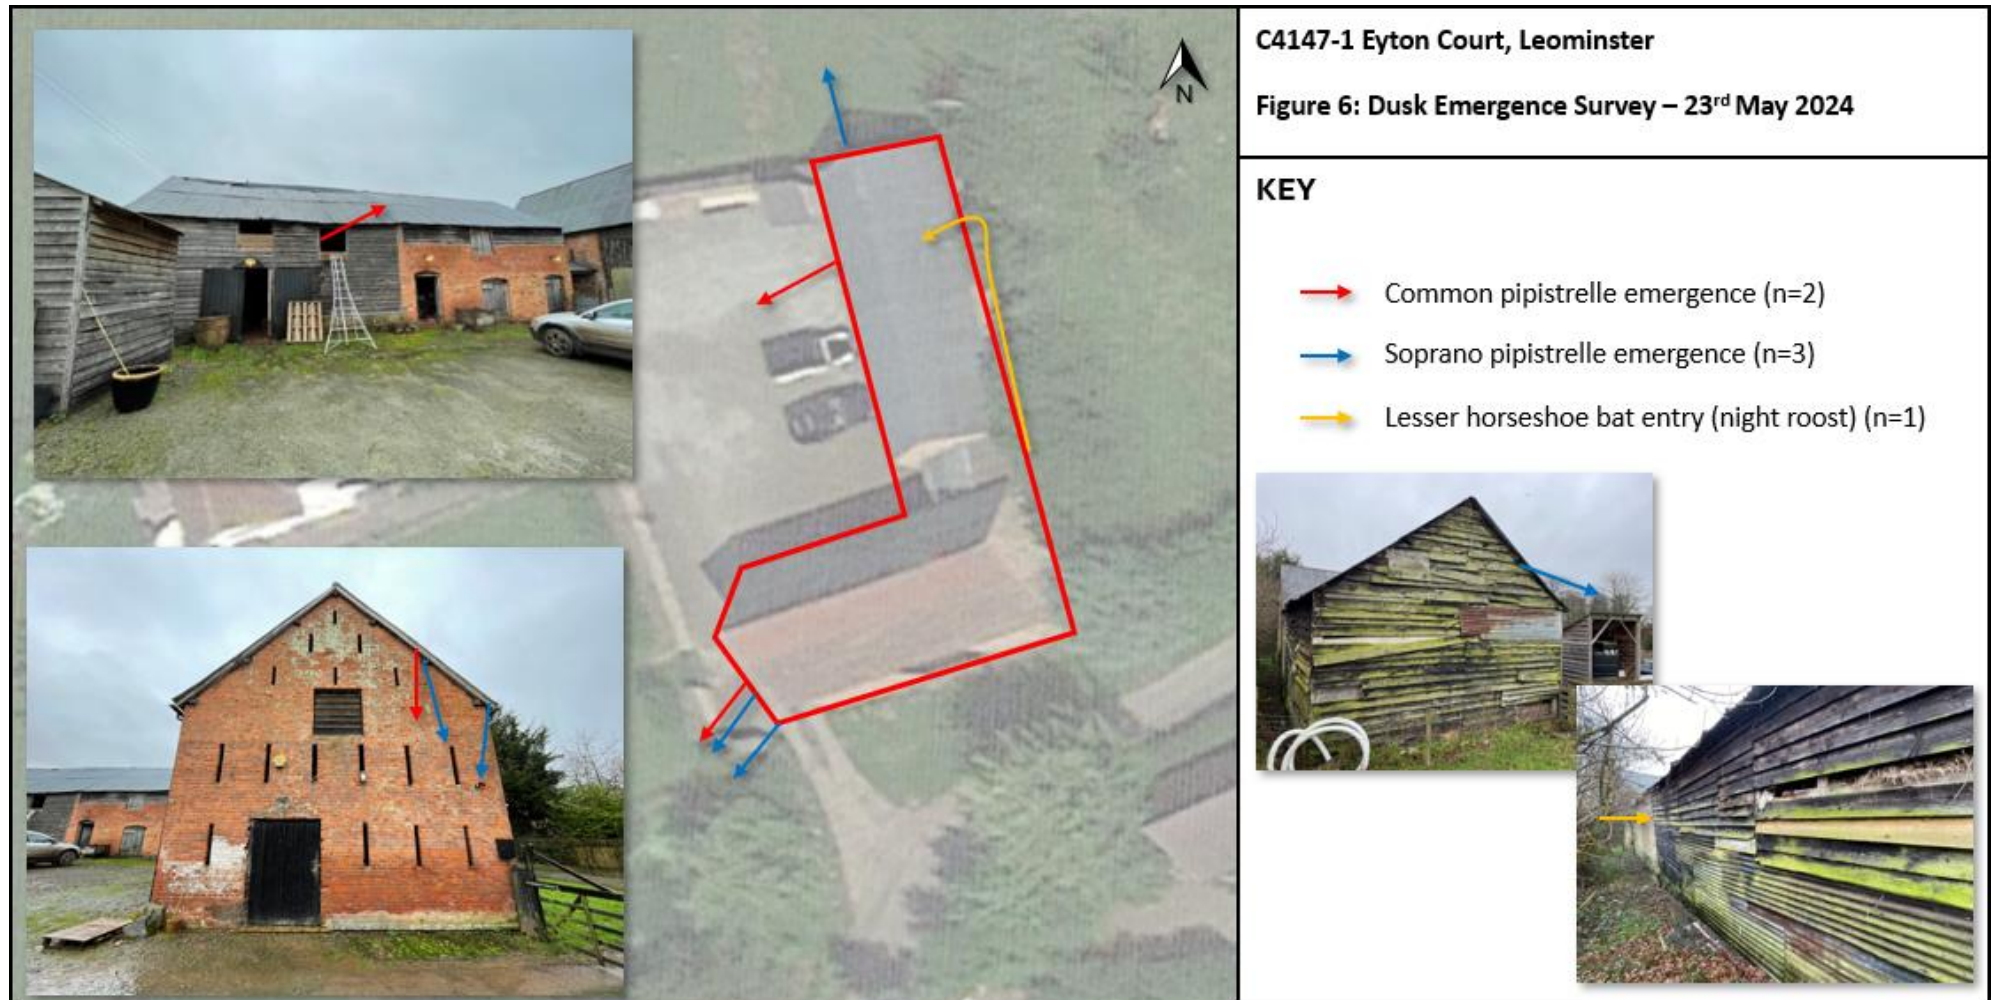
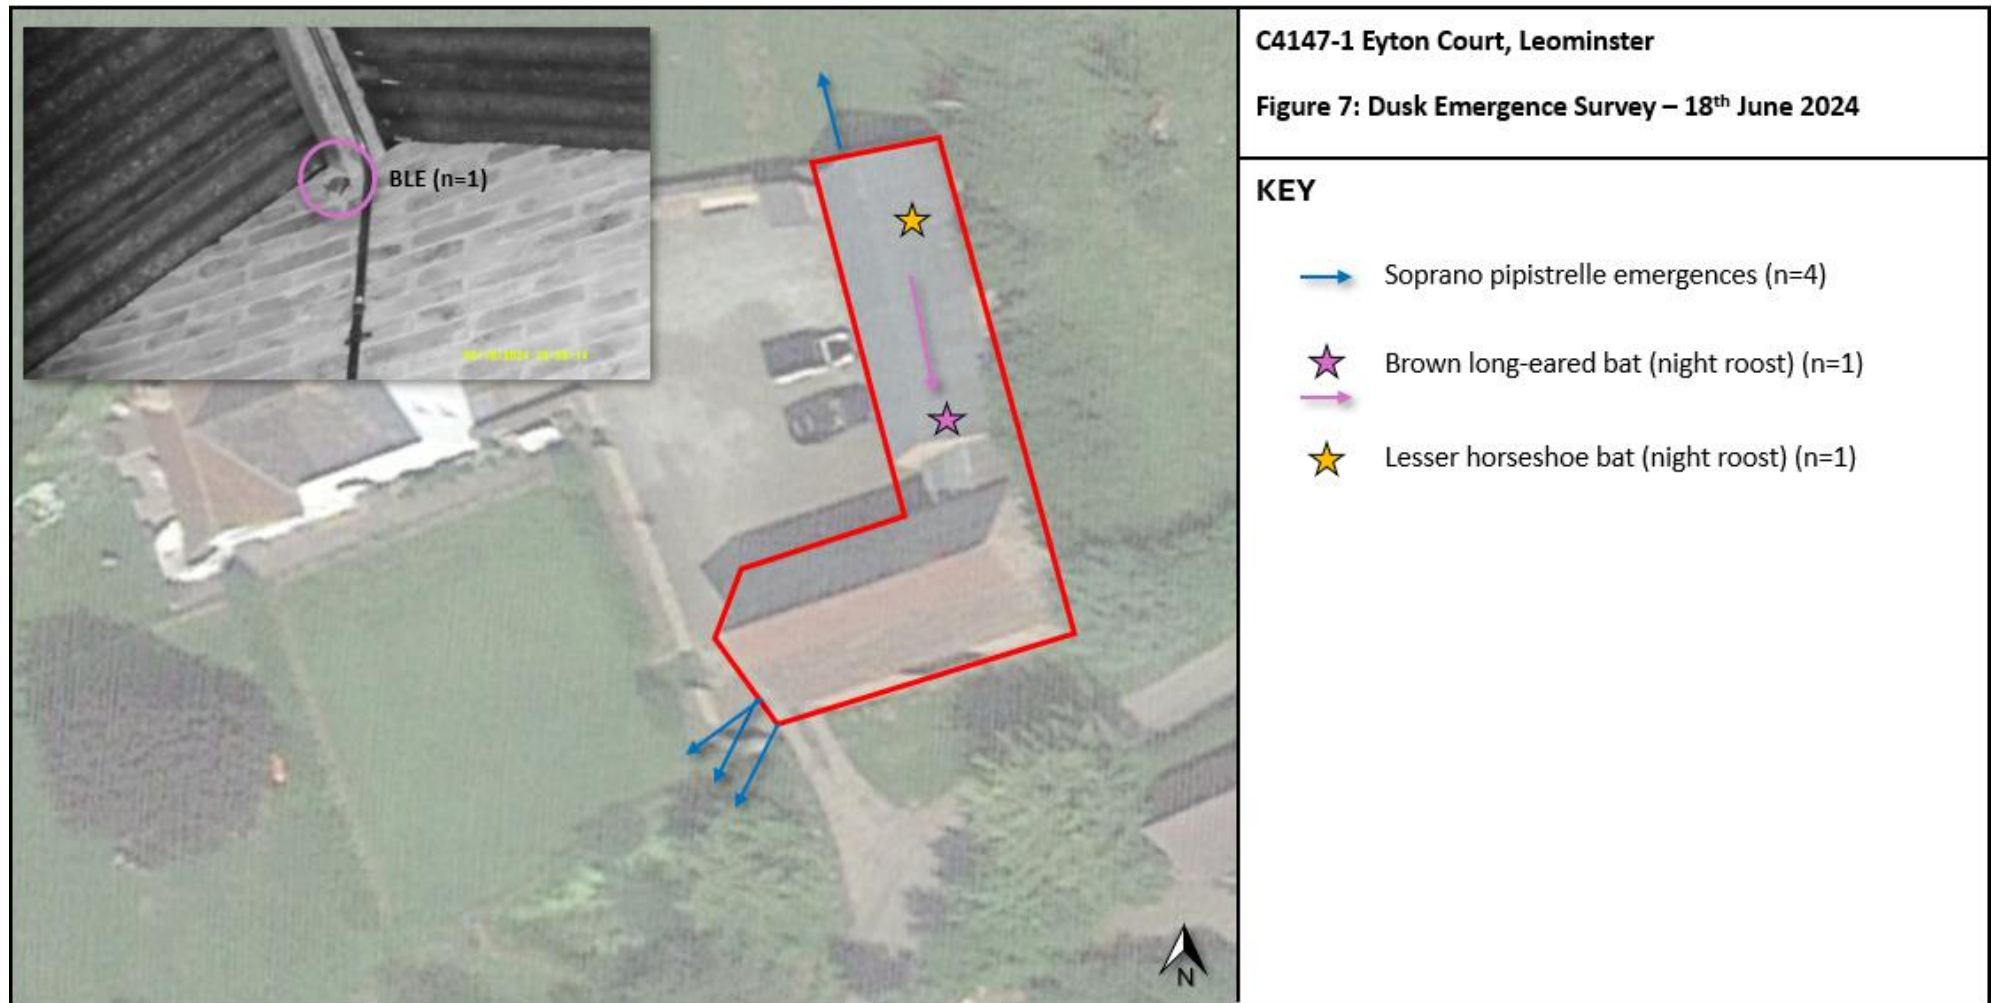
All of the roosts are considered to be non-breeding roosts.

The locations of confirmed bat roosts across the two barns are illustrated in Figure 8.

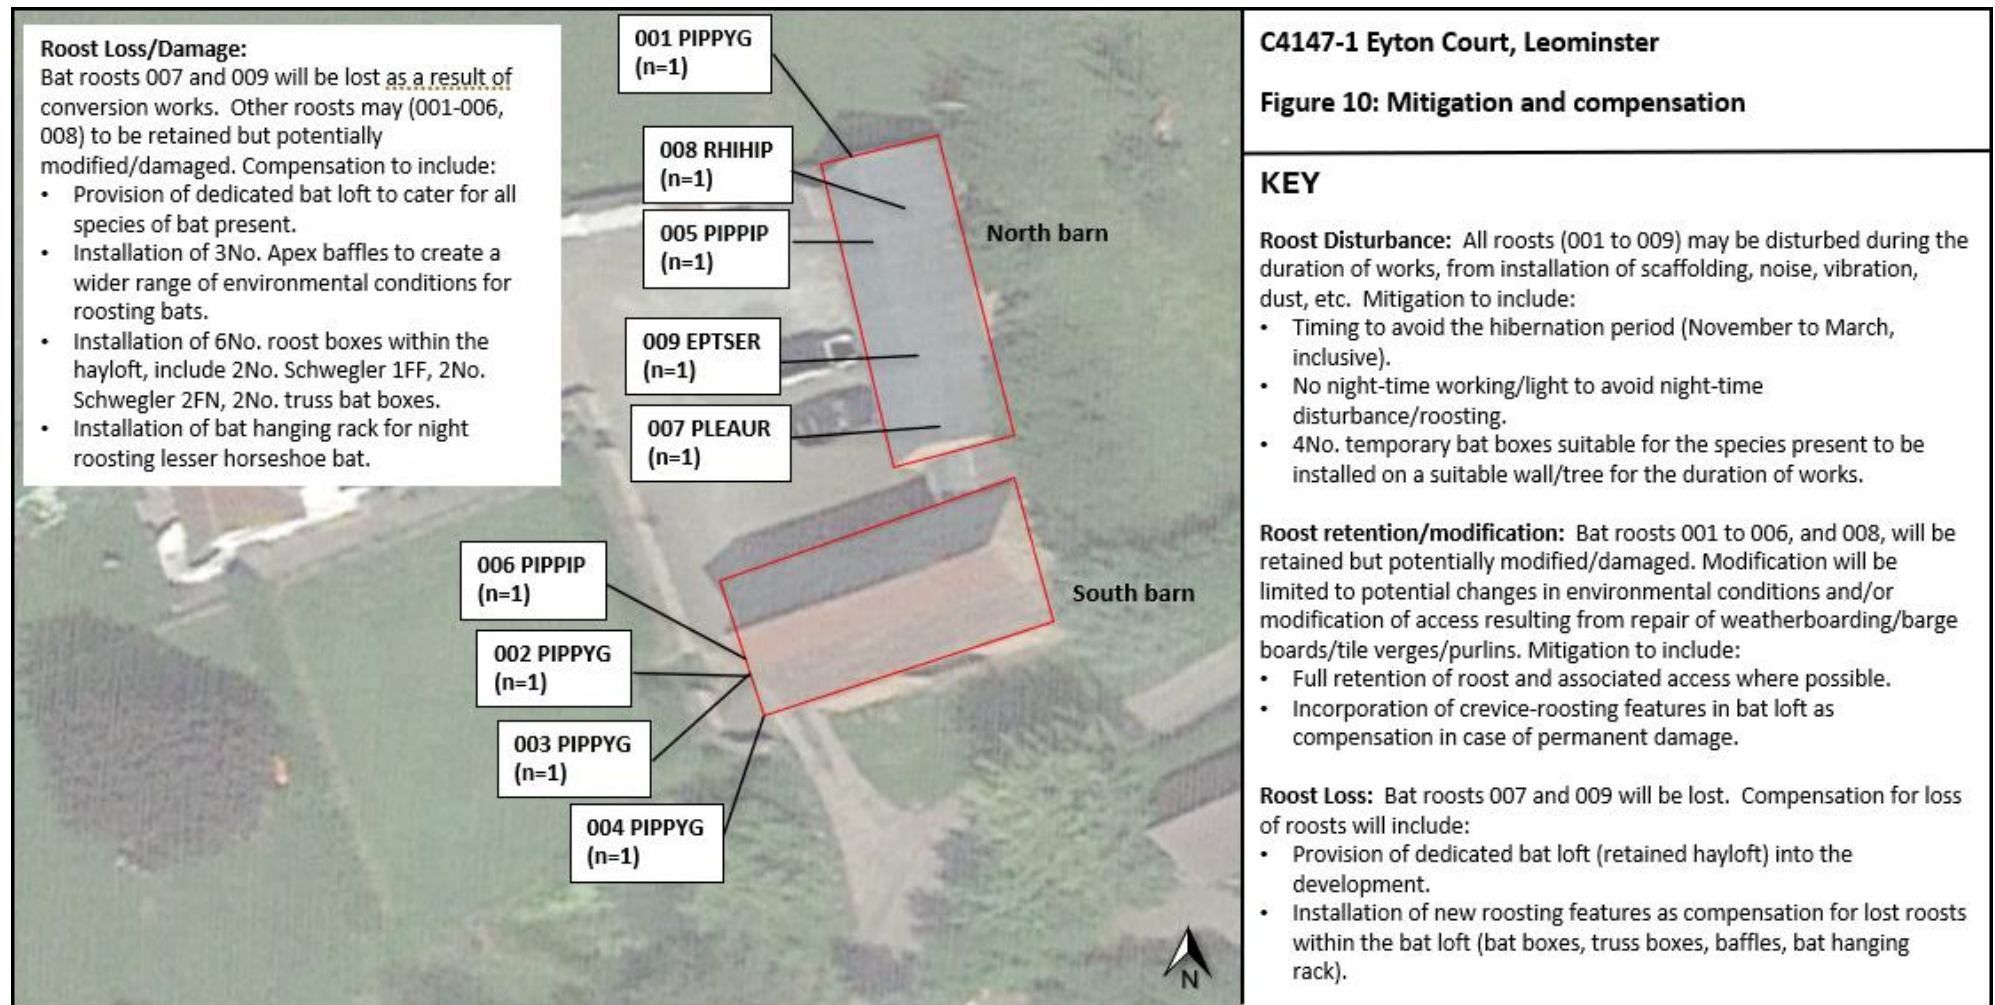
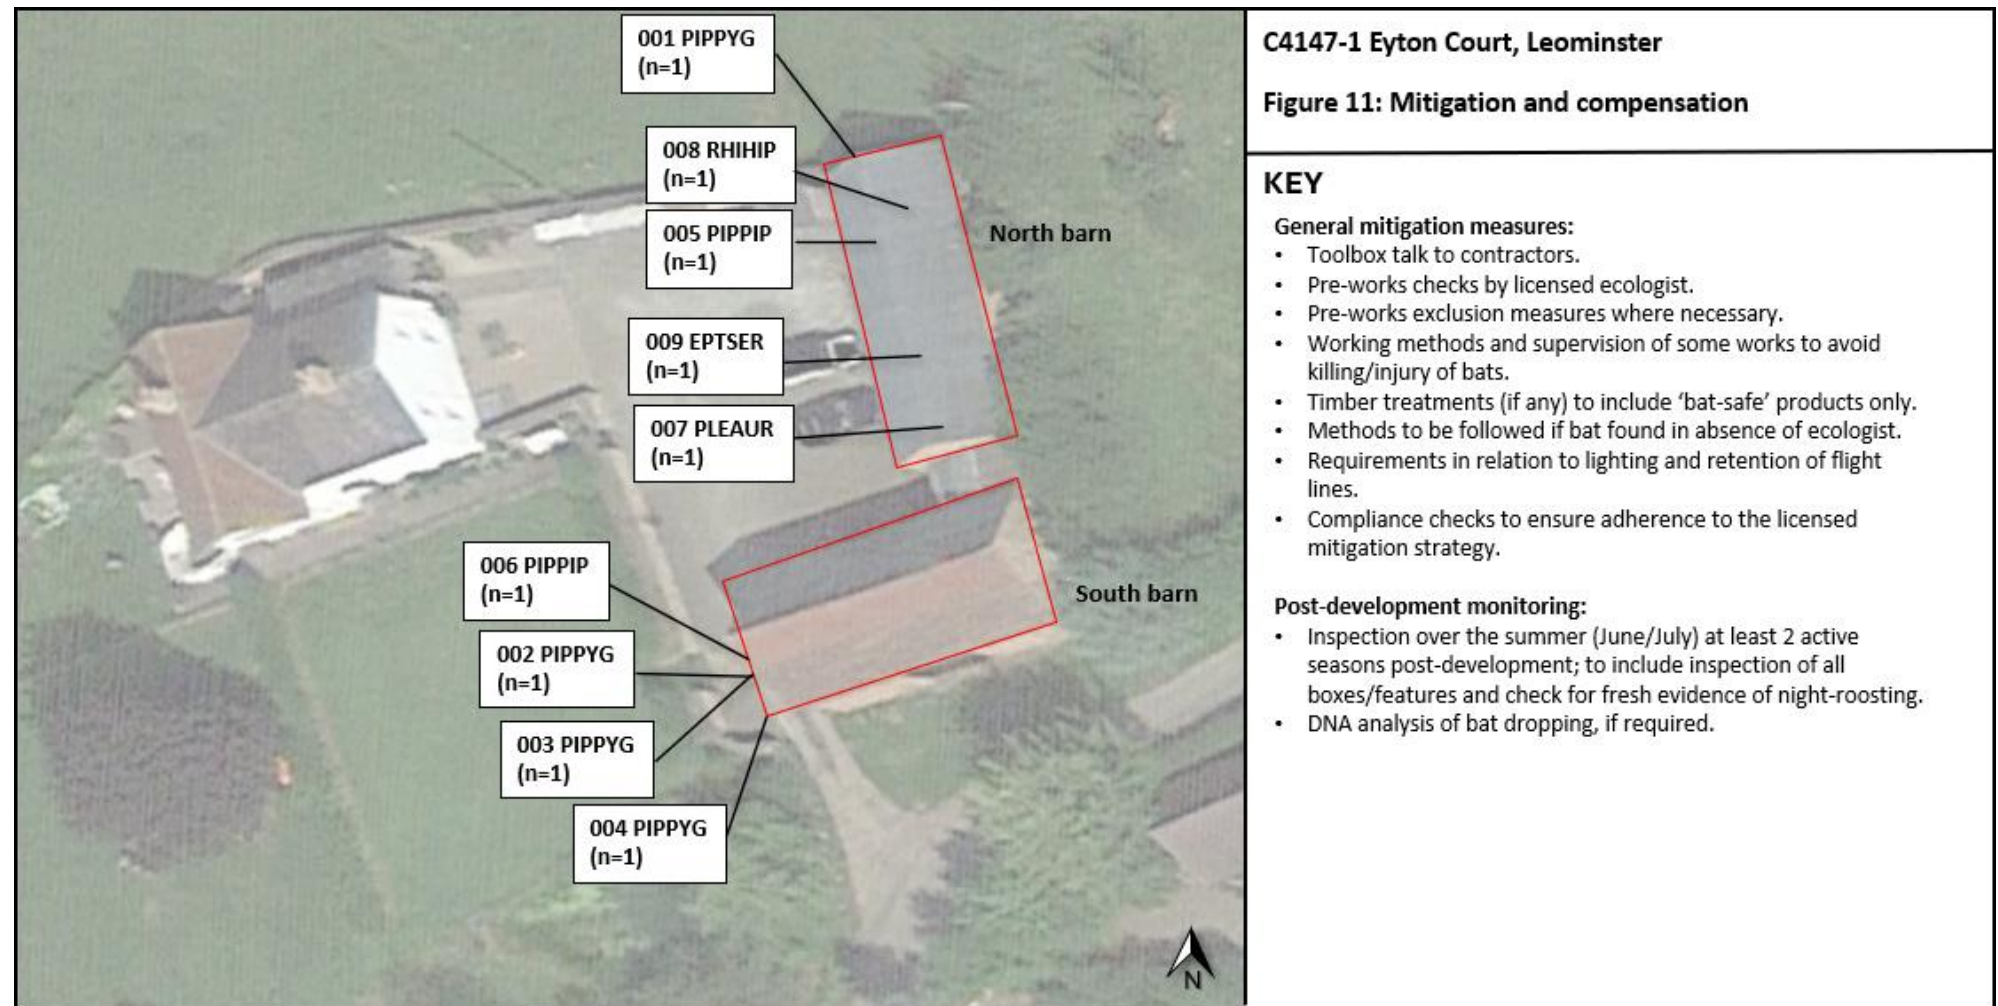
A summary of mitigation and compensation measures is provided in Figures 10 and 11.

In line with Natural England guidance under the Earned Recognition licensing (Minimum Expectations for Monitoring and Maintenance), for a night roost of a group 4 species, post-development monitoring will include inspection of the barns and all mitigation features at least two active seasons (est. 2026 or 2027) after completion of the works. The inspection will include a check of all retained and installed roost features to check for bats/fresh evidence of bats. Monitoring will include DNA analysis of any fresh bat droppings to determine which species are present.
