An Updated Ecological Assessment & Mitigation Report for Peterchurch Primary School

Aim: To establish the presence or absence of bats & birds in the building & importance of adjacent habitats.

Peterchurch Primary School
Peterchurch
Hereford
HR2 0RP

Reference: 3PC-PEAR.doc
29th January 2025

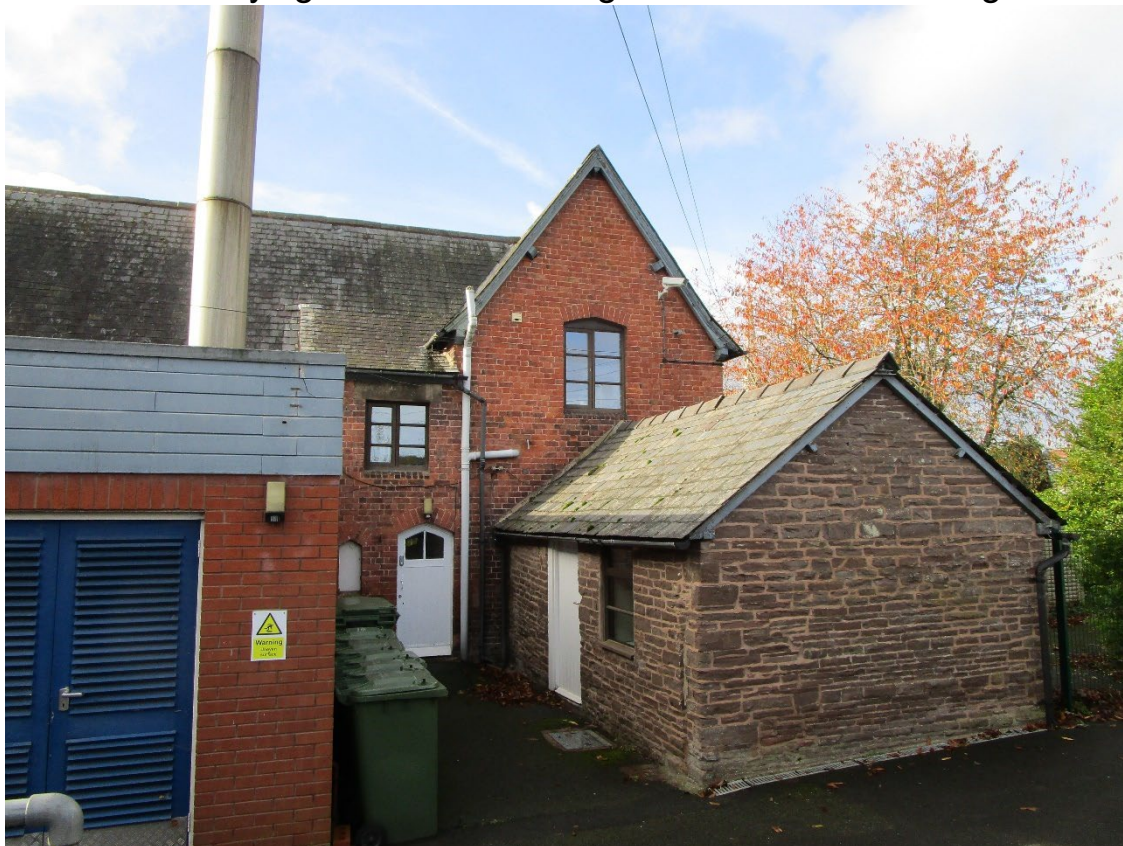
The old original part of the school was built in 1850 & is shown on the report's cover photo & below in figure one. It is a two-storey pitched building comprised of traditional red brick with a traditional slate roof, part of the western elevation the building was painted however this is peeling off as shown in the cover photograph. The slate roof on the front elevation section was replaced 5+ years ago & has tight fitting tiles, in contrast to the old rear elevation roof that has several gaps. There is a single storey stone building with a slate pitched roof to the rear with gaps in the ridge line as shown below in figure one. They is also a modern red brick flat roofed extension also shown below in figure one. There are also a number of external security lights on the buildings as shown below in figure one.

Figure 1 – The old school building (Building 1) with two single storey extensions

All the windows and doors are well sealed on both the main building and the extensions. However, the slate roof on the old building to the rear and the stone extension do have several gaps at the pitch of the roofs & behind the barge boards.

However, the oldest part of the school building (Building one) on the southwest two-storey building part was identified as having a low potential to be used by bats (see Photo on front cover & in figures 1 & 3a & 3b). Whilst the attic areas showed no signs of bats roosting it is not possible to rule out the potential for bats to be using the areas between tiles & the lined roofs on the rear elevation due to the gaps between tiles although the likely hood of bats using the front elevation is considered to be negligible due to this part of the roof having been replaced (8yrs ago) & therefore being very tight fitting. In addition, the single storey stone rear extension with a slate tile was also found to have plenty of gaps in the ridge tiles.

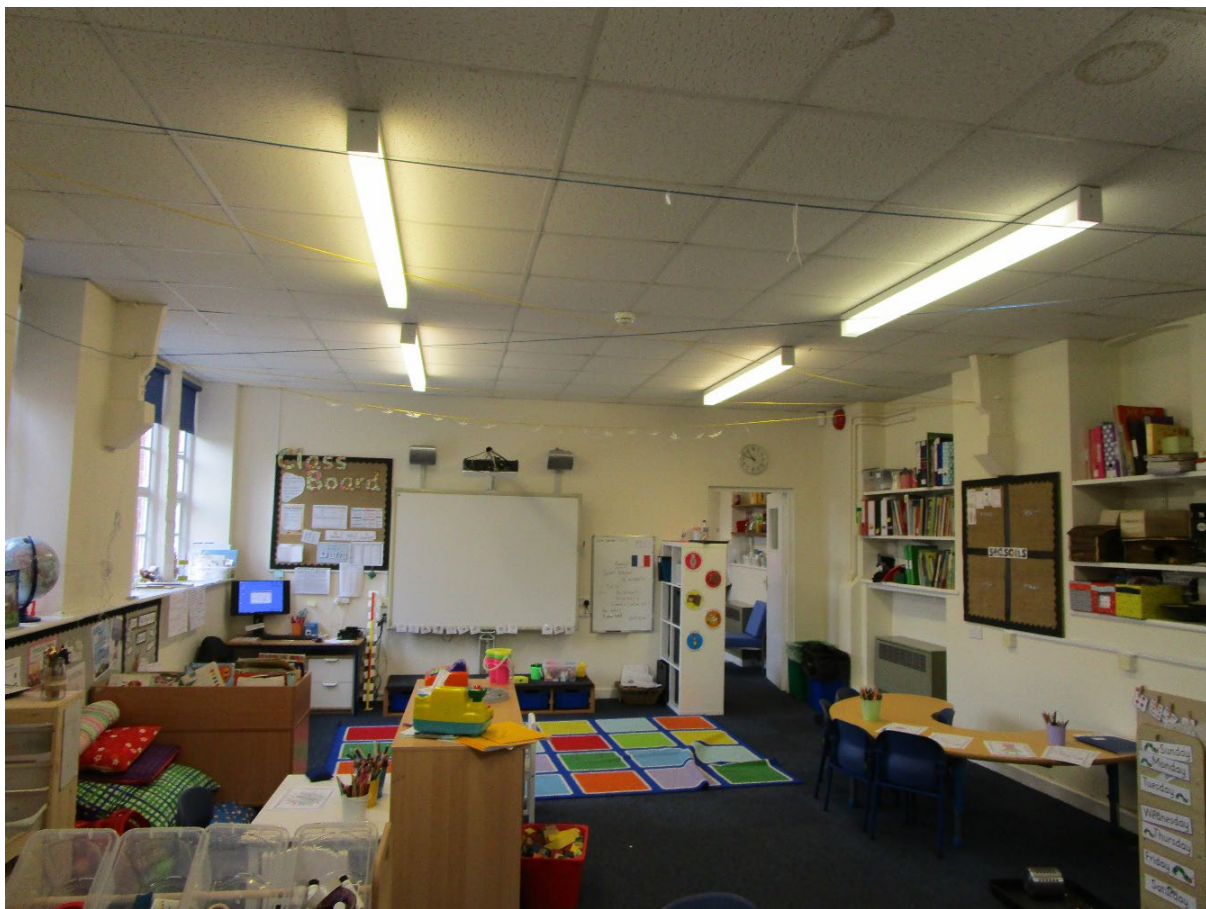
Internally The lower storey of building one has plastered walls that are all painted & in daily use. There is electric strip lighting and a false ceiling with a grid system and square tiles.

The classrooms are well sealed as shown in figure two below.

Figure 2 – classroom on the lower storey of building one

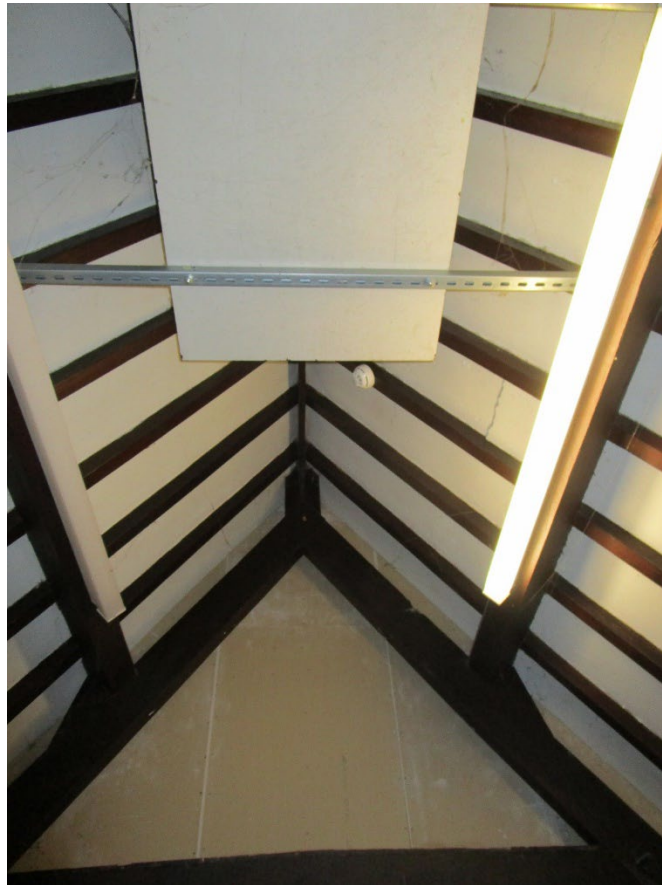
The upper storey of the building is used for storage & lined with painted boarding and timbers and has electric strip lighting as shown over the page in figure three a.

Figure 3a – The used roof space in building one

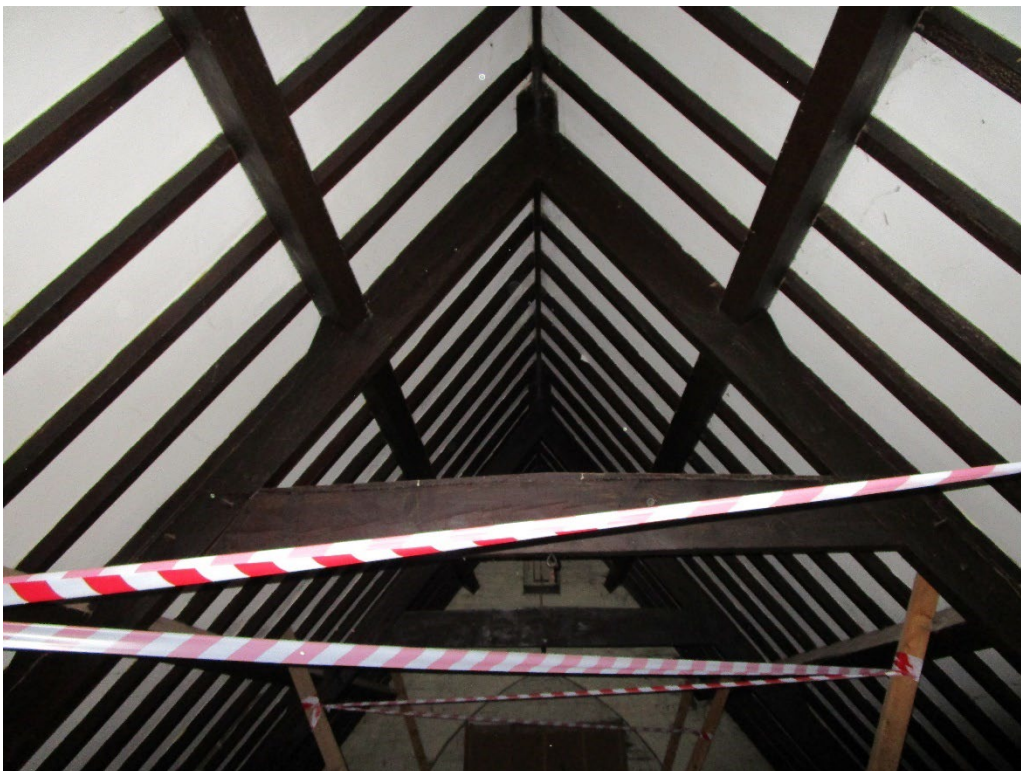
The other part of the roof is a large attic space which was examined from the doorway that leads into it as the floor of the attic was unsafe to walk on (see hazard tape in figure three b over the page). The apex is painted white & no evidence of bats or birds were evident in this area.

Figure 3b – The attic area of the roof space

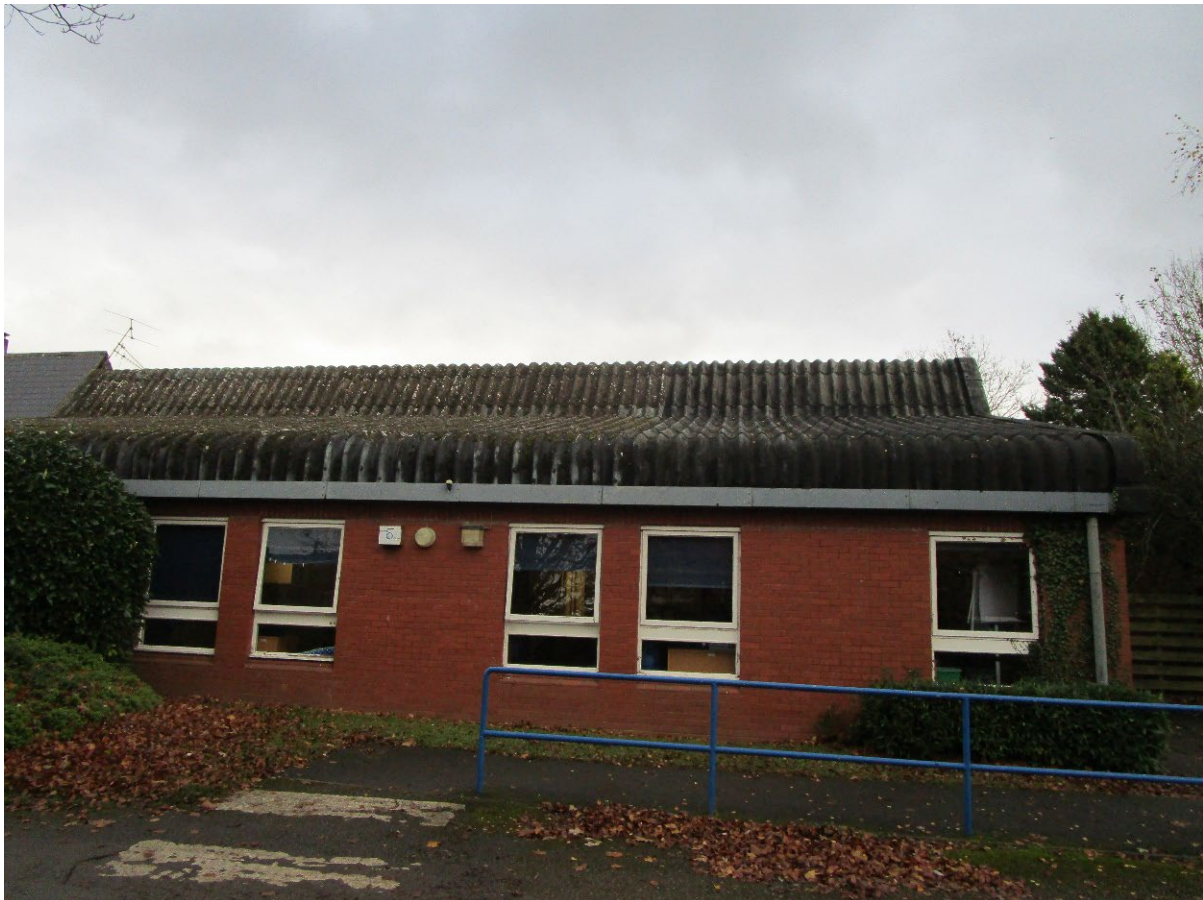
Adjacent to the old school building there is a modern red brick building as shown below in figure four. This building has an unusual barn like curved sheet roof with ridges & the roof overhangs slightly over the bricked wall which is then sealed by metal barge boards as shown below in figure four. The building has large white PVC windows and modern red brick walls & is therefore completely well sealed as shown below in figure four.

Figure 4 – main school block (Building 2) adjacent to the old school building

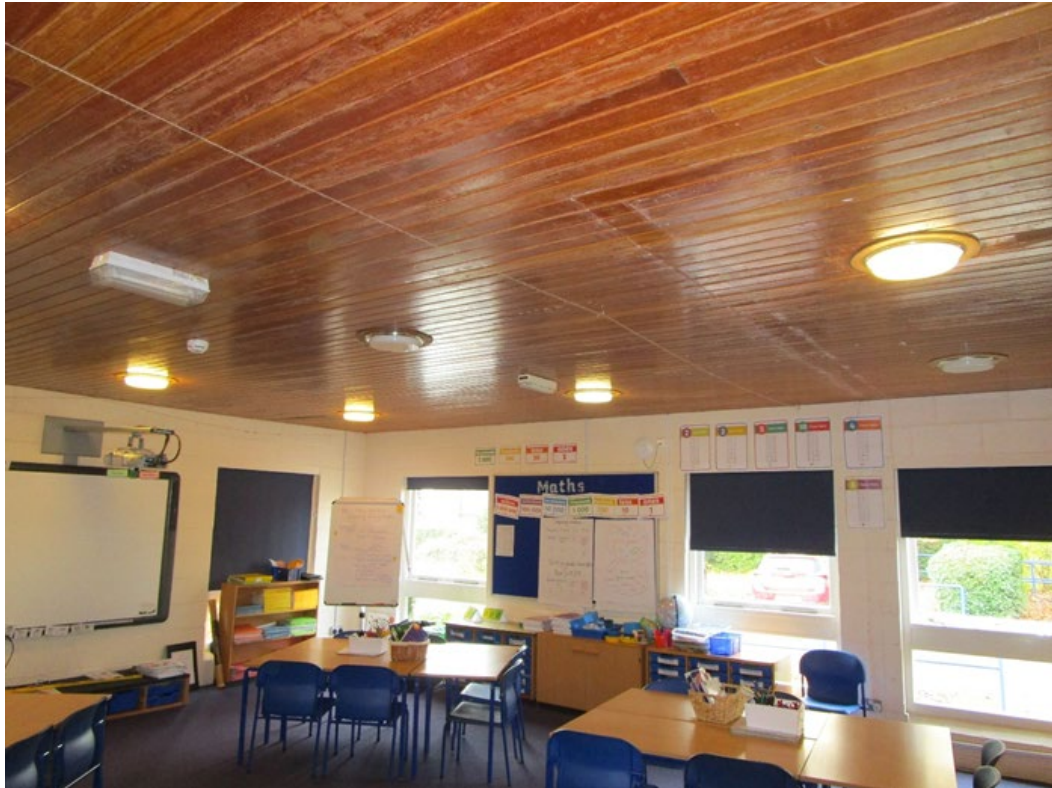
Internally the building has more school classrooms and has a varnished timber lined roof as shown over the page in figure five with a plastered ceiling in the other classrooms as shown over the page in figure six.

The class rooms are naturally well lit from the glazed windows & in addition there is electric lighting throughout in all the classrooms, with the painted walls and lined roofs that appeared to be very well sealed as shown in figures five & six over the page.

Figure 5 – Internal of building section 2

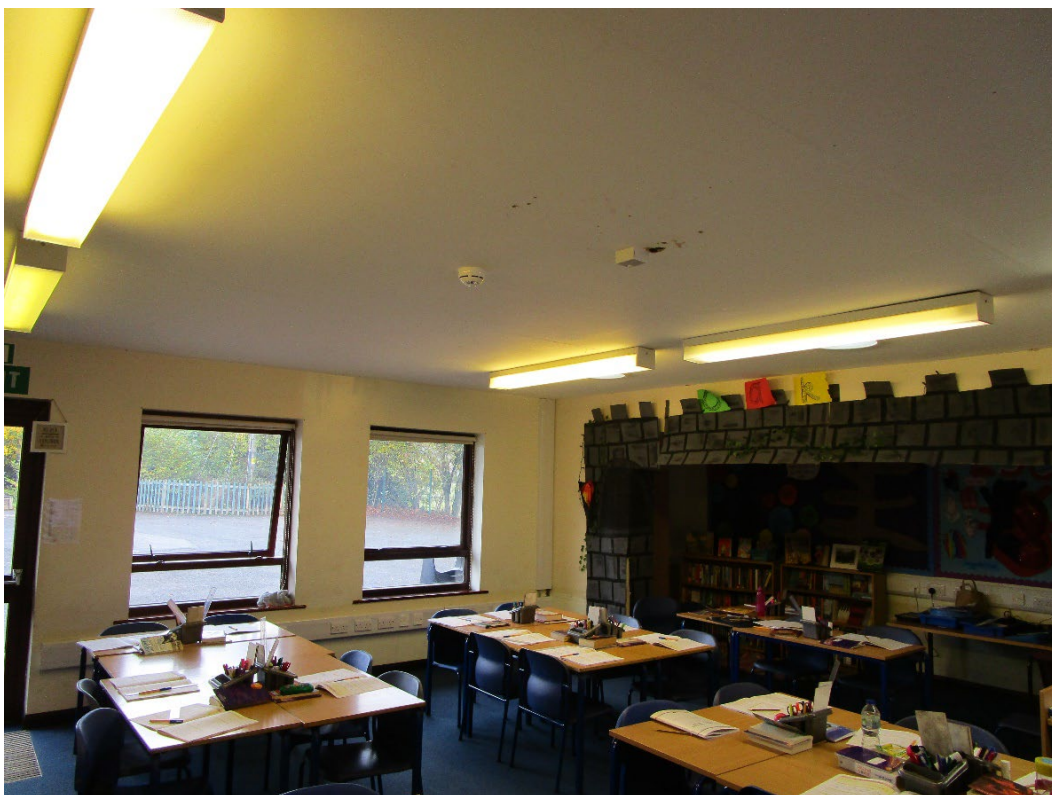
Figure 6 – internal of section 2

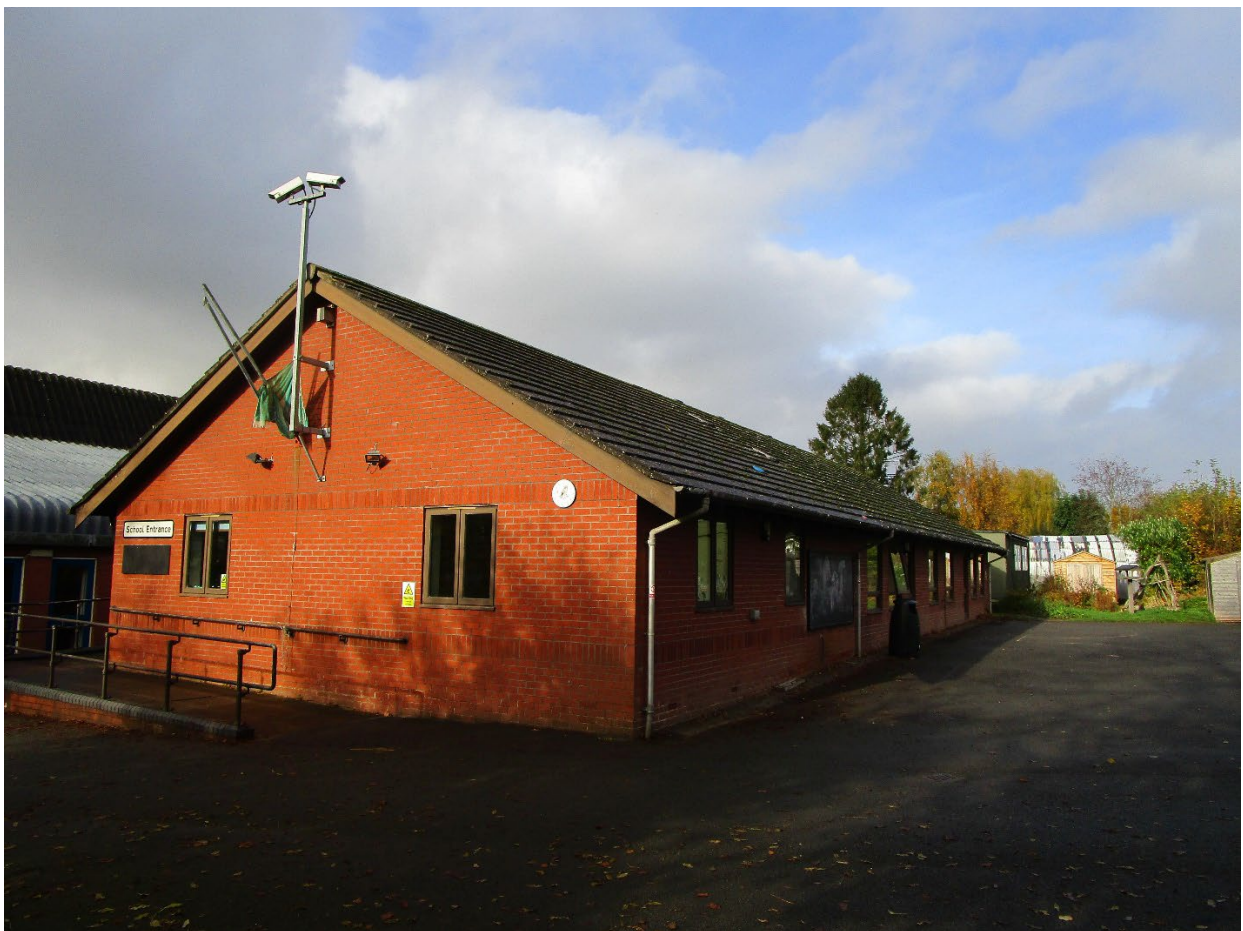
Adjoining building section two is a modern red brick building which houses the school office and reception area & some additional classrooms as shown in figure seven below. This modern single storey building has a roof line that overhangs the walls & is comprised of tight-fitting concrete interlocking roof tiles & is also well sealed by barge boards at the edge of the roof.

The windows are all PVC framed & glazed and there are external lights & security cameras on the walls as shown below in figure seven.

Figure 7 – The school office block

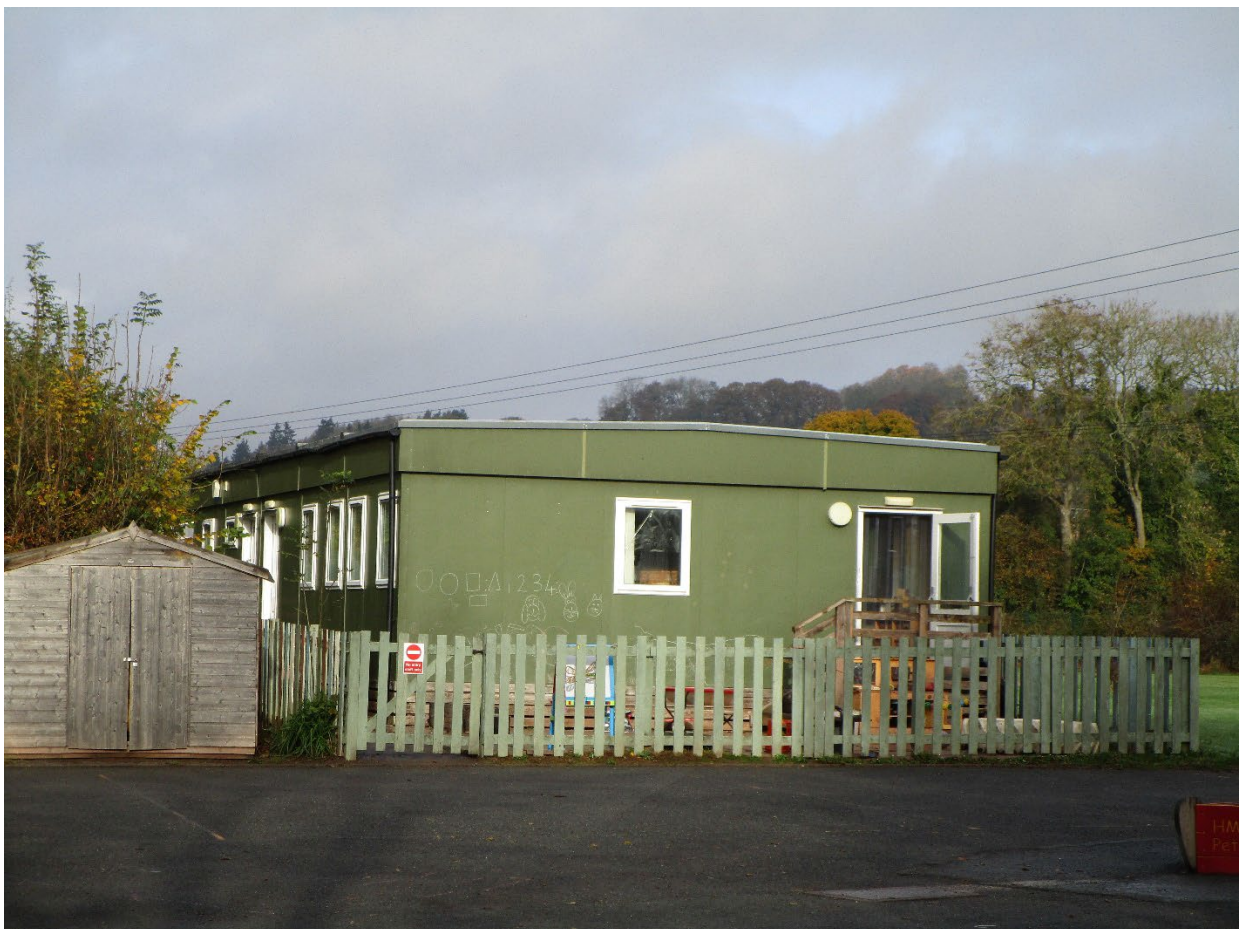
The Nursery on the site is a temporary prefab building as shown in figure eight below. The building is painted green and is very well sealed. The walls are Zinc insulated wall panels. The PVC windows and doors are all glazed and sealed. The building has a flat roof as shown in figure eight.

The nursery area is fenced off from the adjacent playground with wooden picket fencing as shown below in figure eight. Adjacent to the nursery there is a small timber tongue and groove garden shed with a bitumen felt roof as shown below in figure eight. The shed is well sealed and has no windows.

Figure 8 – the school nursery building

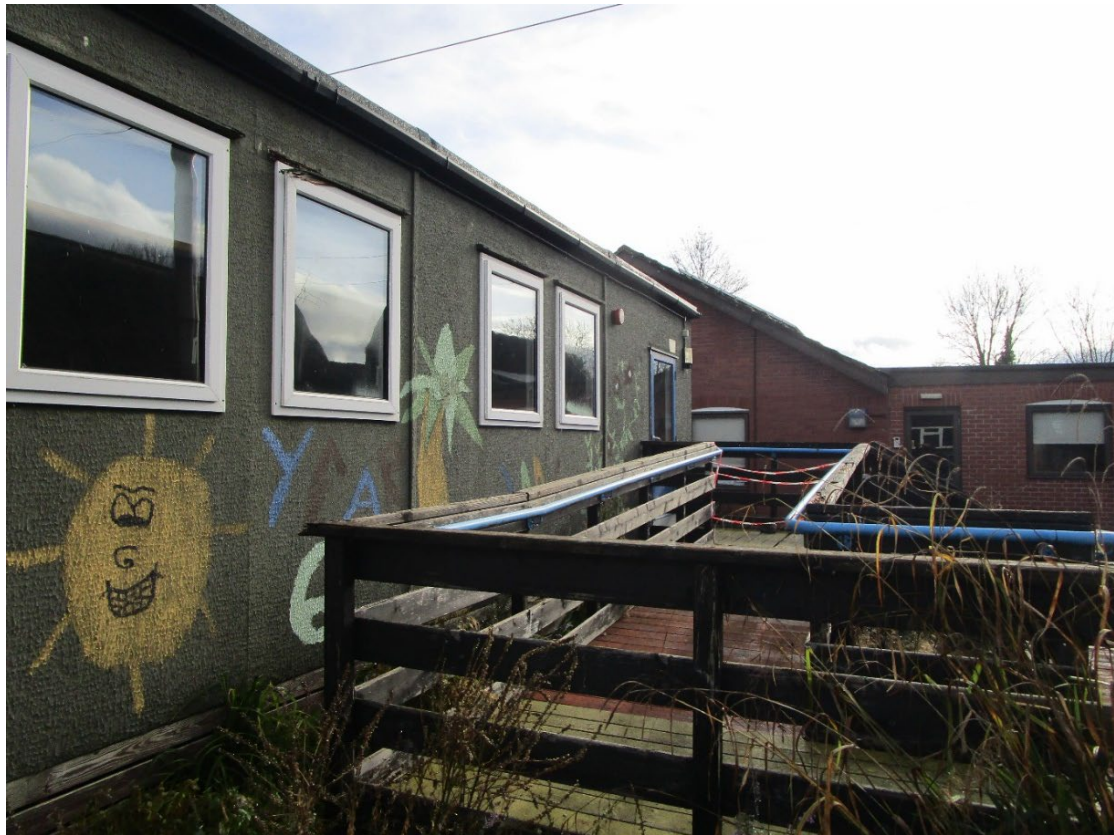
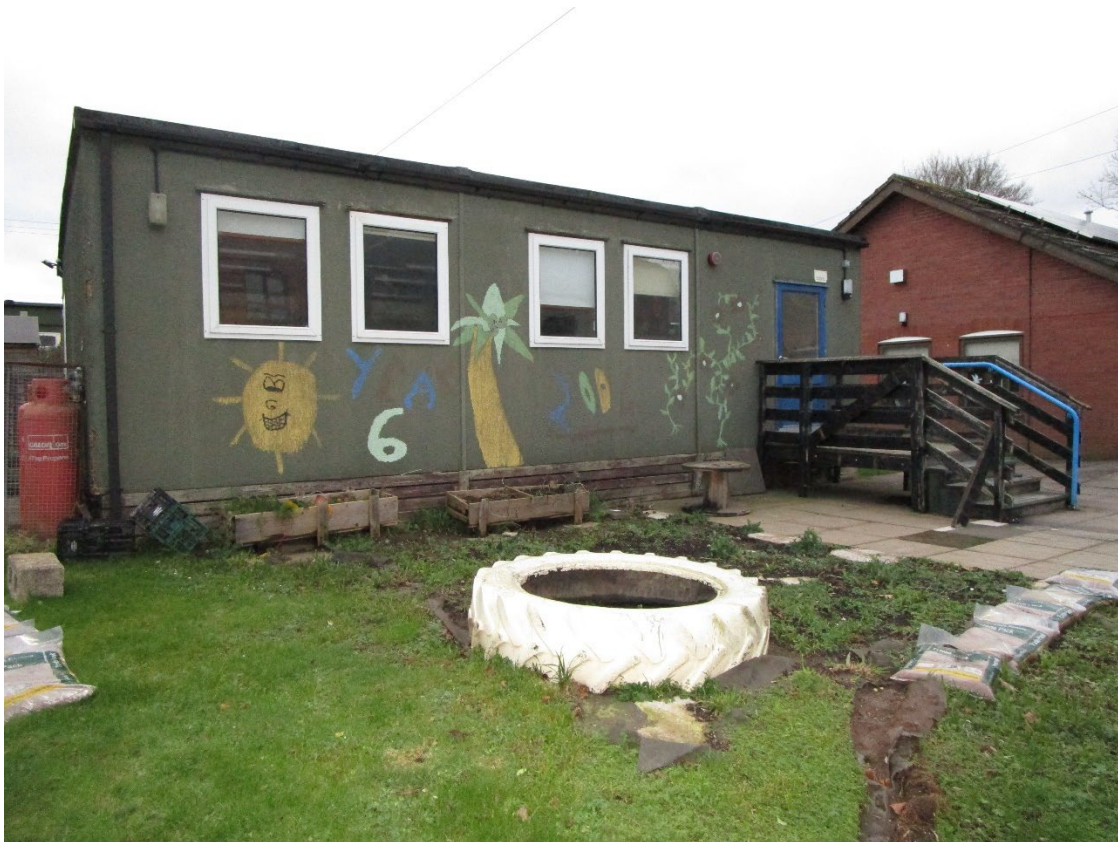
The temporary classroom shown over the page in figure nine is another prefab type building. Like the nursery it is also painted green but unlike the nursery the Temporary classroom has a rough render on the walls. It has PVC windows and doors but the timber ramped access to this classroom was unsafe and unusable with Hazard tapes as shown over the page in figure nine.

Figure 9a & 9b – The temporary classroom with unsafe access ramp removed by 2024

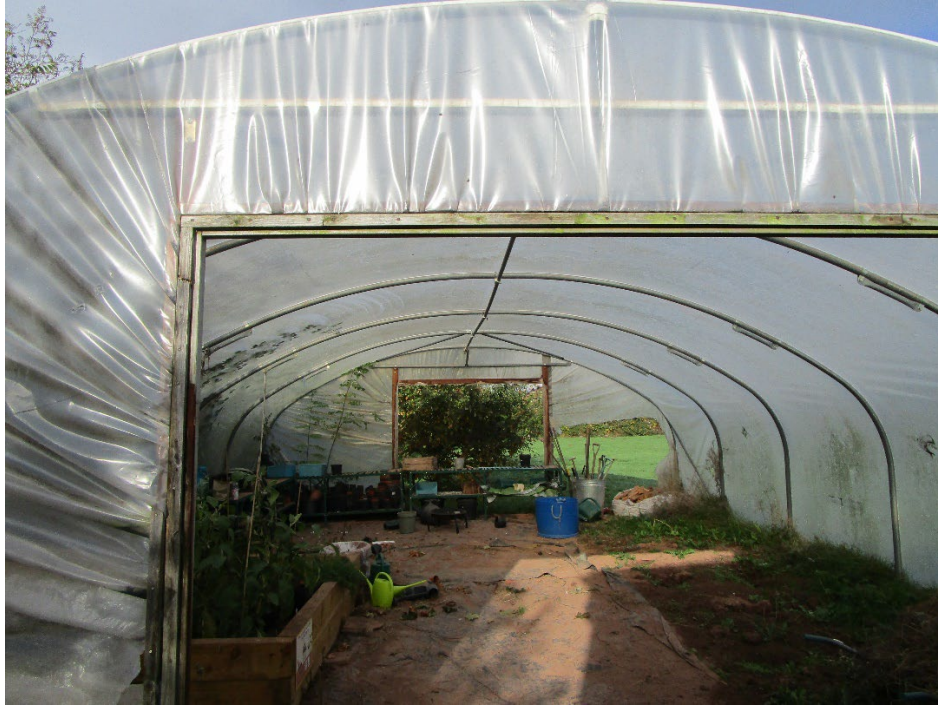
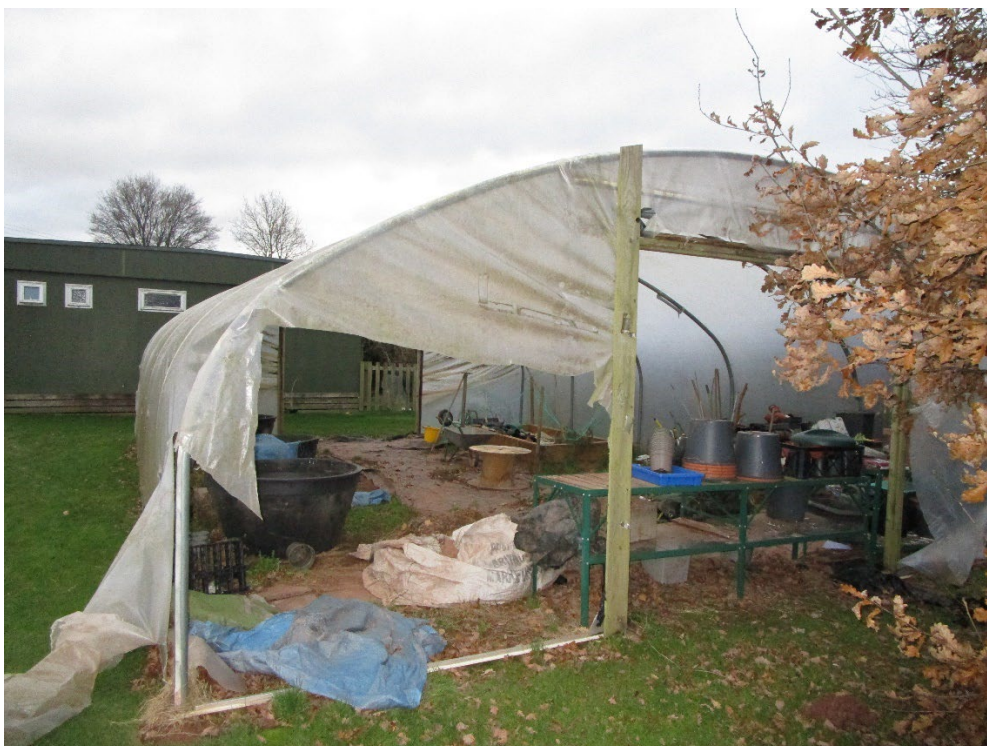
On the site there is one polytunnel. The Polytunnel, has bare ground and is used for growing vegetables. The poly tunnel is open at both ends as shown below in figures 10 a & b. The polytunnel is metal framed and a polythene cover which was shown to have deteriorated slightly by 2024 as shown below.

Figures 10a & b – polytunnel 2021 & 2024

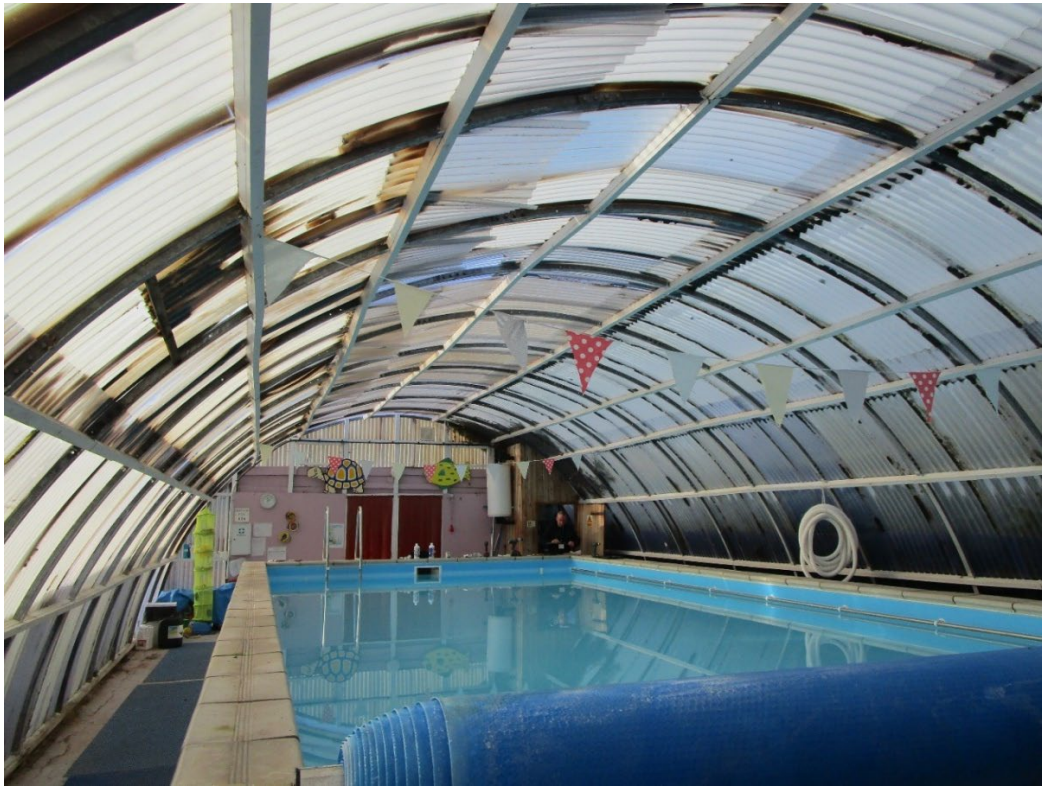
The Schools Swimming pool is housed in a curved metal structure which has corrugated Perspex sheeting and concrete floor base as shown below in figure eleven.

Figure 11 – swimming pool building

Due to the high levels of natural & artificial light throughout the building & the well-sealed swimming pool and shed it is not surprising that there was no evidence of use by either bats or nesting birds within the swimming pool buildings.

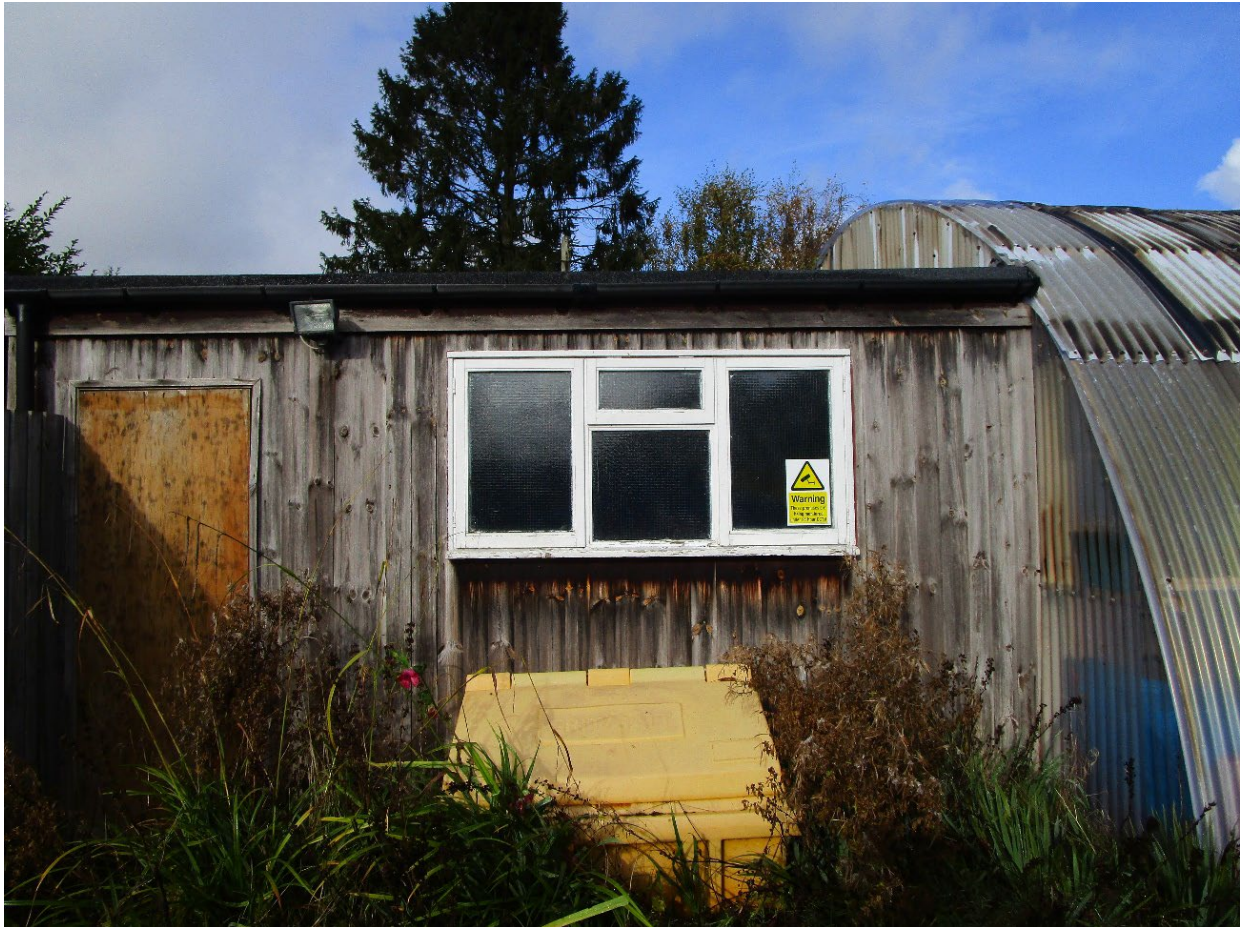
There is a timber tongue and groove shed on the southwest elevation at the entrance to the swimming pool as shown above in figure eleven and over the page in figure twelve.

The timber section adjacent to the swimming pool polytunnel is well sealed and has a large LED flood light as seen in figure twelve over the page. The roof is flat and covered with bitumen felt. The shed has a PVC glazed window and a timber door as shown over the page in figure twelve.

Figure 12 – the shed adjacent to the swimming pool

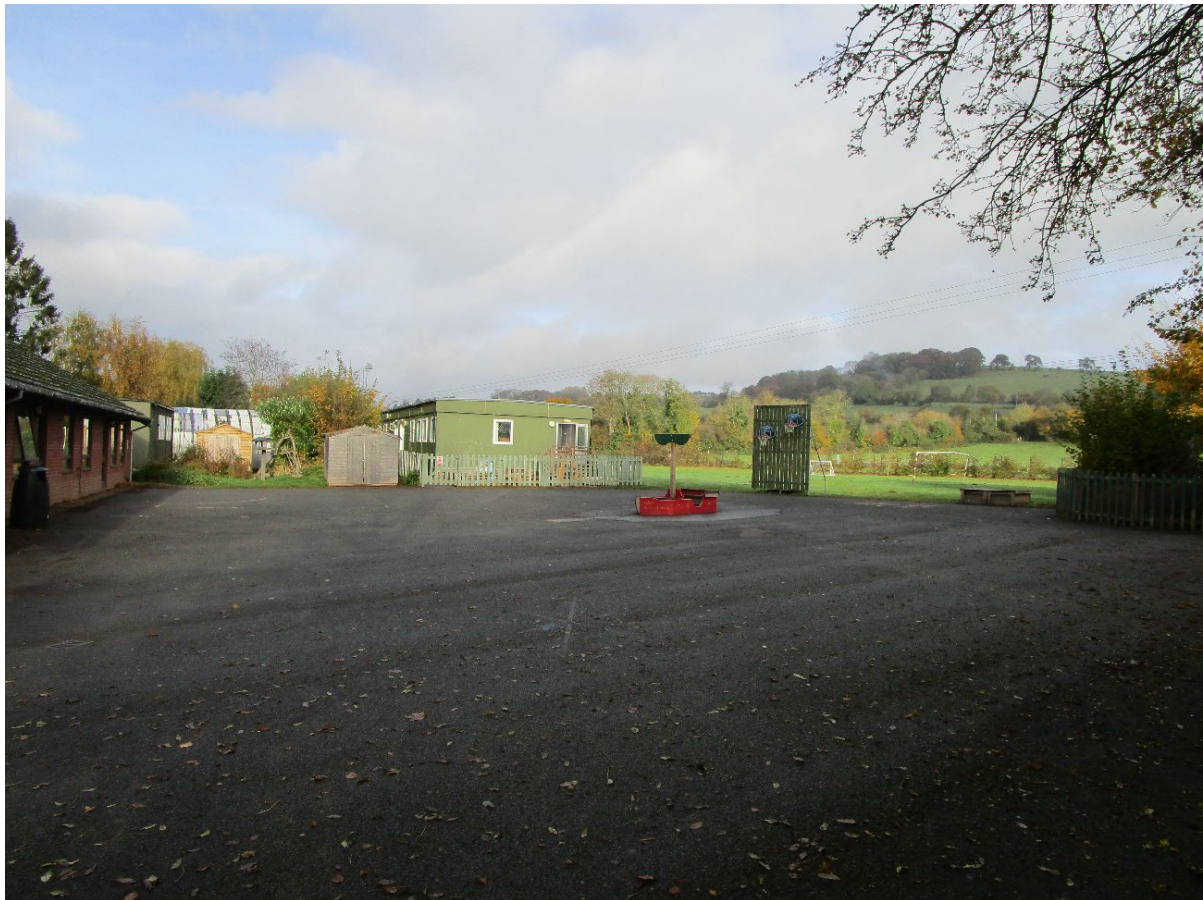
Figure 13 - Photo to Show the playground & garden sheds

The large hard standing playground sits on the southeast of the site in between the school office building and the nursery with a small boat structure as shown in figure thirteen below.

There is another timber tongue and groove garden shed at the edge of this playground by the temporary classroom. It has a pitched roof is covered in bitumastic felt as shown below in figure thirteen.

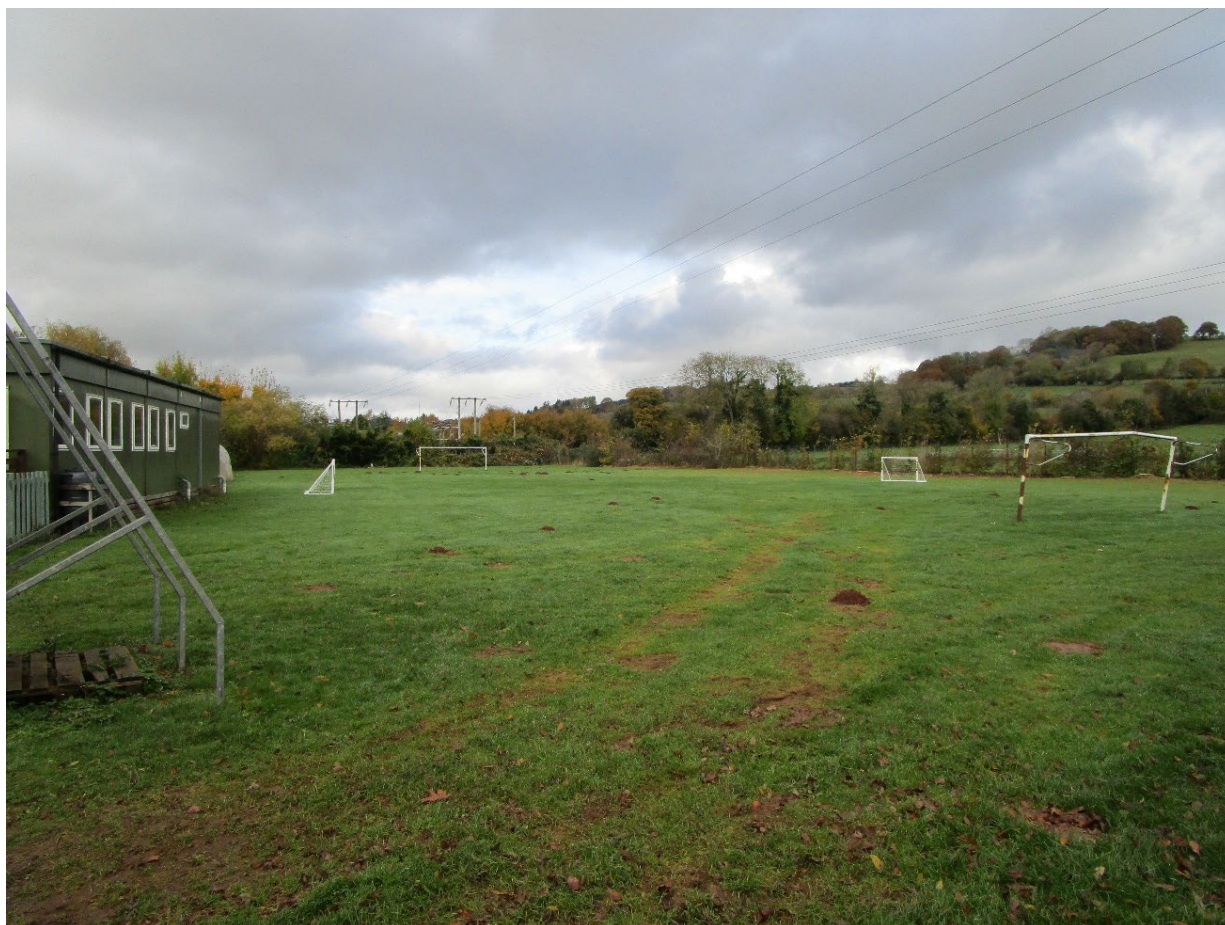
Figure 14 – The playing field

The grassland habitat is classed as a species poor Amenity grassland. It is comprised of Daisy, Creeping Buttercup, Hawkbit, Ribwort Plantain, Yorkshire Fog, Red Fescue, False Oat Grass, Yarrow, Fly Garrick Mushrooms & Rye Grass. The grassland is shown below in figure fourteen.

There are areas of bare ground within the sward and the field is regularly close mown as it is used as a playing field.

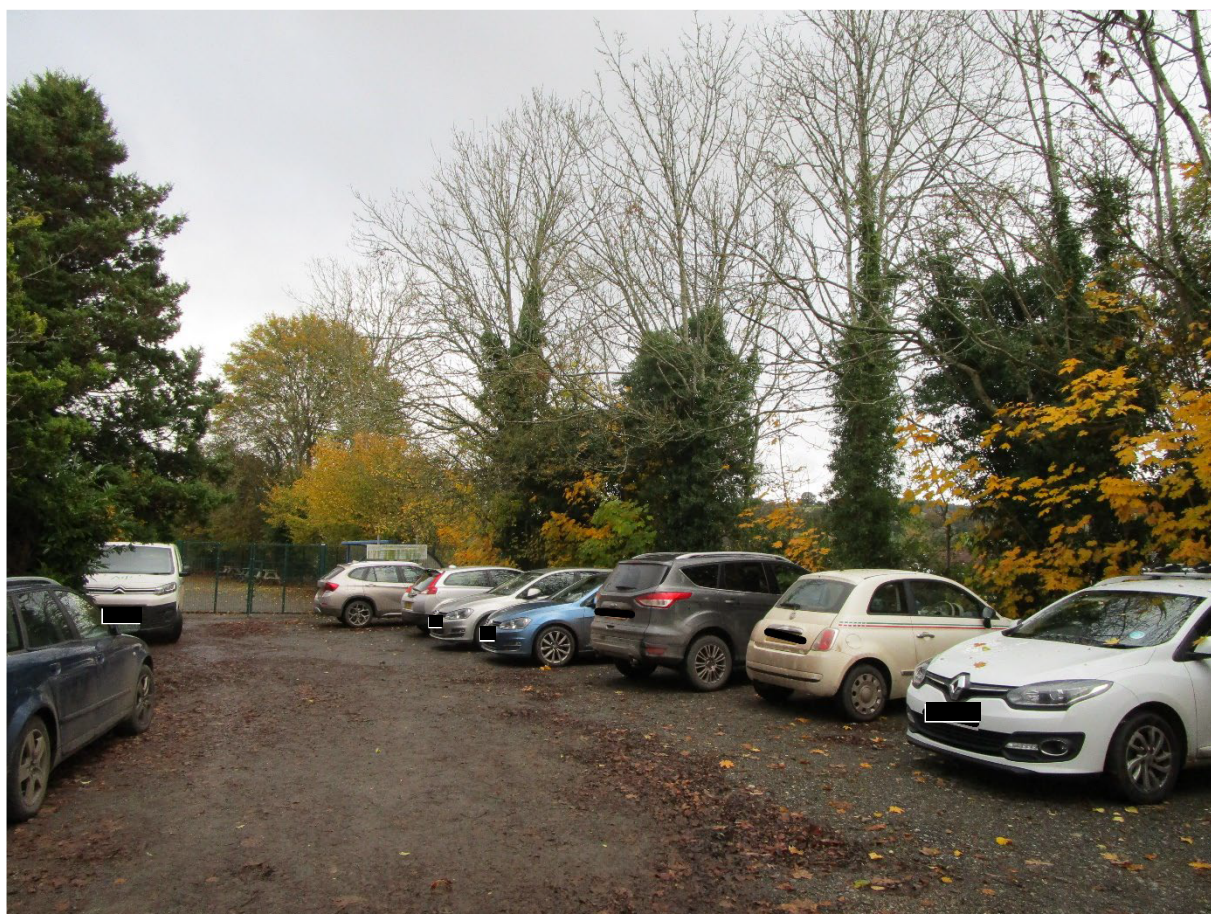
Figure 15 – Boundary one

Boundary One – is comprised of a tall metal fence with a line of trees adjacent to the car parking area comprised of; Sycamore, Ash, Blackthorn, Hazel, Field Maple and a bramble patch. Boundary one is shown in figure fifteen below. Each of the trees & shrubs are marked as T3 to T15 in the Tree report by H.E.C. These trees have recently been confirmed as being owned by the adjacent site.

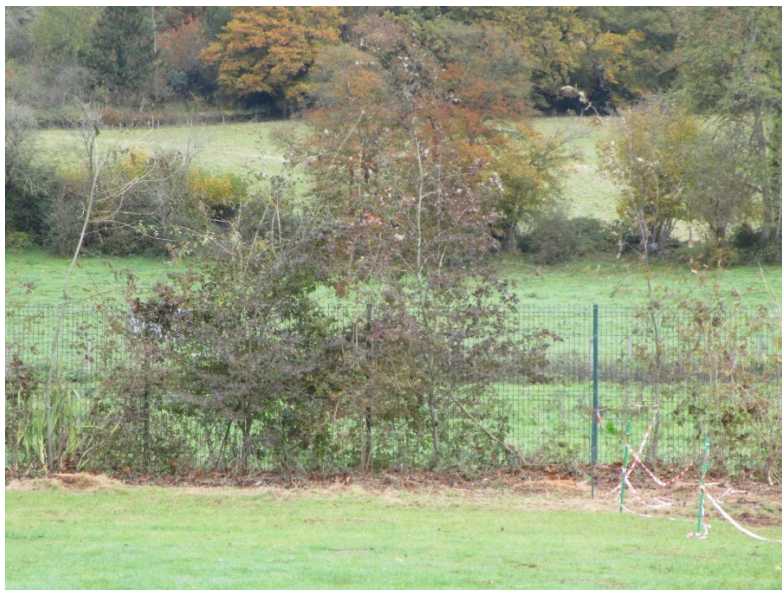
Figure 16a – showing the playing field with B2 fence and shrubs

Boundary two – Is comprised of recently felled line of trees due to the electric power line running across the site (seen in figures fourteen & seventeen). As such there are just shrubs remaining along the fence line comprised of; Hawthorn, Dogwood, Holly, Hazel, Beech and Blackthorn and one young Cherry tree & a young Rowan. A close up of the remaining shrubs along Boundary two is shown in figures sixteen a in 2021 & figure sixteen b 2024 below. This Boundary has developed well from individual shrubs into a hedgerow along the fence in the last three years.

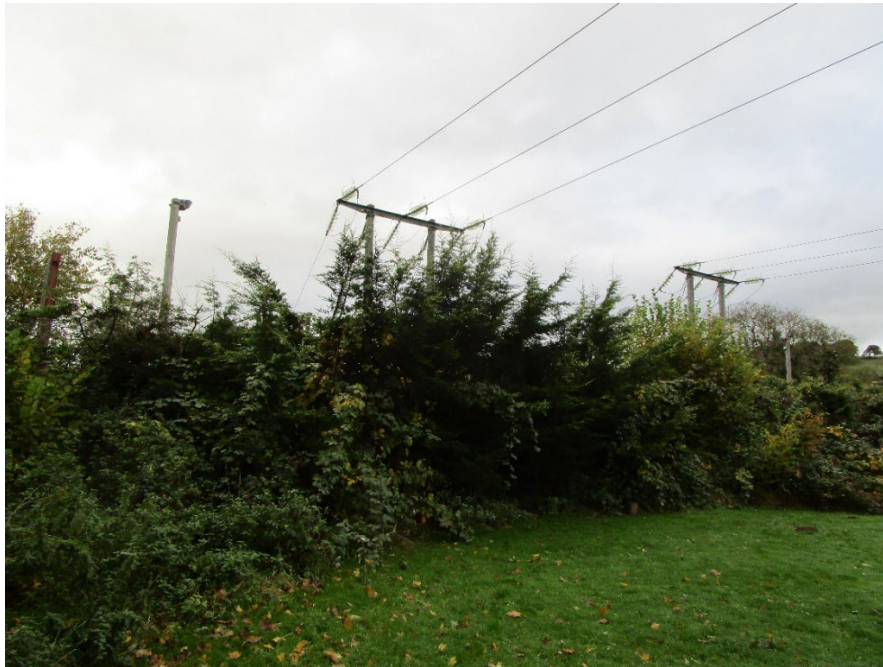
Figure 17a – Boundary three

Boundary three on the northwestern side of the site is a wide patch of trees (including those reduced & felled by the power line) including Cypress, Hazel, field maple & Sycamore with a narrow bramble & nettle patch, as shown below in figure seventeen a in 2021. More recently the amenity grassland has been planted up with young trees & the area is now used for forest school as shown in figure seventeen b in 2024.

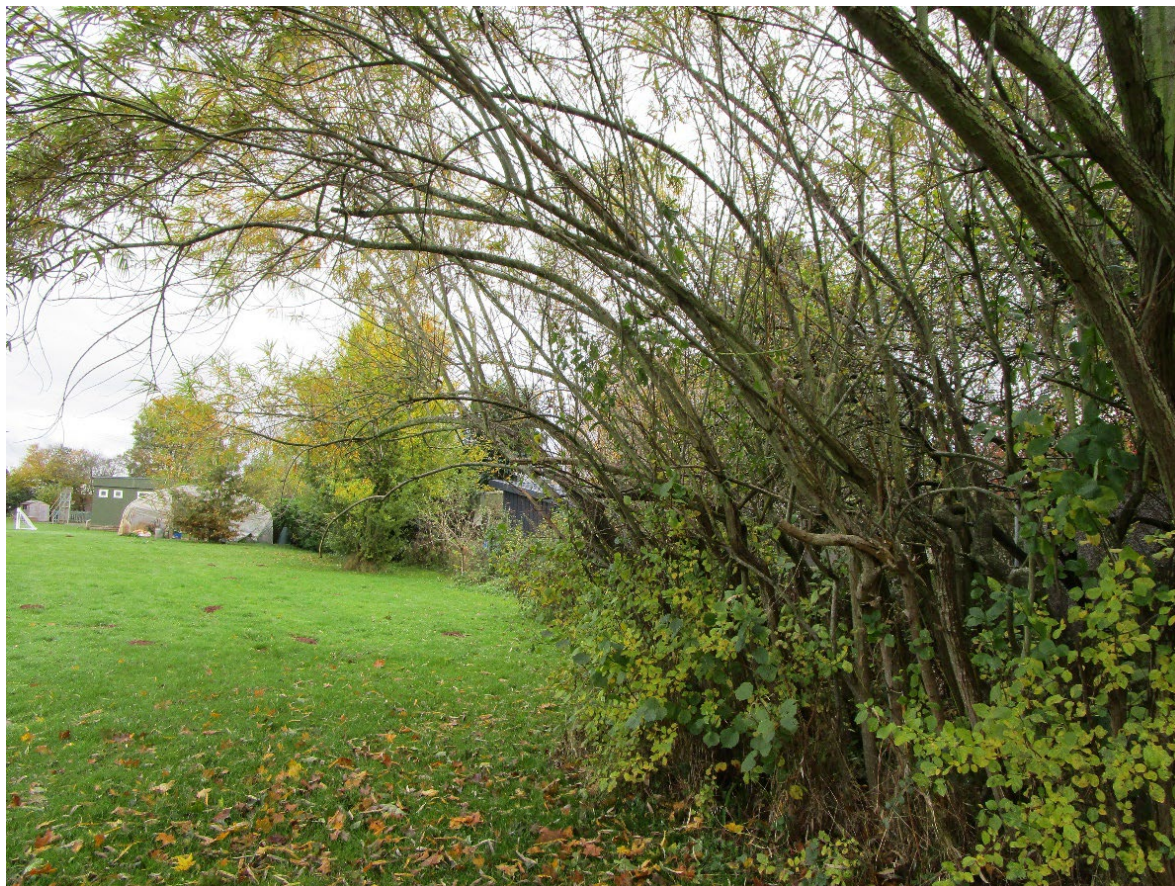
Figure 18 – Boundary four in the North eastern part

Boundary four – Is marked by a fence line with Hazel, Blackthorn, Holly, Willow, & Sycamore shown in figure eighteen below, there is a plum tree adjacent to Polytunnel one. The boundary continues with a cypress only hedgerow adjacent to the swimming pool & the carparking area by the oldest part of the school with two young plum trees.

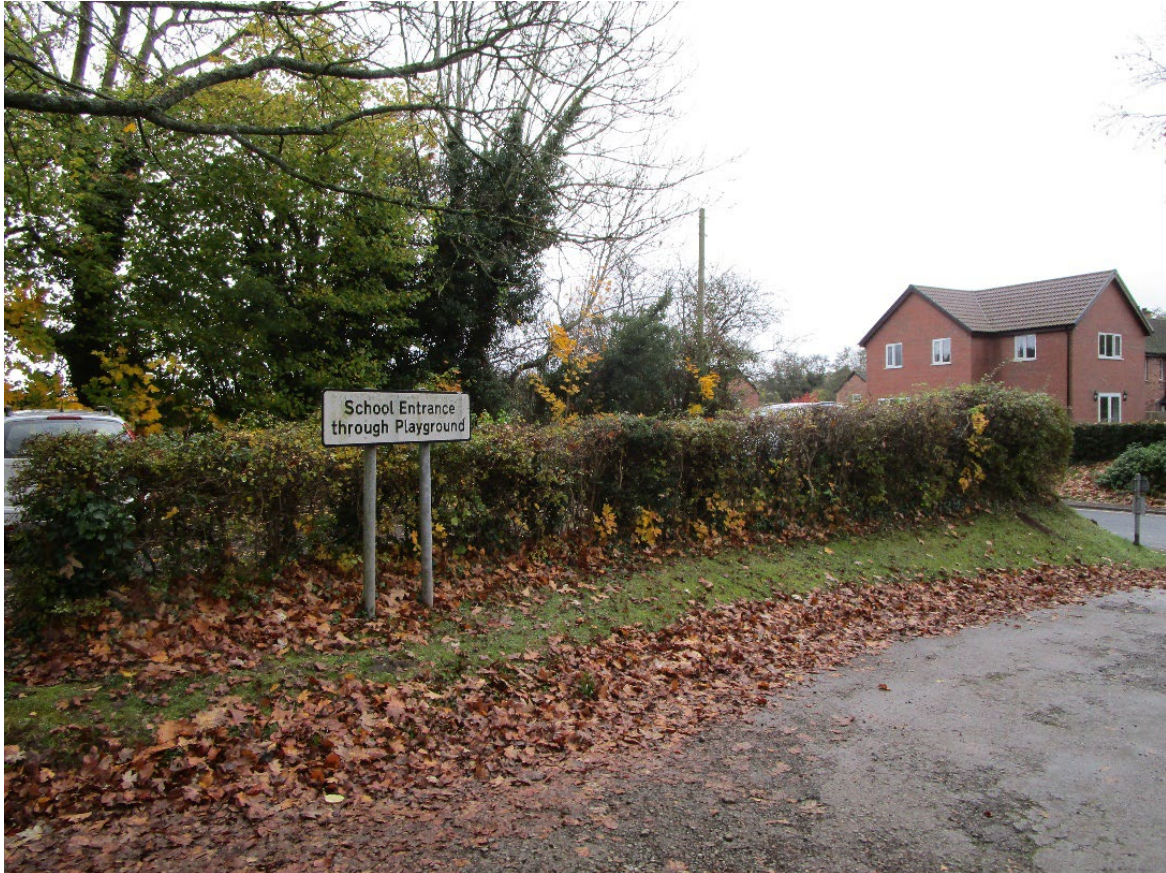
Figure 19 – Boundary five

Boundary Five – the boundary along the front of the school that runs along the car parking and driveway areas is a neatly cut hedgerow that is comprised of Hawthorn, Hazel, Ivy, Blackthorn, & Cypress with an adjacent Ash & Sycamore tree. Boundary five is shown over the page in figure nineteen.

Boundary five by the access road off the main road by the carpark .All the boundaries are marked on the phase one habitat map.
