An Updated Ecological Assessment & Mitigation Report for Peterchurch Primary School

Aim: To establish the presence or absence of bats & birds in the building & importance of adjacent habitats.

Peterchurch Primary School
Peterchurch
Hereford
HR2 0RP

Reference: 3PC-PEAR.doc
29th January 2025

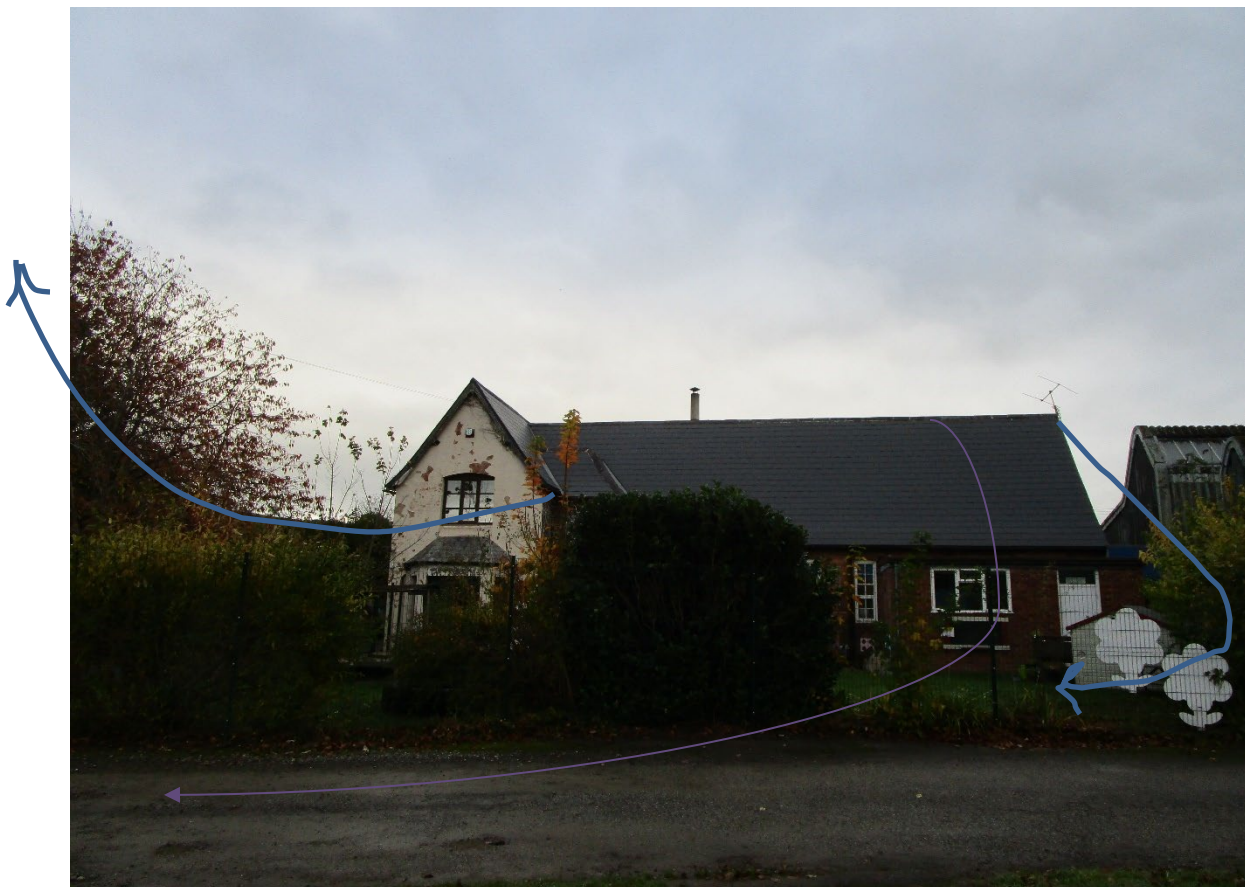
Notes- Total emergence from school: CP x3 as shown below

Figure 20 – Emergence point of CP bats in 2022 & 2024 & BLE in 2024 in purple

The first evening survey found no bats emerging from the school buildings, but the second survey found 3 Common Pipistrelles Emerging from the apex of the southern gable end & the corner of the roof at the western gable end of the oldest part of the school building as shown in figure 20. The third/update survey found 4 Common Pipistrelle bats & 2 Brown long eared bats as shown in Figure twenty. As well as swifts nesting at the northwestern corner of the roof in 2021.

Whilst the building of the new school building will not result in loss of priority habitats, the dismantling of the oldest part of the school building will result in the loss of bat roosts used by 3-4CP & 2 BLE as such both mitigation & compensation will be required & this will be designed into the replacement new building & Licence required to dismantle this part of the school building (see section 5.1 Mitigation).

No works to the old two storey school building will be carried out until a Bat Mitigation Licence has been applied for & granted from Natural England & all works will follow the mitigation as detailed below. In addition, no dismantling of the old school roof will occur during the main bird nesting season March to August due to the nesting swifts (unless found to be absent following a pre-commencement check) & bats (May to August).

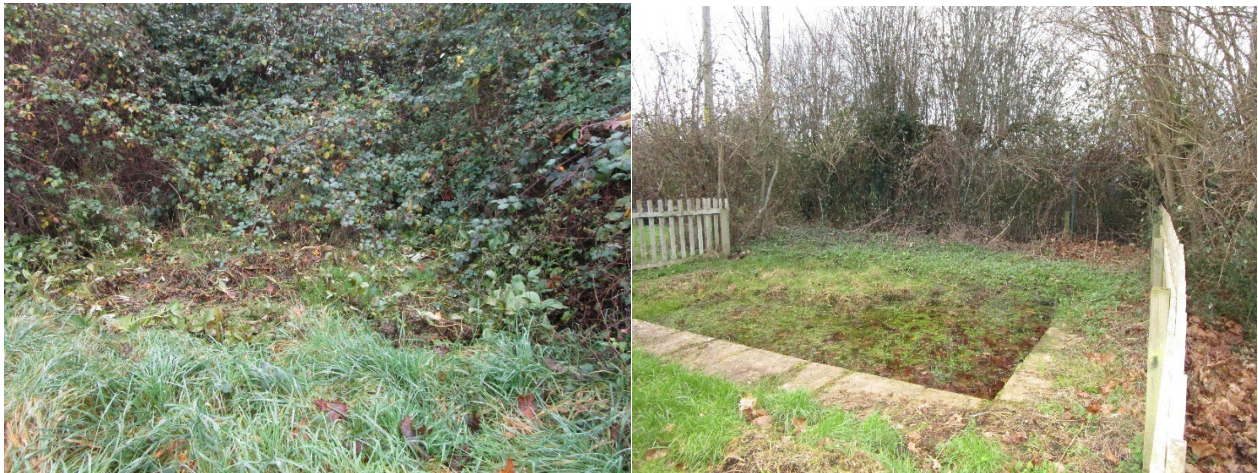
The old onsite pond was created in 2014 and appeared to have almost dried up & is known to dry up in spring & summer each year due to its small size (2m by 2m) and dense covering with bramble and grasses, as shown in the photo in figure twenty-one a below.

During the summer of 2024 the school carried out works to restore the pond by cutting away the brambles & removing the tall grass around the pond in order to try & retain the pond which had some water when the site was visited in December 2024 as shown below in figure 21b.

Figure 21a – The old school pond in 2021 Figure 21b –school pond in 2024

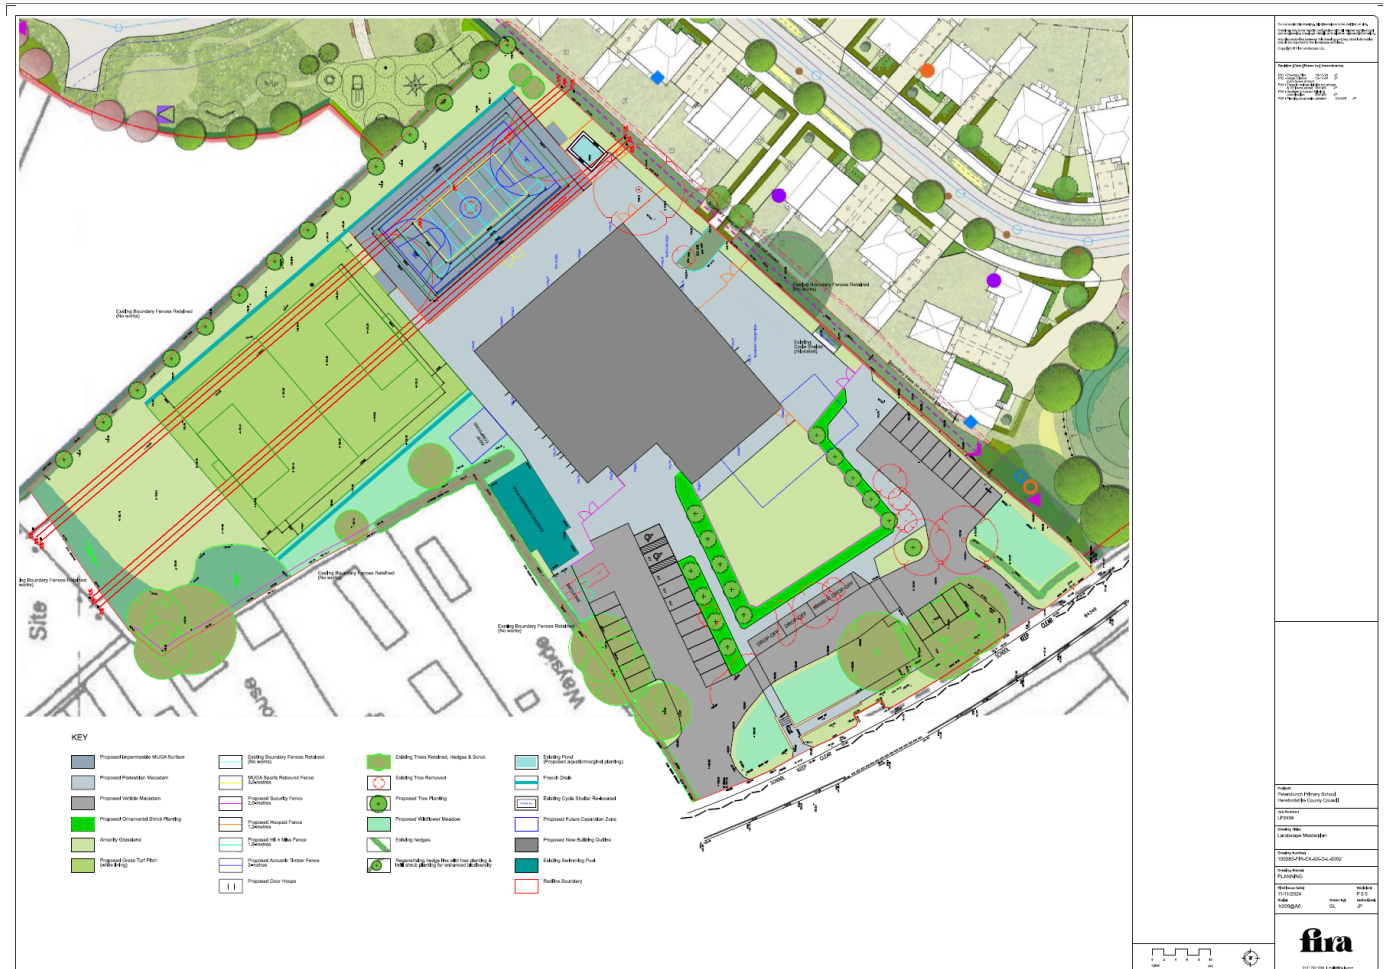
APPENDIX FIVE PROPOSED ENHANCEMENTS

Native Species rich hedges & native fruit trees & wildflower areas
 See *Wildlife pond design, hedgehog houses & insect houses & Integral Bat & bird box details over the page*

Although no bats or birds were found in the modern Buildings & the old school building has had its Bat activity surveys carried out & both bats & birds have been identified as using it as part of the enhancements for the proposal bird boxes such as swift boxes & bat boxes will be incorporated into the new school building as well as open fronted bird boxes incorporated into the new building & bug hotels & hedgehog houses in the hedge lines as shown in appendix five.

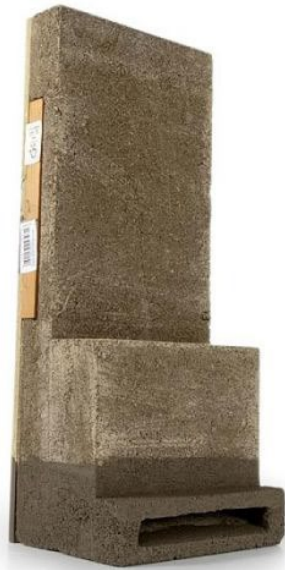
Type 27 Schwegler Brick Box

To be positioned in the walls facing trees & hedges ideally on the apex of the gable ends

Box should be cemented into a wall in a building or underneath a bridge or tunnel in relatively humid conditions. Useful for incorporating into new buildings to attract bats, or provide new roost sites during building renovation. Contains a single internal wooden panel to simulate a crevice for roosting. Front panel is removable for cleaning. Dimensions: 265H x 180W x 240D mm. Entrance hole: 55x26mm. NHBS Price: £41.95 including VAT
