Preliminary Ecological Appraisal, Garden House, Elton, Herefordshire, SY8 2HQ

Prepared on behalf of Mr & Mrs Davis

ISSUE V1.0

December 2021

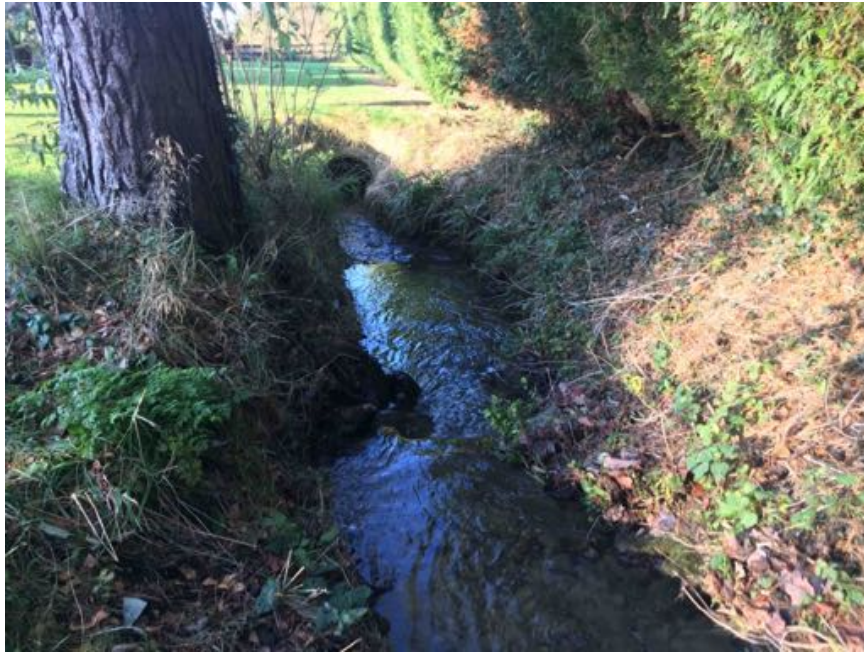
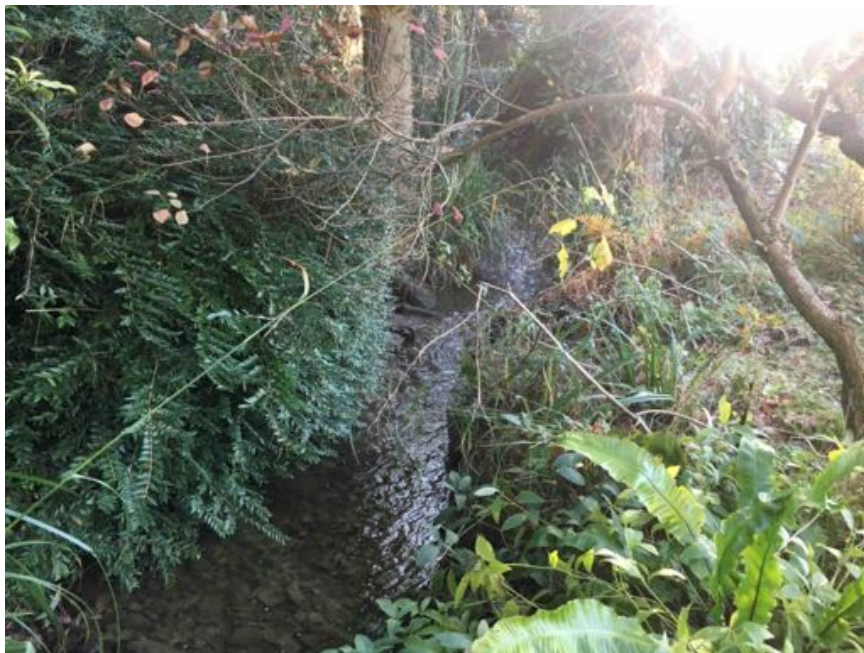
- 4.2.4. The stream is considered to be a LBAP habitat, with a gravel substrate suitable for supporting a range of macro-invertebrate species. The stream was shallow but fast-flowing. There was no in-channel vegetation and but the low banks were vegetated with a range of native and non-native plants species including common grasses, pendulous sedge *Carex pendula*, hart's-tongue fern *Asplenium scolopendrium*, nettle *Urtica dioica*, wood-avens *Geum urbanum* and dock sp. *Rumex sp.*

Image 5. Stream along northern boundary

Image 6. Stream along northern boundary

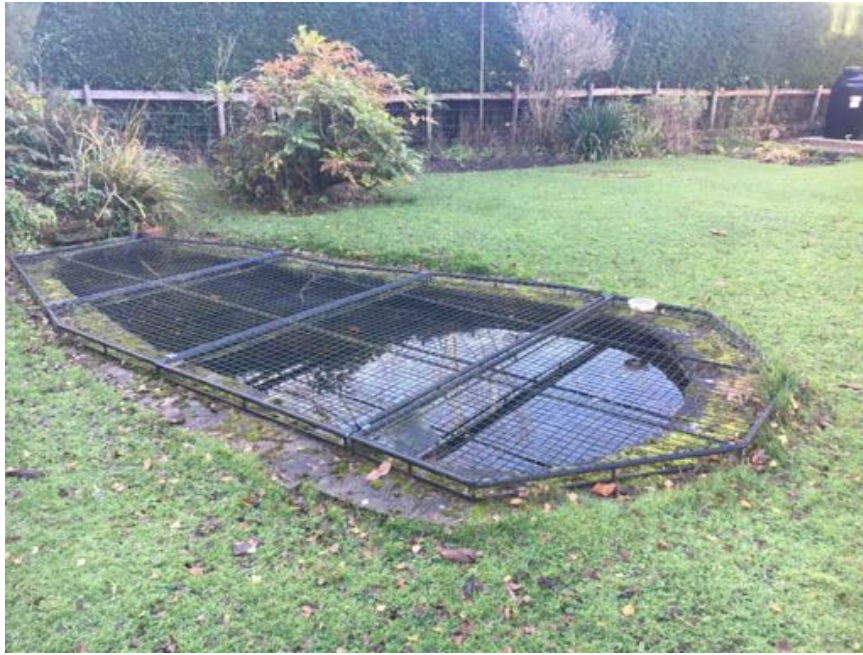
- 4.2.2. The site is bordered by residential dwellings and gardens to the south, east and north, and a pasture field to the west.
- 4.2.3. The pond within the garden comprised an ornamental pond stocked with fish, and with no aquatic vegetation.

Image 9. Fishpond to east of house

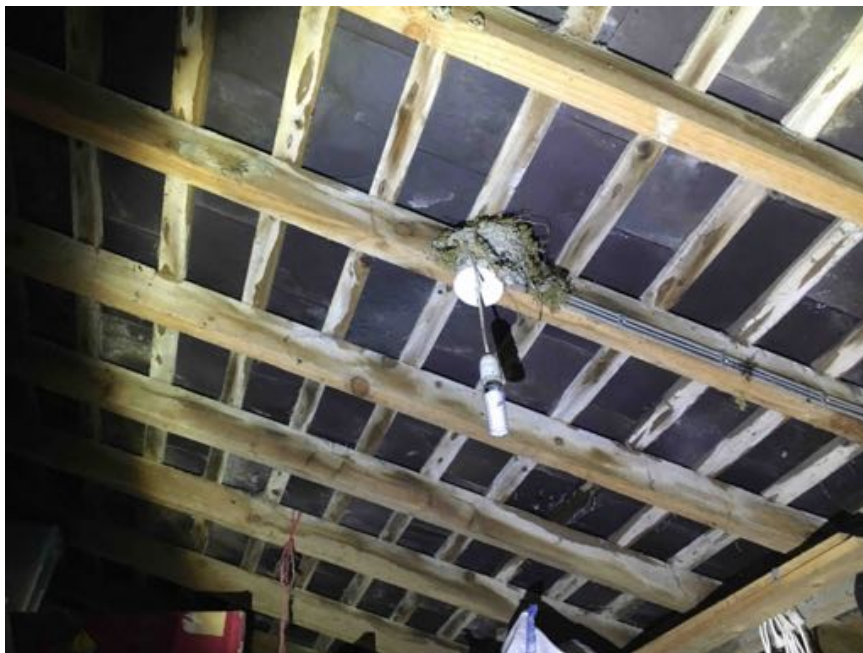
Image 10. Swallow nest cup inside garage

- 6.3.1. Given the presence of swallow nest cups within the garage, there is potential for impacting breeding birds during renovation works. The change of use of the garage into residential use will also result in the permanent loss of swallow nesting opportunities. Therefore the following mitigation is recommended:

- To avoid the risk of disturbance to nesting birds, the clearance of vegetation, internal materials and the key destructive works to the garage should be undertaken outside of the peak bird nesting season (March to August inclusive) to avoid potential conflict with the legislation concerning breeding birds. If building works cannot be scheduled to avoid the bird nesting season then a check by an ecologist immediately prior to commencement of clearance works will be required, and if nests are found to be present, they should be adequately protected until breeding has finished and the nest is no longer in use. Measures to prevent birds establishing nests within the buildings, such as netting, can be put in place prior to the nesting season. However, a detailed method statement for the use of any preventive nesting measures must be prepared by an experienced ecologist and any measures used must not result in the obstruction, damage or destruction of a bat roost.

- To compensate for the loss of swallow nesting opportunities, the design of the new storage to the rear of the existing garage should allow for two replacement swallow nest cups to be located internally, and sufficient access for birds into the building.

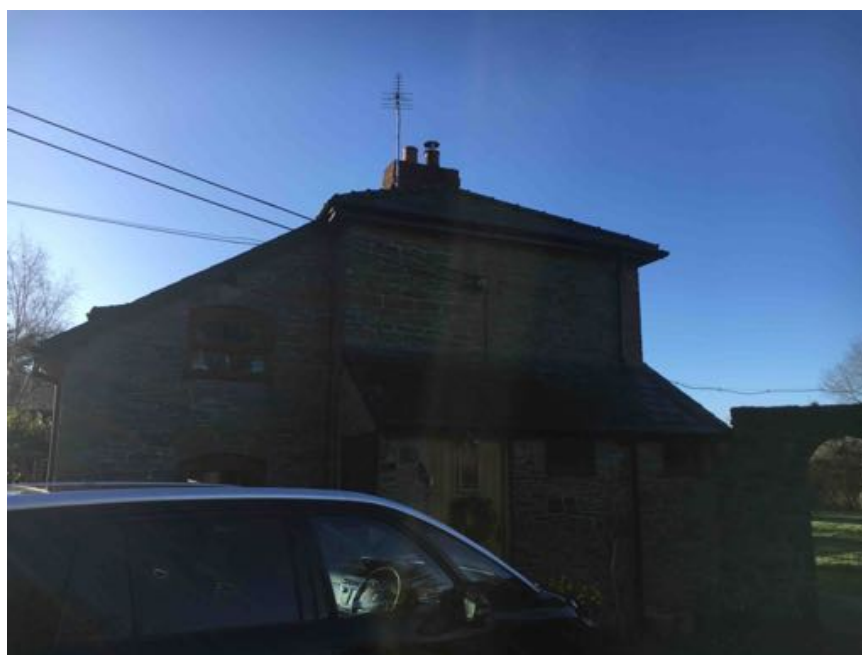
- 4.3.2. The external stonework/brickwork was in excellent condition, with no gaps, cracks or crevices. The timber soffits and fascias were all tight against the stonework/brickwork with no gaps or crevices visual. The mortared verge on the north elevation was in relatively good condition and any gaps had been filled with expanding foam. Two bat droppings were located on the stone wall directly beneath the join of the east sloping roof to the main roof (top of verge). Although no gaps in the verge were visible, there might have been a gap into the end of the main house soffit close to where the two roofs joined.

Image 11. North elevation of house

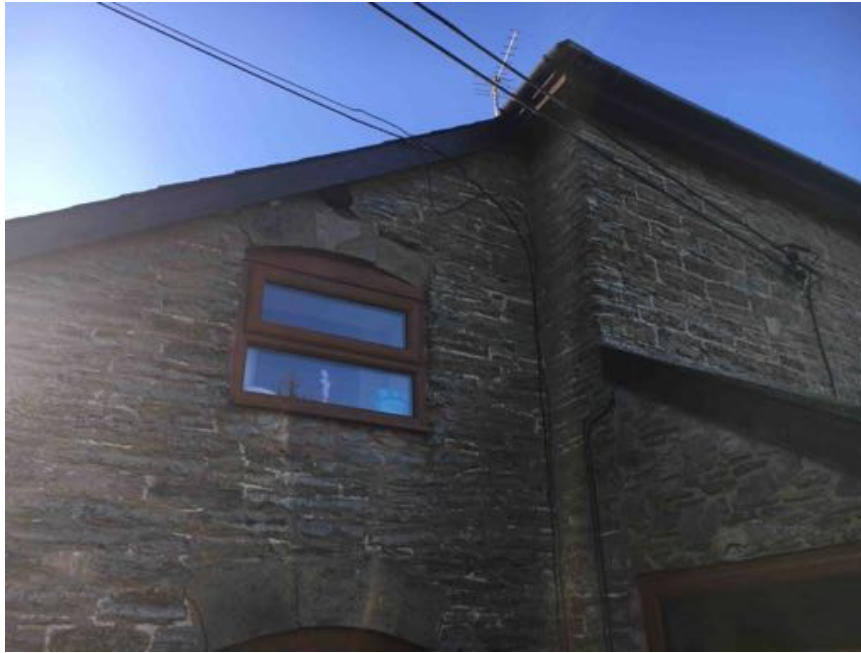
Image 12. North elevation of house where east sloping roof joins main roof

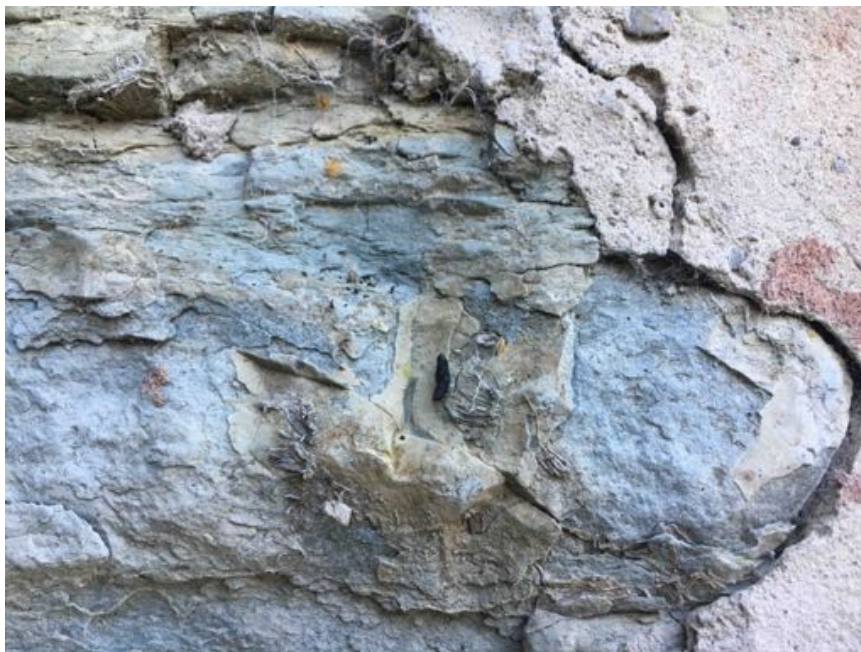
Image 13. Bat dropping on north elevation wall

- 6.4.1. The proposals have the potential to impact bats and their roosts, therefore detailed bat emergence/re-entry surveys will be required to fully characterize the bat roost(s) within the building(s) and to inform detailed mitigation and the need for a mitigation licence. Activity surveys can be carried out between May and September, although the optimal surveys period (for planning application and licence applications) is May to August. Up to three separate survey visits may be required to gather sufficient information to inform any planning application.

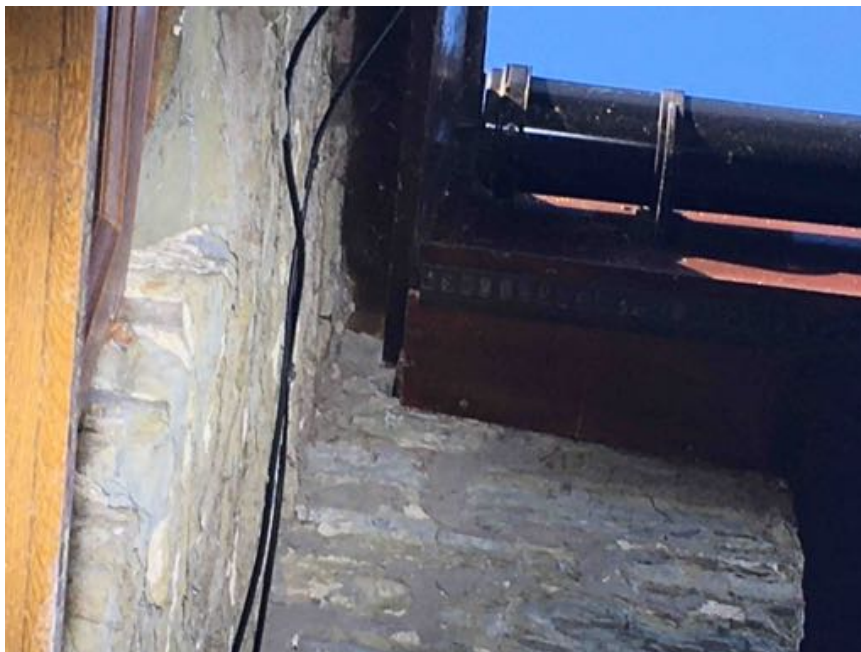
Image 14. Potential gap into soffit box on north elevation

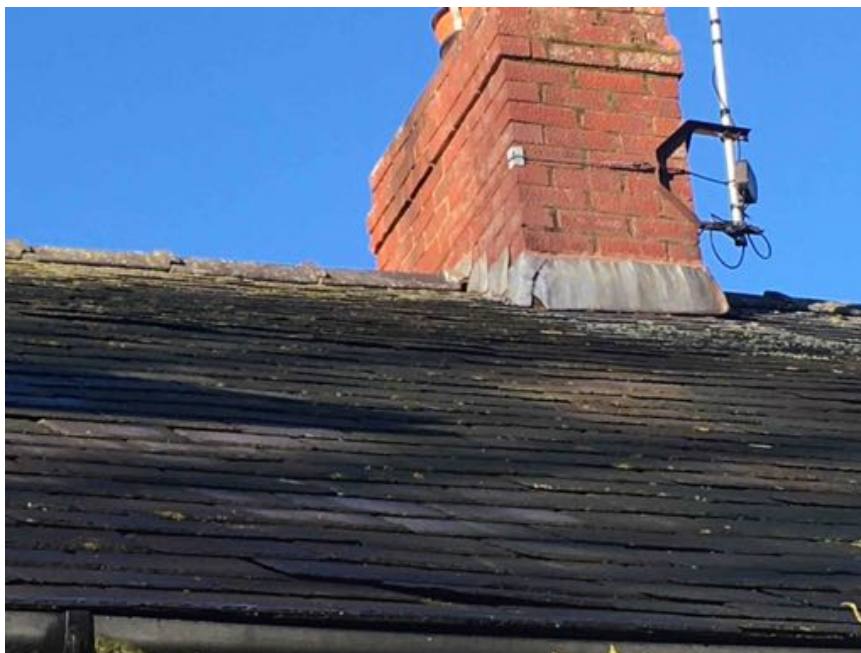
- 4.3.3. The slate roof tiles and ridge tiles (slate) were largely intact and well-sealed with no missing, slipped or broken tiles. On the east elevation there was a gap between the ridge tile and the northernmost chimney (on the south side of the chimney), and another ridge tile (seven tiles south of the northernmost chimney) was also slightly lifted. On the west elevation there were gaps between the ridge tiles (both sides) and the northernmost chimney, and the ridge tile at the southern end of the ridge (where the main ridge joined the hipped ridge) was also slightly lifted. No gaps on the north-facing roof were noted and it was not possible to visually inspect the external parts of the south-facing roof.

Image 16. Gap between ridge tile and chimney

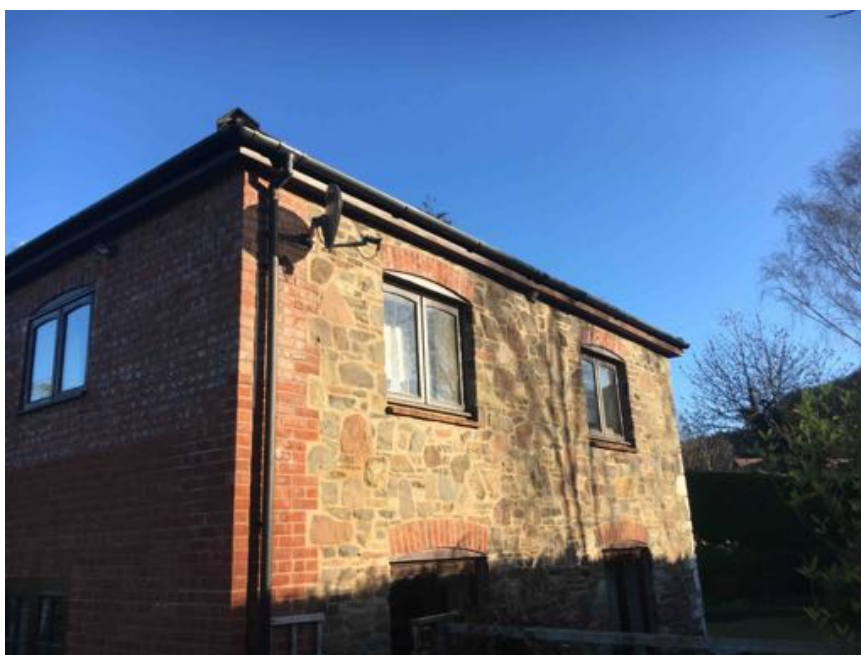
Image 17. South elevation of house, with house martin nest under eaves

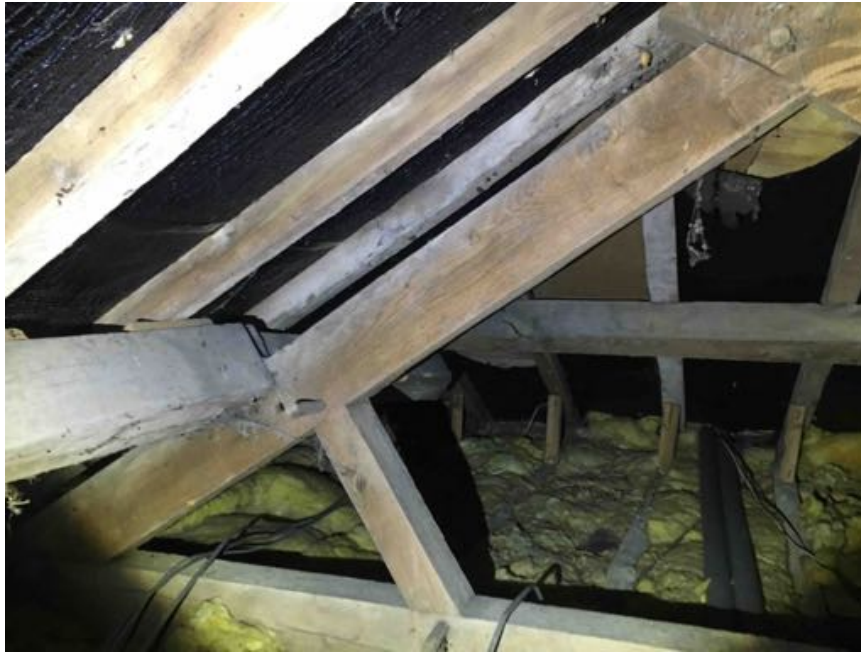
- 4.3.5. The roof void of the main house extended the full length of the property but was divided internally into roughly two halves. The roof (both roof voids) was lined with bitumastic felt and both roof voids were insulated with glasswool insulation on the floor. In the older section of the house (the northern part), the bitumastic felt liner did not quite reach right up to the ridgeline, so the overlying slates were visible. The gaps between the ridge tiles and chimney were noticeable and the ridgeboard was clear of cobwebs at this point and between the adjacent 2-3 rafters. Bat droppings (a mix of fresh and old droppings) were scattered throughout the roof void, but also formed loose clusters directly beneath the ridge, particularly underneath the sections clear of cobwebs. The roof void in the newer section of the house (the southern extent) also contained scattered bat droppings (fresh and older). There was a loose cluster of bat droppings on an angled board where the two roof voids joined, and there was a narrow gap at the top of the internal roof structures that separated two voids, providing potential access for bats between the two roof spaces.

Image 19. House roof void, north end

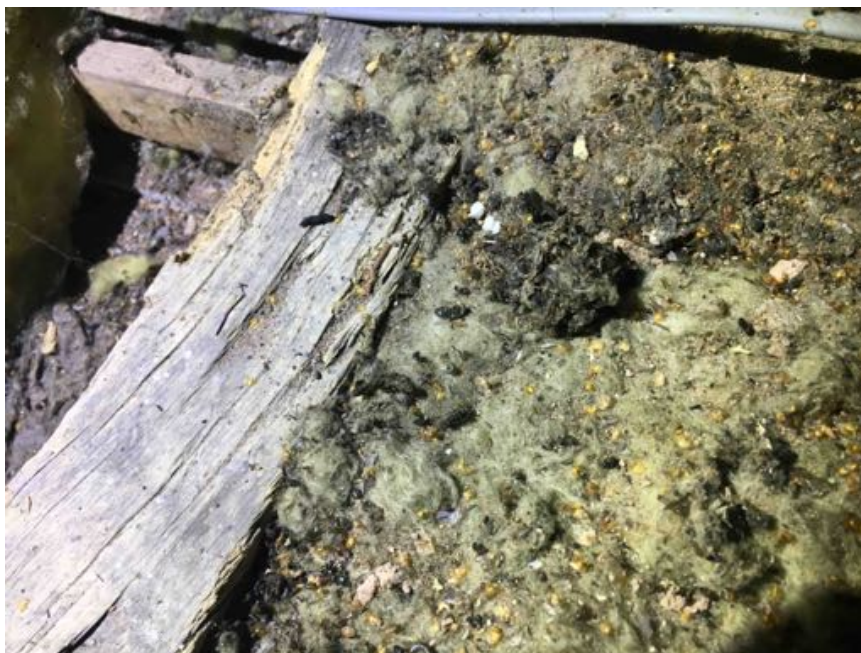
Image 20. Bat droppings in north end roof void

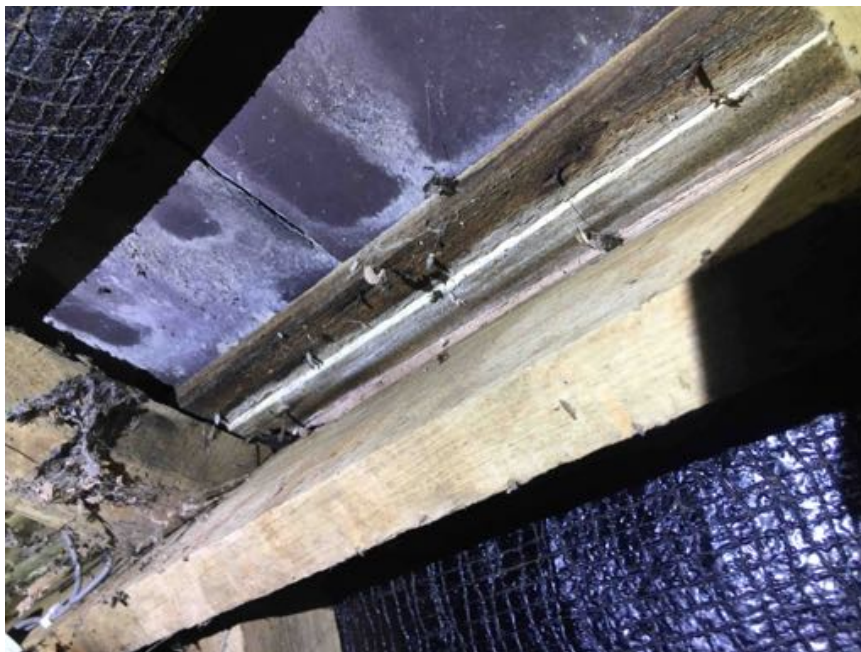
Image 21. Ridgeboard clear of cobwebs, north end roof void

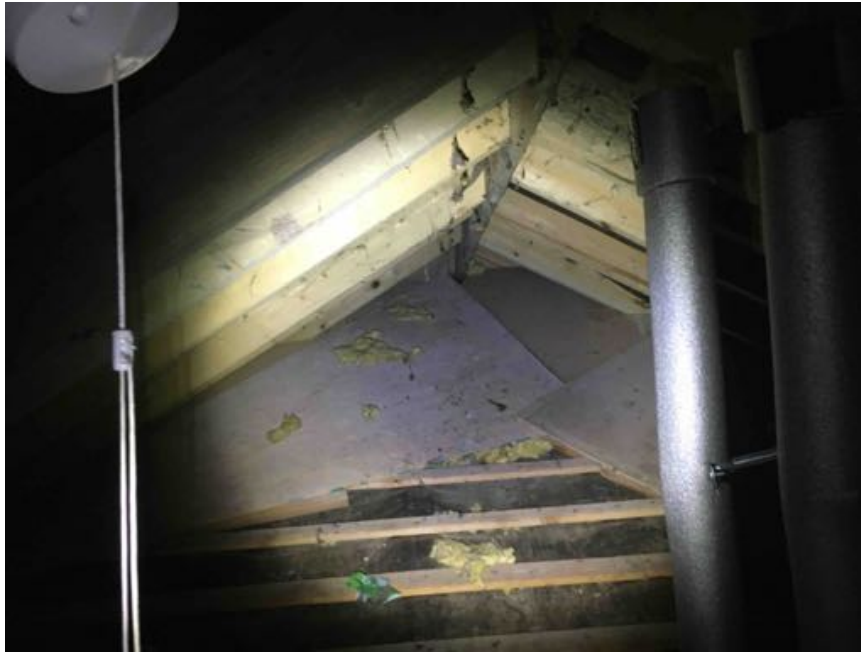
Image 23. Scattered bat droppings on board near internal roof void join

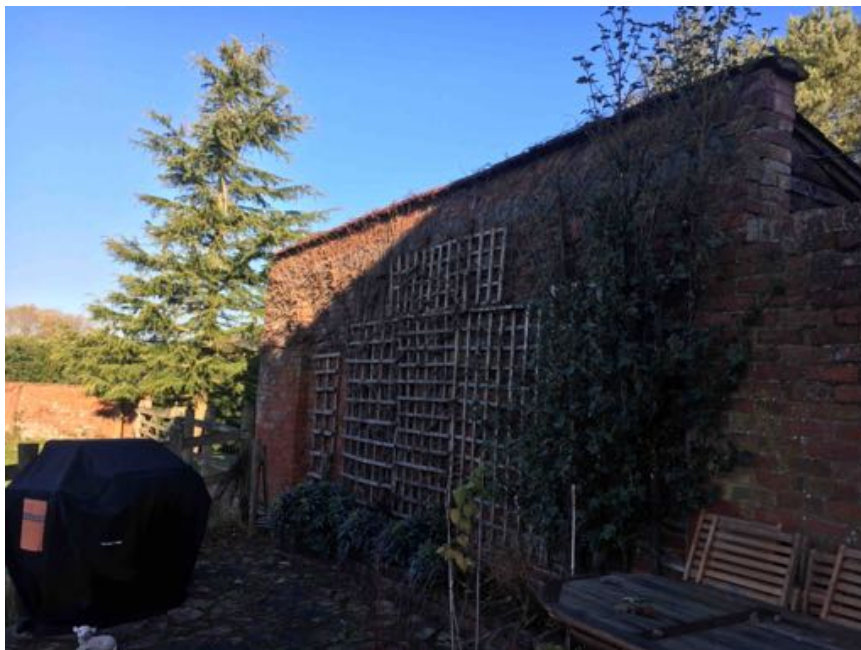
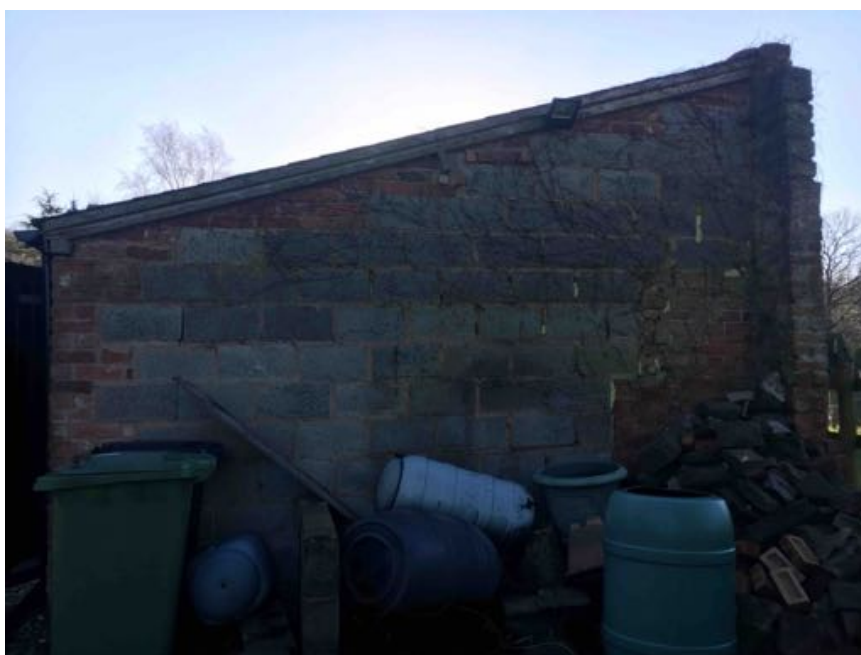
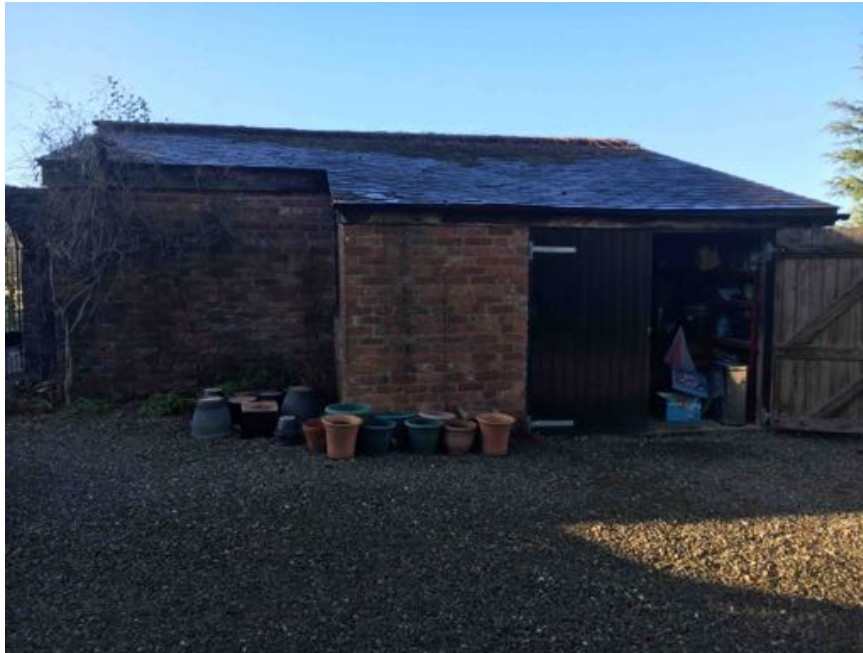
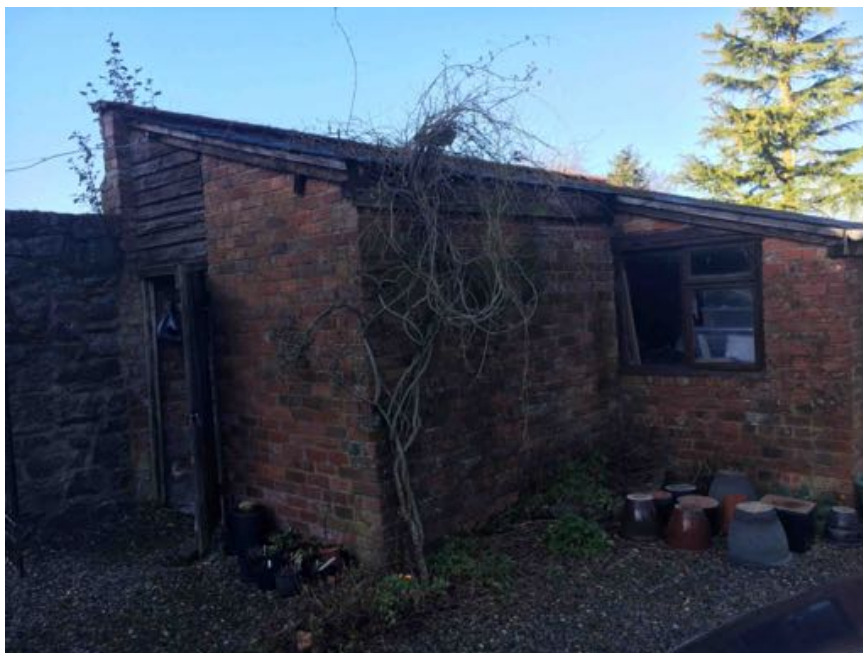
- 4.3.7. The single storey garage, located less than 5m to the northwest of the house was constructed of red brick with a single-pitched slate tiled roof. The roof tiles were in poor condition, with a number of slipped and broken tiles, and a creeper (possible Virginia creeper) had grown underneath the uppermost rows of tiles. Although most of the brickwork was intact there were some missing mortar and gaps between the wall top and roof on the west elevation. There were also gaps between the narrow timber

fascias and walls, and gaps between the single-skin timber cladding above the timber door on the southern elevation.

Image 25. Garage, west elevation

Image 26. Garage, north elevation

Image 27. Garage, east elevation

Image 28. Garage, south elevation

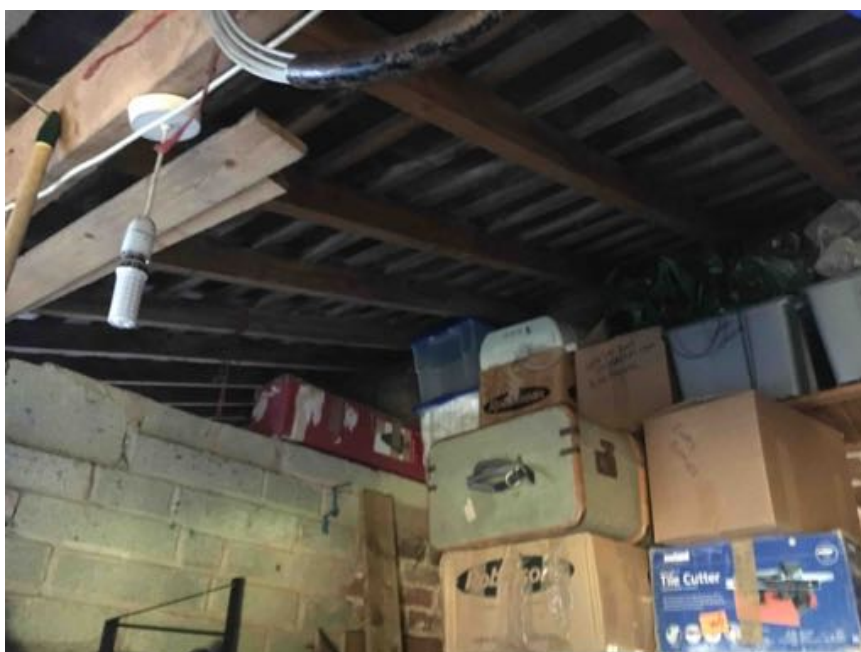
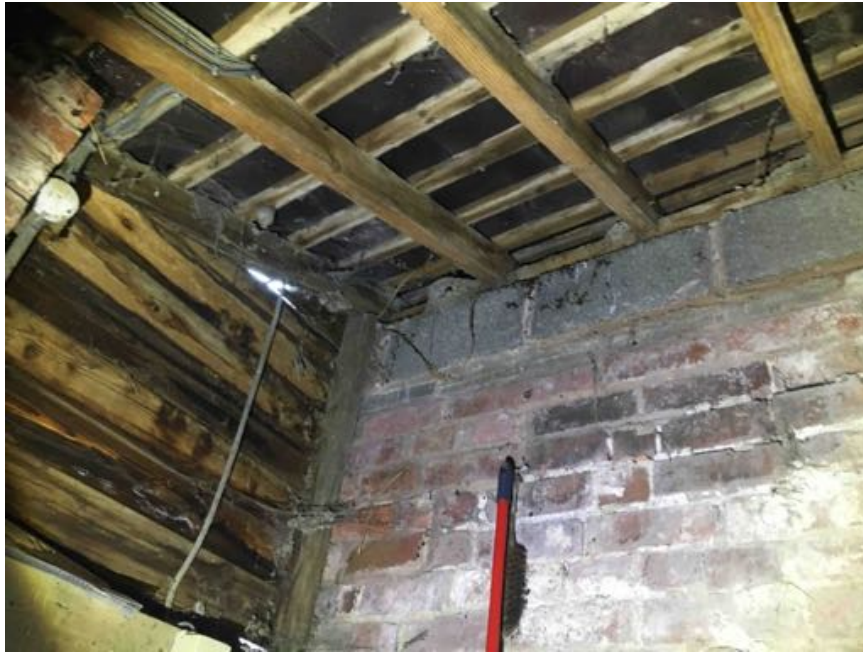
- 4.3.8. Internally the roof was unlined and space was draughty, with natural light visible through numerous gaps around the timber doors and roof structures. Two scattered bat droppings were located on the floor immediately inside the door on the south elevation, and a further 3-4 droppings were caught above in cobwebs on the internal brickwork.

Image 30. Inside garage, north end

Image 31. Inside garage, south end

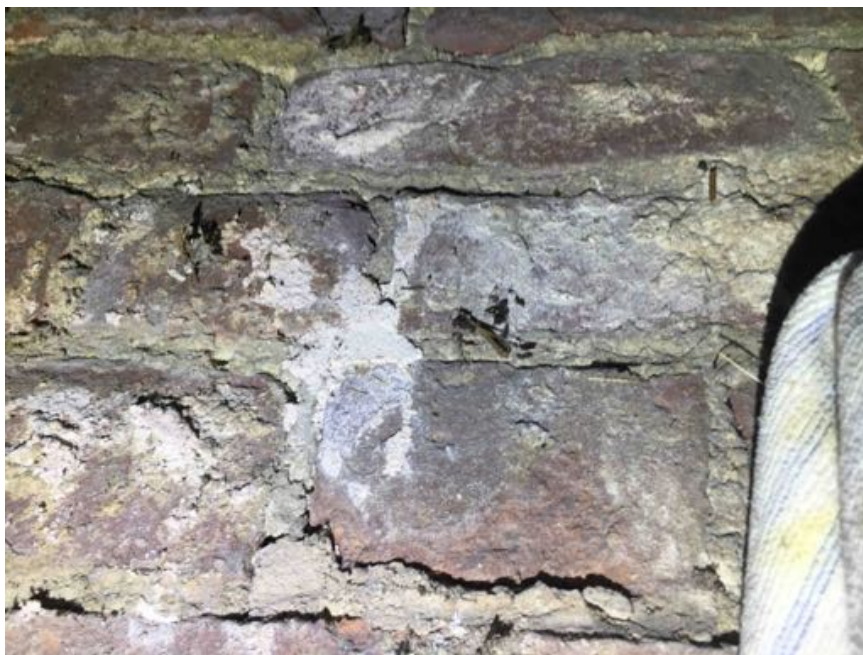
Image 32. Bat dropping son wall inside garage, south end near door
