An Ecological Survey and Mitigation Strategy for Orchard Croft, Putley

Aim: To assess the likelihood of the use of the building by Bats & Birds at Orchard Croft, Putley

Reference: Cross\Bat & Bird's Eco Rep.doc
26th September 2018

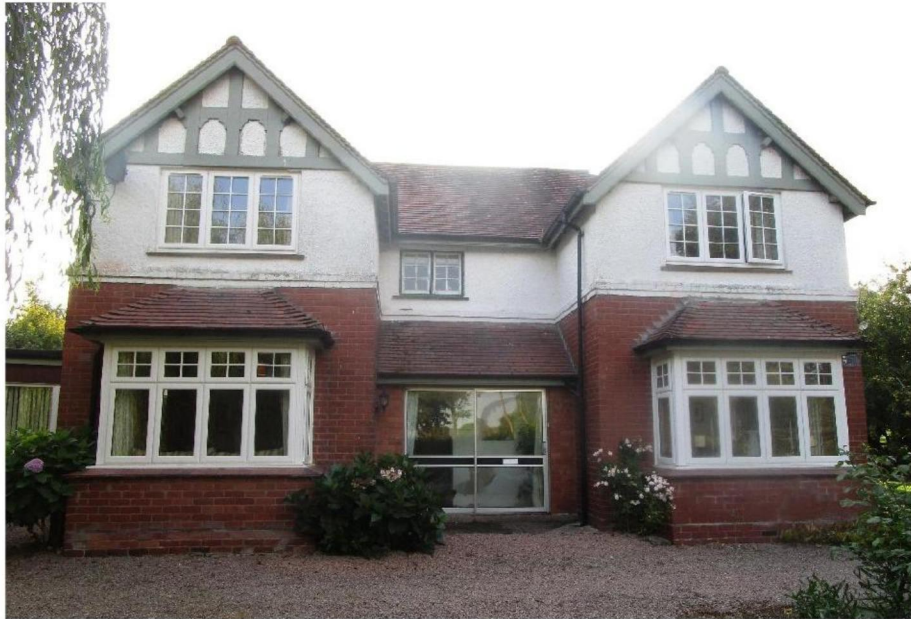
Figure 1: Photo to Show the East Elevation of the Dwelling Proposed for Extension – Orchard Croft, Putley

The Eastern elevation of the house is comprised of a double gable frontage with large uPVC double glazed bay windows at ground floor level and uPVC double glazed windows on the first-floor gable. A recessed red brick lean-to adjoins the double gable ends, at ground floor level, and comprises an aluminium framed sliding patio door unit with single glazed timber framed window above. The gables also feature exposed purlins and a painted timber frame facade at the apex (See Figure 1). The clay tiles of the ground floor window bays and recessed lean-to are tight fitting with the lead flashing lying flush with the building. In places the tiles are further sealed with moss reducing the potential for crevice access. As a part of the proposed works, the recessed lean-to will be replaced with the addition of a small timber porch.

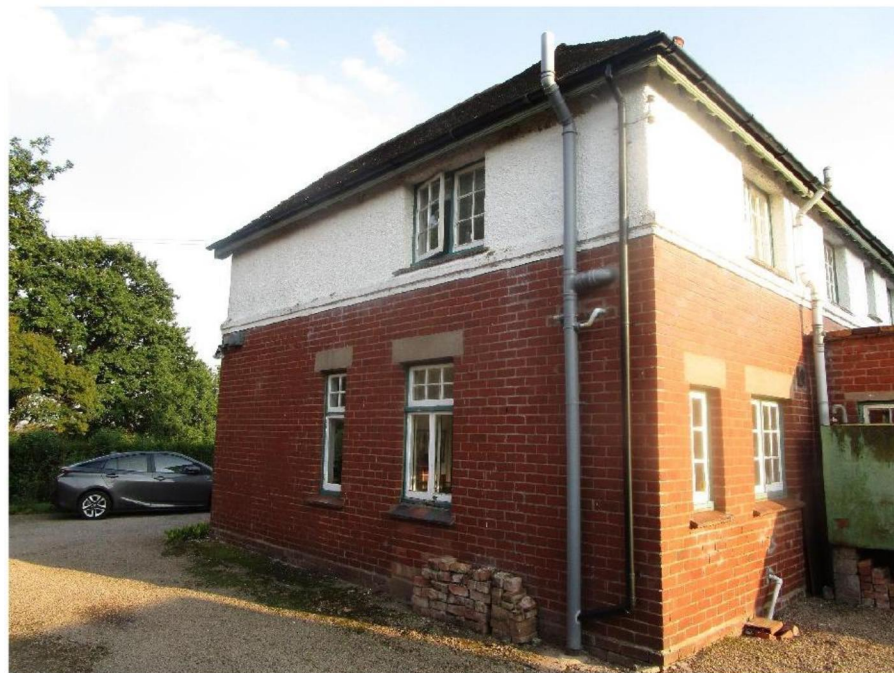
Figure 2: Photo to Show Existing North Elevation of House

The north elevation of the building, to which the only alteration will be the creation of a doorway where there is currently a window, is comprised of bare red brick at ground floor level with painted rendered upper floor exterior (See Figure 2). The North elevation comprises original single glazed timber framed windows with secondary aluminium glazed units fitted at the lower floor windows. The windows are intact and well sealed, as are the exposed rafters and fascia. The clay roof tiles on the North side of the pitch are tight fitting and well sealed with no apparent crevice features.

The North elevation holds the highest number of House Martin nests, it is therefore important that any roof works must maintain the exposed rafters and significant roof overhang that is currently utilised by nesting birds.

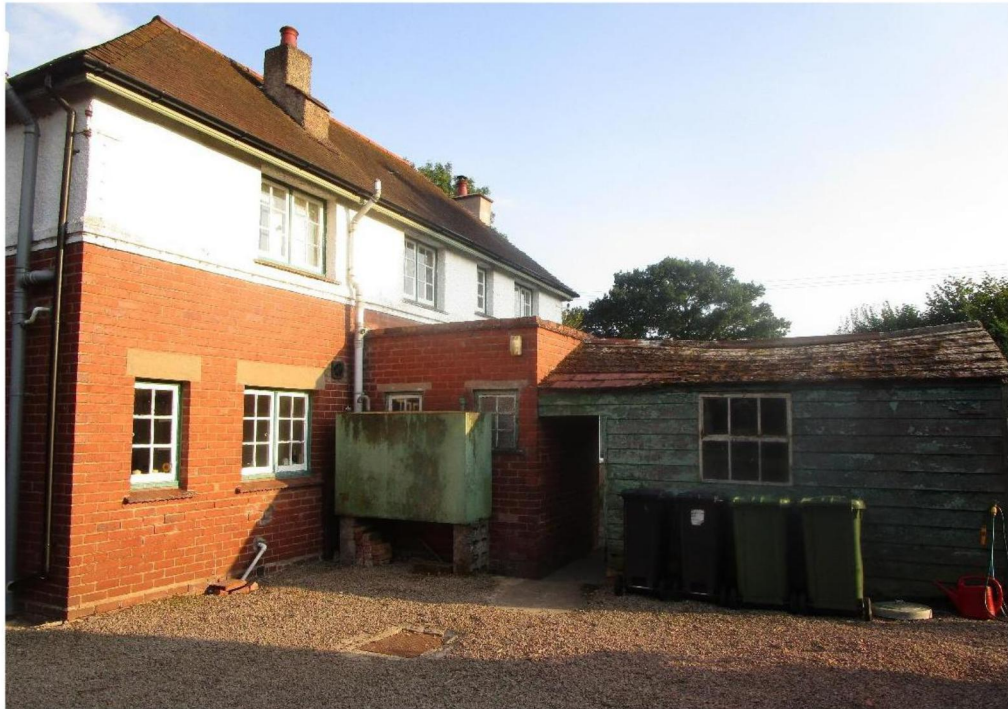
Figure 3: Photo to Show West Elevation of Orchard Croft with Adjoining Red Brick Outbuilding

The West elevation of the house adjoins a small single storey red brick outbuilding from which extends a timber framed shed to the West and a brick built glazed lean-to link building to the South. The brick outbuilding is flat-sided to the North and East with two small timber framed single glazed windows and a sloping roof on the South and West sides of the structure (See Figure 3). The clay tiles and ridge are in tact and well sealed offering no potential features for crevice dwellers.

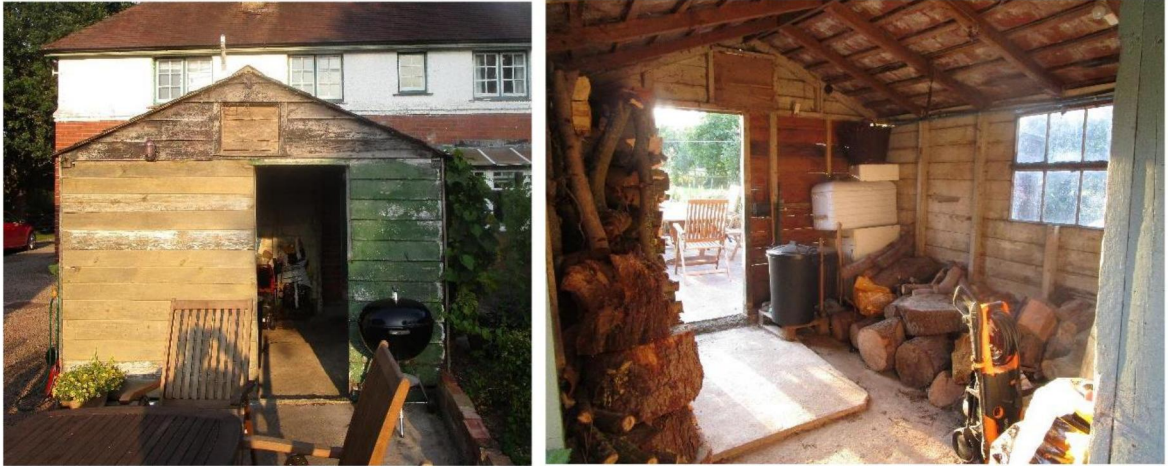
Figure 4 (Left): Photo to Show West Elevation of Timber Framed Shed & Figure 5 (Right): Photo to Show Naturally Well-Lit Interior of Timber Framed Shed

The timber framed shed which adjoins the West elevation of the red brick outbuilding is comprised of timber clad, unlined walls, with an unlined rosemary clay tile roof (See Figure 4 & 5). There is a single glazed window on the North elevation with two doorways, one to each of the East and West gable ends. The doorways are permanently open creating direct flight access into the shed. The shed is used for storage and for the processing or firewood and, as such, is regularly accessed and disturbed.

As a result of the open doorways and glazed window, the interior of the shed is very well naturally lit during the day, there is also electric lighting within the structure. The concrete floor and other surfaces within the shed were checked for signs of bat and bird activity, such as droppings and feeding remains, however, none were found.

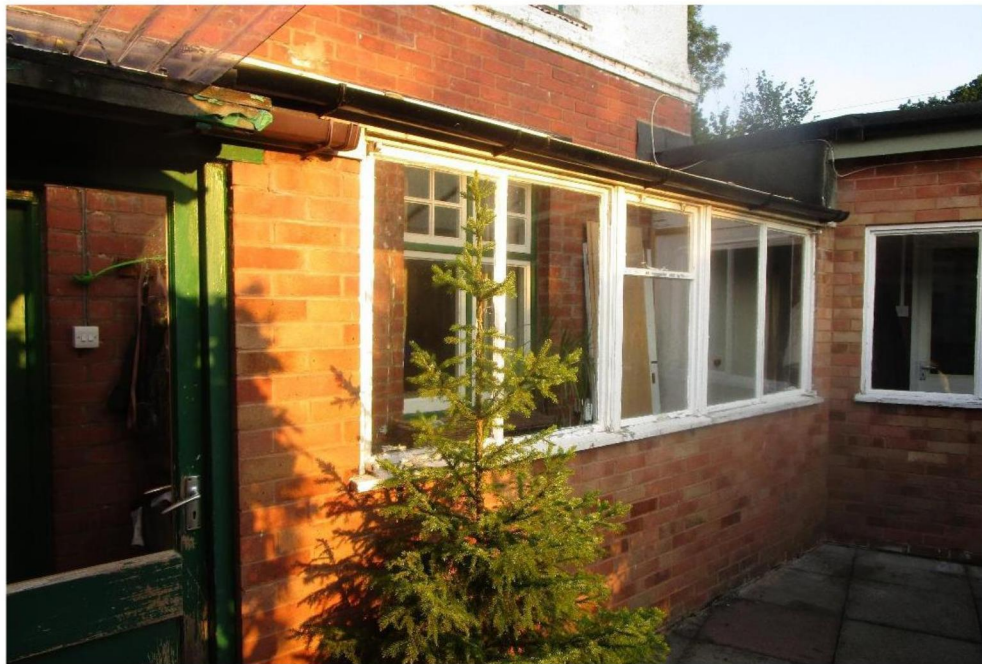
Figure 6: Photo to Show West Elevation of Glazed Link Building Adjoining Main House

Adjoining the West elevation of the main building, and the Southern elevation of the red brick outbuilding, is an existing modern brick-built lean-to which links the main part of the dwelling to an existing flat roof extension to the South. The link building is predominantly glazed and very well naturally lit by a full wall of timber framed single glazed windows to the West and a clear corrugated Perspex roof along the full length (See Figure 6).

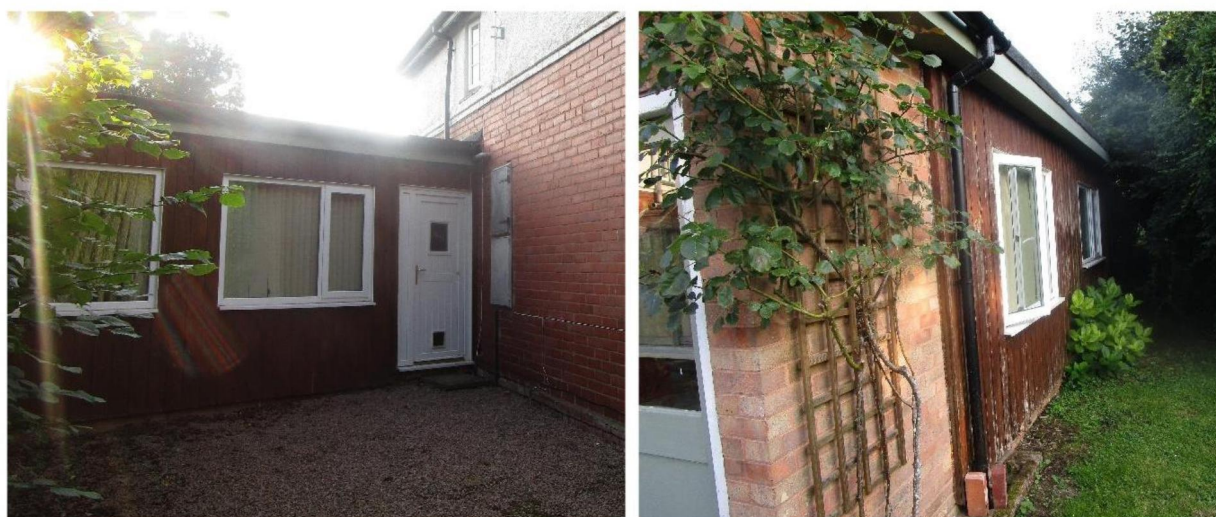
Figure 7 (Left): Photo to Show Eastern Elevation of Flat Roof Extension & Figure 8 (Right): Photo to Show Western Elevation of Flat Roof Extension (To be Retained)

The South elevation of the house has a single timber framed window at first floor level with the flat roof extension adjoining the building at ground floor level (Figure 7 & 8). The existing extension is of modern construction and has an unfilled wall cavity. At present a hive of Honey Bees is located in the South-East corner cavity of the extension. The extension has well varnished vertically hung timber cladding to the Eastern and Western elevations. The cladding is tight fitting and very well sealed and offers no potential crevice features. The North elevation of the existing flat roof extension will be extended in order to integrate the building with the main part of the house via a new corridor/hallway.

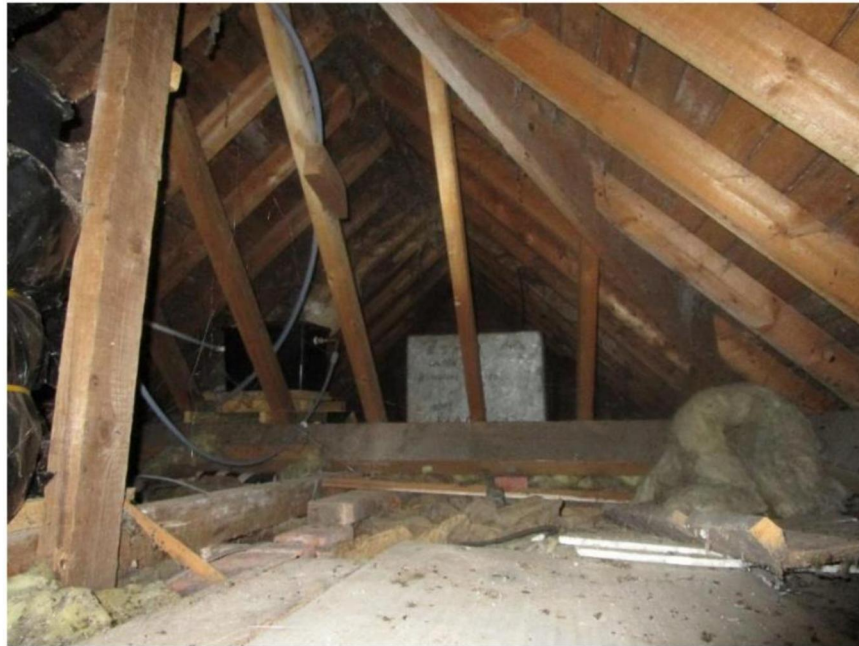
Figure 9: Photo to Show Large Loft Space Above Original Part of Orchard Croft

The loft space of the house is divided into three parts, the attic above the main part of the dwelling is not subdivided by internal walls, however, the small roof voids above the two gable ends on the Eastern elevation are separate from the central loft area and are inaccessible and could not be surveyed. The central loft area can be accessed by two separate loft hatches and spans the full length of the dwelling (See Figure 9).

The roof is of modern timber framed construction and the clay roofing tiles are lined with timber tongue and groove boarding. The loft has been insulated and partially boarded but there is no electric lighting. The loft area is dusty and very well covered with cobwebs, suggesting no flight activity has taken place within the loft, however, there are low numbers (10+) of scattered bat droppings, whose shape and size are suggestive of crevice dwelling bats, such as Common or Soprano Pipistrelle. No bats were observed in the loft during the daytime scoping survey.

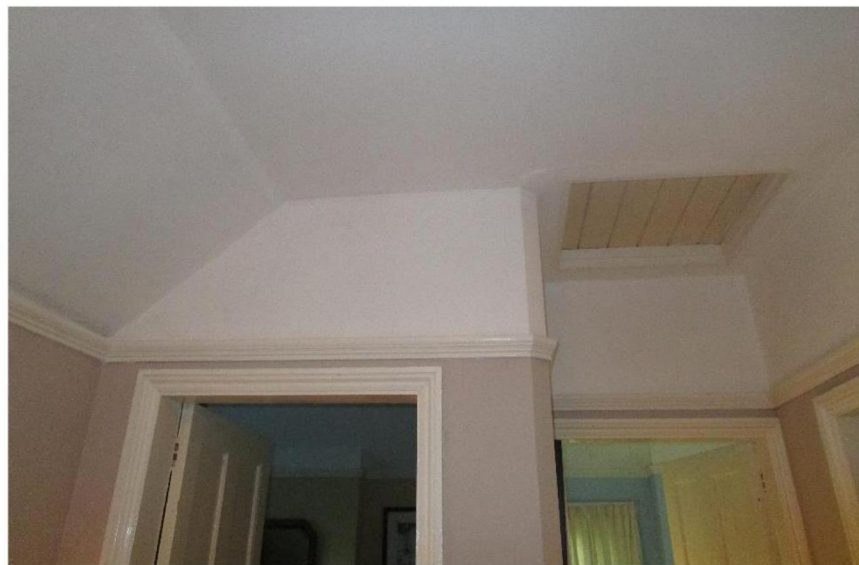
Figure 10: Photo to Show Loft Hatch Access to Main Roof Void from First Floor of Dwelling

There was no evidence of any bird activity, such as droppings or nesting materials, within the attic space. The interior ground and first floor of the main part of the dwelling known as; Orchard Croft, is all plastered and painted or wall papered with high levels of natural light due to extensive glazing and is currently lived in (See Figure 10).

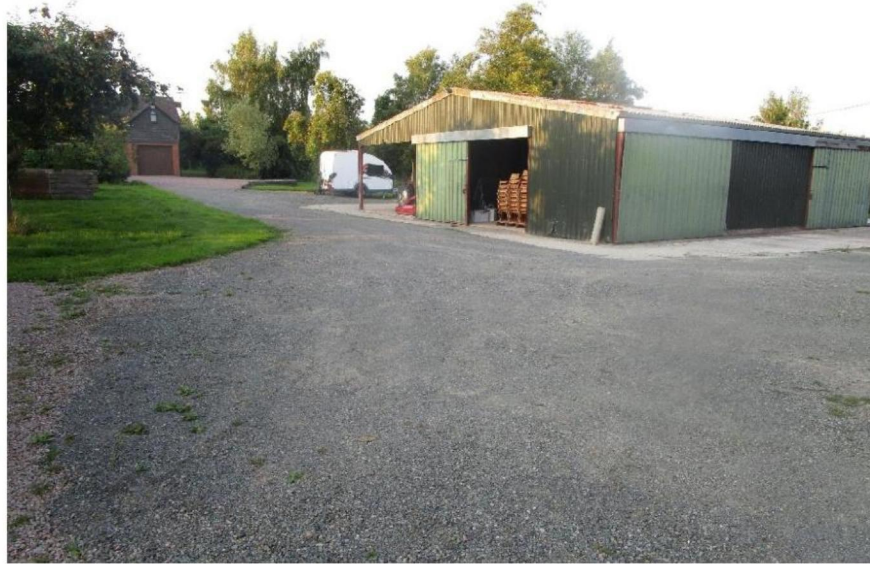
Figure 11: Photo to Show Concrete Yard and Gravel Track Dividing Ponds from Proposed Site

The closest of the four ponds, not divided by a road, is divided from the site by a concrete hardstanding yard and a gravel farm track (See Figure 11). The development will not result in the loss of any Newt habitat, and the likelihood of Newts commuting across the close mown amenity grassland within the site boundary is very low. The likelihood of impact upon potential local Newt populations or upon the pond is considered very low, however, in order to determine the likelihood of any potential impact, a Habitat Suitability Index (Oldham *et al.*, 2000) was carried out for closest pond. Details of the pond's characteristics and the result of the Habitat Suitability Index are given below.

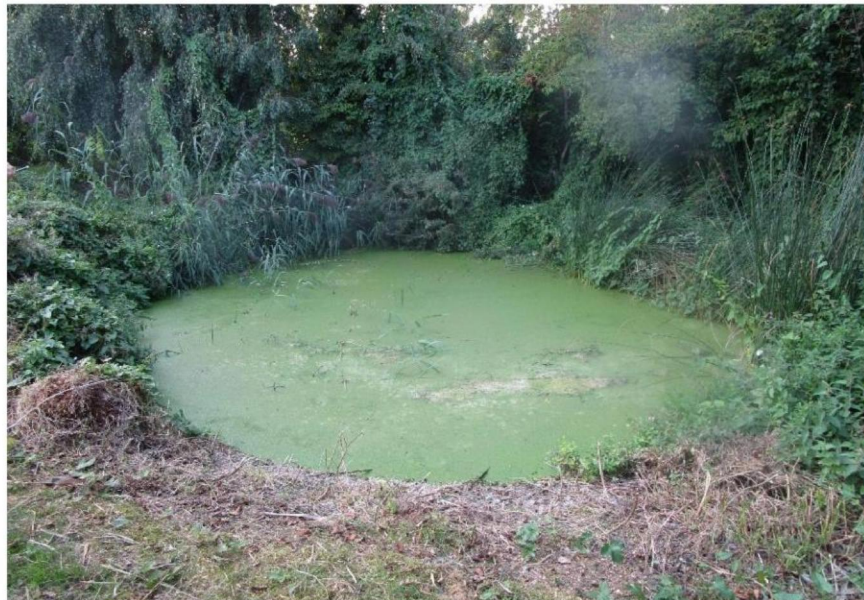
Figure 12: Photo to Show Largest of Two Ponds Located ~140m, NE of Orchard Croft, Putley

Although the MAGIC Map pond search only identified one pond within 140m of the site, upon surveying, two ponds were observed in the same location. The larger of the two ponds is approximately 8m long by 6m wide, is thickly covered with Common Duckweed and is well used by waterfowl. The pond has extensive emergent

vegetation including Common Reed, Rosebay Willowherb, Yellow Flag Iris, Pond Mace, Purple Loosestrife and Bind Weed and is shaded to approximately 70% by adjacent Silver Birch, Alder, Rowan and Field Maple (See Figure 12). There is no indication of any fish within the pond. The HSI score for this pond is 0.56 which equates to a classification of 'Below Average' (See Table 1).

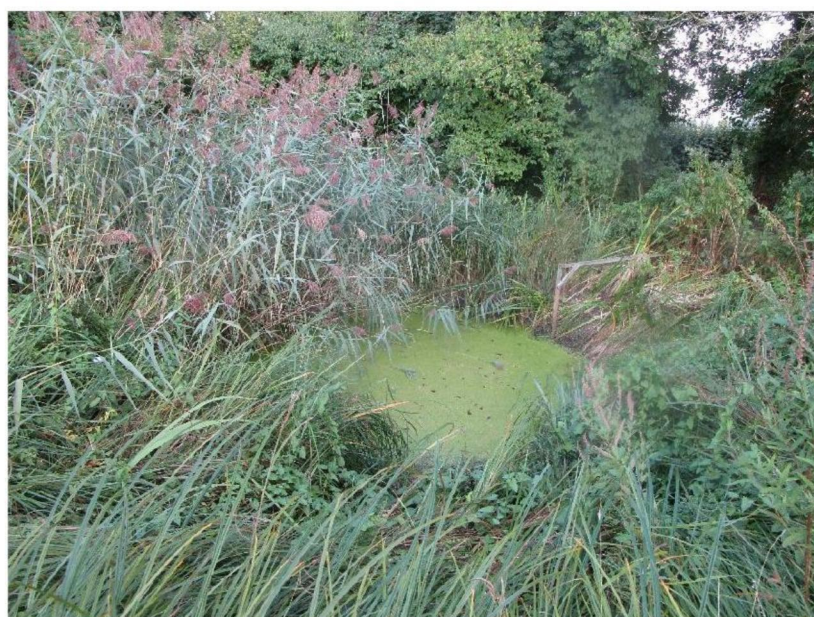
Figure 13: Photo to Show Smaller of Two Ponds Located ~140m, NE of Orchard Croft, Putley

The smaller of the two ponds is approximately 3m long by 2.5m wide, is covered with Common Duckweed with some evidence of minor use by waterfowl. The emergent vegetation includes Common Reed, Pendulous Sedge, Yellow Flag Iris and is well silted. The pond is shaded to approximately 80% by adjacent trees and hedge (See Figure 13). There is no indication of any fish within the pond. The HSI score for this pond is 0.57 which equates to a classification of 'below average' (See Table 2).

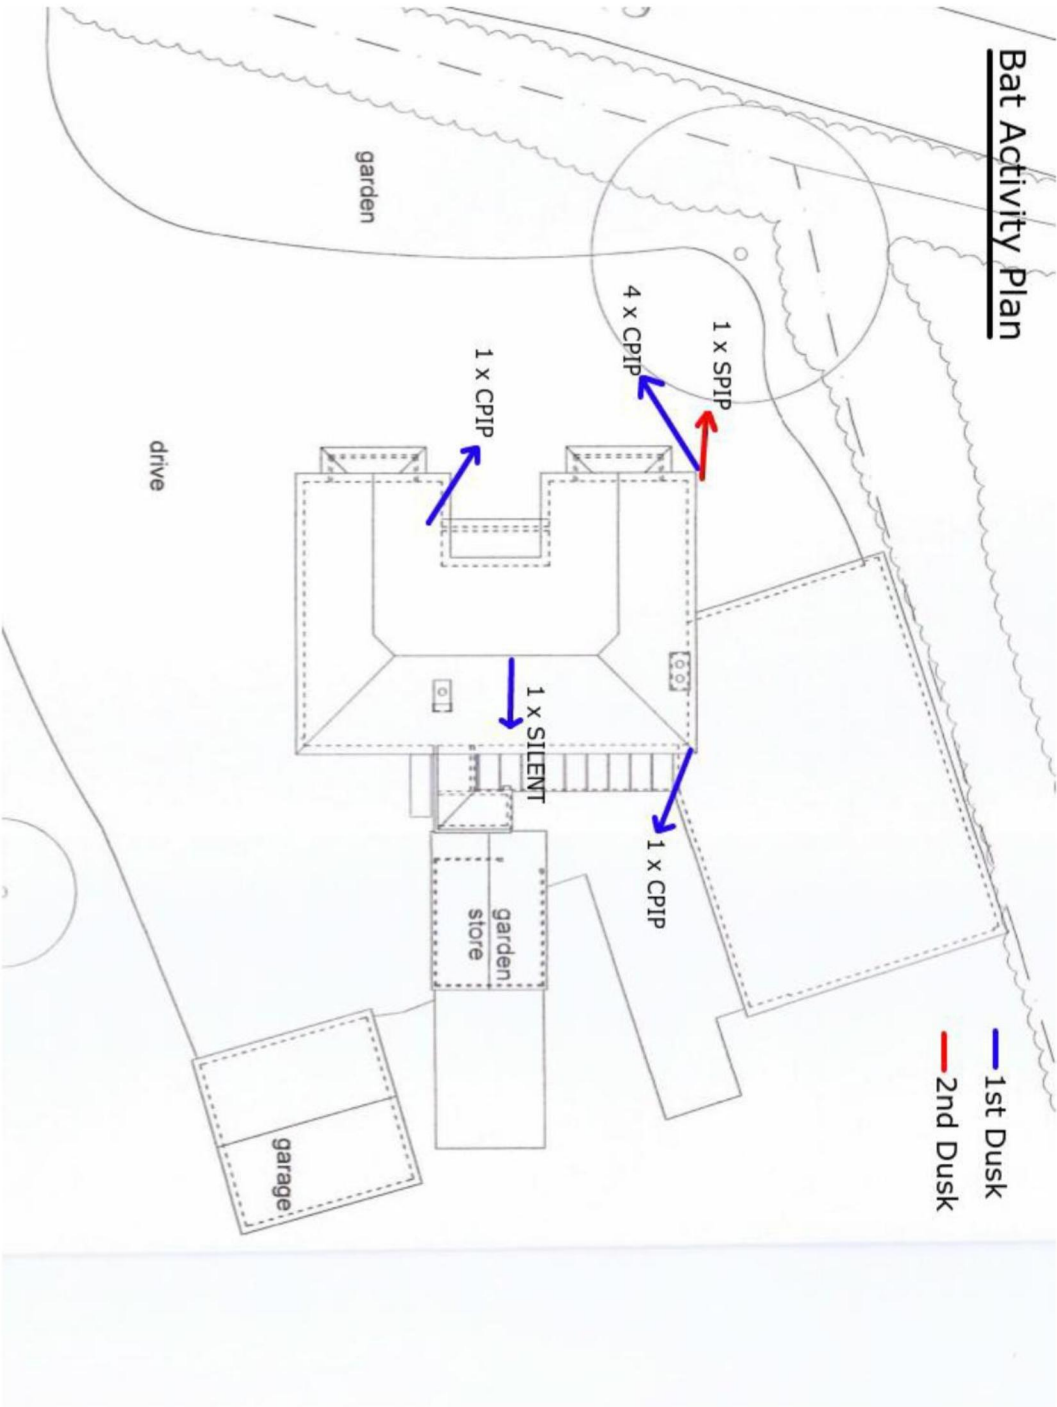
APPENDIX FIVE BAT ACTIVITY PLAN

The survey end temperature was 11.4°C with a wind speed of 0m/s. Six Common Pipistrelle bats were recorded emerging from the East elevation, West roof pitch and South-East and South-West corners of the house proposed for extension. The silent bat is most likely a *Pipistrellus* species as a result of the timing of the emergence. The areas around the site, including the garden and driveway have low levels of foraging activity.

The survey end temperature was 11°C with a wind speed of 0m/s. One Soprano Pipistrelle bat was observed emerging from the building on the South-East corner of the house proposed for extension. Very little foraging was observed around the house and garden.
