## Assessment of Ecological Survey Report

Survey Site: The Cider Mill,  
Lower Court,  
Putley.  
Ledbury,  
Herefordshire.  
HR8 2QP

Report Reference: 072/11

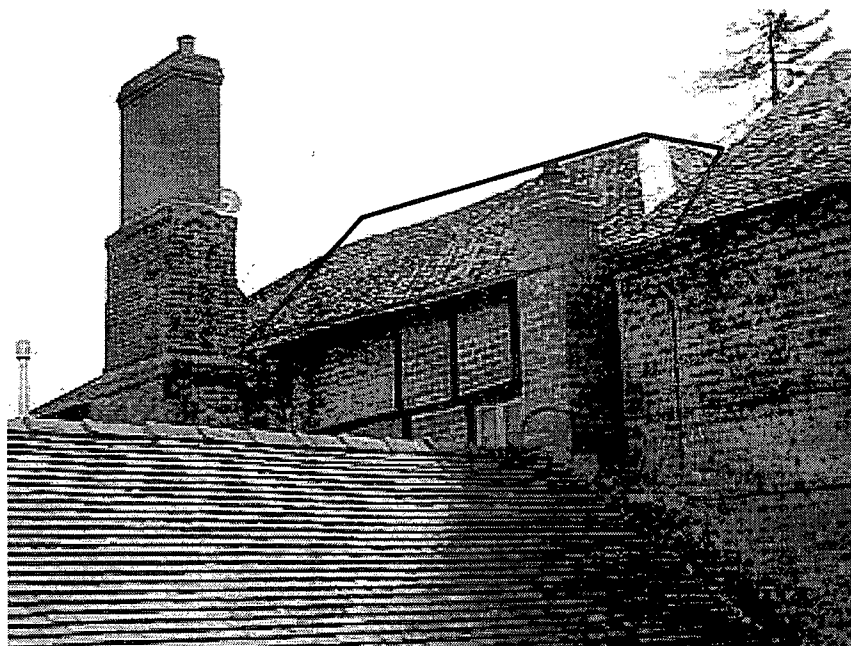
Fig 3. View from north. Roof area of farmhouse considered as mitigation for bat loft highlighted. Also describing the new roof above the north wing (cider / fruit storage)

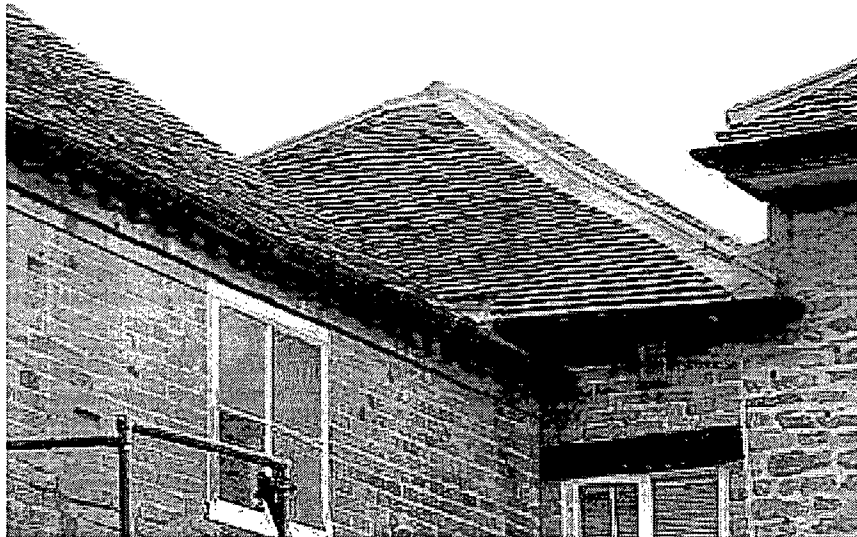
Fig 6. West face of proposed bat loft.

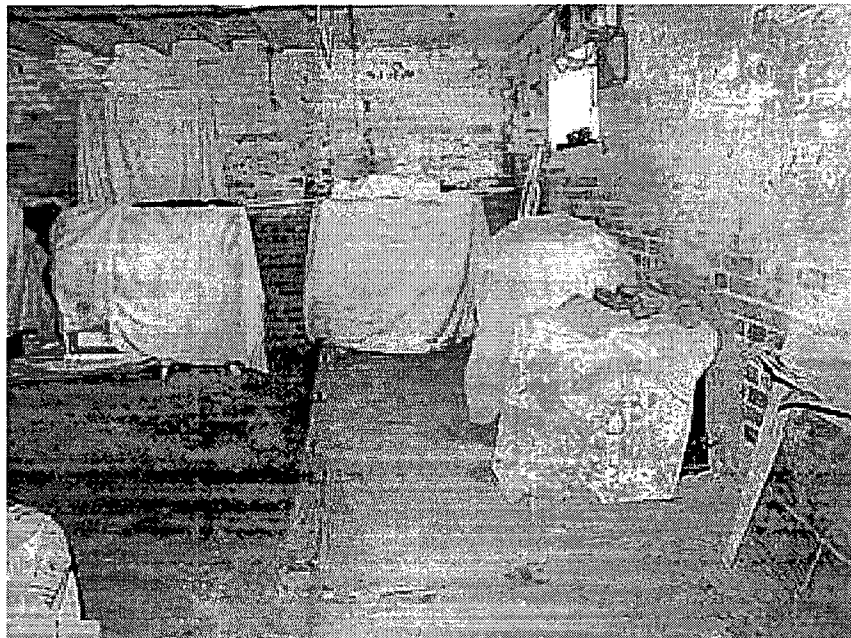
The floor of the Cider Mill was a mixture of compacted earth and concrete and very dry giving unsuitable conditions for any amphibians.

Fig 8. The floor was comparatively clear with only stored items of furniture and small amounts of building materials present. The floor was mainly compacted earth and concrete.

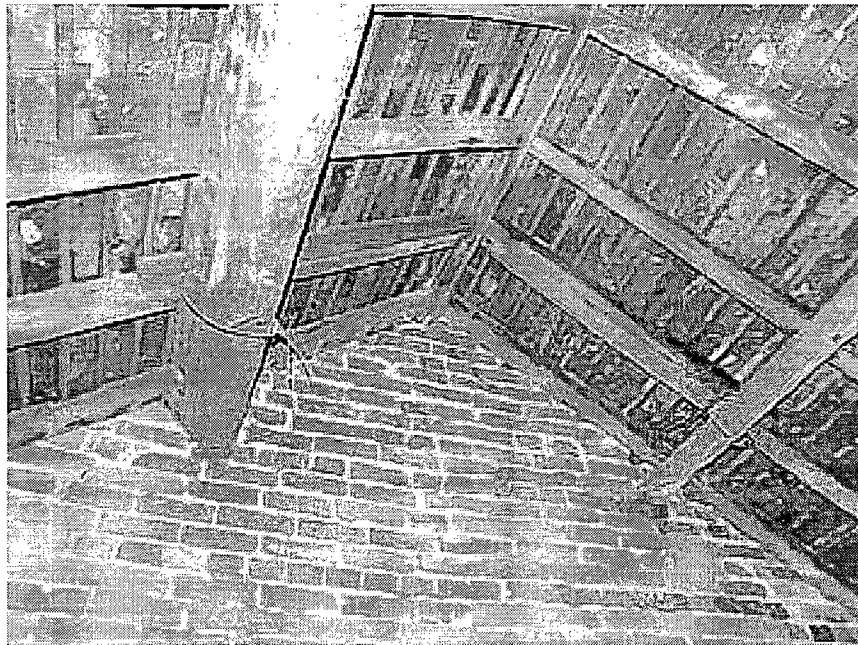
Fig 9. Describing the east gable wall of the Cider Mill.

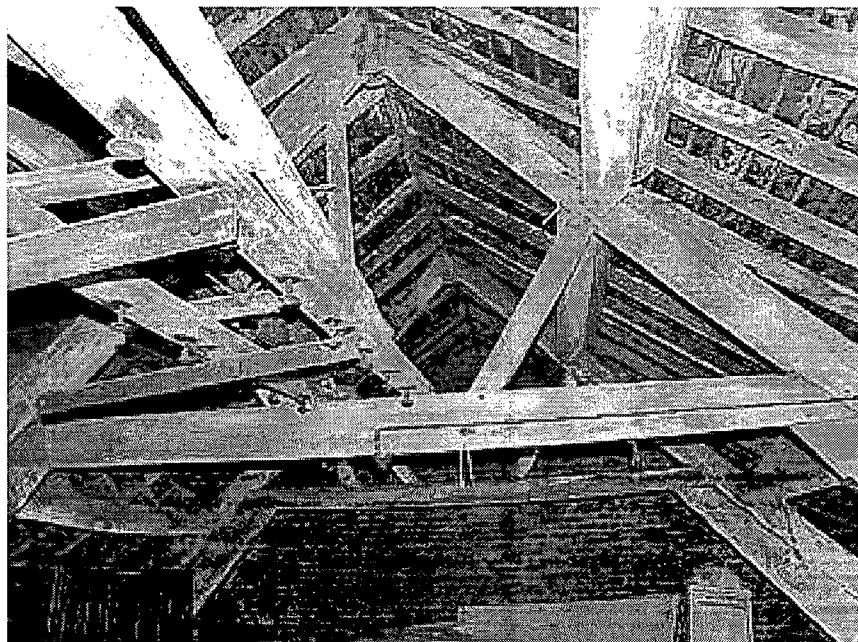
Joints within the roof timber framework were generally tight, where gaps were observed that were of suitable size for bats they were found to be 'cobb webby' and undisturbed.

Fig 10. Describing the timber roof structure of the Cider Mill.

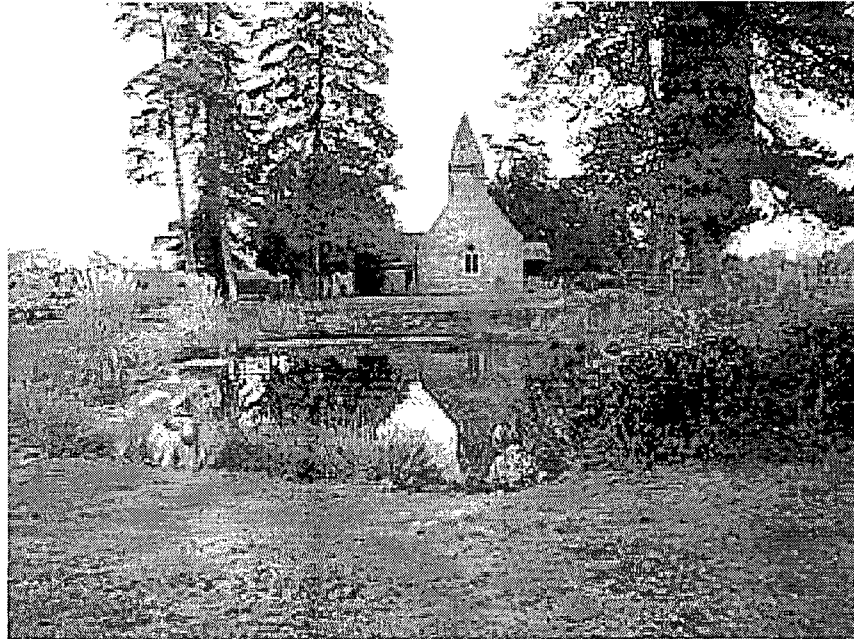
Fig 15. Describing Church pond from the west, this pond scored "good" using H.S.I.

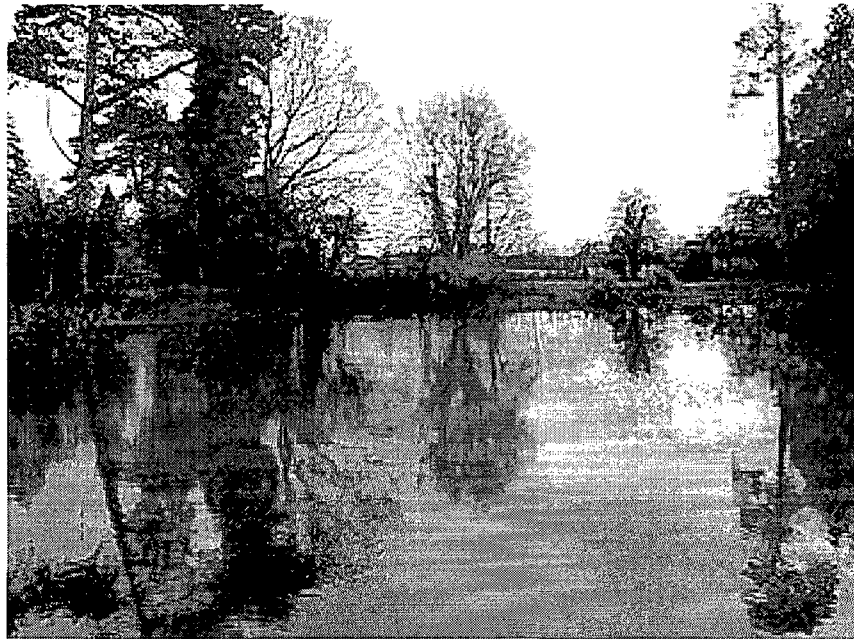
Fig 16. Describing small lake nearby, this scored "excellent" despite presence of fish.

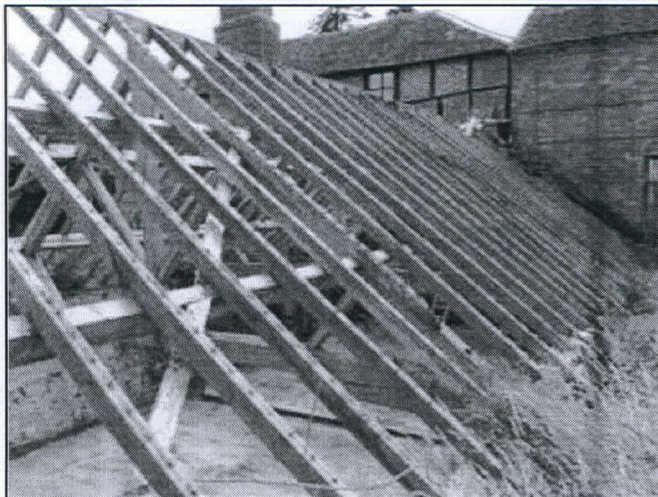
Cider storage barn: subterranean to wall plate height. Clay tiles have been removed from the weak roof timber structure and stacked nearby.

Barn 2 adjoins the farmhouse and Barn 1 on the north aspect of these buildings. The long walls of Barn 2 are in direct contact with the soil to their full height, and are of stone construction with internal mortar cracks evident. The brick gable end supports a few mortar crevices. The large roof structure is decaying and several joint crevices are apparent. There is a small flight of steps down to the floor in the south east corner and there is an access door to a cellar area which was blocked up and not accessible at the time of survey.
