**1 FERNBANK COTTAGES, CROCKERS ASH, WHITCHURCH,
HEREFORDSHIRE**

**BAT SURVEY
ISSUE 1, VERSION A**

JUNE 2020

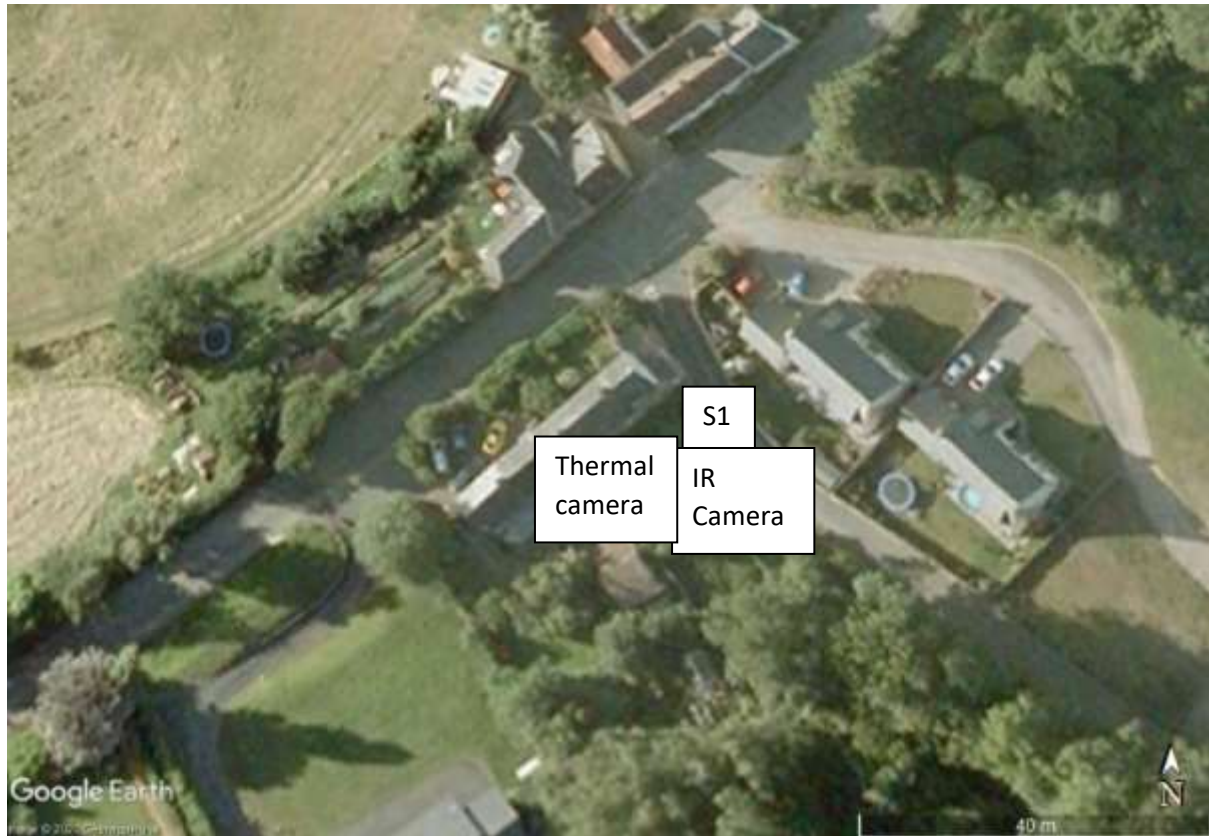
A dusk survey was carried out on 19th June using a single surveyor and two cameras , positioned in such a way that all areas of the building to be affected was visible. Surveyors and cameras were equipped with Batlogger M detectors.

Figure 3: Approximate surveyor locations
