**SOAKAWAY INVESTIGATION REPORT**  
**Proposed Mixed Use Development**  
**Land to the North of Nuttall Farm, Much Marcle**

**Prepared for: Boulton Brooks Real Estate Ltd**

**Report No: 6176/SA**

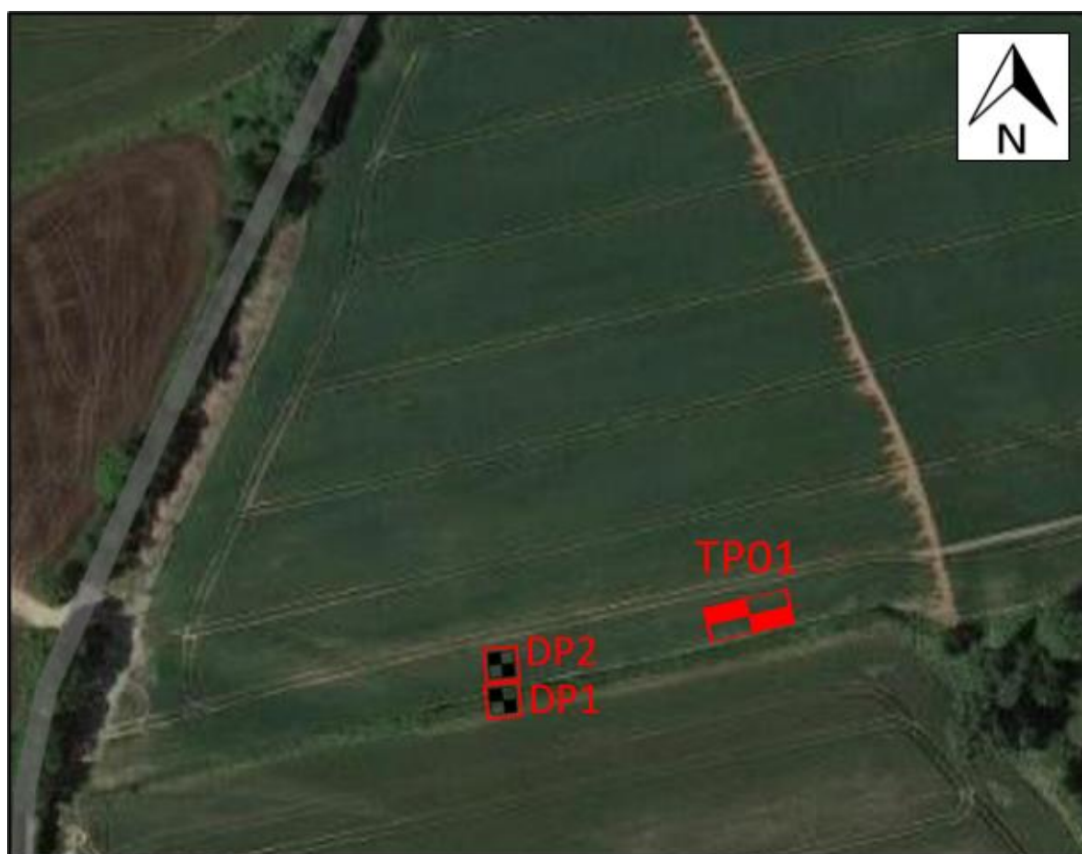
**Drawing 3.1: Exploratory Hole Location Plan**

The exploratory hole logs and in-situ test results are presented in **Annex A** and **Annex B** respectively, and their locations shown on **Drawing 3.1** below.

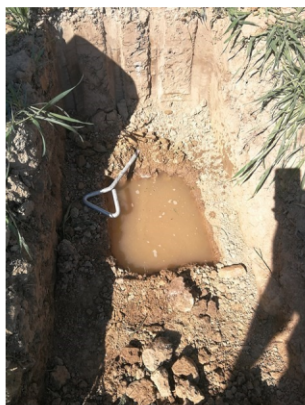
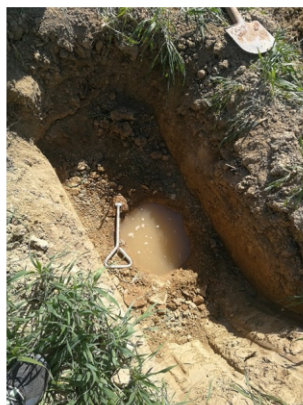
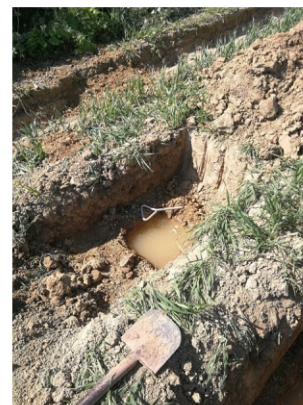
### Trial Pit Photographs

Samples and Results			Depth, (Thickness)	Level	Stratum Description	Legend
Results	Type	Depth				
			(0.30)		TOPSOIL: Grass/crop over firm to stiff light yellowish brown slightly gravelly slightly sandy clayey SILT with abundant rootlets.

0.30			
			(0.30)		Stiff yellowish brown slightly sandy gravelly CLAY. Gravel is angular to subangular fine to coarse of weak to medium strong mudstone.

0.60		End of Trial Pit at 0.60m	
			1			
			2			
			3			
			4

0.3m x 0.3m x 0.3m pit excavated between 0.30m and 0.60mgl for septic drainage test

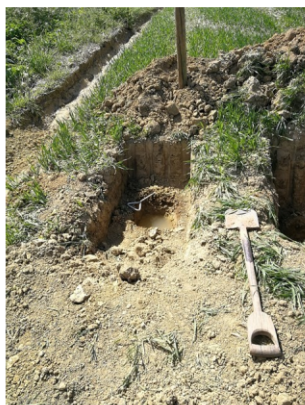
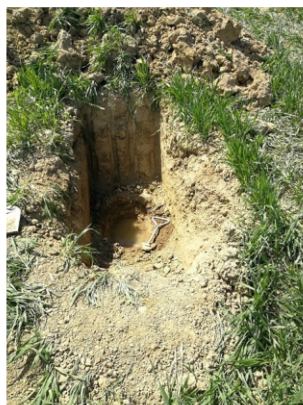
Trial Pit Photographs

Samples and Results			Depth, (Thickness)	Level	Stratum Description	Legend
Results	Type	Depth				
			(0.30)		TOPSOIL: Grass/crop over firm to stiff light yellowish brown slightly gravelly slightly sandy clayey SILT with abundant rootlets.

0.30		Weak MUDSTONE recovered as yellowish brown slightly sandy silty GRAVEL. Gravel is angular to subangular fine to coarse of weak to medium strong mudstone.

0.75		End of Trial Pit at 0.75m

0.3m x 0.3m x 0.15m pit excavated between 0.60m and 0.75mgl for septic drainage test.  
Pit refused at 0.75m on rock head.

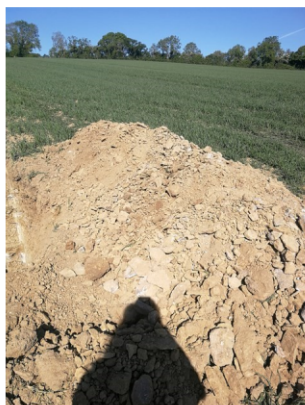
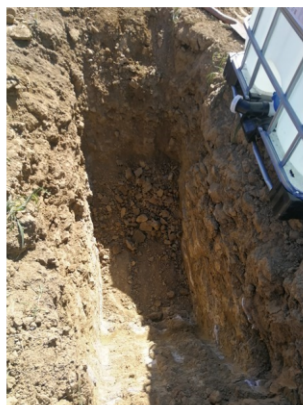
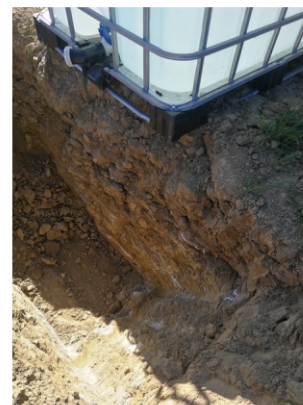
Trial Pit Photographs

Samples and Results			Depth, (Thickness)	Level	Stratum Description	Legend
Results	Type	Depth				
			(0.30)		TOPSOIL: Grass/crop over firm to stiff light yellowish brown slightly gravelly slightly sandy clayey SILT with abundant rootlets.

0.30		Dense light yellowish brown slightly sandy very clayey GRAVEL with frequent cobbles. Gravel is angular to subangular fine to coarse of limestone and mudstone. Interbedded with very thinly to thickly laminated beds of mudstone/shale (1-5cm) and thinly bedded limestone (5-10cm). Fossilised shell remains present.

(0.90)			
			1			
			1.20		End of Trial Pit at 1.20m	
			2			
			3			
			4

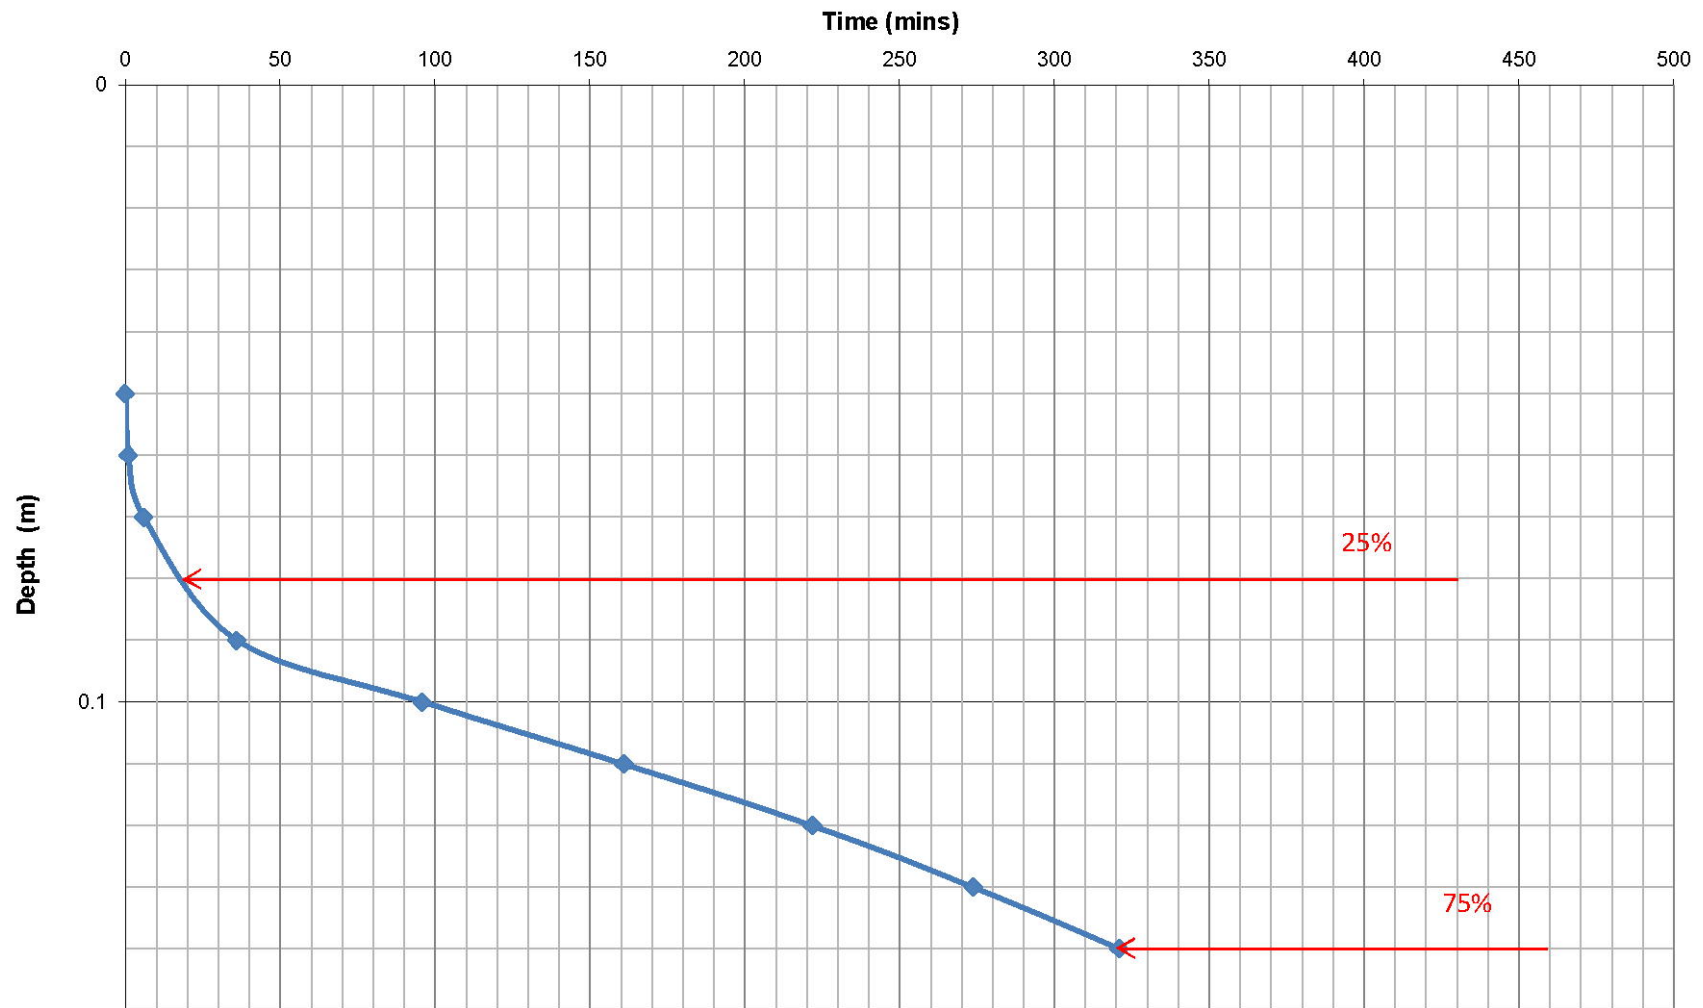
# Soil Infiltration Measurements - DP2, Test 01

Depth to Water (m)	Time (Mins)
(Top of test / effective depth - 100%)	0.05	0
	0.06	1
	0.07	6
	0.09	36
	0.1	96
	0.11	161
	0.12	222
	0.13	274
	0.14	321
(Base of pit / effective depth - 0%)	0.170

Length of Trial Pit (m)	0.3	
Width of Trial Pit (m)	0.3	
Depth of Trial Pit (m)	0.17	Excavated from 0.60m to 0.75m bgl
Effective Storage Depth (m)	0.120	
Vp25	0.0800	
Vp75	0.1400	
Vp75-25	0.005	
50% effective depth (m)	0.060	
Mean Surface area ap50 (m2)	0.162	
Time for 25% <b>Outflow</b> (tp25)	19	
Time for 75% <b>Outflow</b> (tp75)	320	
tp75 - 25	301	
<b>Soil Infiltration Rate (m/s)</b>	<b>1.85E-06</b>	
<b>Vp</b>	120.4

Vp values ranged between 120 and 182 with an average result of 151. It is generally accepted that values >100 may not be deemed suitable.
