**Protected Species Survey  
of  
Gold Hill Farm,  
Clenchers Mill Lane,  
Eastnor, Nr Ledbury,  
Herefordshire.  
HR8 1RE**

**Grid reference SO736364  
On 4th July 2008**

Site investigation undertaken by:  
John Morgan.  
Shropshire Wildlife Surveys  
14, Stretton Close,  
Sutton Hill,  
Telford,  
Shropshire TF7 4LS

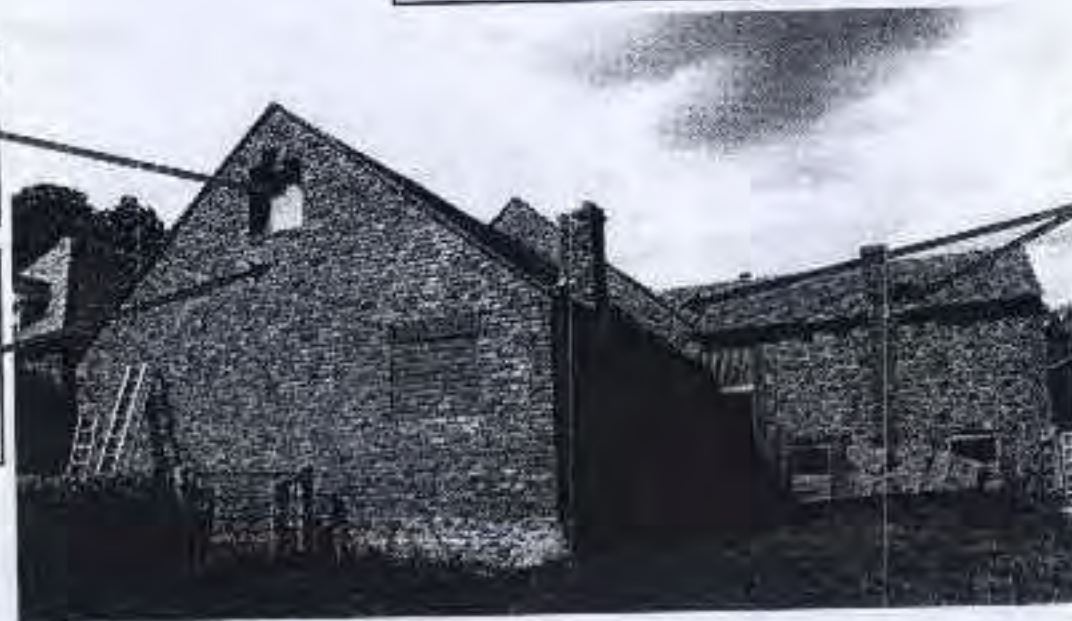
Common Pipistrelle  
was observed  
swarming around  
the chimney stack /  
roof junction during  
the 22<sup>nd</sup> August  
dawn survey.

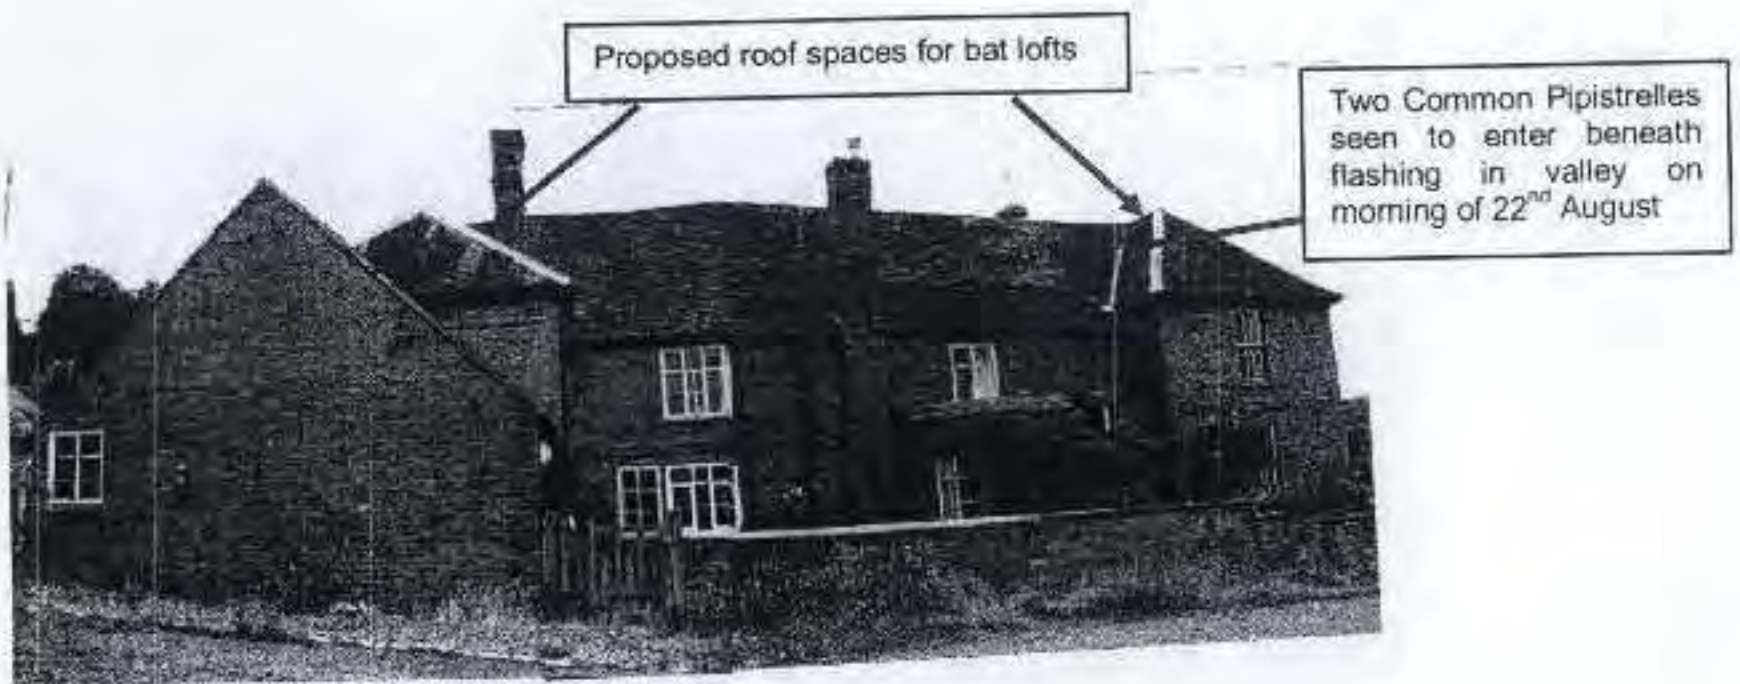
Proposed roof spaces for bat lofts

Two Common Pipistrelles seen to enter beneath flashing in valley on morning of 22<sup>nd</sup> August

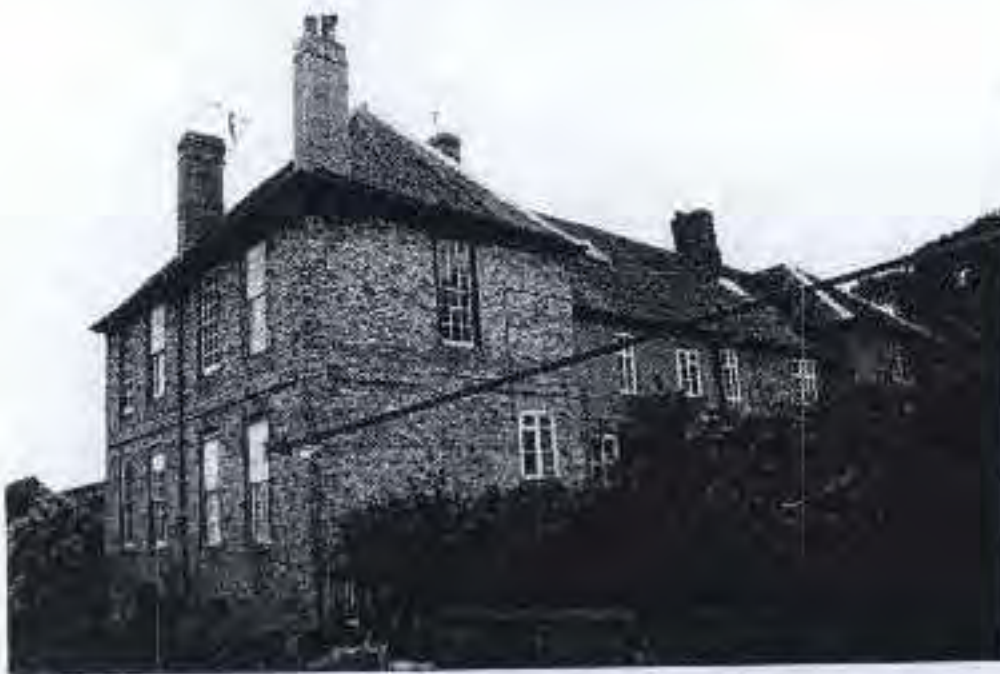
North face of Farmhouse.  
Broken window in study where Lesser Horse- believed to be accessing house.

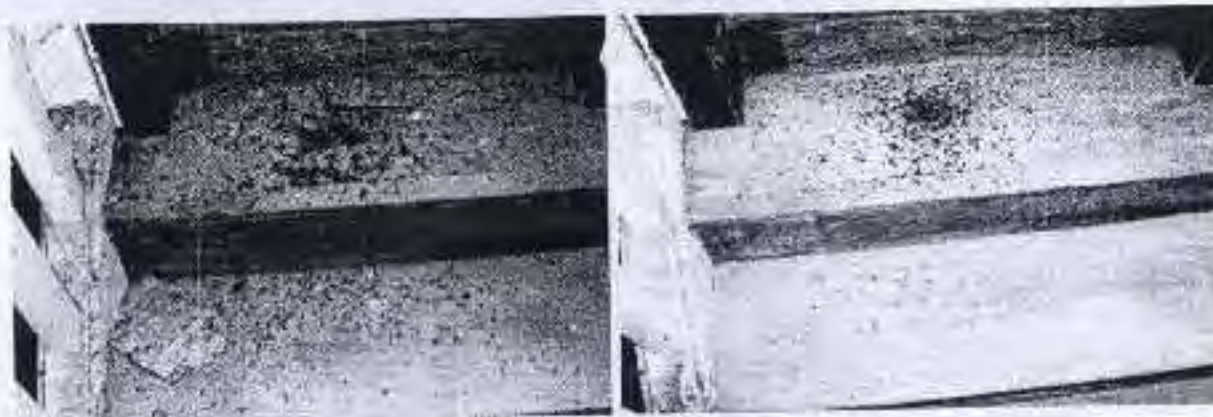
Top of main stairway into attic, Lesser Horse-shoe night roost.

Sequence of photographs showing original quantity droppings. Cleared away 10<sup>th</sup> July

Approximately 150 on 21<sup>st</sup> August (43 days later)

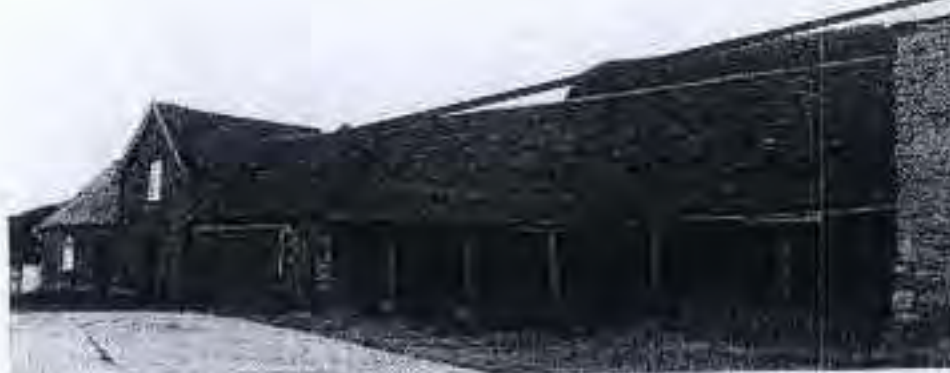
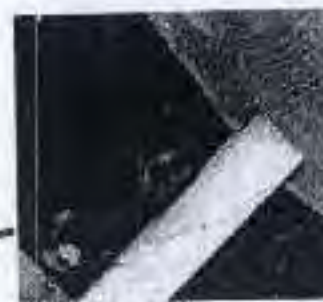
Bldg 4

Brown Long-eared in workshop.  
Present most days.

21<sup>st</sup> August a bat, most likely  
Pipistrelle was observed exiting a  
crevice to the right of the door.

Proposed Bat Loft in the south  
section of bldg 4

- Building 3: Access beneath tiles and ridge incorporated into new roof. Gaps in replacement timber cladding to voids behind boards.
- Building 4: Bat loft to be constructed at south end of building by inclusion of ceiling. Crevices and holes within South gable wall to be retained where structural repairs allow.

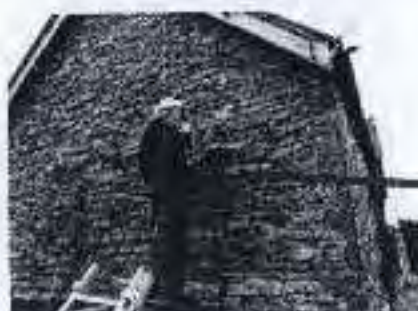
Bldg 4

Two holes in this wall had  
Pipistrelle dropping just inside  
entrance. Several other holes  
would provide suitable roosting  
places

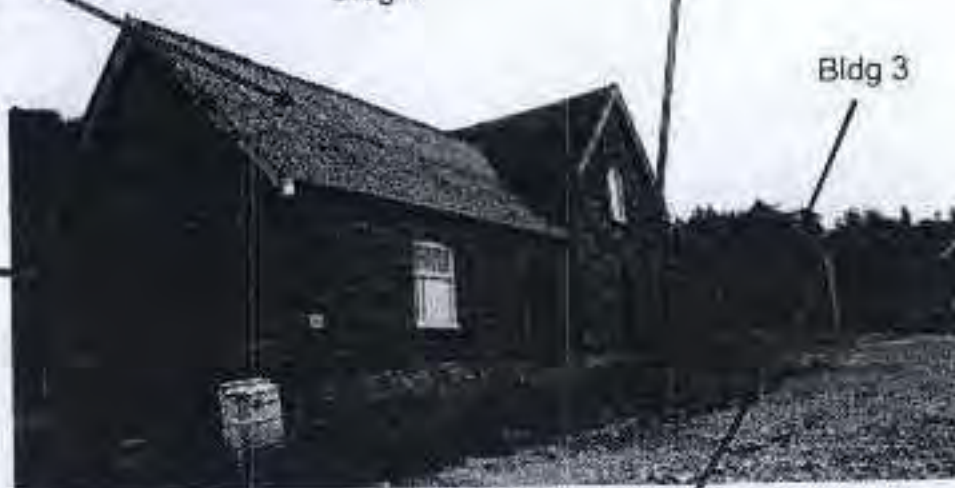
Similar holes were found in Bldg 3 and Bldg 6

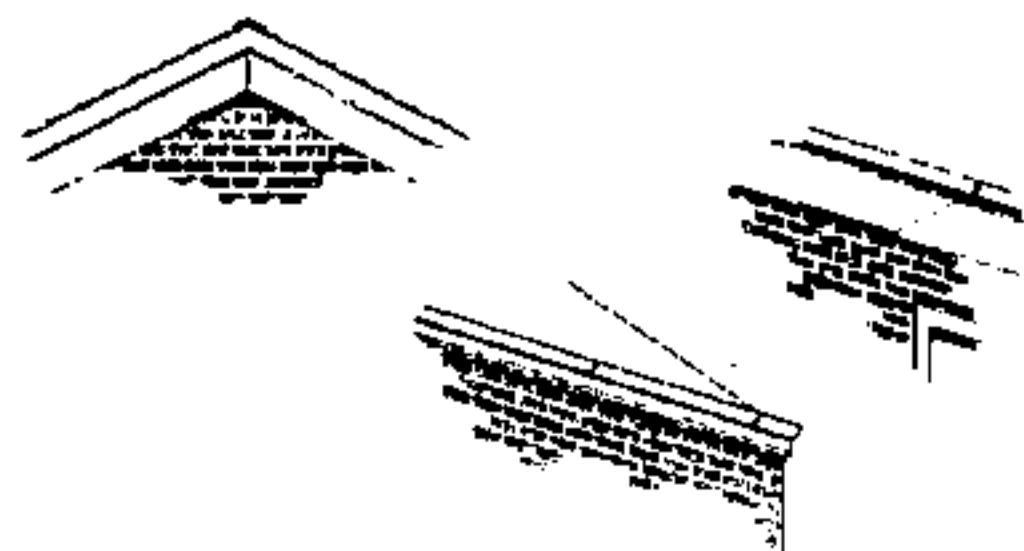
Access slits in soffits.
