PROJECT WILTON COURT HOTEL

TITLE PROPOSED FLOOR BOARD REPAIRS FF LANDING

SCALE 1:20 @ A1
DATE OCT 2020
DRAWN TL DRAWING NUMBER 20-104-RP4

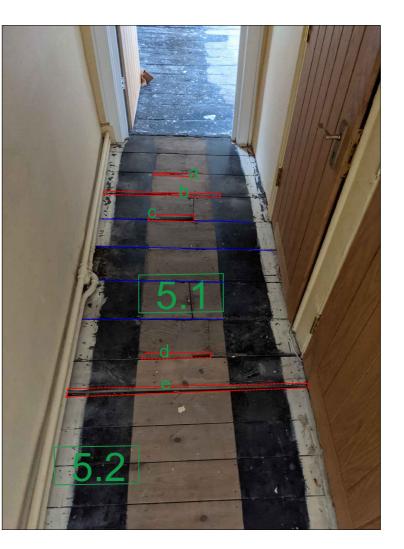
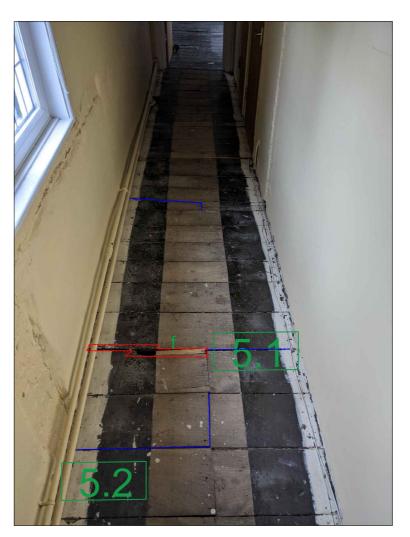
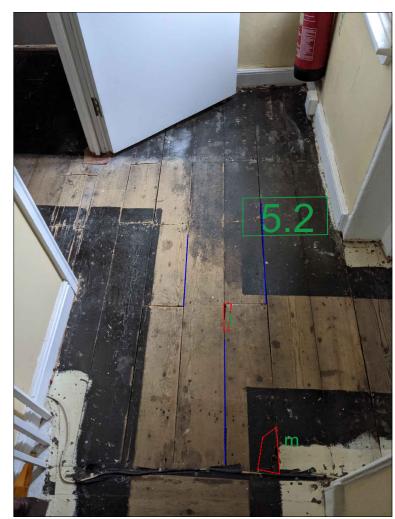
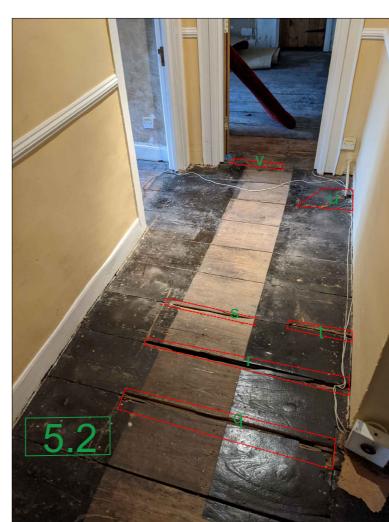
Soft and damaged floor boards to be carefully cut back and repaired with timber to match existing.

Areas of existing finishes to be gently removed using poultice method. This may have to be repeated to allow removal of as much of the finish as possible.

Generally, small gaps between floor boards to be filled with Draughtex floor board gap fill.

Areas of gaps larger than 5mm to be filled using the insertion of timber slips of a matching timber.

Generally where floorboards are loose they are to be refixed using existing fixing points.
