*Potential Ground Contamination –
Desk Study, Losito Stud, Near
Marston, Herefordshire*

April 2011

A desk study has been undertaken to determine the potential ground contamination at the Losito Stud site near Marstow, Herefordshire. The site is currently laid for grazing land. However the site was a former quarry with landfill operations.

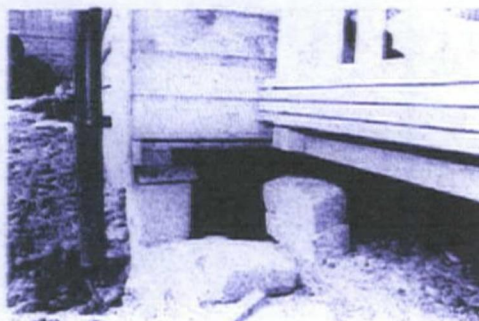
3.1.6 The timber-framed dwelling has been constructed on a raised platform resulting in a void-space approximately 60cm in height. This void-space is open-sided and enables air flow under the property. Essential services (oil, water, electricity) are provided by underground and above ground connections into the property.

Photograph 3 Timber-framed dwelling has been constructed on a raised platform providing ventilation.

3.1.7 These human receptors are now significantly closer and it would be prudent to revisit this issue with a further additional monitoring of landfill gas in and around the location of the building.

3.2.1 It is recommended that further monitoring of land fill gas is considered around the site of the building referred to in paragraph 3.1.5 above. The monitoring undertaken as part of previous work stated the risk to human and building receptors was small. This conclusion is still valid but additional data especially from borehole GM6 located approximately at grid reference 355620,218580 would help to show that pathways for landfill gas at that location do not exist.
