**UPPER BLAEN FARM  
LLANVEYNOE  
LONGTOWN  
HEREFORDSHIRE  
HR2 0NL**

**BAT SURVEY  
&  
METHOD STATEMENT**

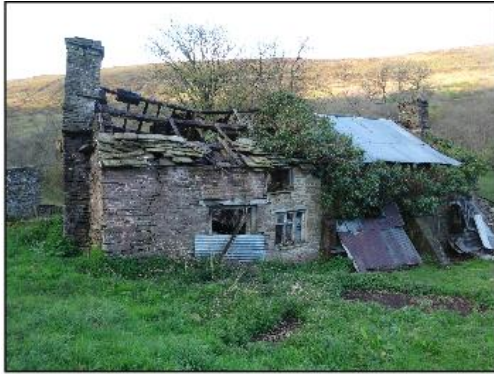
**Figure 1**

The farmhouse viewed from the south.

- 4.1. The farmhouse is in the late stages of dereliction (Figures 1 & 2). The western section of the property has almost completely lost its roof (Figure 5). There is no dark enclosed loft void and the upper floor in the eastern section of the property is fully illuminated by windows and missing sections of the roof (Figure 4). A lesser horseshoe bat roosts in the old bread oven in the ground floor room of the property (Figure 3). This bat was present on the 1<sup>st</sup> May and 4<sup>th</sup> June but was absent on the 19<sup>th</sup> June. No large accumulations of bat droppings were found in the bread oven indicating that this is an occasional roosting site that is probably only used by a single bat. No other evidence of bats was found anywhere within the farmhouse.

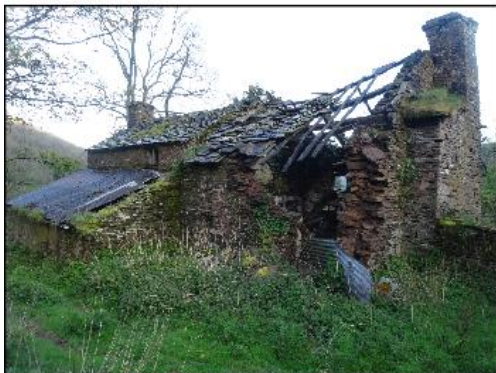
**Figure 2**

The farmhouse viewed from the north.

The adjoining lean-to supports a corrugated iron roof and showed no evidence of usage by bats.

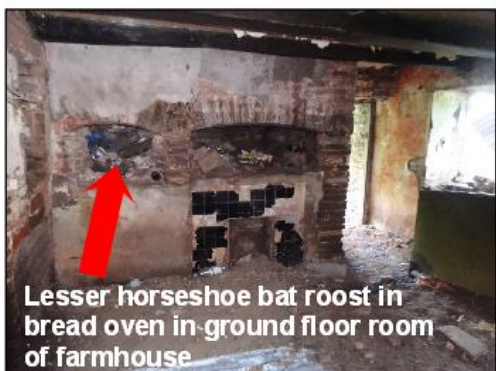
**Figure 3**

The ground floor room of the farmhouse is the occasional roosting site of a single lesser horseshoe bat.

The bat roosts in the old bread oven and was present on the 1<sup>st</sup> May and 4<sup>th</sup> June but was absent on the 19<sup>th</sup> June.

No other bats were recorded roosting in the farmhouse during the survey period.

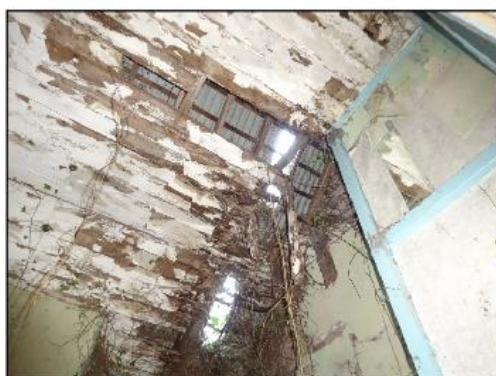
**Figure 4**

The upper floor of the farmhouse is in the late stages of dereliction. It is well illuminated by windows and missing sections of the roof.

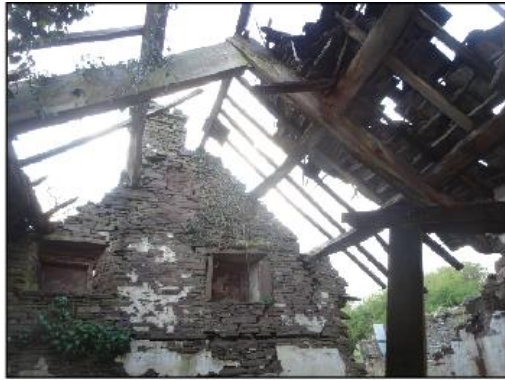
**Figure 5**

The western section of the farmhouse has almost completely lost its roof.

No evidence of bats was found in this area during the survey period.

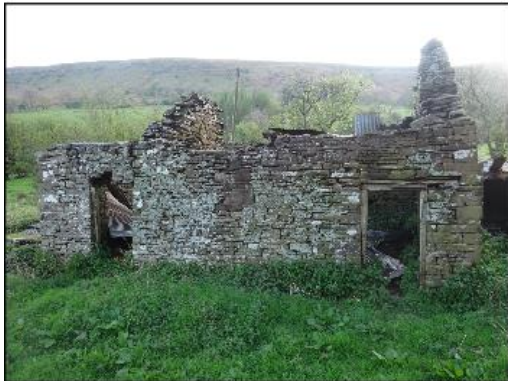
**Figure 6**

The byre viewed from the east.

- 4.2. The byre/cattle shed is completely derelict and, with the exception of a localised area of corrugated iron, no longer supports a roof (Figures 6 & 7). No evidence of bats was found in this area.

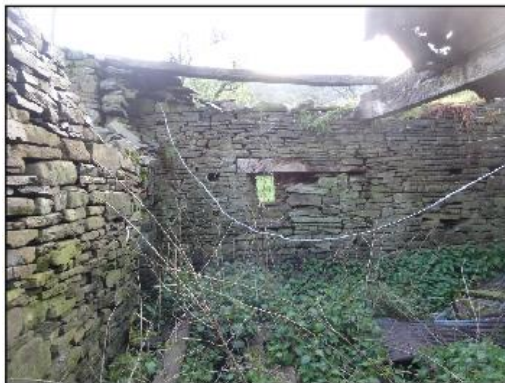
**Figure 7**

The byre viewed from the inside.

With the exception of a very localised area of corrugated iron, the byre does not support a roof.

No evidence of bats was found in this area during the survey period.

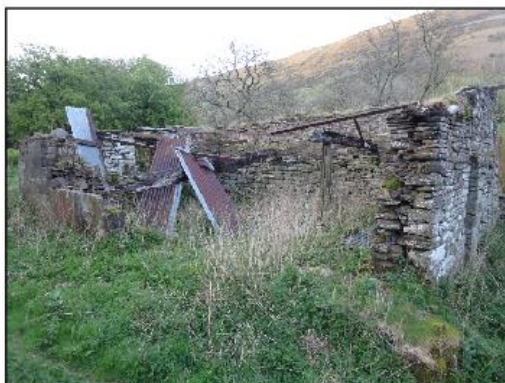
**Figure 8**

The barn viewed from the west.

The barn does not support a roof and is completely derelict.

No evidence of bats was found in this area during the survey period.

- 4.3. The barn is completely derelict and no longer supports a roof (Figure 8). No evidence of bats was found in this area.

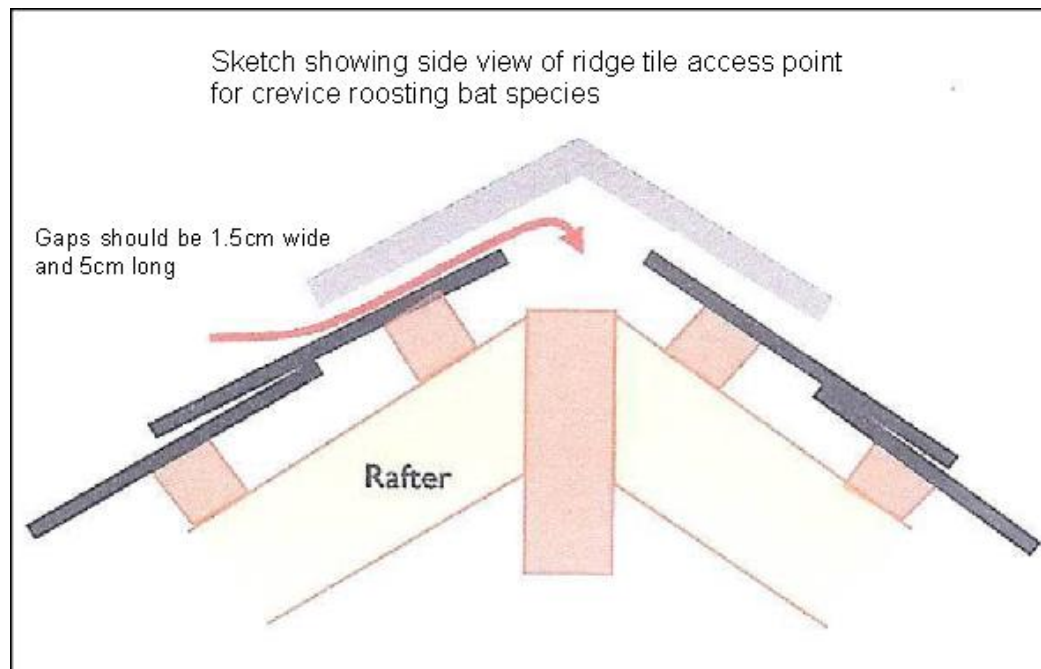
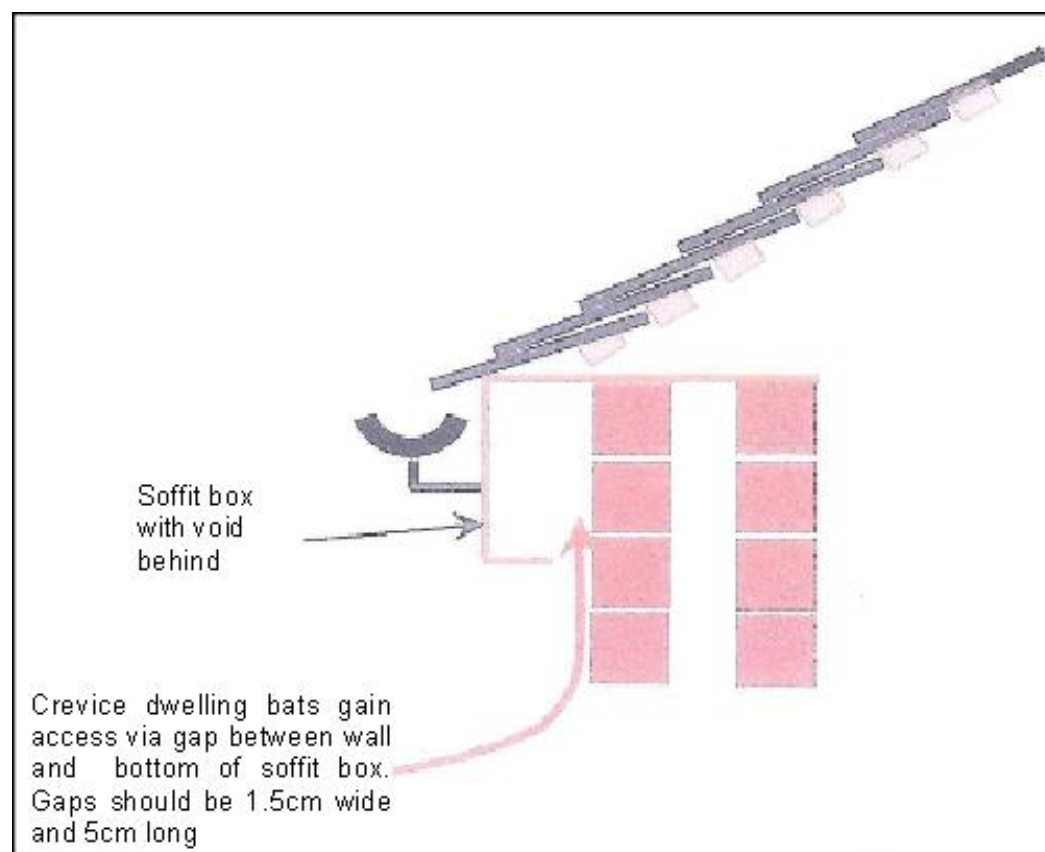
### Bat access point designs

- 5.4. Bat access points into gaps located under ridge tiles; between the roof and gable end walls; and behind soffit and barge boarding will be created in all three renovated buildings. Access point designs are set out in Appendix 1.
