## Soil Infiltration Rate

### PROPOSED DEVELOPMENT AT 16 PRIORY PLACE, HEREFORD, HR4 9ND

Project Ref: 19-1029-17

Date: December 2019

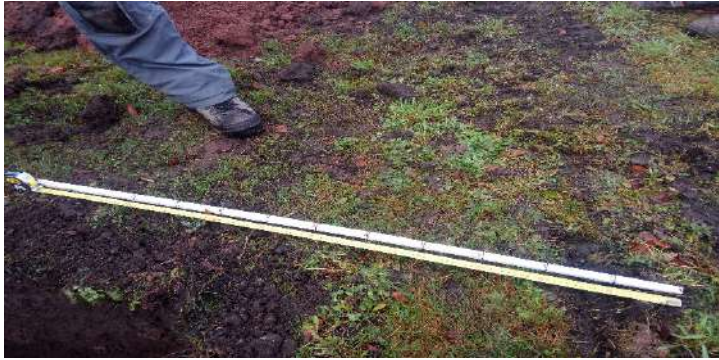
**Test Site 1**

A hydraulic digger was utilised to excavate the test pits, all pits were dug on the 4 Dec 2019. Each pit was dug and measured with a tape measure prior to the addition of water. A dip stick was created and marked every 100mm, markers were then placed inside the pits at 1.0m, 0.75m, 0.50m and 0.25m to assist in identifying key levels.

It was noted that significantly more water than the pit dimensions would hold, was needed in order to reach the 1m mark, this was due to the immediate drainage of water. The local soil varies from 0.6 – 0.7m of top soil, with the next layer descending down to a depth greater than our hydraulic digger could reach. This soil was very gritty and resembled 10mm pea gravel at times.

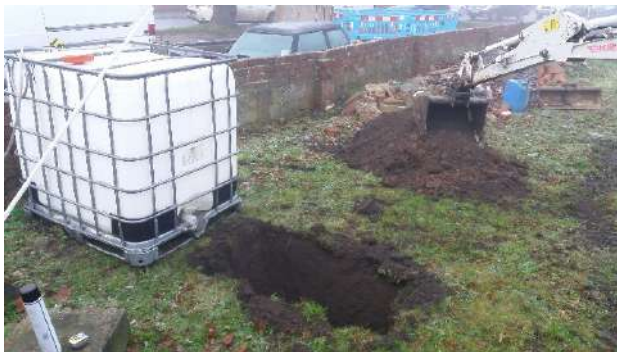
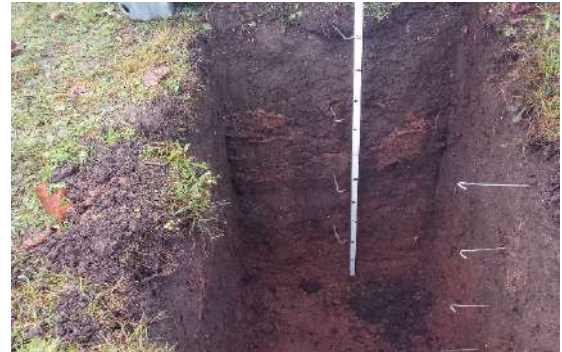
Location	Length (m)	Width (m)	Depth(m)	Date Dug and Tested
Test Site 1	1.2	0.65	1.0	4 Dec 19
Test Site 2	1.2	0.7	1.0	4 Dec 19
Test Site 3	1.3	0.65	1.0	4 Dec 19

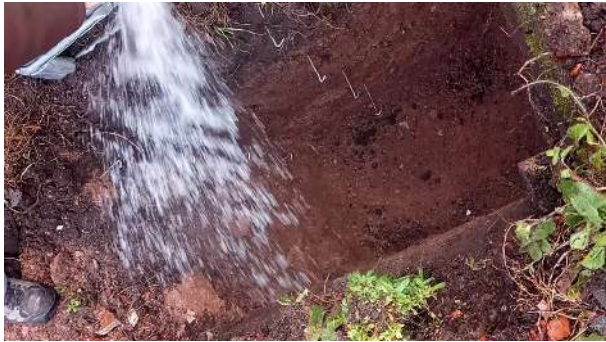
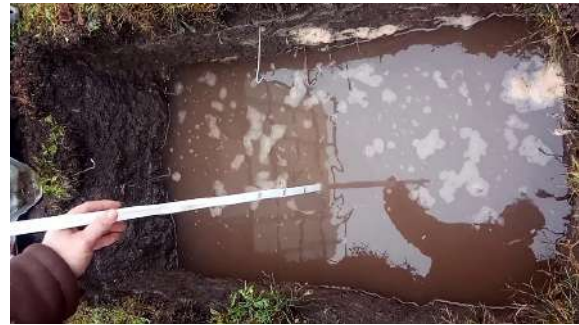
Each was filled with water until the water level was stable at the 1m mark. The clock was then started and the time recorded when the water level reduced to 0.75m, 0.50m and finally 0.25m.

Once the water level had dropped comfortably below 0.25m the pit was filled again to the 1m mark and the process repeated.

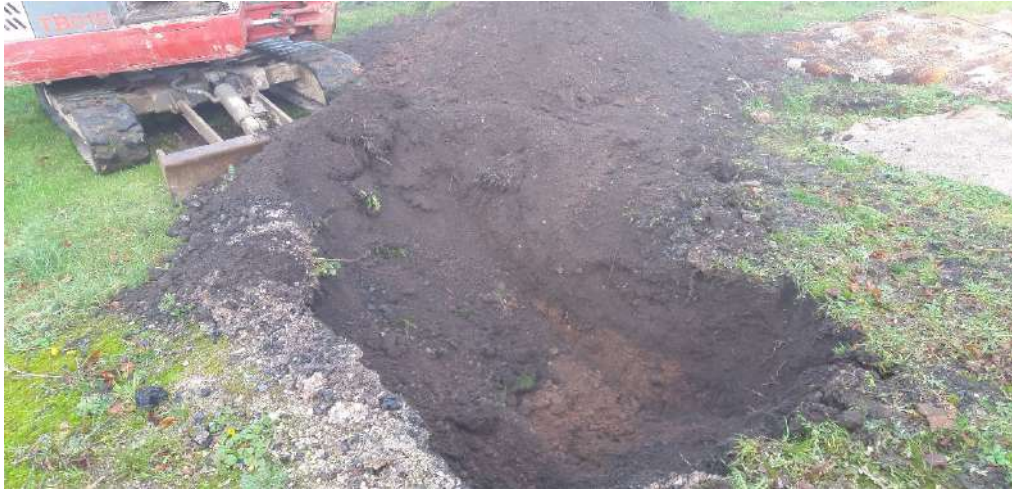
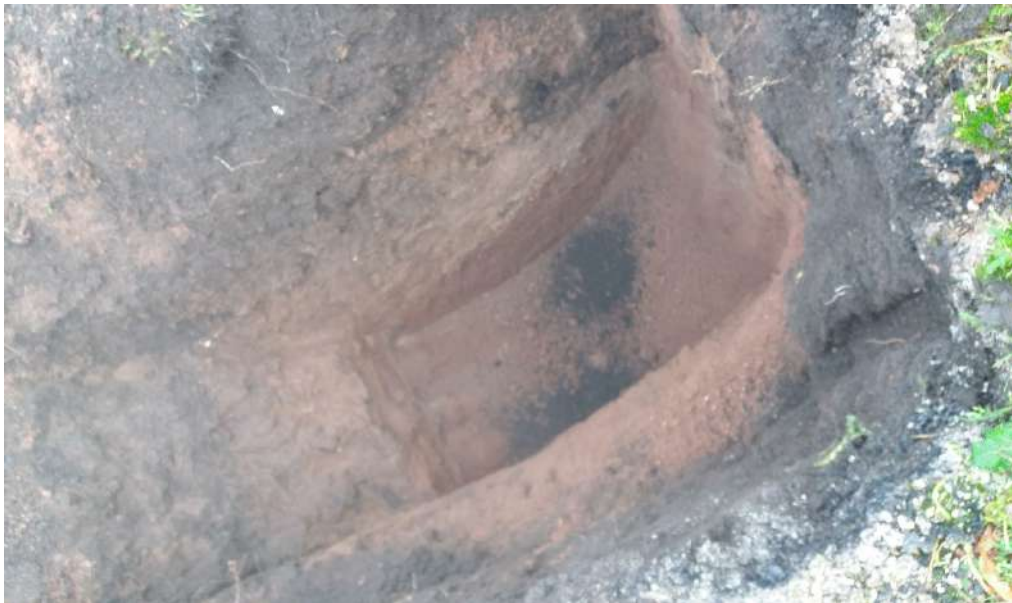
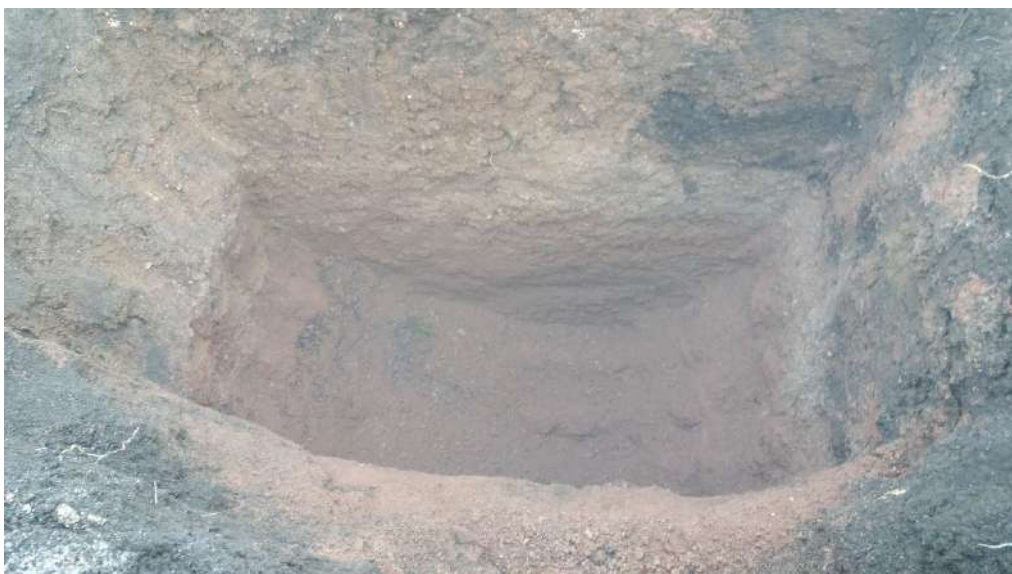
A separate dig was conducted in order to try and find the water table and also to identify soil types. The following pictures show a final dig depth of **2.35m** (no water found) and the gritty/ gravel soil.

3 test sites were dug, each site was filled 3 times and allowed to drain until the water level was below 0.25m from the starting level of 1m. A separate dig was conducted (equidistant from each of the 3 test sites) to ascertain depth of the water table – not found and digger maxed out at 2.35m.

The soil levels were consistent between all sites, 0.6 – 0.7m of top soil before giving way to gritty gravel-based soil type (up to 10mm stone) that continued to a depth of 2.35m as a minimum (unable to dig deeper).
