# 1.0 Introduction.

- 1.1 Justin Ayton was commissioned to prepare a Statement of Significance & Impact Assessment in order to understand the evolution, special interest, heritage values, & significance of Bollitree Castle, including the house & two of the barns, & to assess the impact of the works that have been undertaken on that significance.
- 1.2 From 2004 until early 2013 Justin Ayton was English Heritage's Historic Buildings Inspector for Bristol & Gloucestershire, before which he was a Conservation & Design Officer for the Royal Borough of Kensington & Chelsea; Justin received a degree in History of Art & Heritage Management from the University of Buckingham in 1997, & an M.A. in Architectural History from the Courtauld Institute of Art in 1998.

# 6.0 STATEMENT OF SIGNIFICANCE.

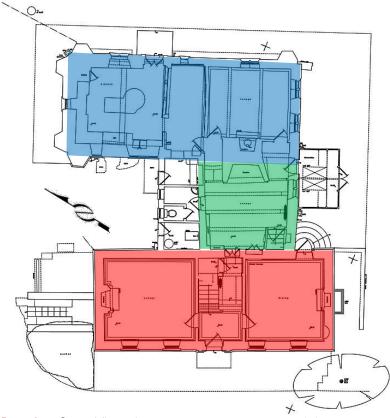
Figure 2 Ground-floor plan; western range; eastern range; link.

6.1 Bollitree Castle is composed of several distinct elements: the formal, rectangular western range; a more informal eastern range, & a linking structure between the two.

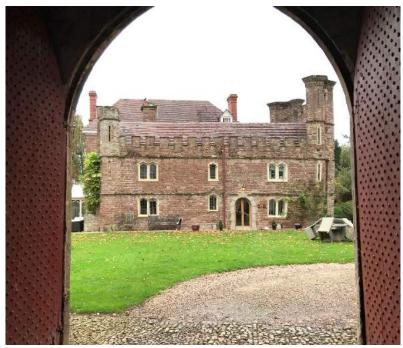
Figure 6 East elevation.

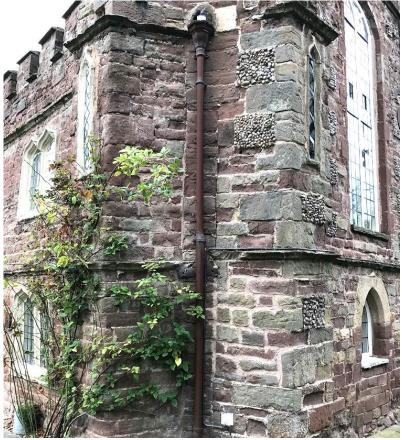
6.7 The refronting appears to have been done in a piecemeal fashion, with a distinct joint between the east & north

elevations, as well as suggestions of possibly differing treatments.

Figure 7 Junction of east  $\delta$  north elevations.

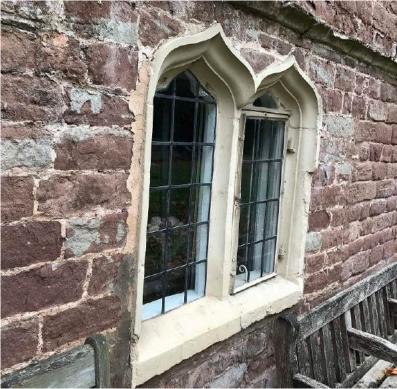
The east elevation, appears to have been rendered; all the stone mullions have a raised profile, & suggestions of render around some of them survive. This would not be uncharacteristic for

18th-century gothick; Strawberry Hill itself, the most famous gothick house (hence the phrase *"Strawberry Hill gothick"*) was fully rendered.

Figure 8 Eart elevation, detail of ground-floor window.

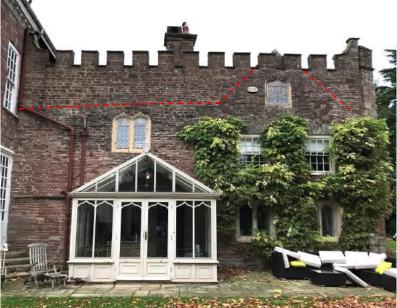
- 6.9 The south elevation of the east range, which is continuous with that of the link, appears similarly detailed, although two of the first-floor windows remain as sashes (although the joinery of these is itself modern replacement). The junction between these two elevations was substantially obscured by vegetation, & it remains unclear as to whether the coursing is continuous.
- 6.10 The patina of the stonework may suggest that the parapet levels have been altered, although this could potentially be due to differential weathering or repair of masonry that is exposed on both faces to the elements.

Figure 10 fouth elevation, changer in patina of maronry indicated by dotted red line.

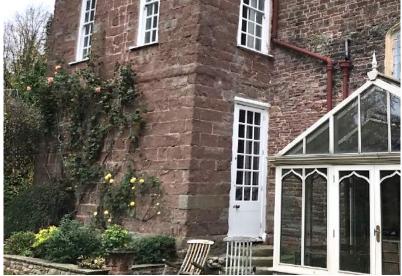
Figure 12 Fouth elevation; detail of junction between deflected wall  $\delta$  feneratation of western range.

- Where the south elevation of the link meets the rear of the western range, the wall deflects to the north. Due to this deflection, the wall just avoids the fenestration of the latter, suggesting that the alignment of this elevation, of the link at least, appears to post-date the construction of the western wing (there is a straight joint whose origin is unclear, but this joint lies not at the point of deflection, but within it).
- 6.12 The north elevation, by contrast is quite distinct & less frivolous in character, which, with the miss-aligned coursing & straight joints of the junction with the south, would suggest a slightly different phase.

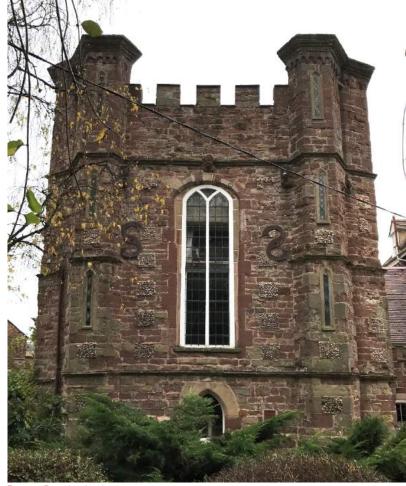
Figure 13 North elevation.

6.13 This elevation rears up to above the ridge-height, with a long window (crossing two storeys), & a small door (now a window) beneath it. There is more than a suggestion of the brooding

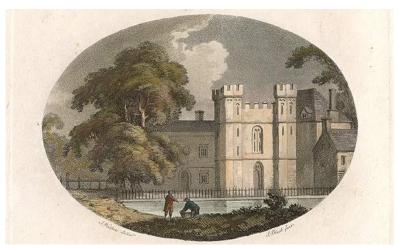
Figure 16 Bollitree from the north-east; aquatint, c.1800.

The fenestration on the north elevation is more severe & less frivolous that on the east; the principal fenestration is devoid of decorative mouldings; the door is a simple equilateral arch with a plain chamfered moulding, the window above an equally severe, is curiously un-gothic three-centred arch, similarly plain. From the lack of raised edges & from the decorative panels of pebbles, the north elevation appears never to have been rendered, which would again suit its more brooding, &

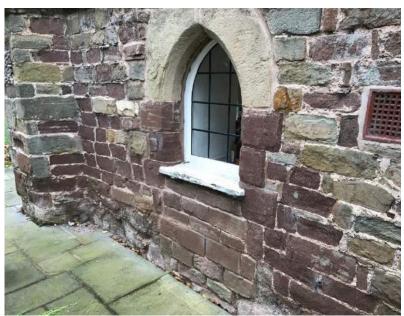
Figure 17 Former door in the north elevation.

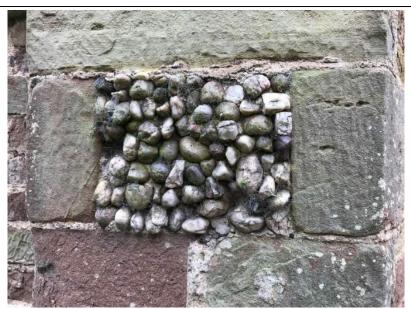
Figure 18 North elevation; detail of a pebble panel.

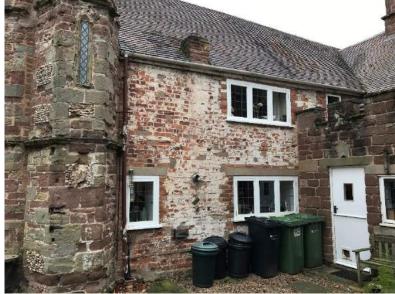
6.15 Beyond the towered pseudo-abbey façade the elevation returns into a modest service yard, with the western elevation of the east range exposed as a plain brick front which appears to have been unfenestrated; although there are a number of modern openings. This utilitarian elevation was clearly never intended to be visible, & indeed early photographs & maps indicate that it would have been substantially obscured by a crenelated single-storey projection.

Figure 19 East range; western elevation.

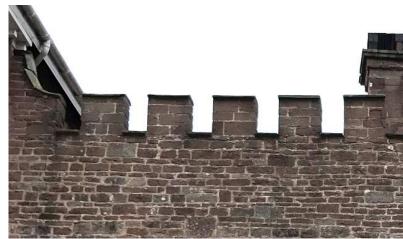
6.16 The date of this projection is unclear, however the proportions & coping of the crenulations & the lack of a drip beneath them do appear very similar to the treatment of the parapet on the southern elevation, thus an 18th-century original for this projection cannot be ruled out. This would seem to be circumstantially supported by the otherwise disproportionate ratio of higher-status rooms to service rooms within the house, even by 18th-century standards.

Figure 23 Detail of crenulation on youth elevation.

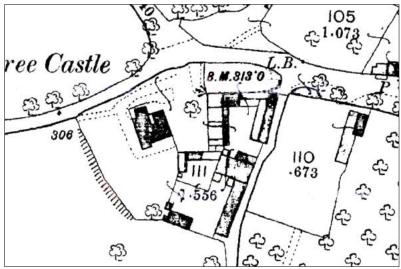
6.17 Photographs & map regression confirm that this projection overlapped the northern elevation of the western range, & it

would therefore have enclosed the now external cellar stairs. The maps also suggest that a narrow, enclosed yard separated this projection from the west elevation of the eastern range. This projection survived into the latter-20<sup>th</sup> century before being removed.

Figure 24 Extract from 1888, 1:2,500 O.J. map.

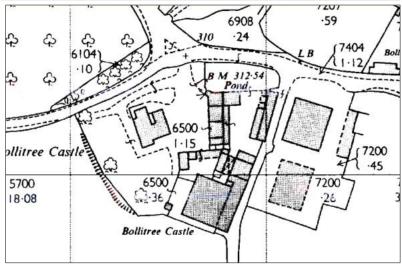
Figure 25 Extract from 1970, 1:2,500 O.J. map.

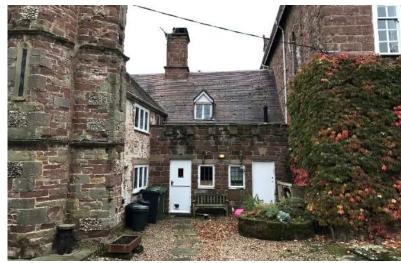
Figure 26 Link; north elevation.

- The removal of this projection opened up this side of the house, but the rear of link is now obscured by a modern extension, crenulated, & faced in stone presumably reused from the demolished range.
- 6.19 The rear elevation of the western range has two blocked windows which relate to the half-landings of the stair. There is no visible evidence of disruption around them, suggesting that they are part of the original design of the western range, & were intended to illuminate the two half-landings.

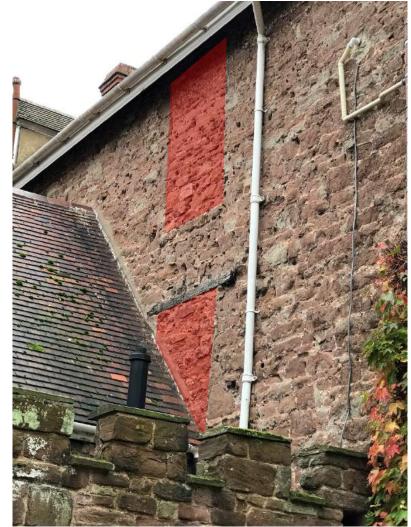
Figure 27 Western range, east elevation; blocked stair windows highlighted red.

6.20 The lower of these two blocked windows is cut across by the roof of the link, indicating that the roof, in its present form, post-dates the western range. However, the presence of an early-18<sup>th</sup> century door adjacent to this blocked window, providing access from the half-landing into the link, suggests that there was a first-floor link, albeit in a slightly different form.

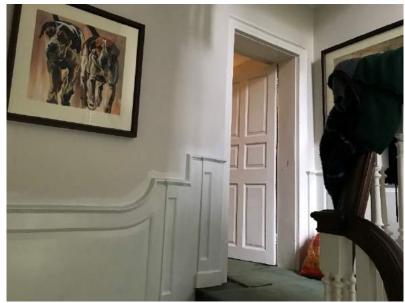
Figure 28 First half-landing of the stair, showing early- $18^{th}$  century,  $\delta$  apparently undisturbed door into link, adjacent to the blocked stair window (approximately where the picture hangs).

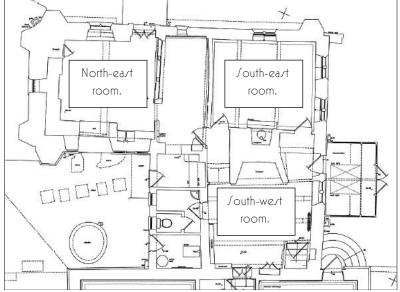
Figure 29 Ground-floor plan of east range & link.

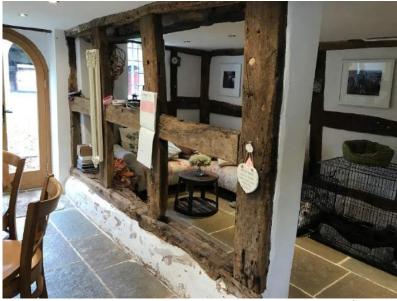
6.21 The north-east room comprises the current kitchen, & generally has few historic features; however at its southern end is an area of timber-framing (some of that referred to in the list description), which would appear to date to an earlier, possibly 17th-century vernacular building, which, much extended, formed the kernel of the modern house. As this timber framing extends into the room above the kitchen, it is likely that there is more around the kitchen itself, concealed behind the present finishes.

Figure 30 Timber framing at the routhern end of the north-eart room/kitchen.

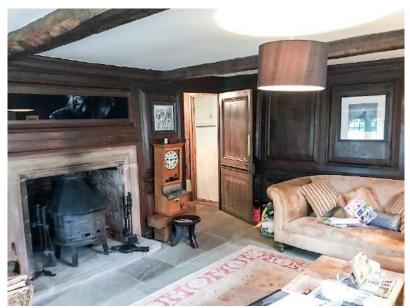
- 6.22 Within the east range, there is one room that is fully panelled with bolection-moulded, raised-&-fielded panels, with a two-panel door & a limestone, bolection-moulded fireplace.
- 6.23 Tradition suggests that this room may be reused from elsewhere; however there is little sign of the panelling having been adapted to fit the available space, which would suggest that it was more probably made for its current location. Bolection moulded panelling was fashionable from the Restoration into the very early years of the 18th-century as an

Figure 31 South-east room, facing north-west.

6.24 Consequently, this room could either be slightly earlier in date than the western range (which has entirely raised-&-fielded panelling); although it could also be contemporary, albeit slightly old-fashioned. The particular detail of a two-panelled door with a short length of dado rail between them does match the inside faces of the ground-floor doors in the west range.

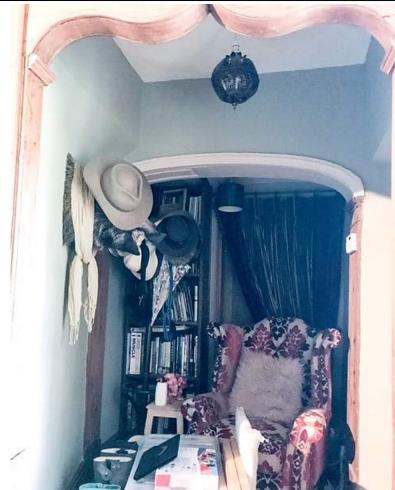
Figure 34 Southern lobby.

- 6.27 The southern lobby also contained a three-centred arch beyond the ogee arch. This had a raised-&-fielded panelled intrados, originally with three panels, although two have been lost/infilled; this arch rests on a pair of simple pilasters. The form & panelled intrados of this arch would suggest an earlier-18th century date, probably prior to the gothick phase, possibly even contemporary with the south-east room. It would also suggest that this entrance was of comparatively high status, & no mere service entrance.
- 6.28 The fireplace itself does not appear to survive in its 18<sup>th</sup>-century form. The jambs appear historic, although there is clear modern disruption symmetrically to the upper edge of each, & the bressumer does not appear to follow any characteristic historic form.

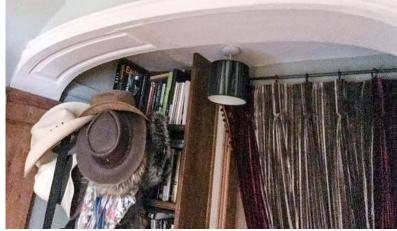
Figure 35 Detail of arch in routhern lobby.

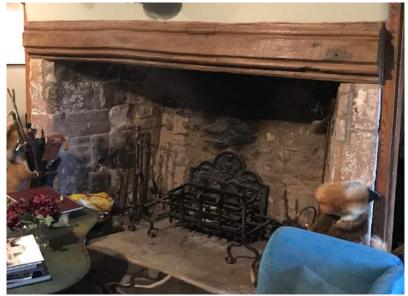
Figure 36 South-west room; detail of fireplace.

- 6.25 The south-west room lies within the linking range, & is the only interior in the house with any gothick detailing. This takes the form of three timber, ogee-headed arches; one on either side of the fireplace, & one over the door to the cellar steps.
- 6.26 To either side of the fireplace is a lobby, with a door at the far end of each leading to the south-east room. The northern lobby also leads to the north-east room/kitchen; the southern lobby leads to a formerly external door, which now leads into a modern conservatory.

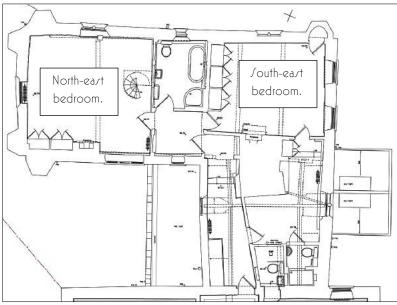
Figure 37 First-floor plan of east range  $\delta$  link.

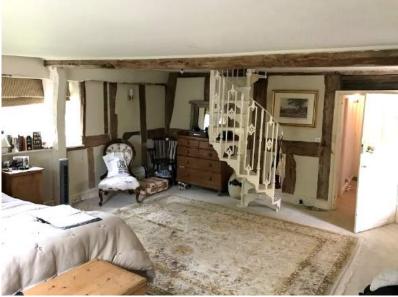
6.29 Within the north-east bedroom, & the adjacent bathroom, extensive areas of timber-framing are exposed; within the bedroom a post runs directly across a window, reinforcing the sense of the gothick elevations being a veneer that was applied to an earlier, vernacular building, & that the veneer was designed entirely for aesthetic purposes, to the extent of conflicting with the earlier structure.

Figure 38 North-eart bedroom, facing routh-eart.
