Images of England

IoE Number: 150391
Location: THE MALTHOUSE,
ALMELEY, HEREFORDSHIRE, HEREFORDSHIRE
Photographer: Mr John Burrows DPAGB
Date Photographed: 19 July 2007
Date listed: 16 July 1987
Date of last amendment: 16 July 1987
Grade: II

The Malthouse

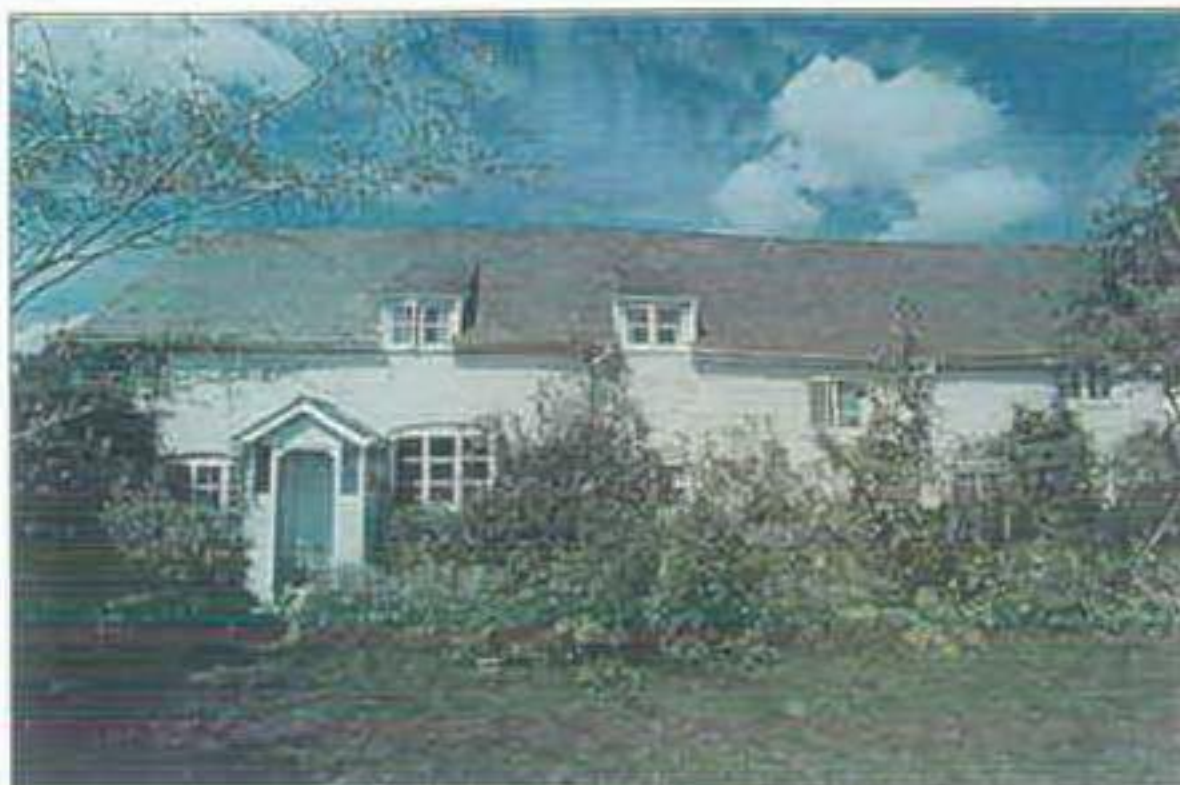
ALMELEY CP ALMELEY WOOTTON SO 35 SW 1/22 The Malthouse GV II House. Probably C18 with C19 and later alterations. Sandstone rubble and brick with timber-frame. Tiled roof with sandstone rubble and brick stacks. Rectangular plan of seven or eight structural bays aligned roughly east/west. Two storeys and attic. South elevation has two raking-top dormers, each with a 2-light late C19 casement, to left-hand side over C19 brick extension. Ground floor of brick extension has two early C19 wooden casements each of three lights, between which is a glazed early C19 porch. Rubble part, probably C18 is to centre and right. This has two first floor 2-light mid-C19 casements and a blocked opening to the right. Ground floor has three similar irregularly placed casements to ground floor. Entry to extreme right side, which is curved slightly back from the rest of frontage, with mid-C20 ledged door. West gable has rough-cast finish. North elevation has two sandstone rubble and brick stacks and cat-slide lean-to. Interior has a variety of trusses in C18 part. Two have curved raking struts, and others interrupted tie-beams. C19 part has collar trusses. Some timber-framed walling. Ground floor rooms have ceiling beams with straight-cut chamfer stops. Included for group value.
