BASELINE ECOLOGICAL SITE AUDIT¹ AND PRELIMINARY BAT ROOST ASSESSMENT

PURLAND CHASE, COUGHTON, ROSS-ON-WYE,
HEREFORDSHIRE

January 2017
S6432, J000722

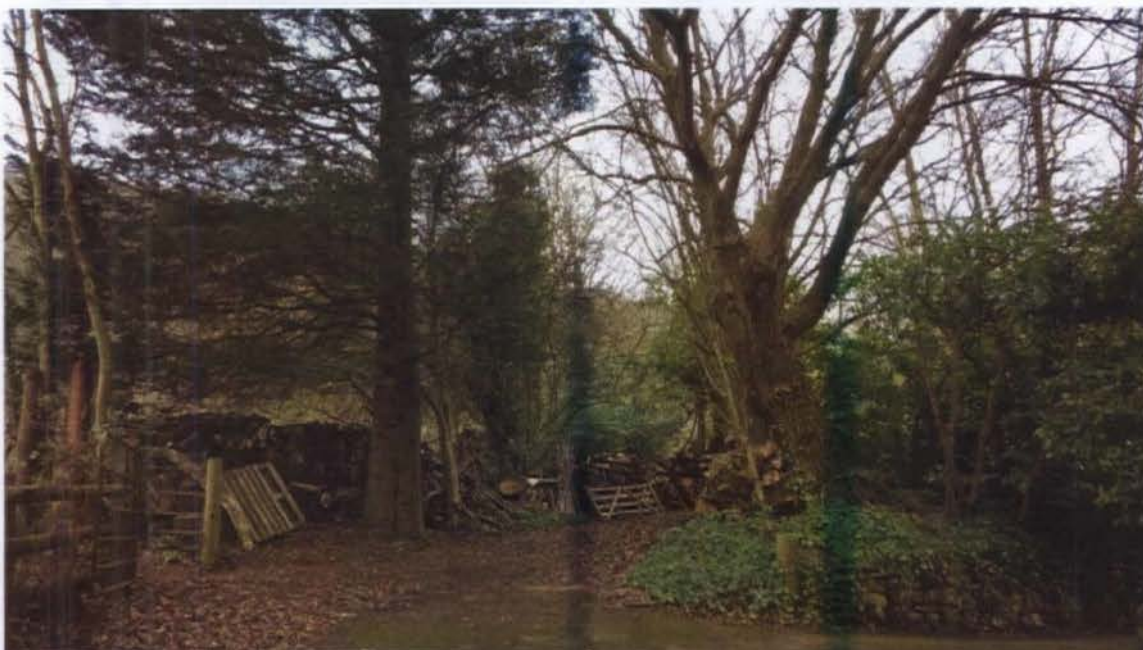
Plate 1: The northern site boundary showing the entrance off the main driveway. These mature and semi-mature trees will be retained.

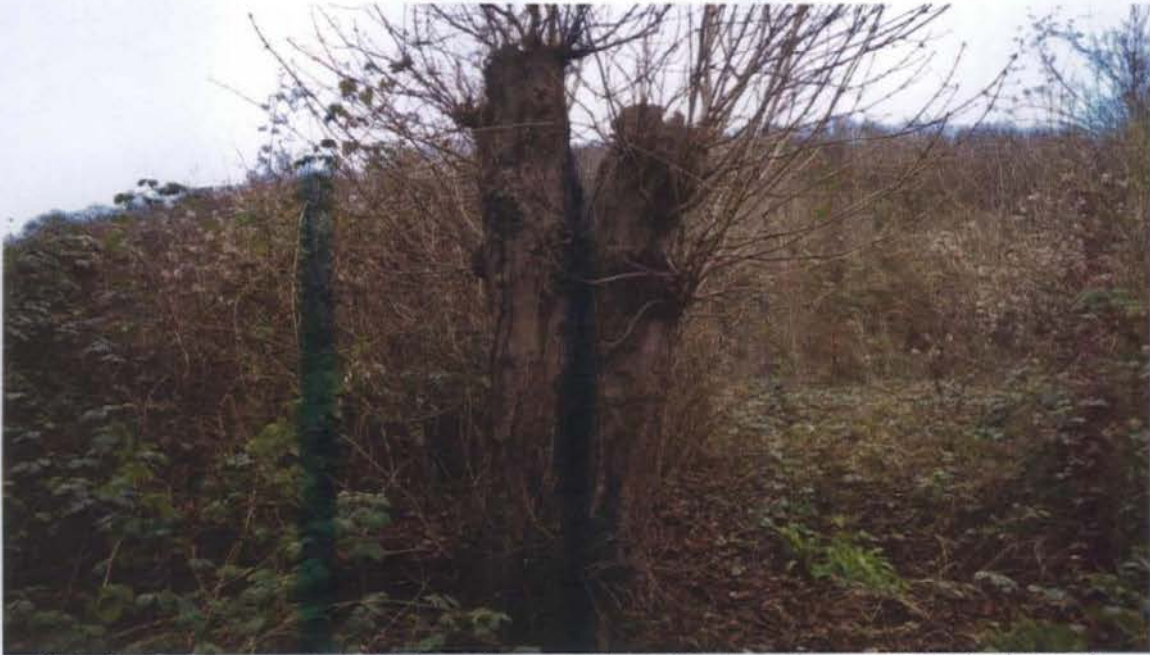
Plate 2: The horse chestnut off-site to the east (Chase Woods can be seen in the background).

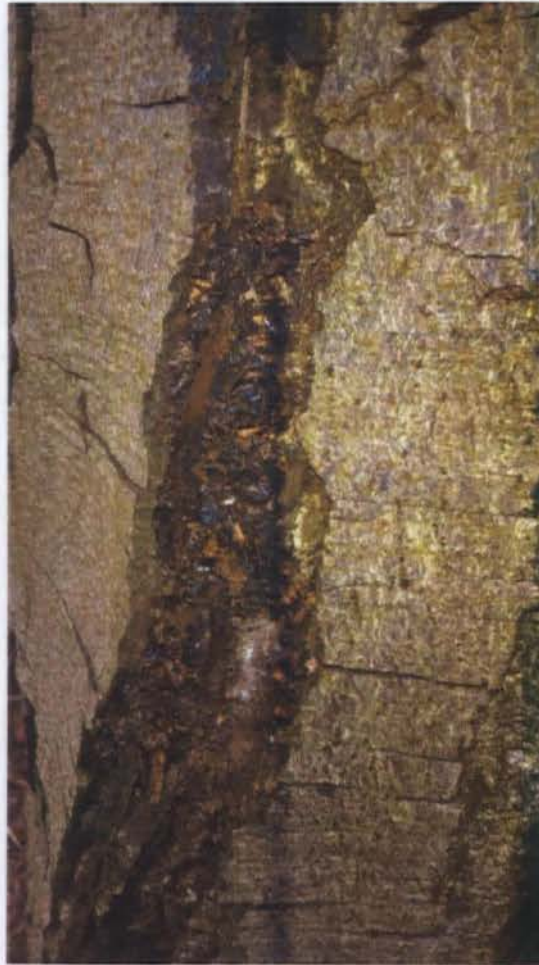
Plate 4: One of the horse chestnuts showing the damage caused by bleeding canker.

ITEM	OBSERVATIONS
TN 5	The two mature horse chestnuts, one in the east of the site and the second off-site in an area of bramble scrub. Both trees are infected by bleeding canker (<i>Pseudomonas syringae</i> pv. <i>aesculi</i>) and have been recommended for removal (please see the Arboricultural Report, J Ross, 2016) (Plate 4). The trees are discussed further in the bat section below.
Statutory designations (on/near)	<p>A public records search was not commissioned for this project. However, a search on Magic.gov.uk revealed three Special Sites of Scientific Interest (SSSIs) nearby:</p> <ul style="list-style-type: none"> • Coughton Wood and Marsh SSSI 1.2 km to the south-west is designated for areas of ash and yew woodland, with wet alder carr woodland. • Wilton Bluff SSSI 2km north of the site is a small site containing Brownstone outcrops. • The River Wye SSSI is 2km north-west of the site. <p>The proposed development is sufficiently distant that it will not affect these SSSIs.</p> <p>The site also falls within the Wye Valley Area of Outstanding Natural Beauty (AONB).</p>

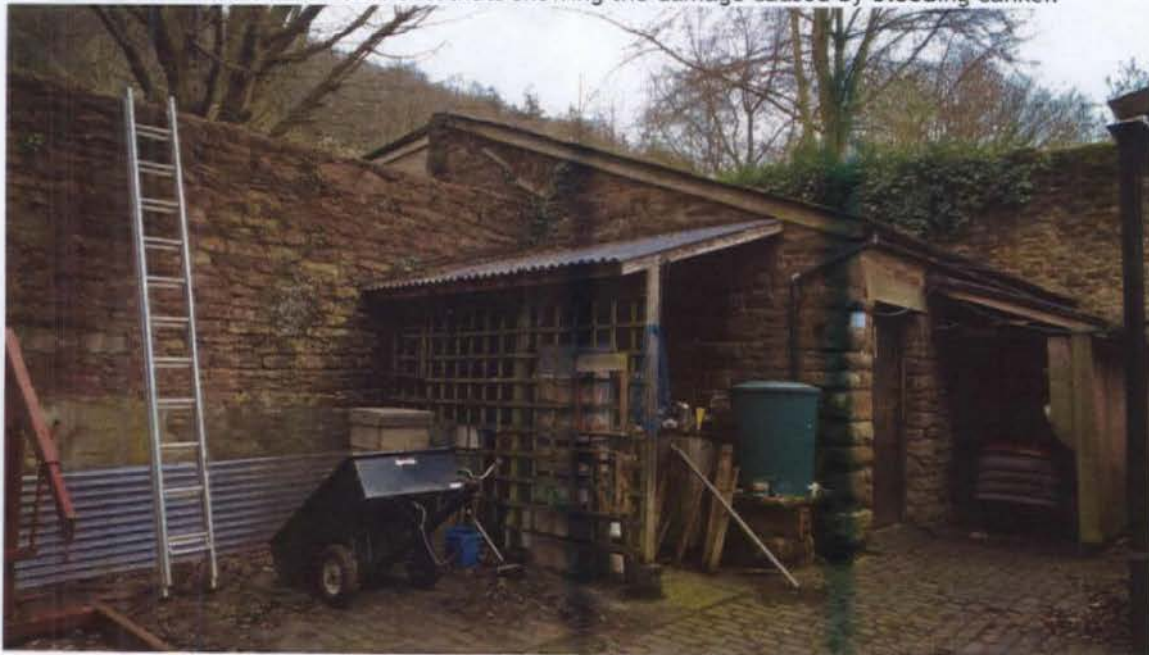
Plate 5: The workshop on the right-hand side showing the two lean-tos.

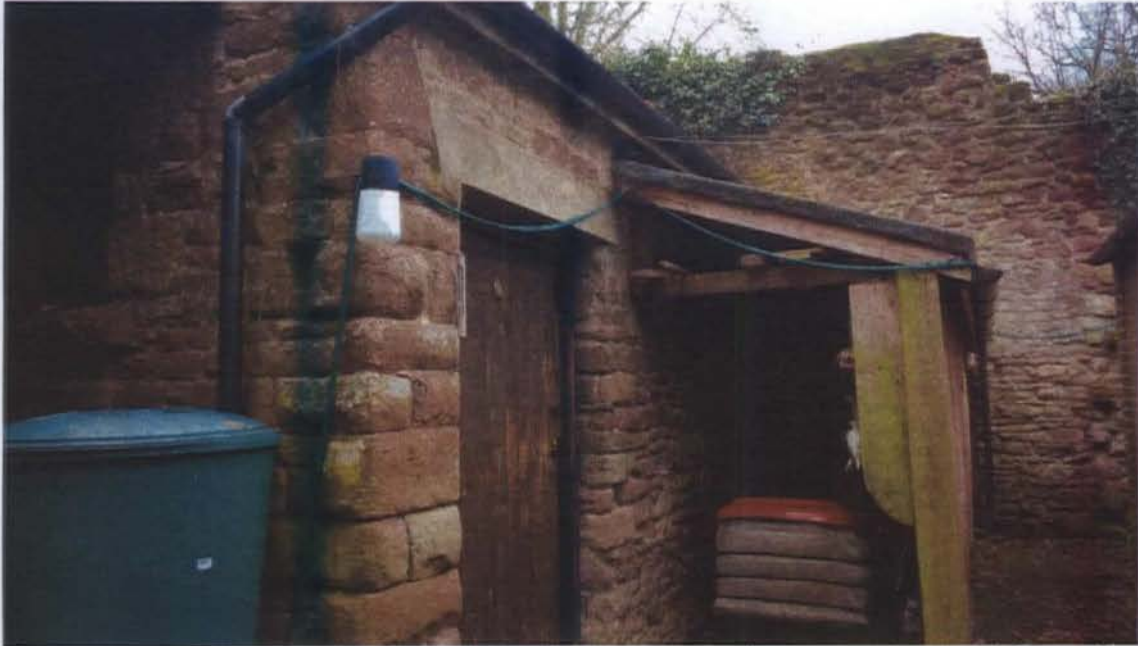
Plate 6: A close view of the workshop and one of the lean-tos. The area was inspected thoroughly for evidence of use by bats and none was found.

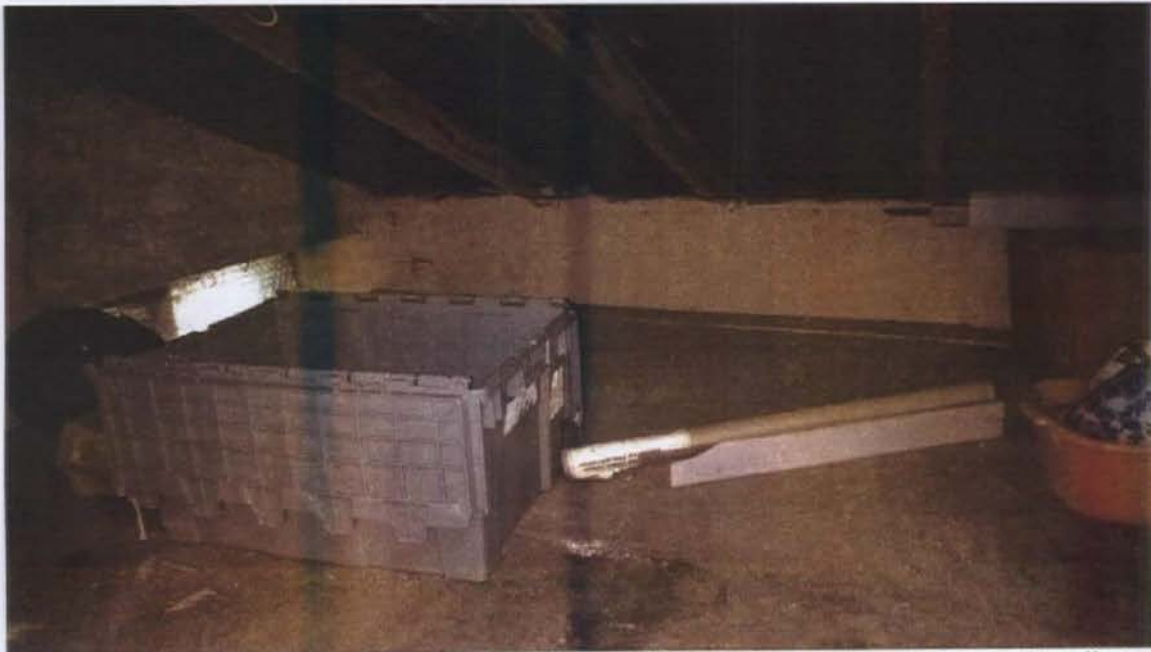
Plate 7: The interior of the storage area on the first floor of the workshop; the area is well illuminated by the window on the left. No evidence of bats was observed.

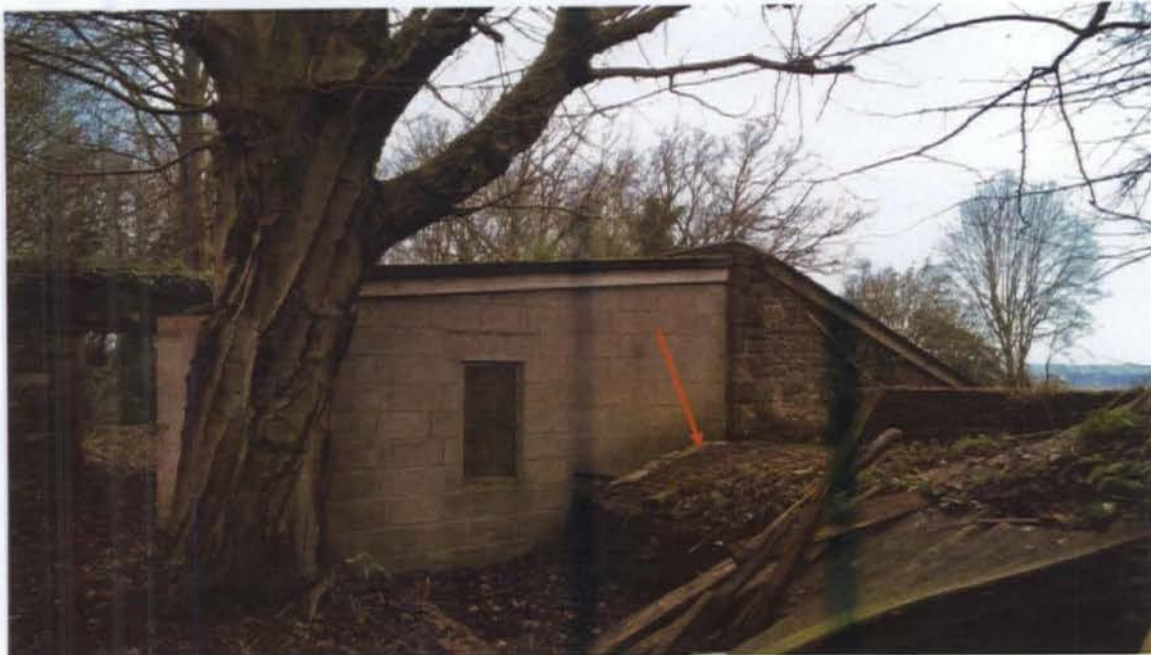
Plate 8: The storage building (breeze block structure) The edge of the workshop can also be seen on the right. The water tank is shown on the right (red arrow) and the mature horse chestnut is clearly visible at the corner of the building.

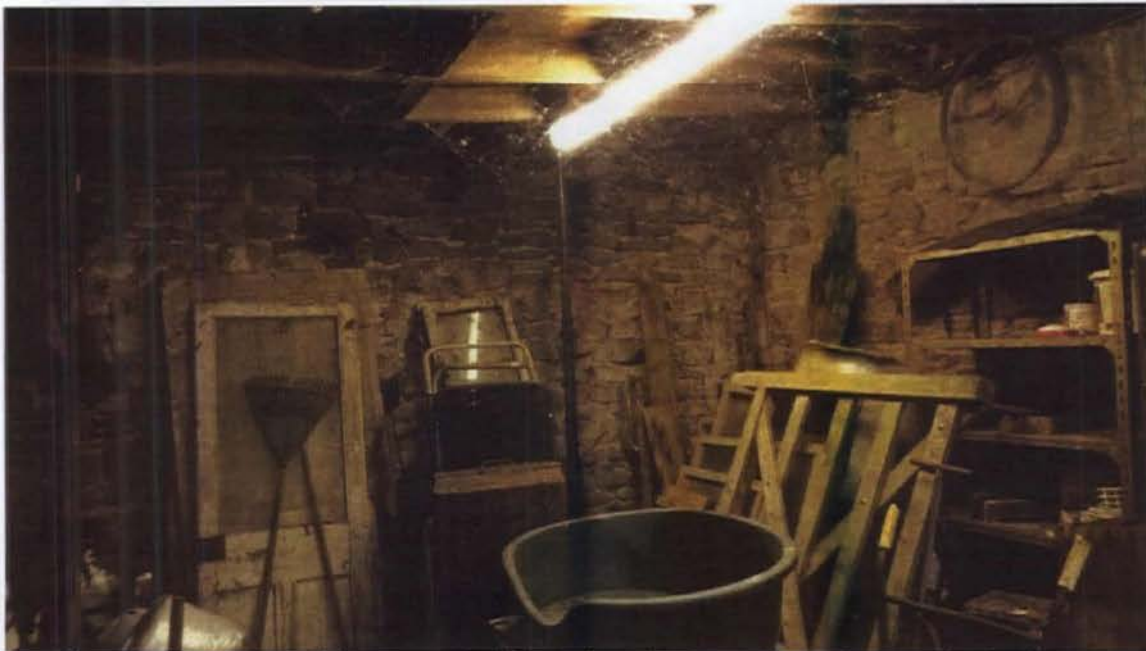
Plate 9: The interior of the storage building; the cobwebs on the ceiling are clearly shown.

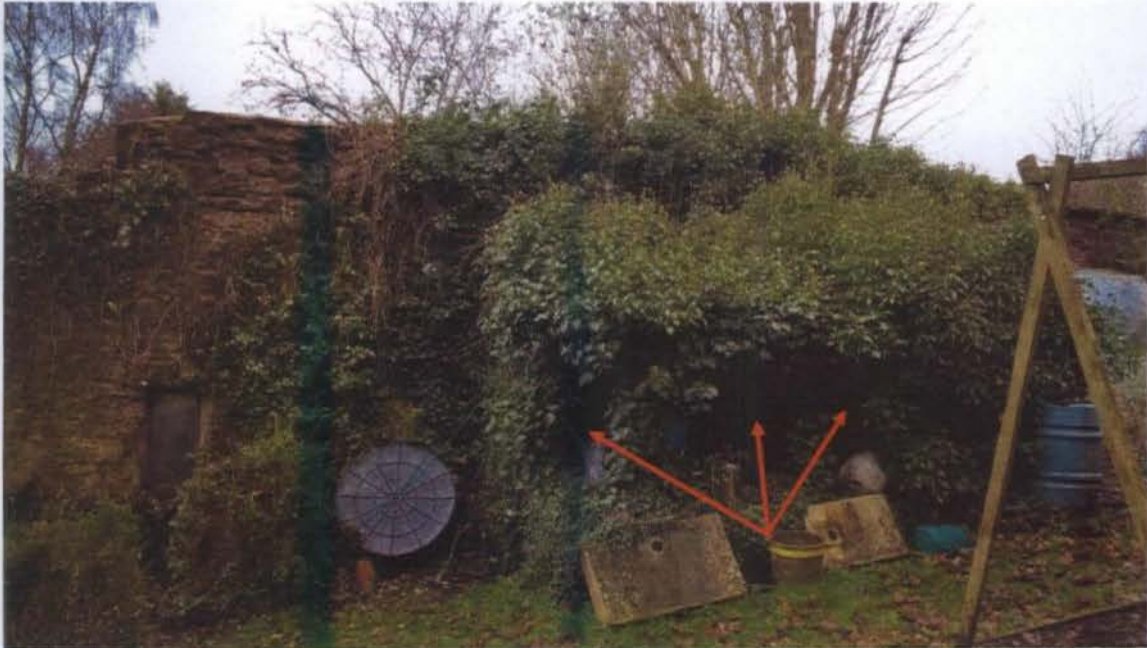
Plate 10: The lean-to against the southern aspect of the garden wall where the bat roost is located. The entrances to the roost are shown (red arrows).

The bat roost in the lean-to must remain untouched during the development. However, it is our understanding that the plans include removal and replacement of the workshop roof on the other side of the wall with a flat roof that will act as a patio area/terrace for the new dwelling. The workshop on the ground floor will remain unchanged. There is concern that the construction works (noise, vibrations, dust, etc.) could cause some temporary disturbance to the roost if they are not carried out in a sensitive and sympathetic manner. Therefore, a detailed Method Statement, written, approved and implemented before works begin is required to ensure the protection of the roost and foraging areas during and after development works. This method statement will include details of retention of access points to the roost, restricted areas of working and, lighting, and most importantly the timing of the works so that any potential disturbance to bats can be avoided.

Also noted during the visit, and which is of concern to the landowner, is the derelict state of the roost. Future pruning of the ivy is not recommended unless approved by a bat ecologist, as it may compromise the integrity (shelter and thermal properties) of the roost. However, the weight of the ivy, combined with the rotting nature of the wood will, ultimately, cause the structure to collapse. Further advice should be sought to preserve and retain the roost and sources of information will be provided to the landowner.

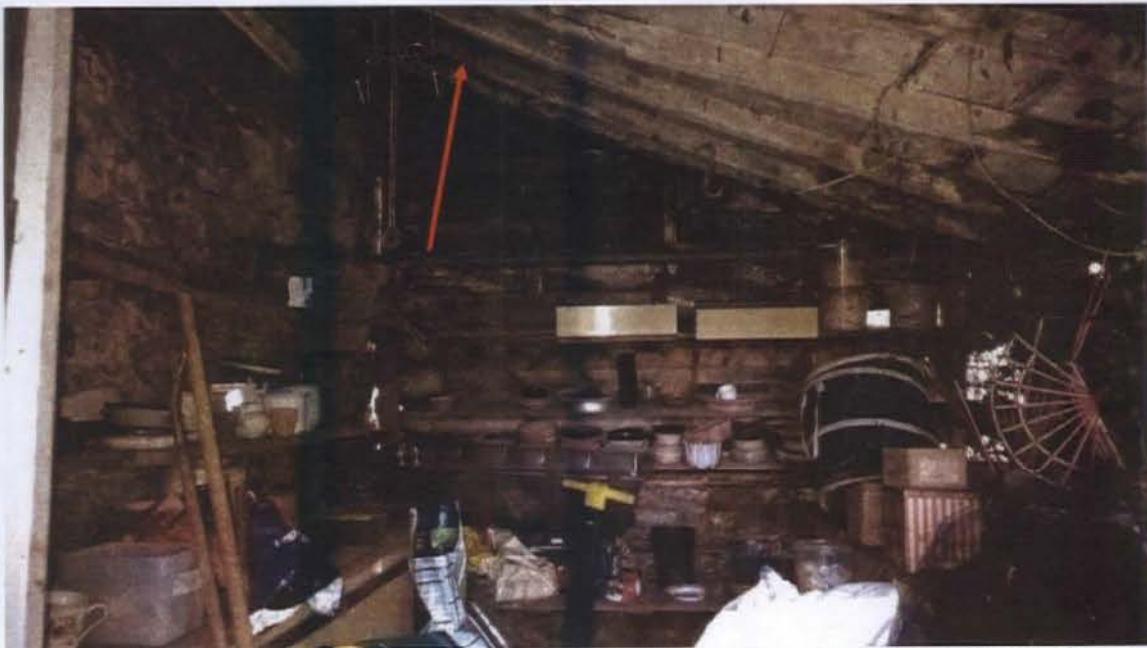
<p>Bats</p>	<p>A thorough internal and external inspection was undertaken of all buildings and trees on site, for any bat field signs or evidence of, or potential for, bat roosting such as faeces, feeding remains, oil staining, scratch marks, access points, loose claddings, cavities and hollows, etc. Methods followed those outlined in the Bat Conservation Trust's Bat Surveys: Good Practice Guidelines (2016). Please see Fig. 1 for the locations of the buildings described below.</p> <p>The former stable (TN1) External inspection: the workshop retains the original stone walls although the roof has been replaced with a shallow pitched roof with slate roof tiles and sky lights. There is a small wooden lean-to on the northern aspect with a corrugated metal roof and a further one along the western aspect with a felt lined roof (Plates 5 and 6).</p> <p>The walls and roof appeared to be in good condition. There were no missing or loose roof tiles and the wooden eaves appeared to be tightly fitted with no visible gaps suitable for crevice dwelling bats. The lean-tos are used for storage and were inspected thoroughly. No evidence of roosting bats was observed and the lean-tos are likely to be too flooded with daylight and exposed to inclement weather to be suitable for use by bats.</p> <p>Internal inspection: The interior is used as a workshop and for storage with steps leading up to a small area used as an office/storage area. The interior of the roof can be viewed from the storage area (Plate 7). The felt lining is visible and a few tears can be seen exposing the slate tiles above, although no daylight could be seen during the survey. The area was thoroughly inspected for evidence of roosting bats and none was observed. The workshop and office are frequently used and therefore subject to noise from machinery, lighting and other anthropogenic disturbance.</p> <p>Storage building (TN 2) External inspection: This building was recently built and lies adjacent to the workshop. It is single-storey, of breeze block construction and has a felt lined roof with a very shallow pitch. The wooden soffits are tightly fitted with no suitable gaps for crevice dwelling bats (Plate 8).</p> <p>Interior inspection: The ceiling is flat with visible wooden beams and felt underlining. The ceiling, walls and floor were inspected thoroughly for evidence of roosting bats and none was found. The interior is covered with large spiders' cobwebs suggesting that it is unlikely bats are present or have been recently flying in the interior (Plate 9).</p> <p>The workshop and the storage building have negligible potential to support roosting bats and no evidence was observed. No further surveys are recommended on this area of the site.</p> <p>Lean-to (TN3) This is a small lean-to against the southern aspect of the garden wall (Plate 10). It is supported by wooden timbers and has a corrugated metal roof and a wooden slat ceiling, upon which the bats appear to be roosting (Plate 11). It has an open doorway and two unglazed</p>

Plate 11: The interior of the lean-to; based on the positions of droppings the bats are roosting on the ceiling in the far corner (red arrow).

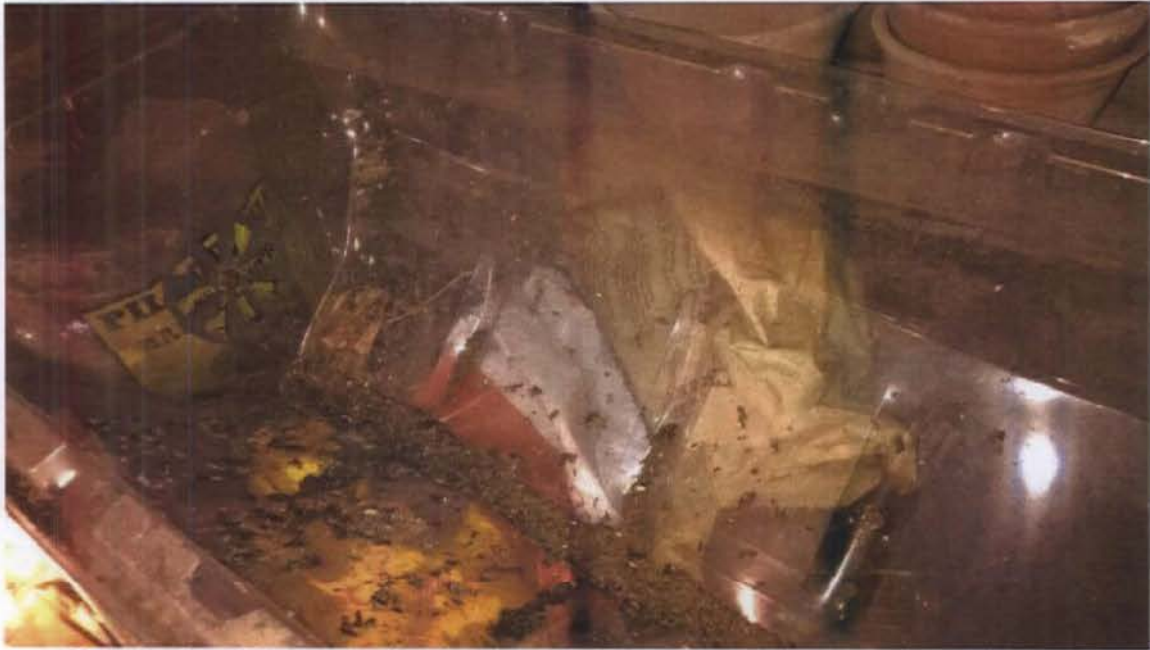
Plate 12: One of the containers containing large amounts of bat droppings of varying age.

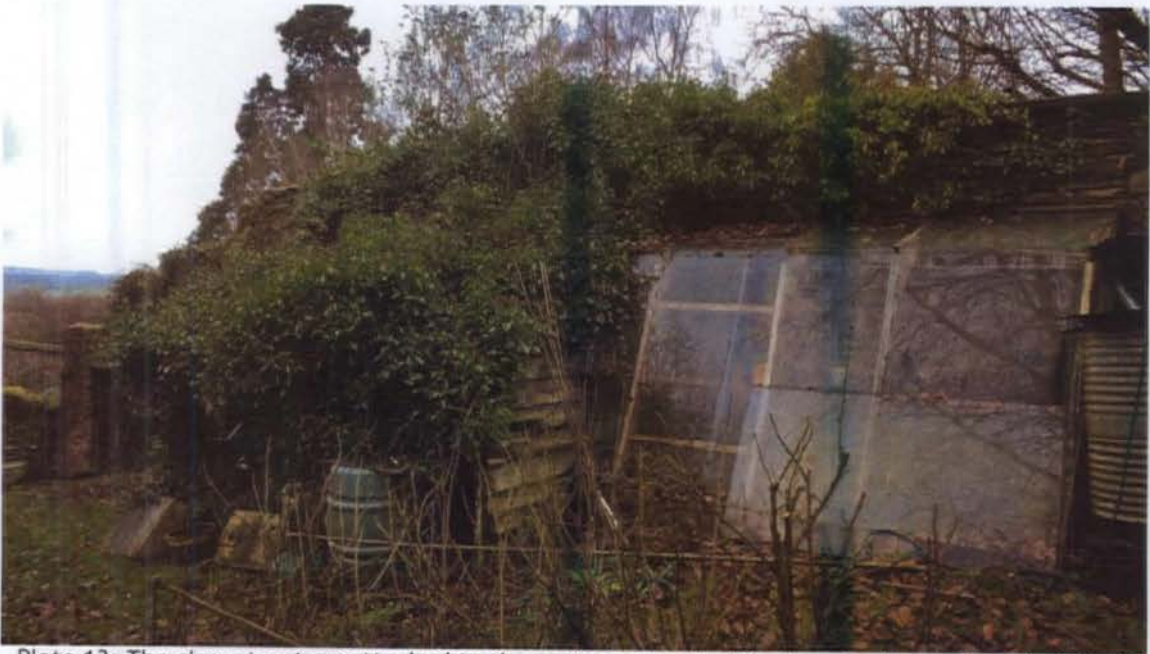
Plate 13: The glass structure attached to the eastern aspect of the lean-to (located on the left of the photo).

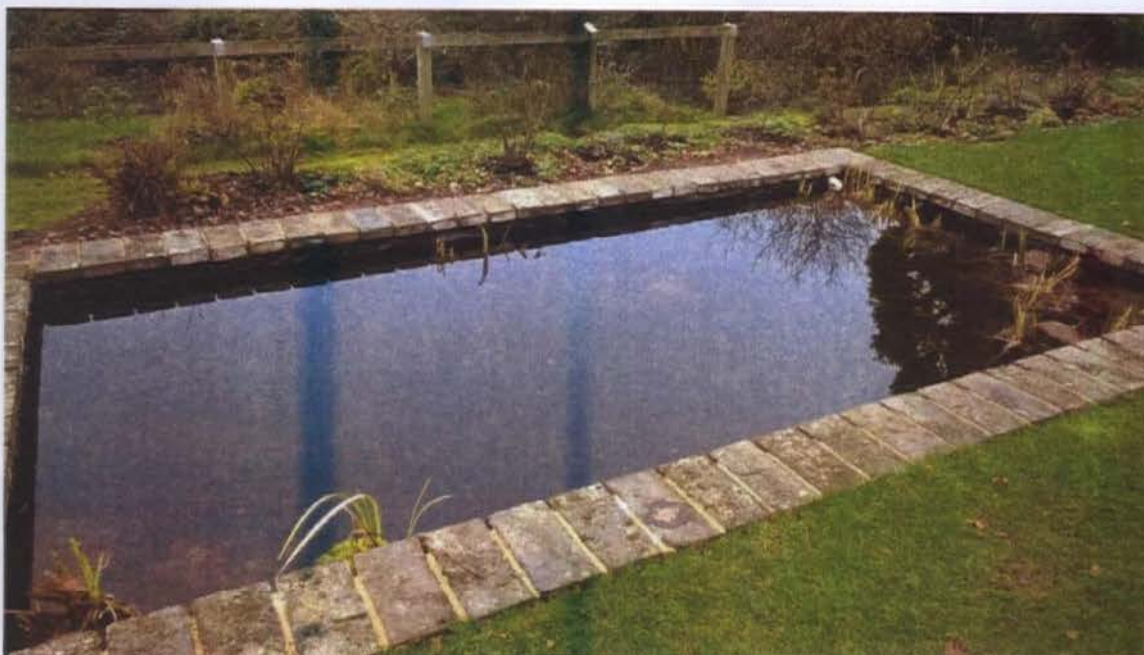
Plate 14: Pond 1, to the west of the site; smooth newts and frogs are known to use this for breeding. It will not be affected by the development.
