**Old Rectory  
Brampton Abbotts  
Ross on Wye  
Herefordshire  
HR9 7JE**

**Bat Search & Evening Emergence Survey & Assessment**

**Sept 2014**

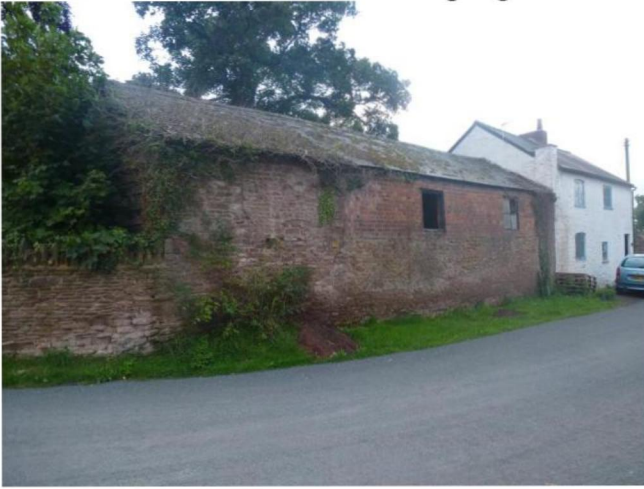
Photo 1 – Northern side of barn and garage

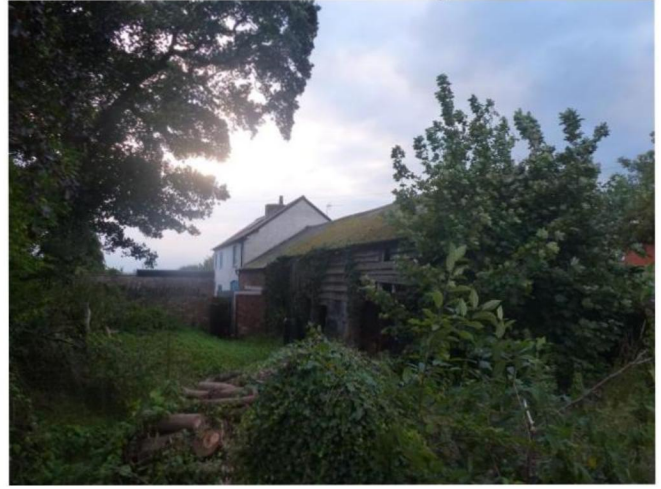
<b>Walls:</b>	Brick accounts for the majority of the walls. On the southern side wooden cladding is above a six foot high brick wall.
<b>Roof:</b>	Slates tiles with no underlay
<b>Access points</b>	The southern side is open in a number of places. The northern side has an open window aperture. Therefore, the building could be easily accessed by bats.
<b>Signs of bats:</b>	A small concentration (10 fresh, 30 old) of brown long-eared bat droppings (photo 4.) were present below the ridge beam. Tortoiseshell butterfly wing cases were also present. For the exact location of bat evidence please refer to the plan below.
<b>Bat roosting opportunities:</b>	The loft area of the timber/brick barn was very open making it draughty. However, there were dark areas. There were gaps above the wall plate leading into the loft above the garage (photo 7); although this loft area was dark and secluded it was covered in cobwebs (photo 6). The timber joints were tight and there was no underlay. The ridge beam above the bat droppings was clear of cobwebs (photo 8).

Photo 2 – Southern side of barn and yard

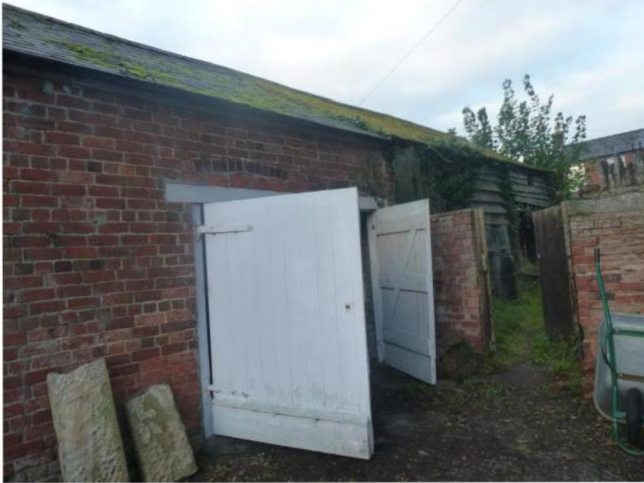
Photo 3 – Garage doors

- It is recommended in this circumstance, that access is made into the adjacent garage. This shall be achieved by creating a gap at the top of the double garage doors (photo 3). The gap would need to be at least 10cm deep and run the length of at least one door. Within the garage, enhancements should be made to create better roosting conditions. This should be done by allowing access for bats into the small loft area. Access via a gap in the loft floor at the western end would suffice. The gap will be 20cm wide and run the width of the loft floor. Cobwebs will be removed from the loft area and at least two pieces of timber will be attached abutting the ridge beam and bridging two rafters. These pieces of wood will run down 40cm from the ridge beam.

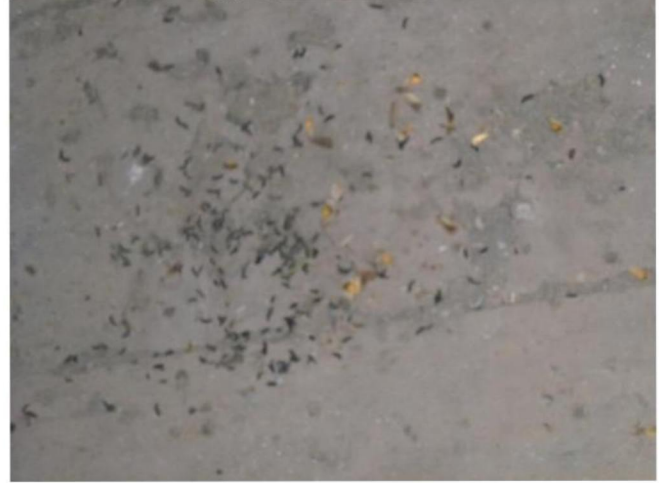
The only evidence of bats using the timber/brick barn was recorded as fresh and old long-eared bat droppings in the loft area. The bat had most likely accessed the loft via the numerous large gaps on the southern side of the building. There is a possibility that access was gained on the northern side of the building through the open window aperture, however, the southern side provided more cover with the presence of trees. The droppings were accompanied by tortoiseshell butterfly wing cases. The number of droppings and the presence of wing cases indicate that the loft being used as a feeding/resting perch. This is where bats will hang up and eat insects between bouts of catching their prey. The bats will dismantle and discard the parts of their prey that are not edible, wing cases for example.

There is, to the best of our knowledge based on current survey evidence signs, no current bat roost in the building. The quantity and age of droppings found on the search survey indicate that this is likely to be one bat (common species) and occasional use. Under Natural England guidelines this would be a roost of low conservation value.

Photo 4 – Bat droppings in barn

The proposals to convert the barn to residential use will lead to the destruction of an occasionally used feeding/resting perch, therefore an alternative roost site will need to be provided.

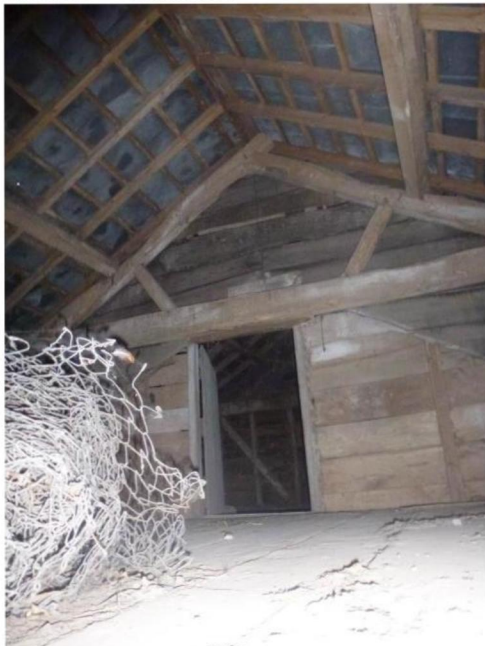
Photo 5 – Barn loft

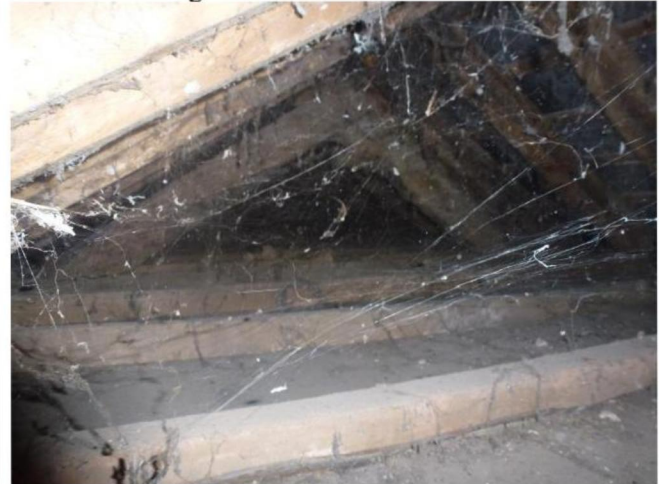
Photo 6 – Garage loft

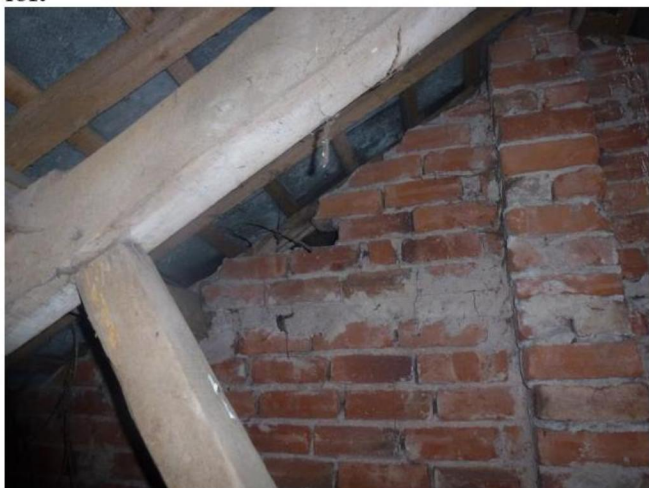
Photo 7 –. Dividing wall between barn loft and garage loft
