A Preliminary Ecological Assessment & Mitigation Strategy for The Old Stable Barn at Greenway Farm.

Aim: To establish the presence or absence of bats & birds in the building & importance of any adjacent habitats.

Mr & Mrs P Scrivens
Greenway Farm
Whitchurch,
Ross on Wye
Hereford
HR9 6DH

Reference: 1PS\Bat & bird's survey.doc
19th September 2020

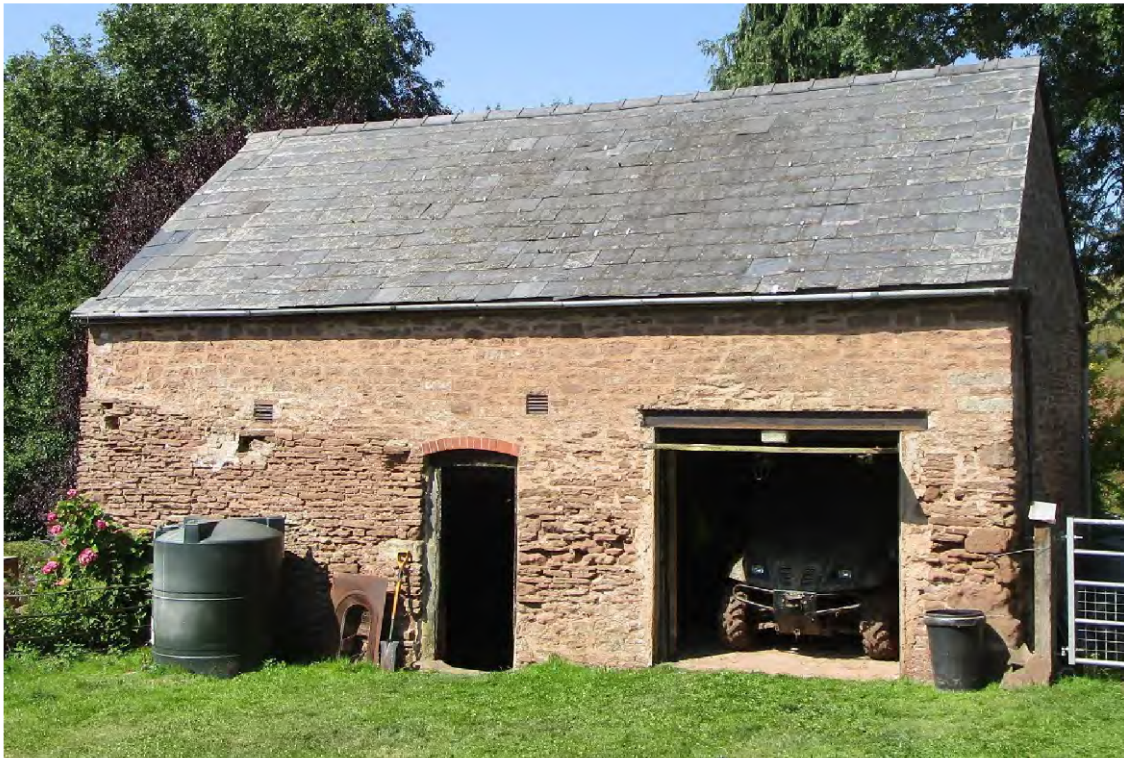
The building proposed for conversion has been in daily use for storage of farm machinery & other farm equipment. The main construction for the walls is traditional stone, the mortar is generally in good condition meaning there are limited cracks or crevices between the stones. The Eastern elevation has a large single skinned timber door with a large metal garage type door (as shown below in figure 1).

Figure 1: Photo to Show the eastern elevation of the stable building

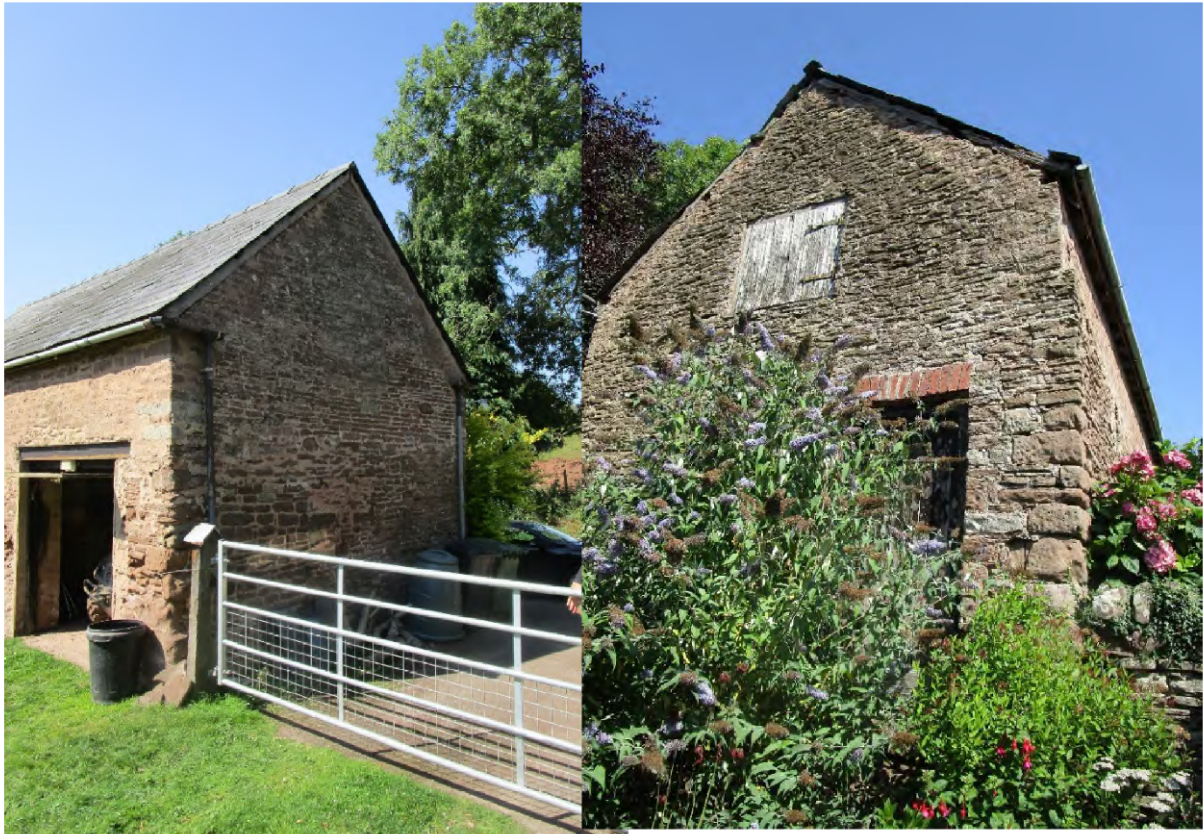
The northern elevation of the stable barn has roof timbers leading to the apex of the roof, these timbers have been unusually worn away leaving large gaps (seen in figure 2). The timber has been worn down by wasps which have created a large nest within the interior of the stable and they have created a 3-inch gaps which would allow for direct flight access into the barn at the edge of the roof.

The roof of the stable barn is covered in close fitting slate tiles. The southern gable end elevation (figure 3) has a timber door on the lower storey and a traditional hay loft door leading to the second storey of the stable barn. At the edge of the roof by the apex timbers there are gaps which also provide some direct flight access.

Figure 2 & 3: The Northern and Southern elevation of the stable building

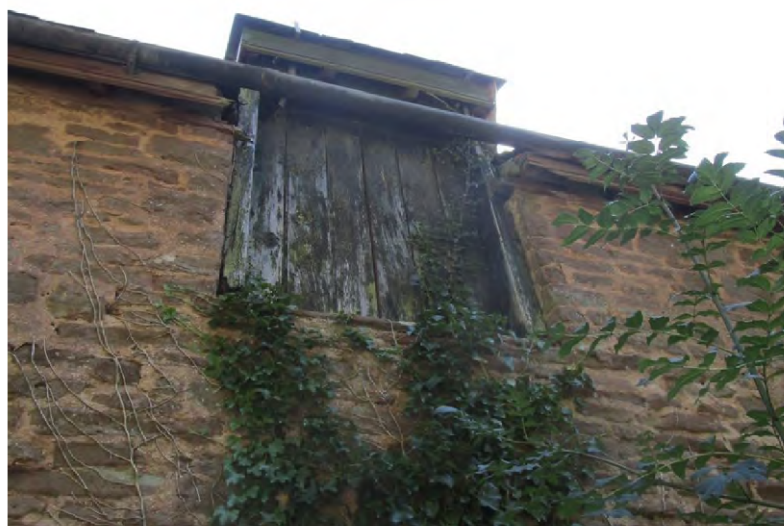
The western elevation of the stable barn is adjacent to the roadside. There is a painted hay loft timber door which has some gaps above it as seen in figure 4. The rest of the western elevation is well sealed.

Figure 4: The western elevation showing the timber hay loft door

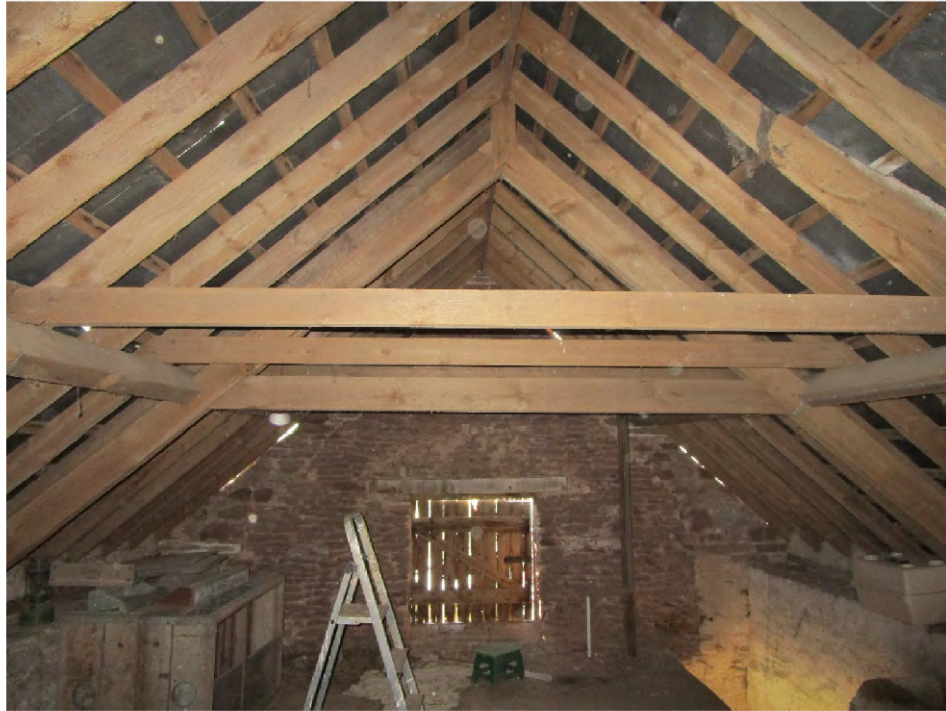
Figure 5 – internal view of the hay loft showing southern elevation

The hay loft door on the southern gable wall elevation has gaps that are around the door and apex timbers (as shown in figure 5). These gaps around the door & the apex roof timbers not only provide direct flight access but they also allow a lot of naturally light throughout the barn.

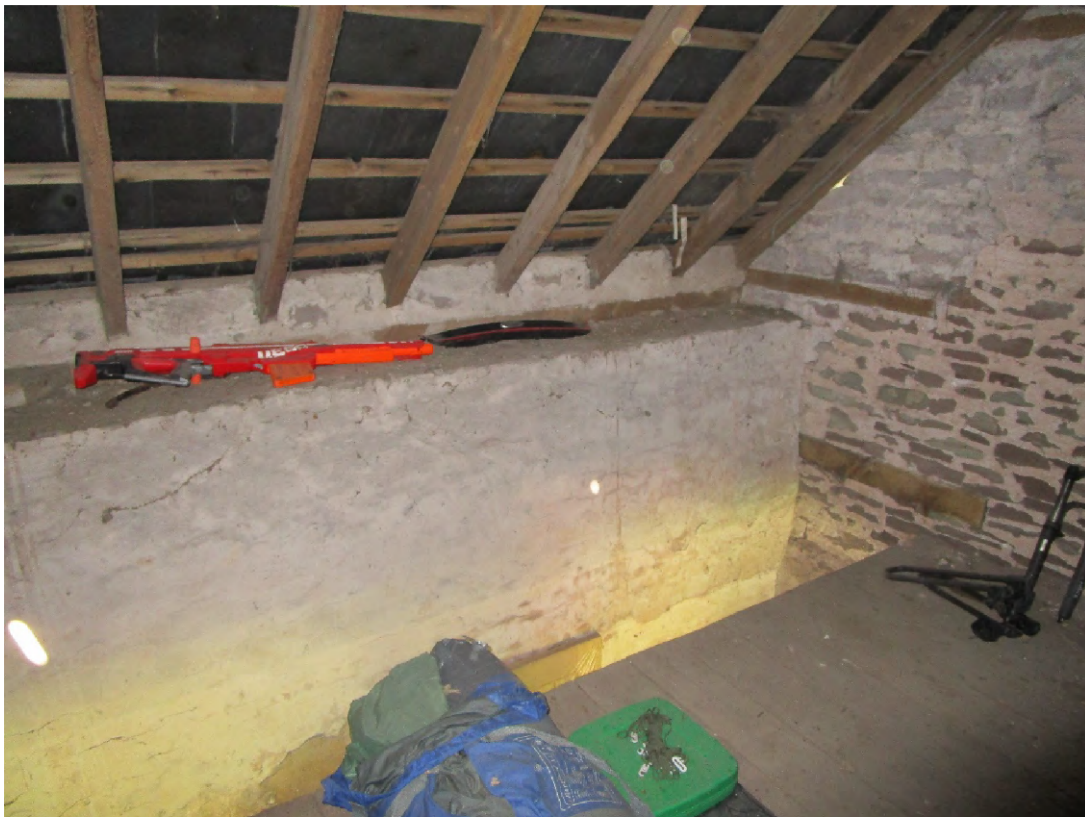
Although there were no bat droppings in the rest of the barn, upstairs in the hay loft evidence of use by bats was found. As shown in figure 6 there were scattered bat droppings and urine stains found within the upper storey. The timber floor covers the whole of the second storey except for a strip around a foot wide where the floor does not meet the western elevation wall which allows additional light upstairs into the barn as shown in figure 7.

Figures 7: showing the gap along the western elevation floor

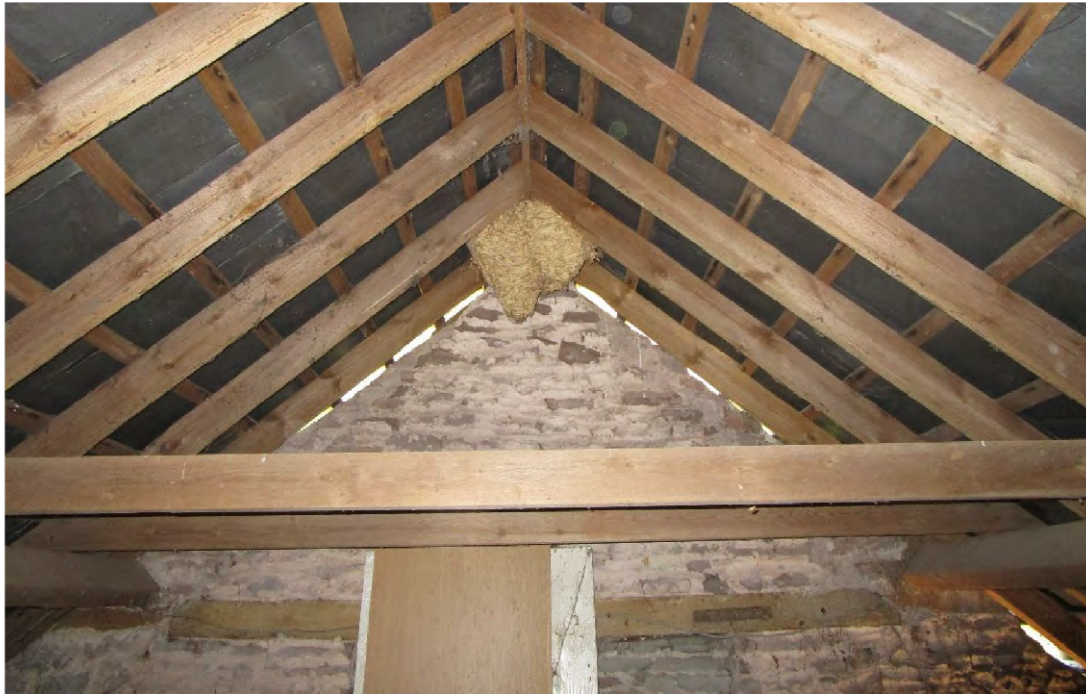
The northern gable end has small clear flight access gaps but also has a very large wasp's nest, as shown over the page in figure 8.

Figure 8: Northern gable end with direct access gaps and wasp's nest

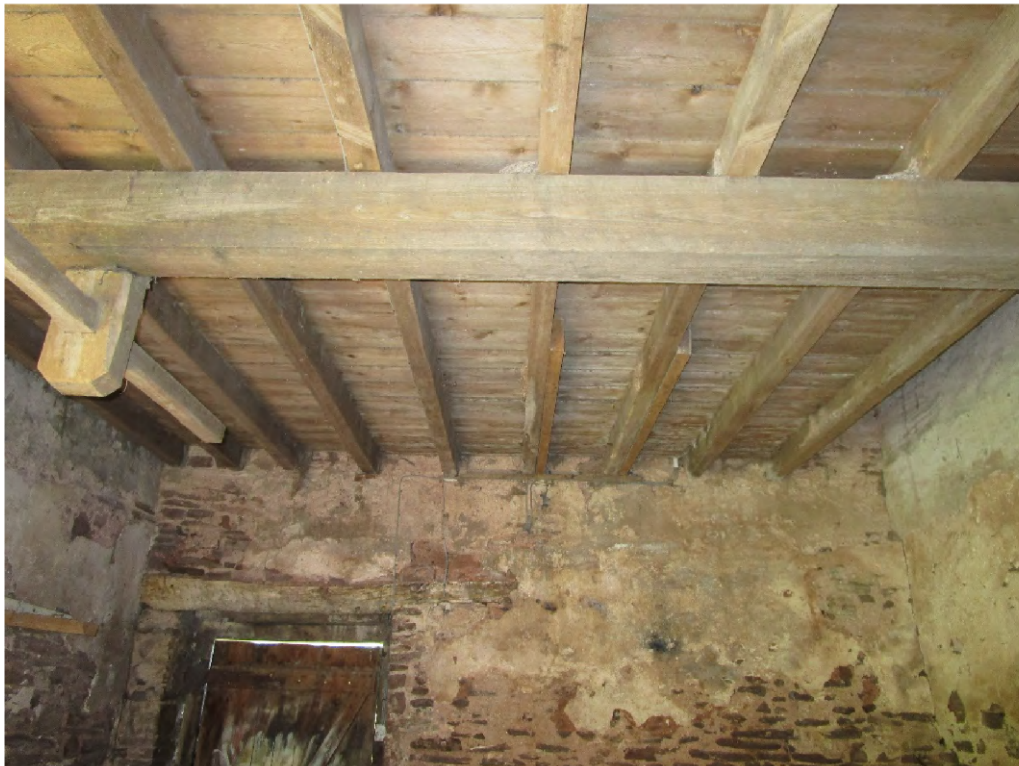
The ground floor of the stable barn is split into two sections. The first section has been used as a garage storage for the farm machinery and has a large metal garage door. The second section is larger and has rendered walls. There is the single skinned timber door on the southern gable end wall as seen in figure 9. Four historic swallow nests were found within this downstairs section of the stable barn.

Figure 9: The southern elevation internal wall

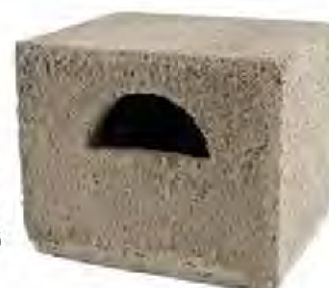
WoodStone Build-in Open Nest Box is designed for use in new build or renovations. The nest box is intended to be built into walls to provide nesting cavities. This provides much needed nesting cavities for species such as Robins, Wagtails and Black Redstarts. Constructed from FSC certified WoodStone this nest box will not deteriorate like a traditional wooden nest box. NHBS Price: £17.95 including VAT.

Due to historic birds' nest being found a stone open fronted bird box will be incorporated into the barn wall on the side elevation as shown in appendix five.

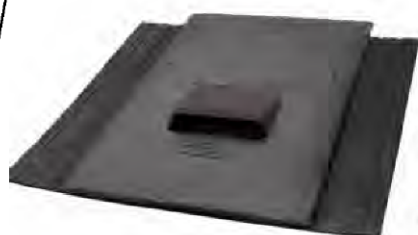
Habibat Bat Access Slate - Standard

Dimensions: 418Hx375Wx80Dmm, entrance hole dimensions: 20Hx100Wmm, weight: 1.3kg. The Habibat Bat Access Standard Slate is designed to provide access to roof space for our protected bat species. The Bat Access Slate consists of a standard sized slate, with a capped vent which allows access to roof felt (for roosting Pipistrelles) or roof space.

the roofing tiles. Access into the roof will be by Habitats slate bat access tiles will be included in the roof of the barn and the roof will be lined with bitumastic roofing felt to encourage future use of the roof area under the tiles by bats as shown in Appendix five.
