A Preliminary Ecological Appraisal of St. Nicholas Rectory, 76 Breinton Road

Aim: To establish the presence or absence of bats & birds in
the buildings & importance of the habitats on site.

The Hereford Diocesan Board
C/o Hook Mason Ltd

16th June 2020

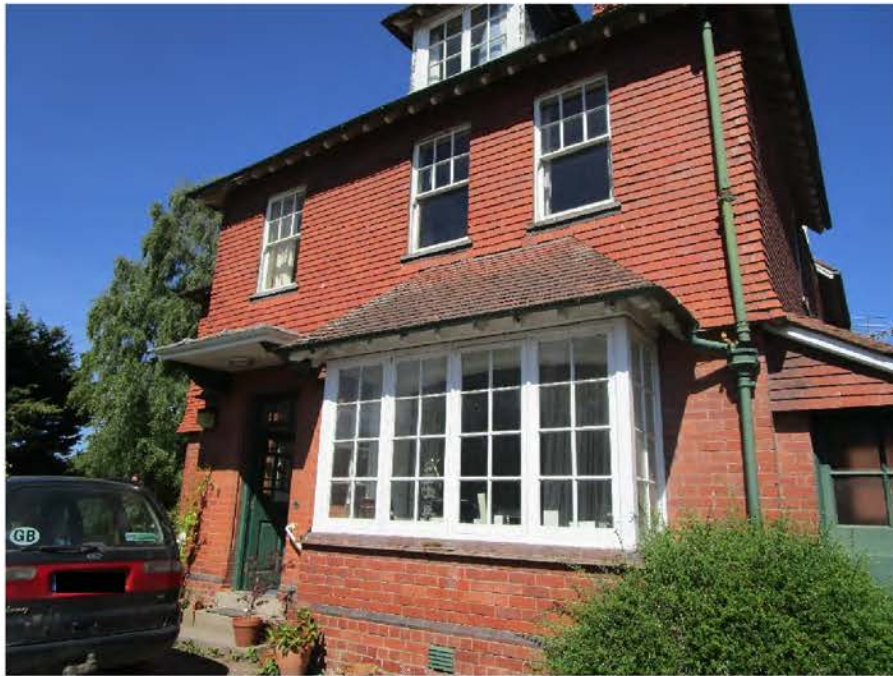
The building proposed for demolition is in daily use as a residential property. It is a three-storey building with Dormer windows (lead sided) in the roof see figure 2. The main construction for the walls is red brick. The brick walls are then clad with red tiles from the second storey up and the roof overhangs all the house walls (see figure 1).

Figure 1 – Showing the dwelling with the red brick and tiled cladding

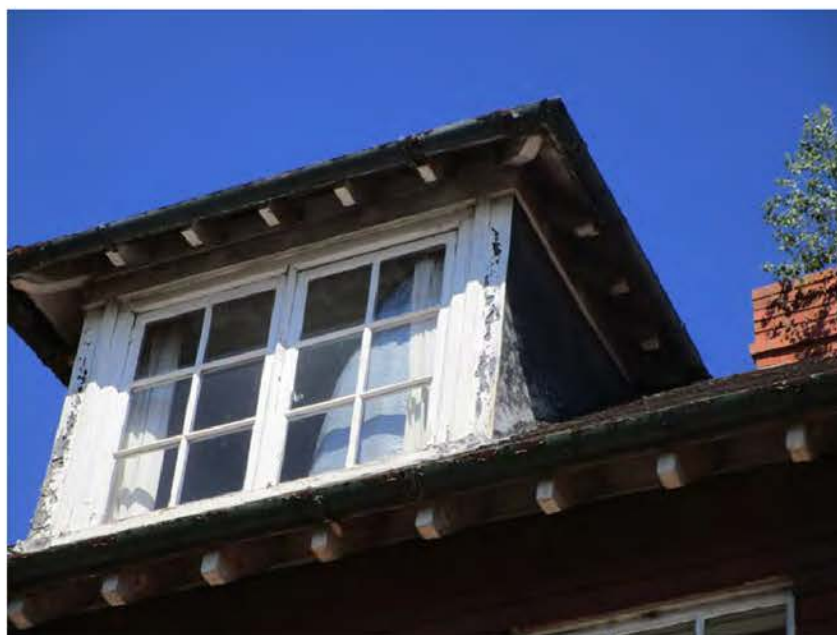
Figure 2 – Dormer windows within the roof

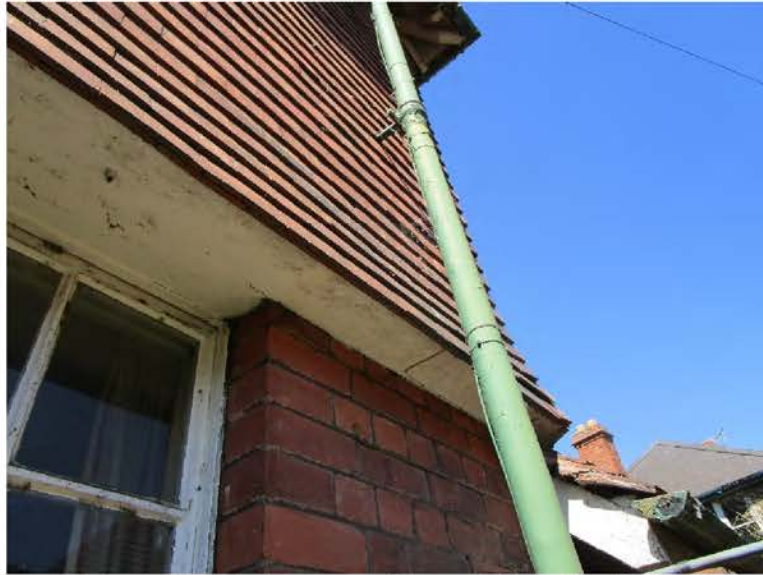
There are no gaps within the bricks and tiles on the building except for two small sections where two tiles have slipped slightly. The soffit of the building is painted timber with extremely limited gaps as shown in figure 3. The roof has hermetically sealed clay tiles however there are occasional small gaps along the roof ridge tiles see figure 4.

Figure 3 – A close up of the soffit on the house

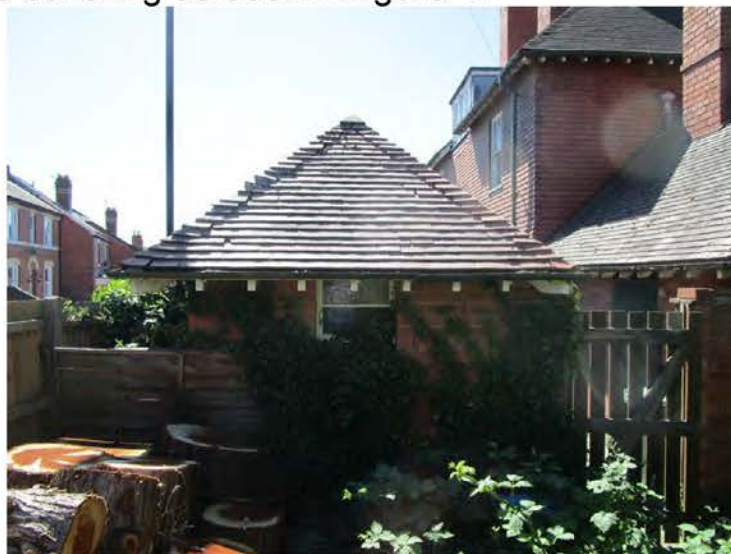
There are three large flood lights on the front of the house which are on each evening and light up large areas around the house including the garden. The window and doors are timber and have no gaps as seen in figure 1. There is a lean to on the North-eastern elevation of the dwelling which is also red brick. The roof of the lean to is clay tiled that are covered with moss. Adjacent to the lean to there is an outbuilding that is also red brick with clay tiles and has some moss covering as seen in figure 4.

Figure 4 – The outbuilding on the north eastern elevation

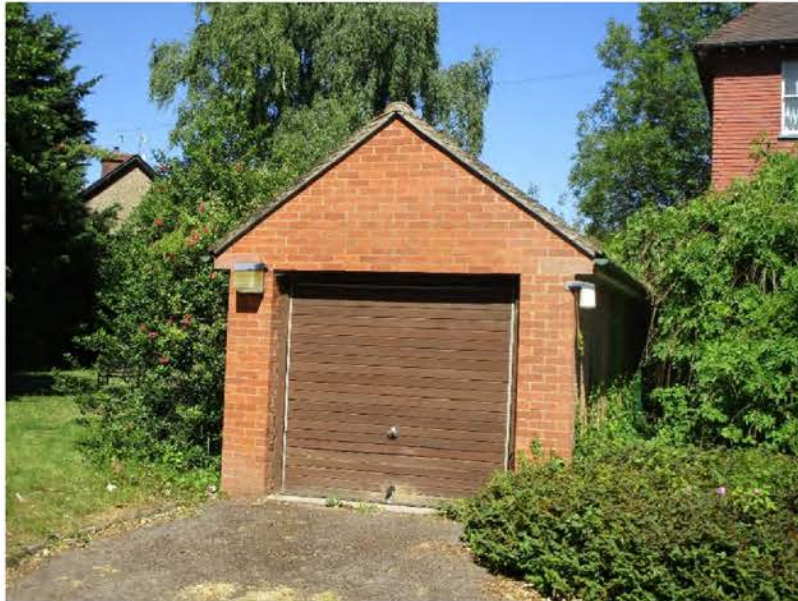
To the south west of the site there is the garage which is of a red brick construction & sealed red clay roof tiles. The garage has a large garage door and two bright flood lights either side of the door & flower borders & shrubs either side of it as shown in figure 5.

Figure 5 – The garage with the flood lights

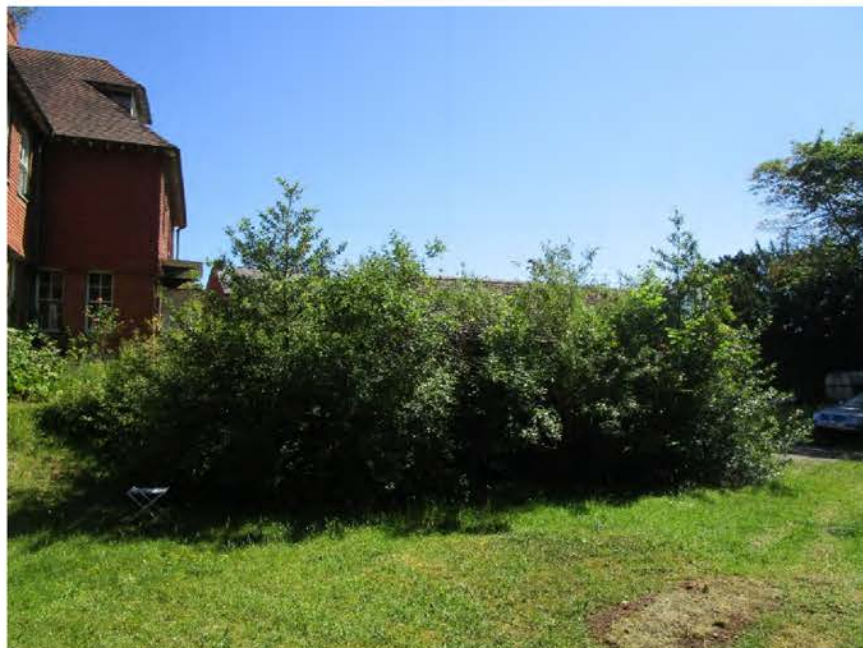
Figure 6 The shrubs adjacent to the garage

By the side of the garage there is a patch of shrubs which are comprised of buddleia, Hazel, Holly, Dogwood, Dog Rose and Ash as shown in figure 6. Around the southern elevation of the dwelling there is a border by the garage & the house which consist of garden shrubs and flowers such as Ivy and Rose which has grown up to the base of the window (see phase one habitat plan in Appendix one).

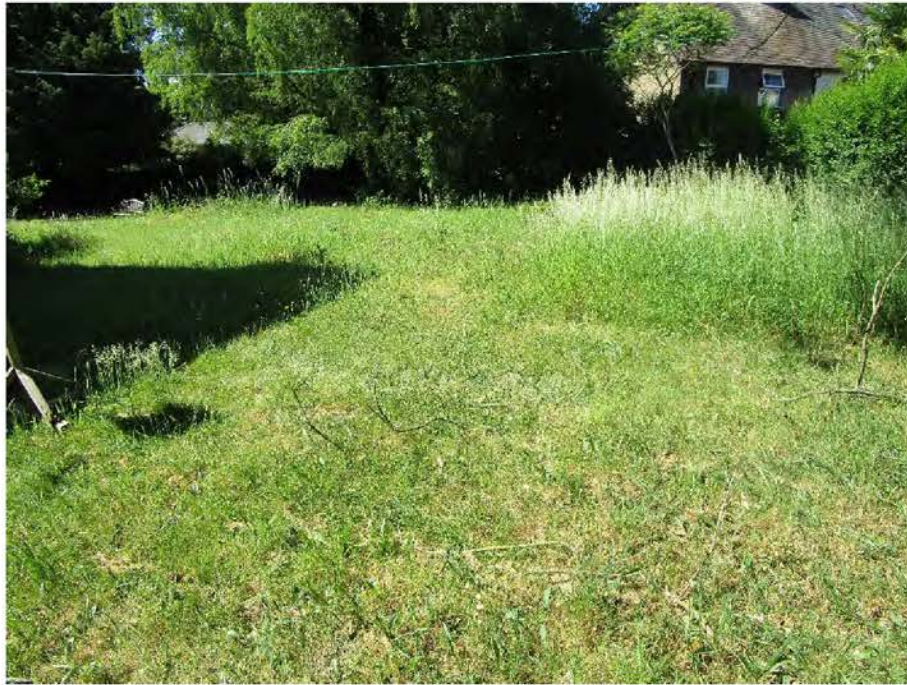
Figure 7 – the amenity grass

The garden area is normally regularly close mown amenity grassland and comprises of species such as Germander Speedwell, Daisy, Yarrow, Autumn Hawkbit, Creeping Buttercup, Ribwort Plantain, Sorrell, Rye Grass, Ivy, Bramble. There is a bank which leads to the western side of the garden which comprises of Common Dock, Columbine, Herb Robert, Knapweed, Forget me Not, Silverweed, Hedge woundwort, young Elder, Sumac, False Oat Grass and Autumn Hawkbit.

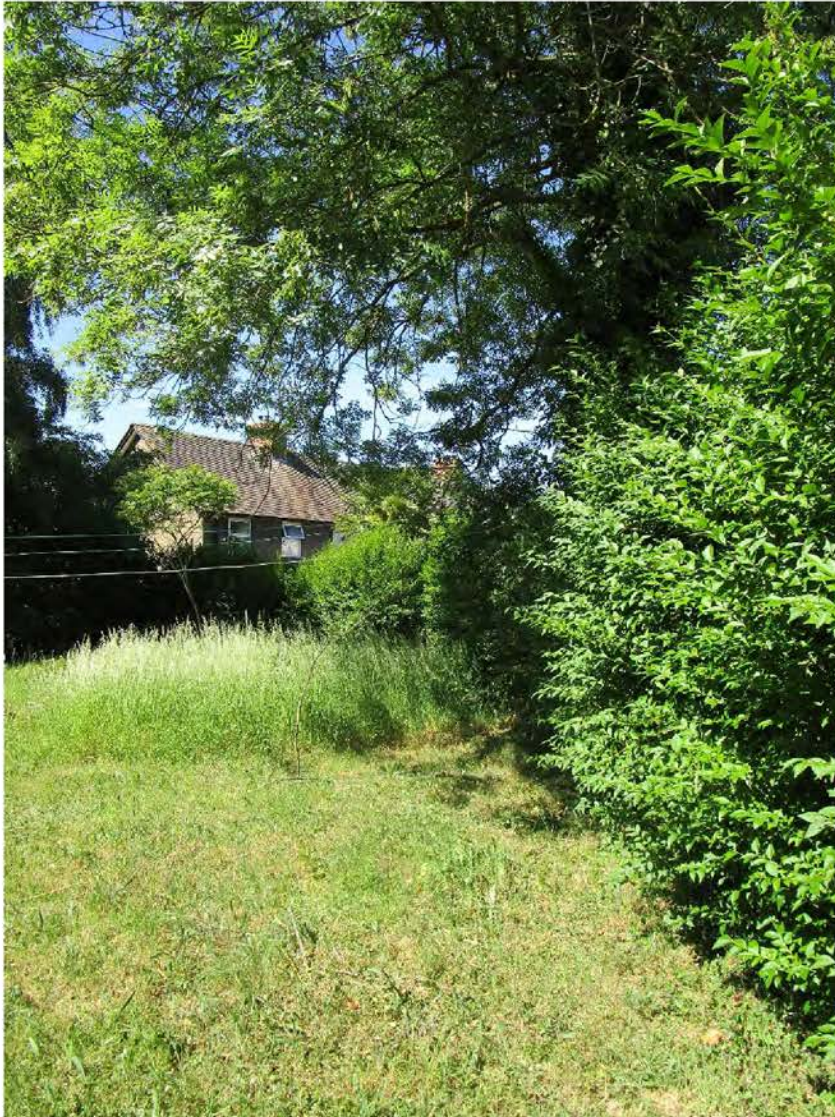
Boundary two – Is along the eastern boundary of the site and is a hedgerow with trees and comprised of Dog wood, Cherry and Privet species poor hedge along the fence line as shown in figure 7 & 8.

Boundary three – Is along the southern boundary of the site by Breinton road & is comprised of A large Lawson Cypress in the corner with a Leylandii, Apple and Ash trees, a leylandii stump, together with two Yew Trees, Privet shrubs, Silver Birch & Holly as shown adjoining Boundary two below in figure 8.

Figure 8 – Boundaries 1 (at the forefront), 2 (in middle) & 3 (far edge)

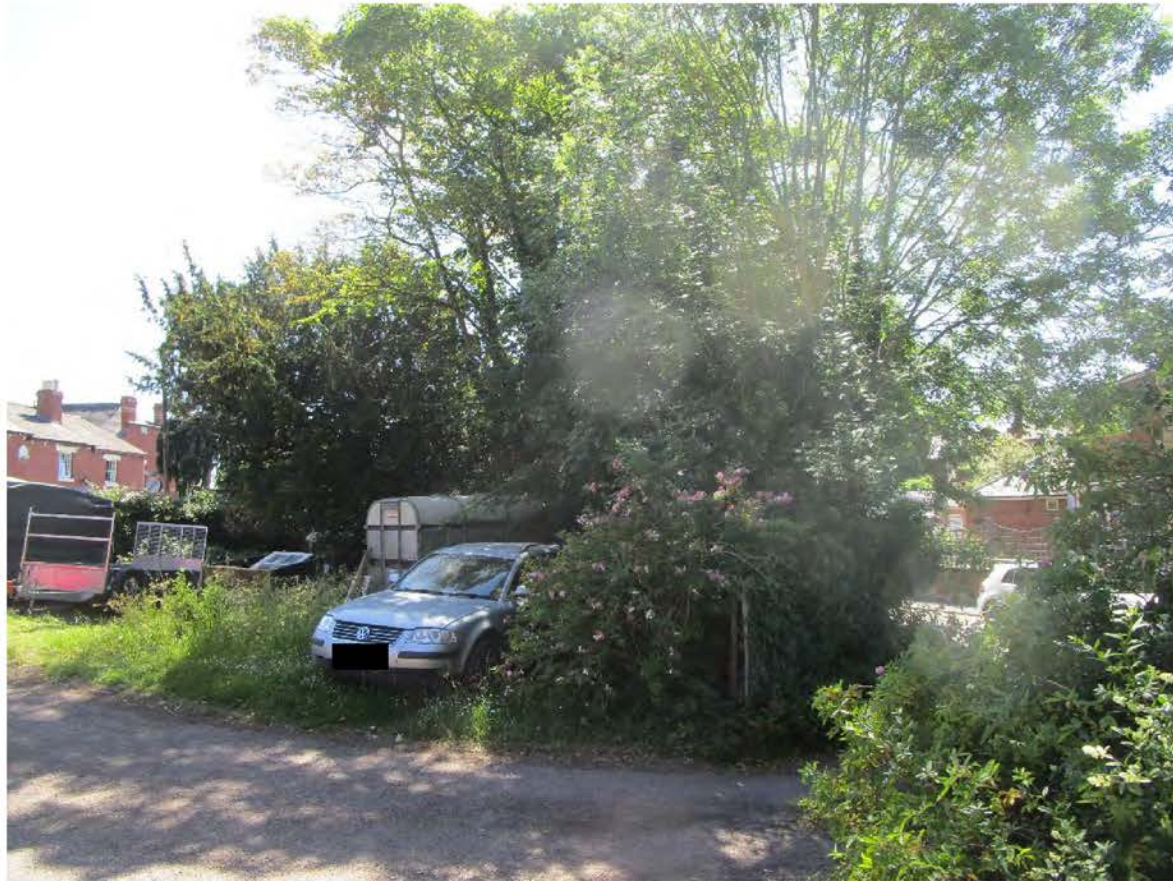
Boundary Four – Is along the southern boundary of the site alongside Breinton Road and is a line of trees comprised of, Ash, Holly, Sycamore (mature pollard]), Hazel, Ornamental Shrubs, Yew tree & Buddleia as shown below in figure 9.

Figure 9 – South eastern corner of the site, Boundary 4 & the mature Sycamore tree

The area in the south west corner of the site next to boundary four is comprised of bare disturbed ground which is used for storage of trailers & cars. There is also a small patch of semi improved grass here with a similar mix of species as the rest of the grass lawned areas with an ornamental knapweed as shown in figure 9.

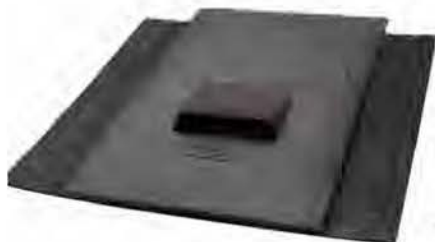
Habibat Bat Access Slate - Standard

Dimensions: 418Hx375Wx80Dmm, entrance hole dimensions: 20Hx100Wmm, weight: 1.3kg. The Habibat Bat Access Standard Slate is designed to provide access to roof space for our protected bat species. The Bat Access Slate consists of a standard sized slate, with a capped vent which allows access to roof felt (for roosting Pipistrelles) or roof space.

As an enhancement for bats two Habitats slate bat access tiles will be included in the roof of the building proposed on the corner plot and the roof will be lined with bitumastic roofing felt to encourage future use of the roof area under the tiles by bats in addition two bat tubes will be included in the elevation of the end walls of the buildings either side of the footpath as shown in Appendix five.

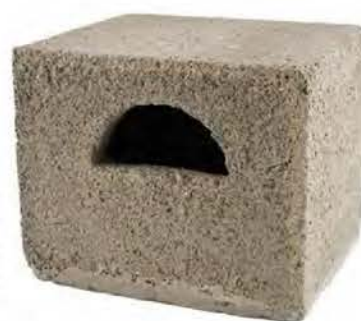
WoodStone Build-in Open Nest Box is designed for use in new build or renovations. The nest box is intended to be built into walls to provide nesting cavities. This provides much needed nesting cavities for species such as Robins, Wagtails and Black Redstarts. Constructed from FSC certified WoodStone this nest box will not deteriorate like a traditional wooden nest box. NHBS Price: £17.95 including VAT.

Due to a bird's nest being found in the chimney of the house to be dismantled integral bird boxes will be incorporated into the new dwelling walls on the front elevations as shown in appendix five.
