BAT SURVEYS AND MITIGATION PLAN

**Farm Barns and Granary at
Warryfield Farm, Walford,
Herefordshire**

**Report
3rd September 2019**

**Report reference
C2258-2**

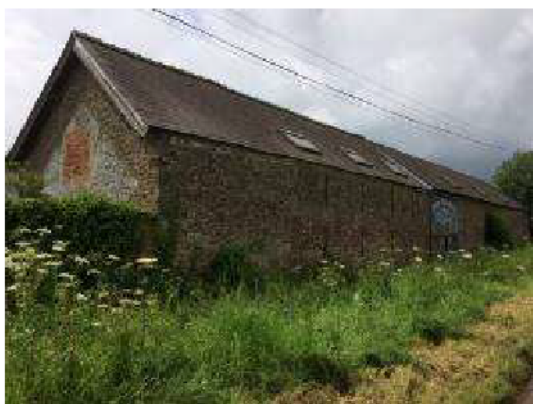
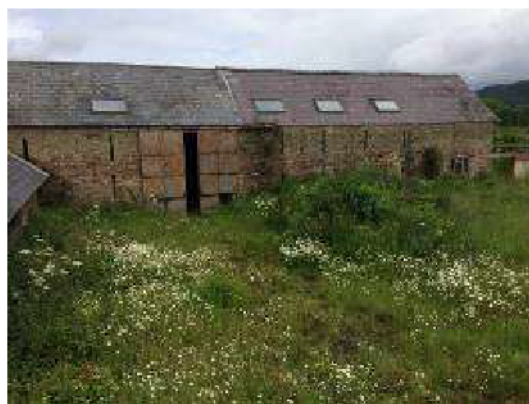
Plates 1 and 2: North (left) and south (right) elevations of barn 1.

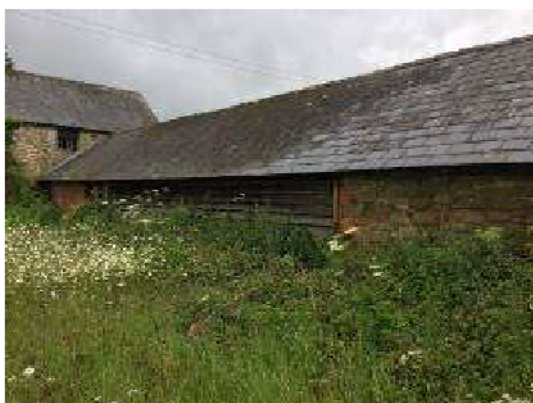
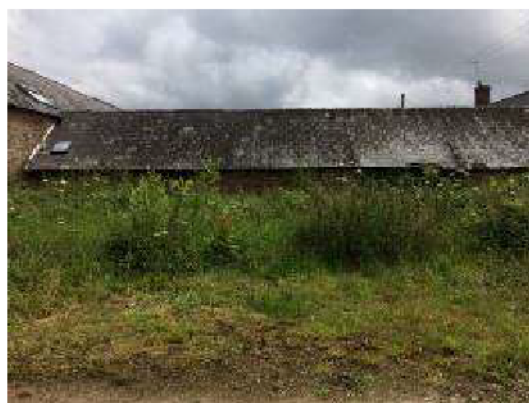
Plates 3 and 4: East (left) and west (right) elevations of barn 2.

The stone elevation of barn 2 contain gaps, cracks and crevices suitable for roosting bats. However, the walls are not very high and partially obscured by tall vegetation (Plates 3 and 4), and thus less suitable for roosting bats compared to the higher wall elevations of barn 1.

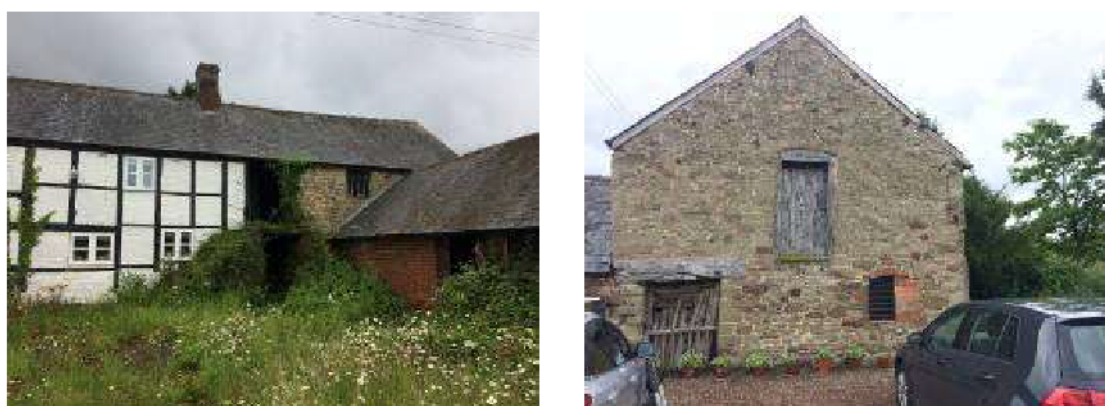
Plates 5 and 6: North (left) and west (right) elevations of the granary. The building is located at the western end of the converted south barn (Plate 5: black and white building in left of photo) and southern end of barn 2 (Plate 5: single-storey red brick building in right of photo).

The exterior stone walling of the granary (Plates 5 and 6) has gaps, cracks and crevices suitable for roosting bats. The roof slates are mostly well-sealed but there is a hole in the roof (Plate 27) and a lifted ridge tile at the west end of the roof that would provide flying access into the building and roosting opportunities respectively for bats.

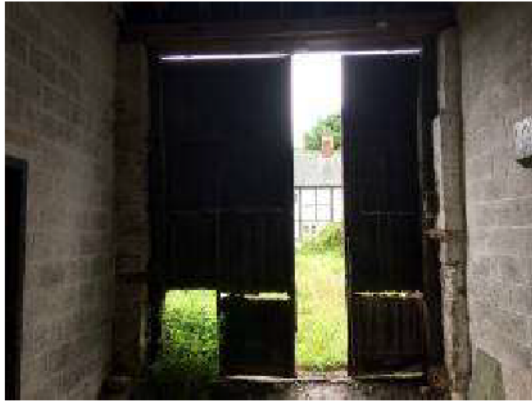
The central sliding metal doors (Plate 7) are loosely fitted and provide flying access for bats around the sides, over the top and between the doors. An access door on the west gable is also loosely fitted and would provide flying access for bats. Most of the vertical slit-style windows on the north and south elevations (Plate 8) are glazed or covered with Perspex but several are open and would also provide easy flying access for bats. There are several additional glazed windows in the south elevation, at the western end of the barn; these appear well-sealed to the adjacent stonework. The eaves are open and would offer suitable access opportunities for bats into the building.

Plate 7: Barn 1 - metal sliding doors.

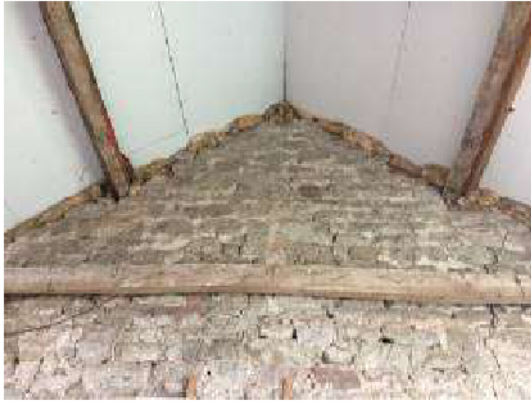
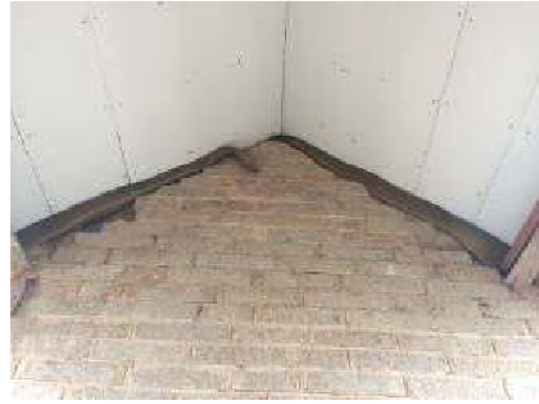
Plates 13 and 14: Barn 1 – glass fibre (left) and foam (right) insulation below recently installed roof boarding.

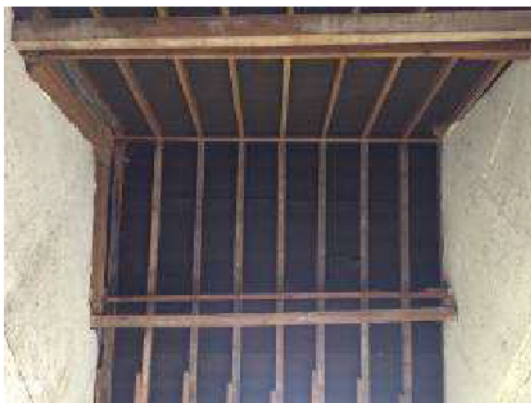
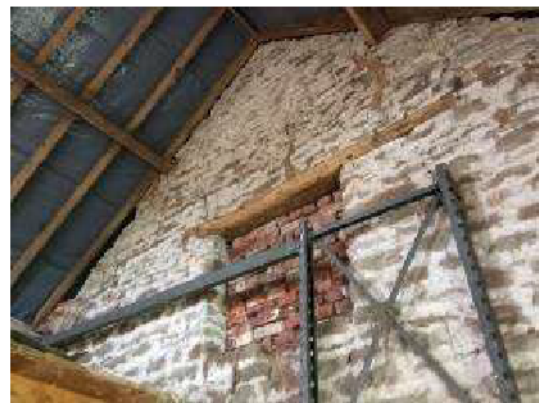
Plates 15 and 16: Barn 1 – Central room (left) and east room (right) showing traditional bituminous felt lining (left – central room) and more recently installed plastic roof lining (right – east room).

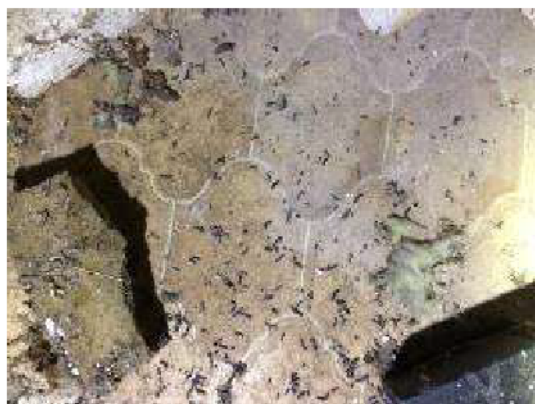
Plate 19: Barn 2 – north room floor with scattered bat droppings.

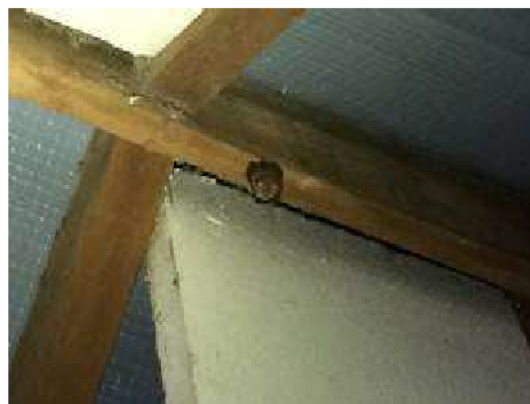
Plate 20: Barn 2 – north room with roosting lesser horseshoe bat.

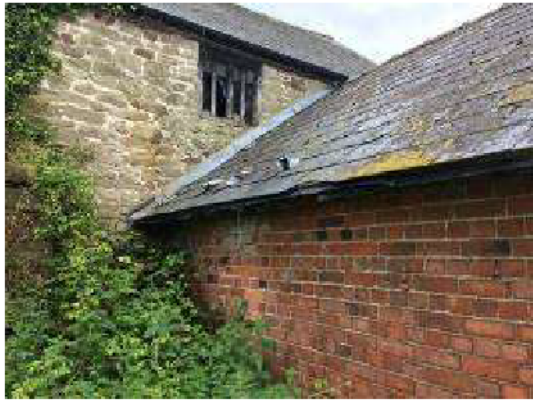
Plate 21: Barn 2 – lead ventilation previously installed bat access points?

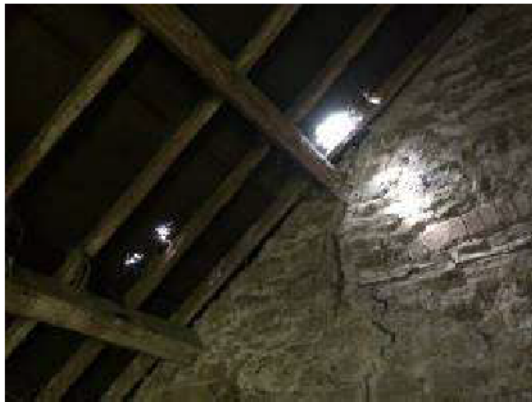
Plate 27: Granary – hole in roof.

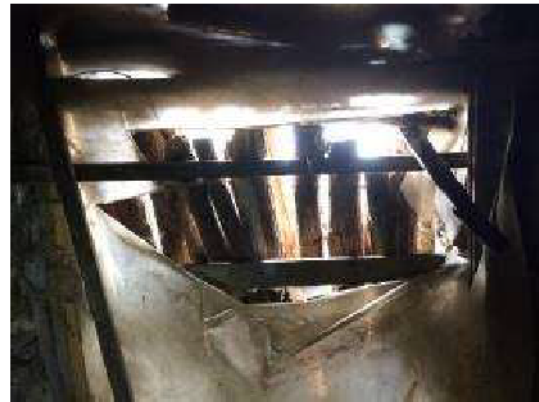
Plate 28: Granary – partially blocked unglazed window at ground-floor level in west gable.

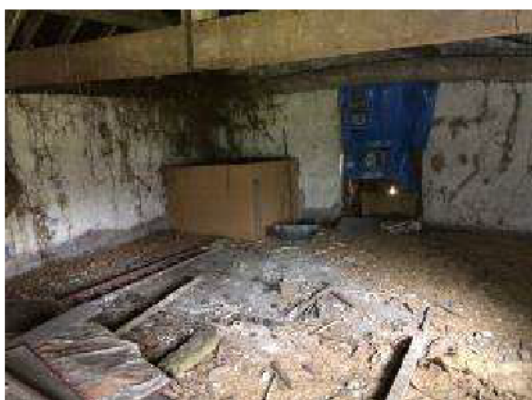
The ground and first-floor rooms (Plates 29 to 32) are moderately dark and enclosed, and might provide suitable conditions for void-roosting bat species. In the south-west corner of the first-floor room is an old, blocked hopper chute (Plate 31) forming an enclosed cavity accessible from the ground room beneath; this might provide a suitable roosting site for some species, particularly lesser horseshoe bats.

Plate 31: Granary – first-floor room with hopper chute in corner.

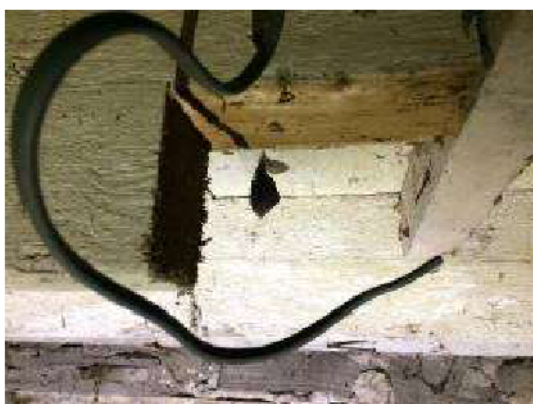
Plate 33: Granary – roosting lesser Horseshoe bat in first-floor room.

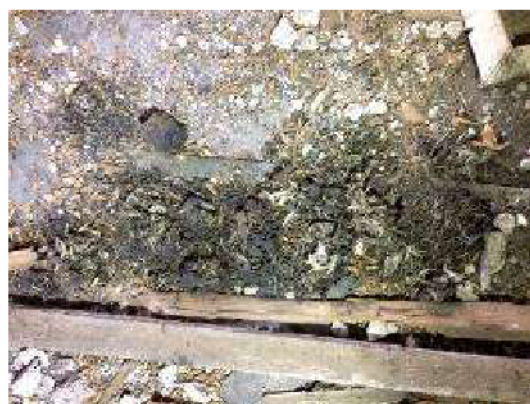
An old barn swallow nest cup was noted on one of the granary roof timbers. A collection of approximately 30 dozen old and mostly disintegrated barn owl *Tyto alba* pellets were present scatted across the floor, below the roof timbers (Plate 34); the pellets were estimated to be several years old, and it is unlikely that this species has roosted on the site recently.

Plate 34: Granary – several dozen old barn owl pellets on the floor of first-floor room, below the roof timbers.

- It is recommended that prior to development works of the building at Warryfield Farm, an inspection by a qualified ecologist is undertaken for fresh evidence of roosting or nesting barn owls. If any evidence is found of nesting/current use, further surveys or mitigation might be required; and
- To mitigate for loss of a barn owl roosting site, an artificial roost/nesting box located away from any likely disturbance, and easily visible to barn owls, should be provided.

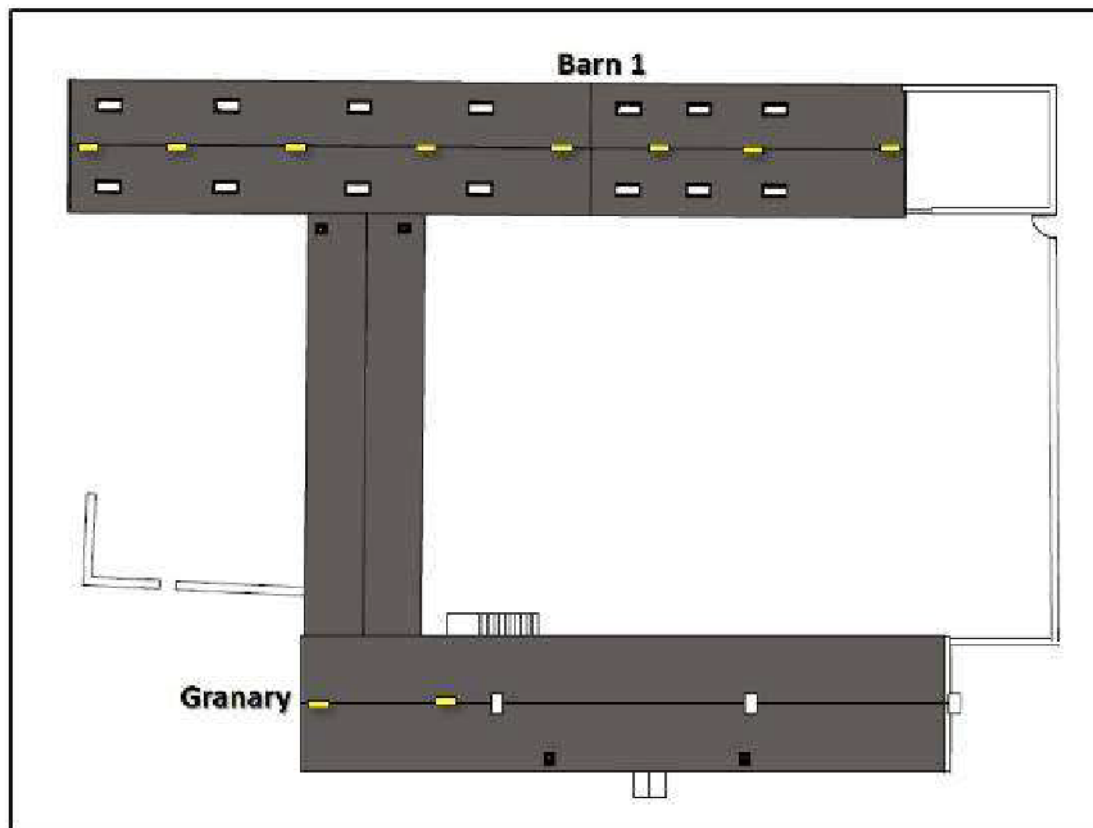
Figure A3.1: Indicative locations (yellow rectangles) of ridge tile bat access gaps or bat access tiles on the roofs of the granary and barn 1.
