Old Castle Lodge Barn
Wilton, Ross-on-Wye
Bat Activity Survey

July 2010

MPEcology

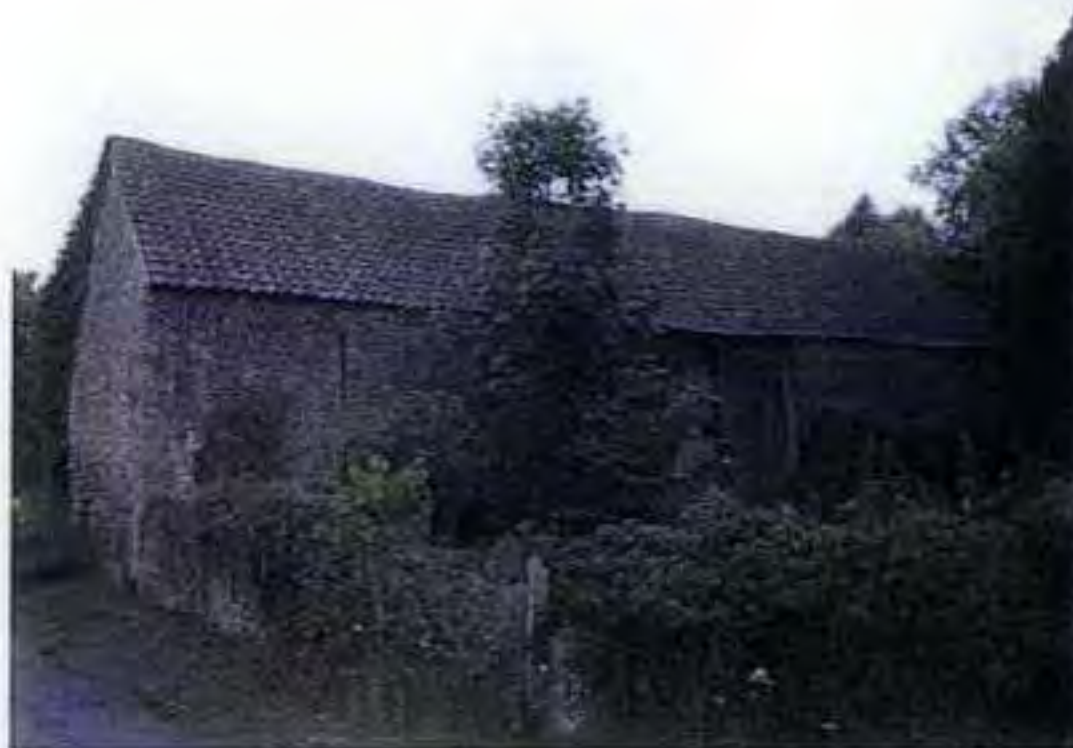
Cover photograph: View of barn from south-east.

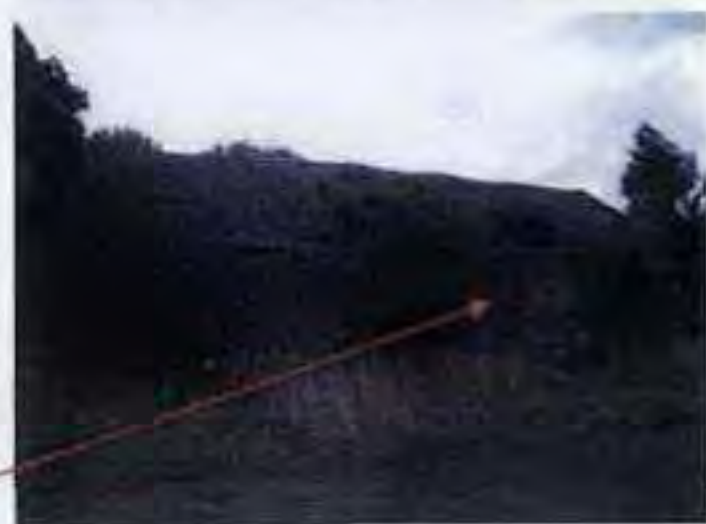
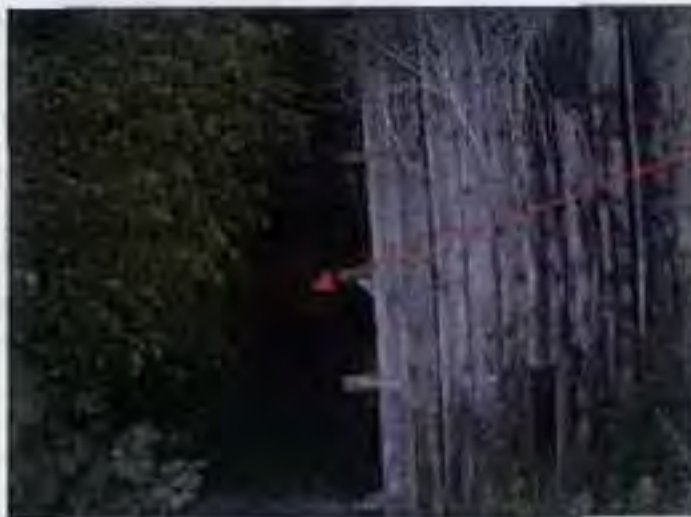
2. An open door immediately adjacent to the hole in the roof, in addition to ventilation slits in the barn walls, allows alternative access point into the barn for bats. Holes and crevices in the roof provide alternative but less obvious potentially entry points to the barn.

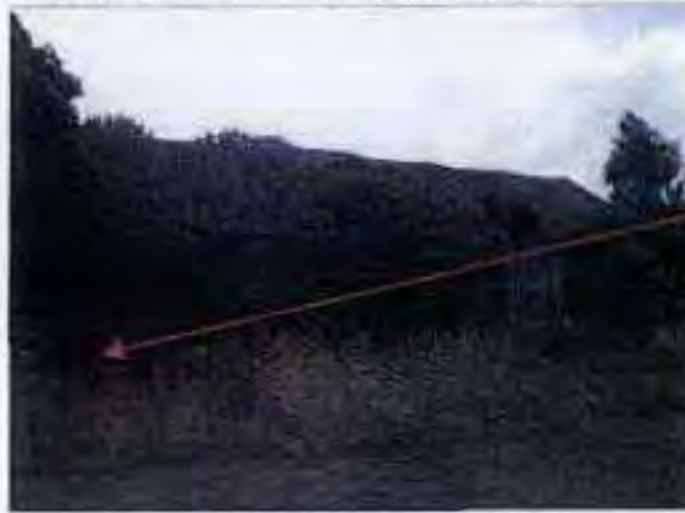
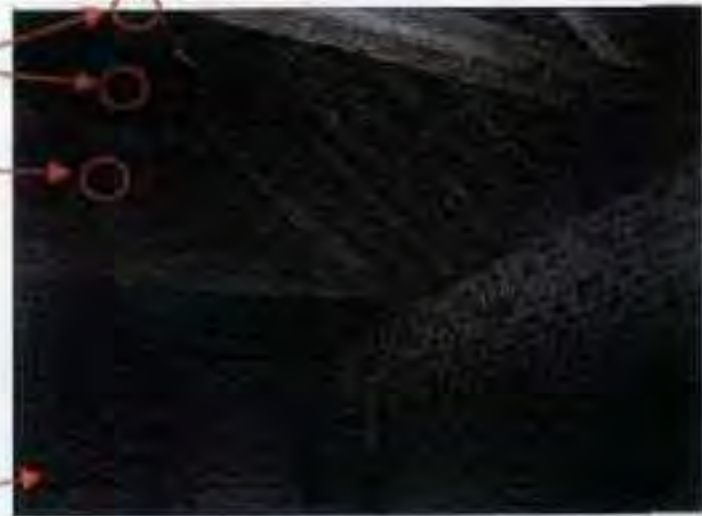
A bat was recorded re-entering a roost beneath ridge tiles in the barn at 0411hrs. A further bat(s) was recorded by video camera flying inside the barn between 0415hrs and 0431hrs but a roost location was not detected.

A bat was recorded at 0433hrs re-entering a different roost beneath ridge tiles to that noted the previous day. A further bat (but possibly two) was recorded by video camera flying inside the barn between 0433hrs and 0441hrs but a roost location was not detected. Both the bat re-entering its roost and subsequent bat appeared to investigate the ridgeline at the northern-most end of the barn. Towards the end of the morning a bat was observed to briefly exit the barn and then re-enter via the section of collapsed roof. This particular bat appeared to favour the ridgeline at the southern end of the barn and sound analysis suggested a species of *Myotis*.

The Castle Lodge barn appears to support a small number of roosting bats probably consisting of one or possibly two male brown long-eared bats and/or a species of *Myotis*. The bats appear to occupy gaps and crevices associated with the ridge tiles which are accessed from inside the barn.

4. Gaps beneath the ridge tiles provide bat roosts at two locations along the barns northern ridge. Bats were also observed by video camera flying up to the apex at the gable end. It is likely roosts are present towards the southern gable also.

Other requirements to safeguard bats would include careful timing of works and targeted ecological supervision particularly when existing tiles are removed from the building.

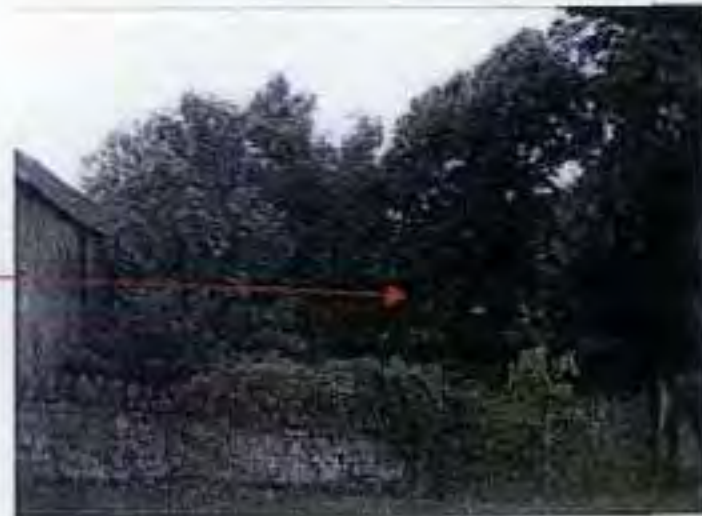
During the lighter period of early evening, probably exacerbated by the flood-lit exterior of the hotel, bats appeared to favour a commuting route following a Leyland Cypress hedge to a sheltered area immediately east of the barn. The shelter, formed by mature trees adjacent to the A40 and eastern side of the barn itself, appeared to be favoured by foraging soprano pipistrelle bats prior to movement across the A40.

5. An area partially enclosed by trees growing on the embankment of the A40 provides a sheltered area on the north-eastern side of the barn. The area is actively used by commuting and foraging soprano pipistrelle bats.

Roof repairs will ultimately retain the potential for roosting bats albeit with modified access points. In addition, careful consideration and implementation of lighting plans to avoid light spill to the east of the property would avoid impact to the commuting routes of other bat species, particularly soprano pipistrelle bats.

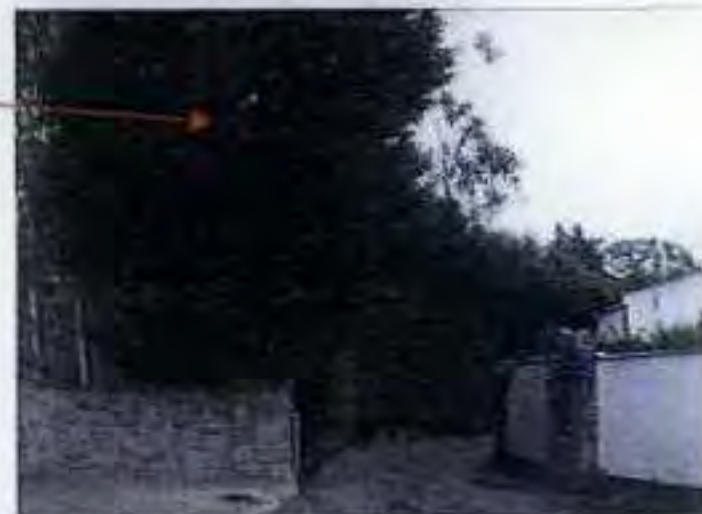
6. A Leyland cypress hedgeline to the south of the barn appears to be used by commuting bats.

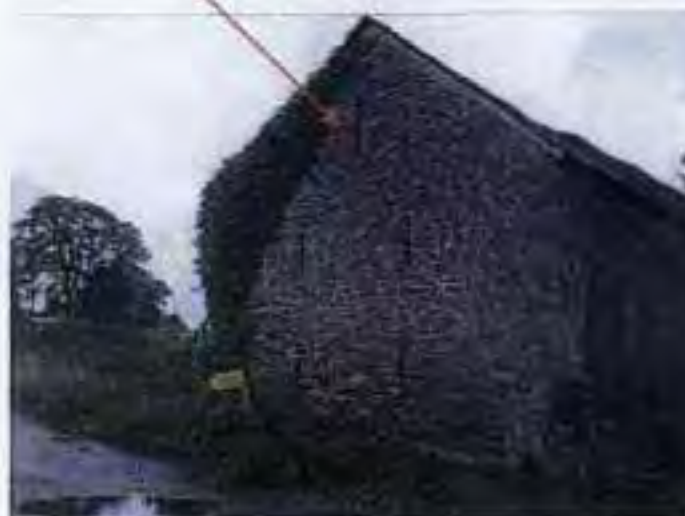
7. The southern gable end is clear of vegetation and potential access is provided by ventilation slits in the barns structure.
