**Re:- Barn C, Upper Grove Farm, Sellack, HR9 6LZ**

## **Barn C, Upper Grove Farm, Sellack, HR9 6LZ**

### **Inspection Notes**

Project:	
Grove Farm	
Client:	
Mr and Mrs P Rimmer	
Drawing:	
Barn C - Existing Structure	
Reference:	
19005/34	
Date:	
May 2020	
Scale:	
1:50 @ A1	
3D Eco

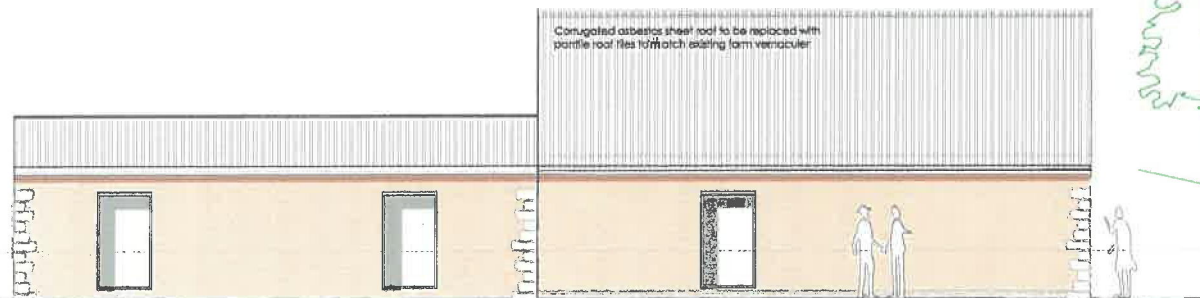
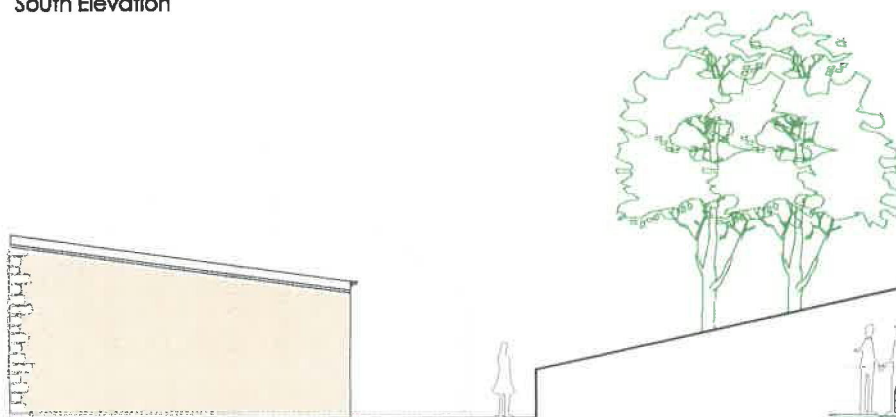
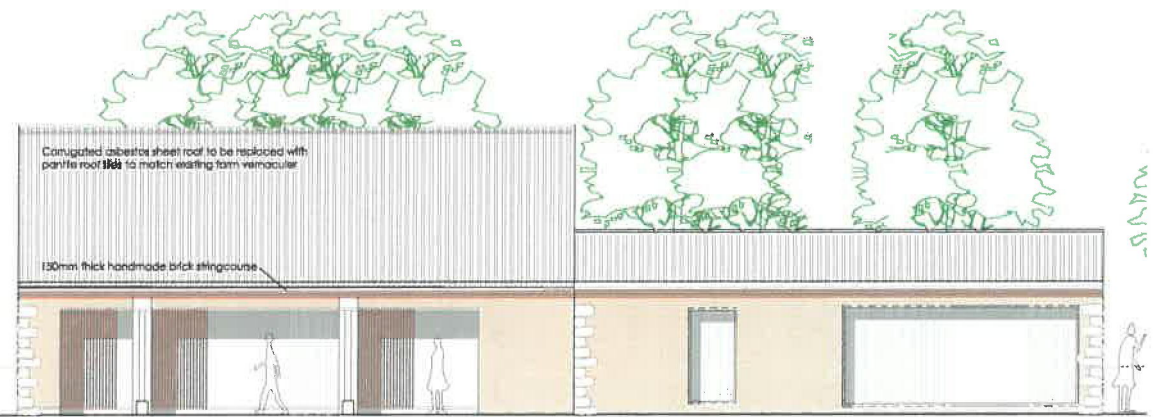
Project:  
Grove Farm  
Client:  
Mr and Mrs P Rimmer  
Drawing:  
Barn C as Proposed  
Reference:  
19005/26  
Date:  
September 2019  
Scale:  
1:50 @ A1

Conversion proposals for “Barn C” are shown on the 3D Eco Planning drawing providing a basic room layout together with external elevations.

I note from the drawing that stonework to the walls on the left hand side will be reinstated to original wall-plate level. The timber posts internally will be reused to support the vaulted ceiling arrangement. In this respect there are beams spanning front to rear with intermediate support from the internal timber posts which are capable of supporting timber joists spanning from side to side.

The floor plan for the right hand part of the Barn replicates that existing to form two bedrooms each with en-suite facilities. The new roof will remain as a mono-pitch spanning front to rear making use of the existing timbers.

In essence, the proposed floor plans and elevations do not require any significant alteration to the original structural load path. To conclude therefore, I consider that conversion of the building to form the required residential accommodation is structurally feasible without need of any major alteration to the original load bearing fabric of the building.
