Florence House Hereford

Preliminary Ecological Appraisal, Bat Survey and Protected Species Assessment

July 2017

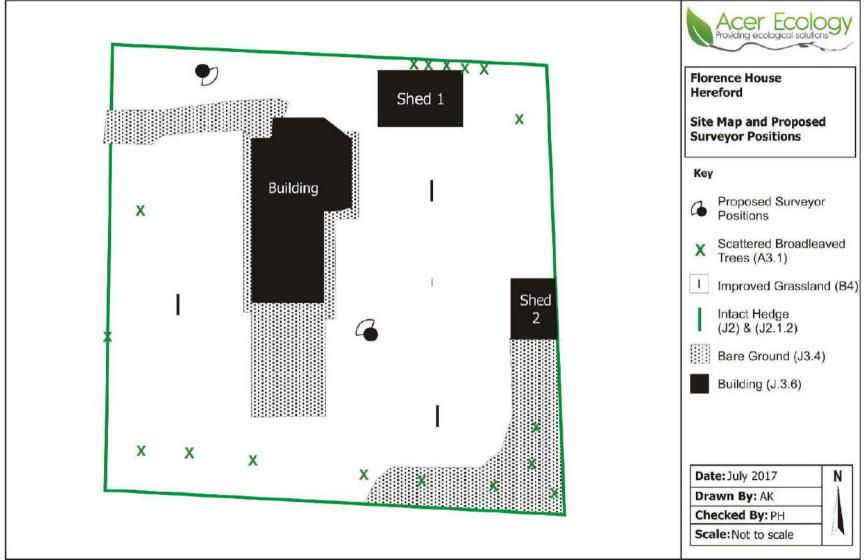
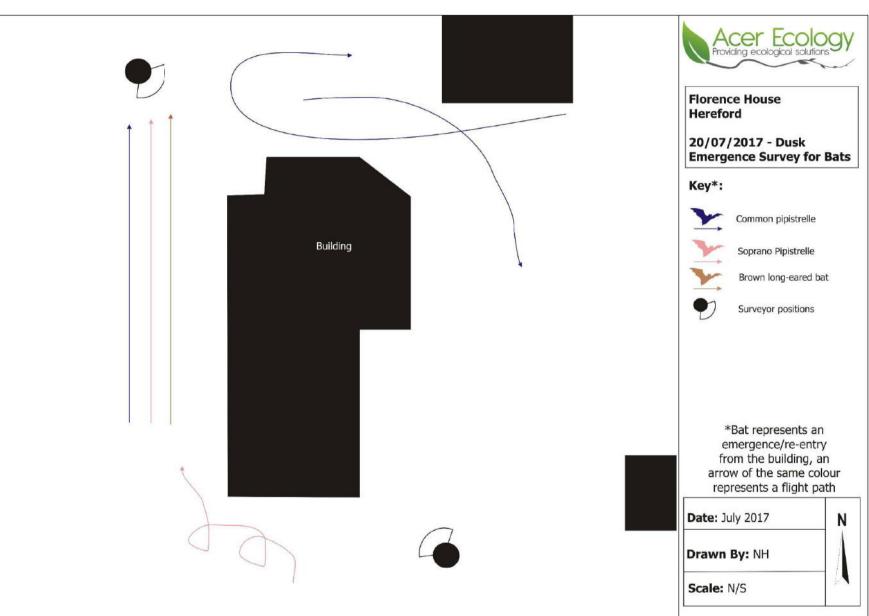
PLAN 2: HABITATS AND VEGETATION AND PROPOSED SURVEYOR POSITIONS FOR DUSK EMERGENCE OR DAWN RE-ENTRY SURVEY

Surveyors were positioned at viewpoints where they had good sight of all the elevations of the building, so that all potential roosting features could be observed to detect any bat emergence from or re-entry to the buildings. In addition, bat activity near the building was also recorded to help ascertain flight lines.
