# **GEOENVIRONMENTAL DESK STUDY AND CONTAMINATION ASSESSMENT REPORT FOR GLENLEITH BARN, ASTON COURT FARM, LITTLE GORSLEY GL18 1PG**

**PREPARED FOR  
J & R DAVIES FARMING PARTNERSHIP**

**Report No. 41**

| <b>Report Production Record</b> | | |
|---|---|---|
| <b>Report on</b> | Geo-Environmental Desk Study and Contamination Assessment | |

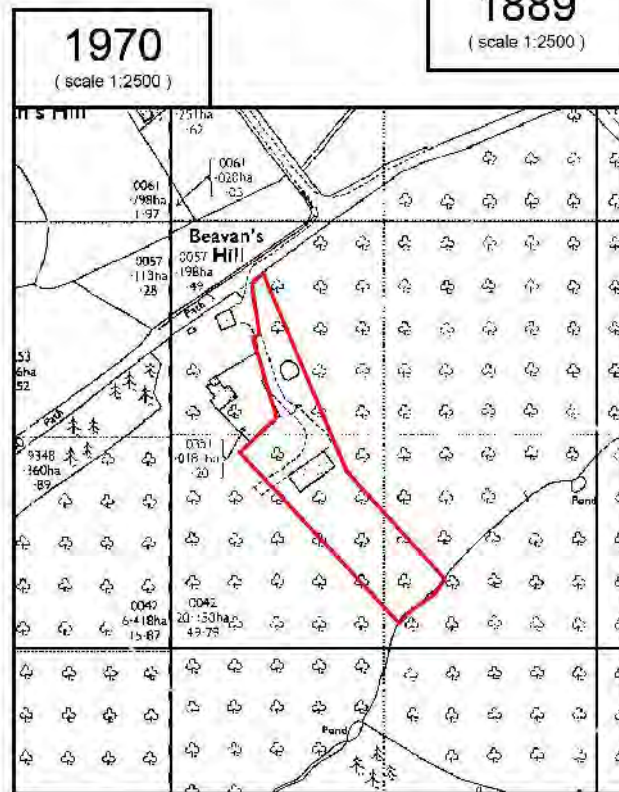
1970

| Date<br>(Source Map<br>Scale) | On-Site Features | Off-Site Features | Contaminants with Potential<br>to affect Site | Likelihood of<br>Site Impact |
|---|---|---|---|---|
| 1970<br>1:2500 | Building appears to be larger<br>due to infill extensions; UST<br>installed? | No significant change | Petroleum hydrocarbons,<br>toxic metals | Moderate |

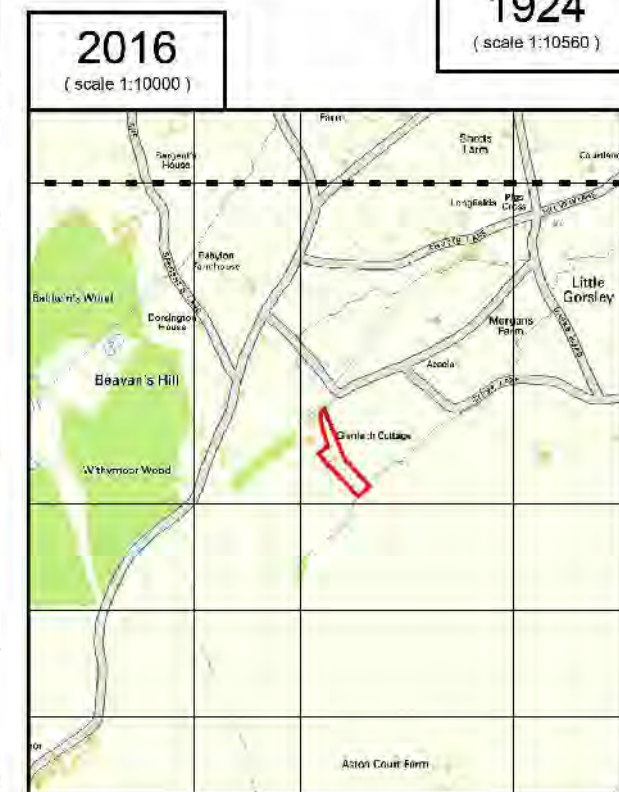
2016

| Date<br>(Source Map<br>Scale) | On-Site Features | Off-Site Features | Contaminants with Potential<br>to affect Site | Likelihood of<br>Site Impact |
|---|---|---|---|---|
| 2016<br>Present day | No significant change | No significant change | As above | As above |

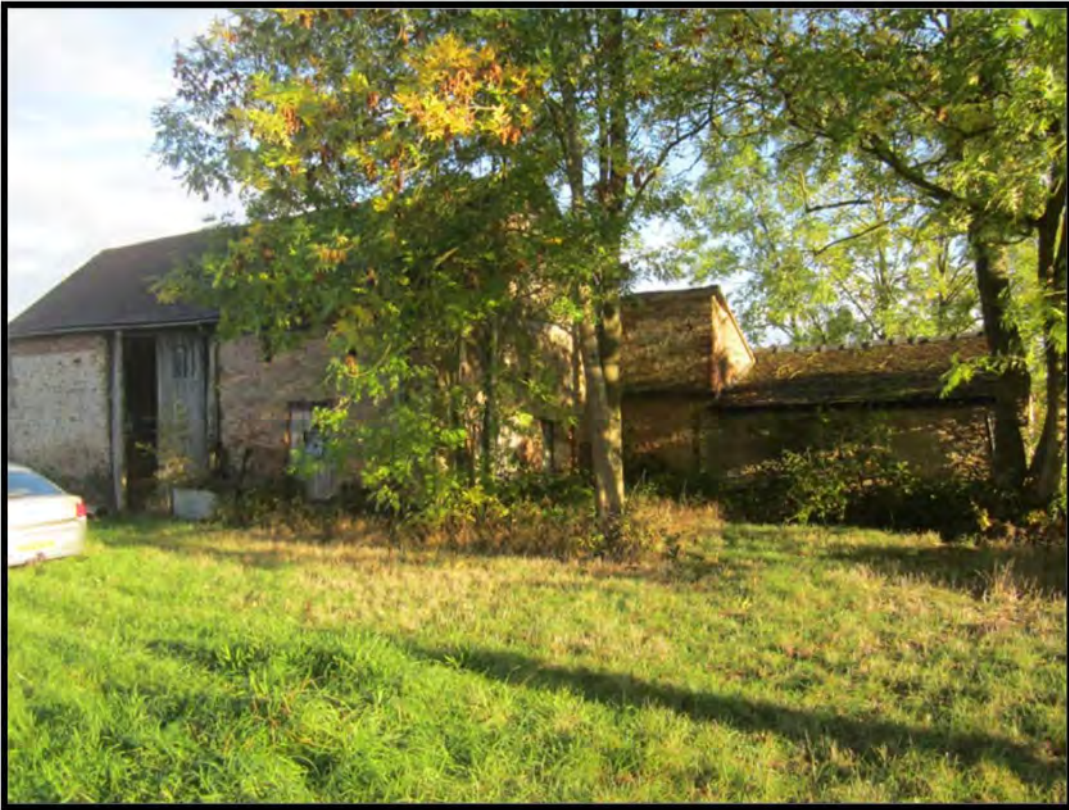
Photograph **P1**: showing northwest elevation of barn

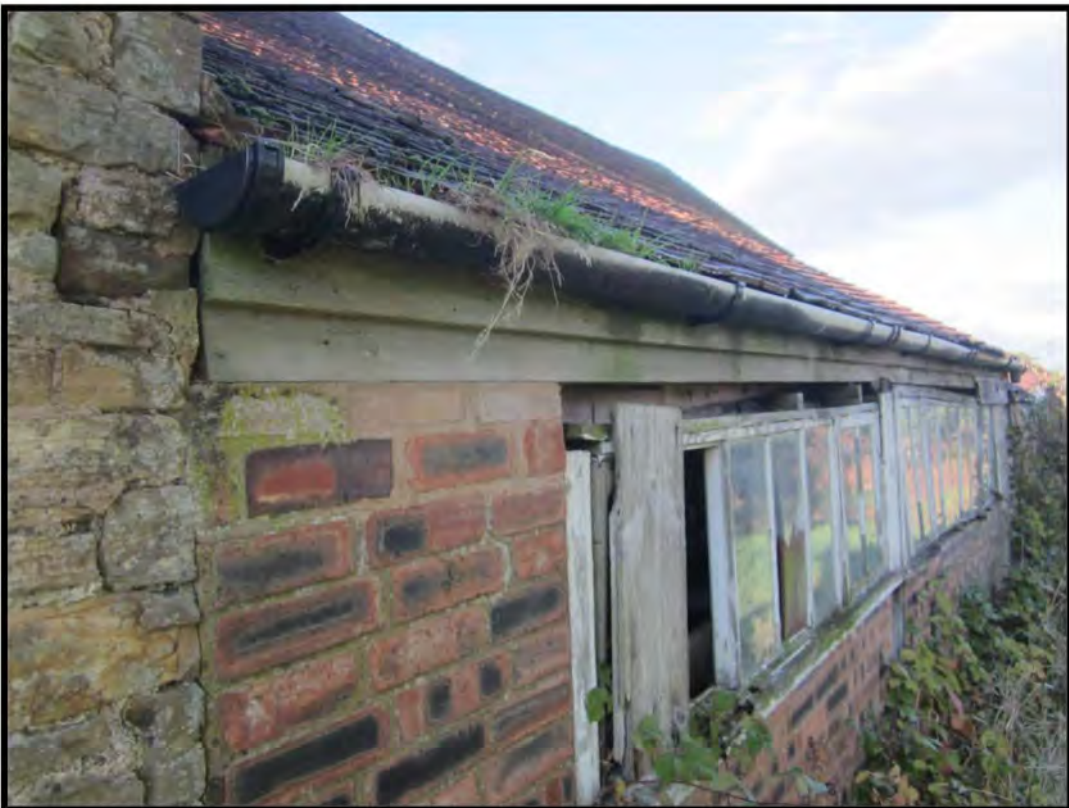
Photograph **P2**: showing clay-tiled roof and plastic guttering

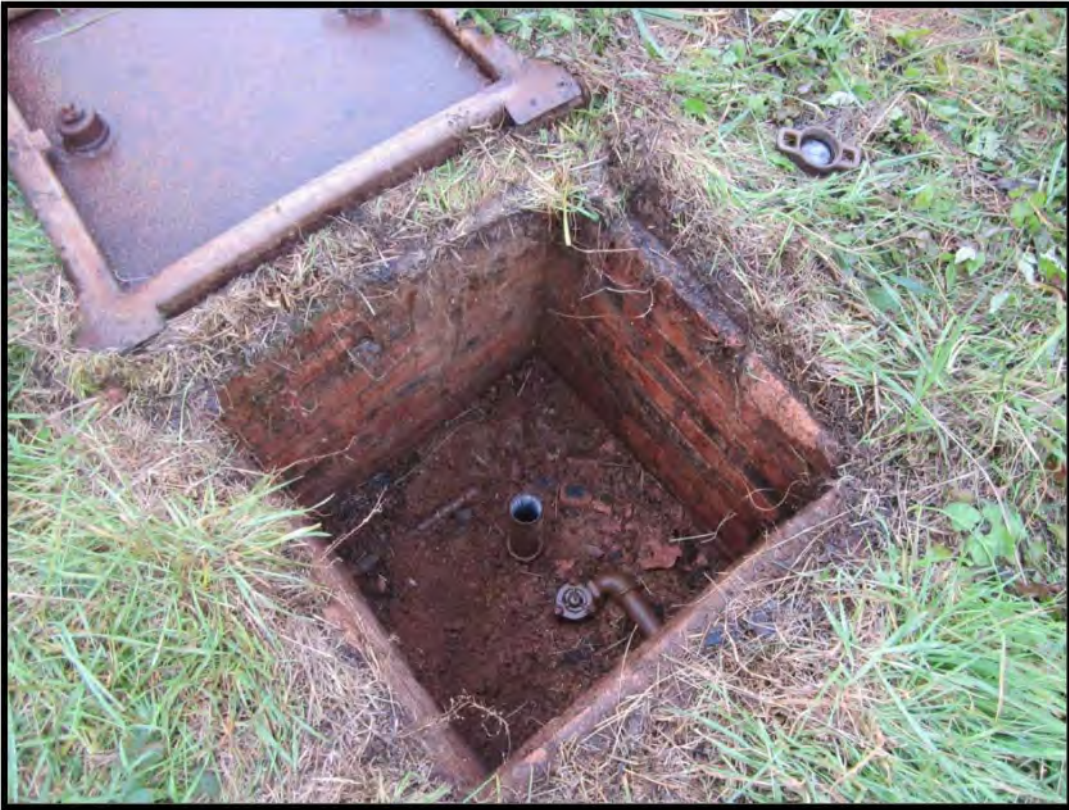
used by the decommissioning contractor when considering disposal options. As previously noted the fact that the UST is holding water is taken as a sign that there is unlikely to have been any long-term leakage via rust-holes or other breaches, this it is envisaged to remain intact. Normal UST decommissioning procedure would be to de-gas it, pump out any residual fuel/water content then remove it from the ground; all water/sludge arisings normally undergo controlled removal and landfill disposal by the licensed contractor, and often the remnant UST is cold-cut for disposal as scrap metal.

Photograph **P3**: showing UST fill-chamber

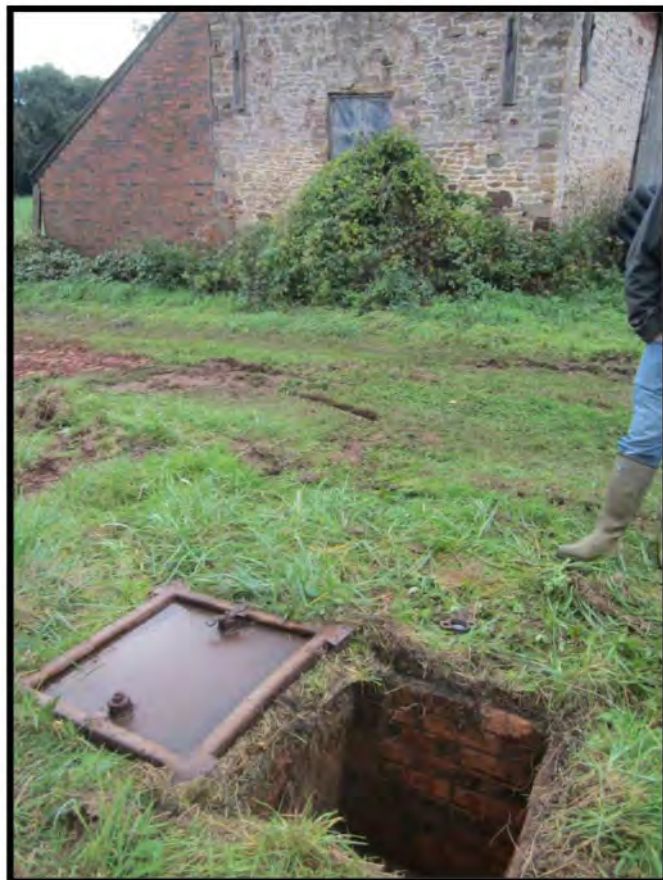
Photograph **P4**: showing UST position relative to X corner of barn

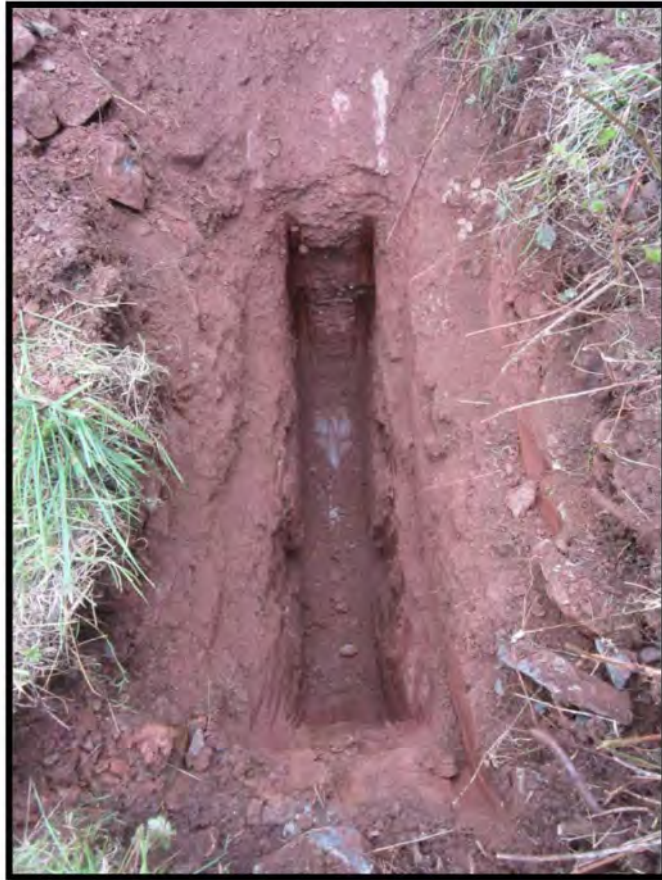
- 6.2 The fact that the UST was holding water suggested it unlikely to have suffered long-term product leakage, but as a precaution TP1 and TP2 were excavated at c5m distance on the downslope sides to both north and south (see drawing 4119/2). As shown in Appendix 1 there was no visual or olfactory evidence of near-surface hydrocarbon impaction or a plume at depth, with both pits instead encountering clean reddish-brown clay grading to weathered mudstone, and it was agreed with the Petroleum Officer (in attendance) that laboratory testing was not needed. Water contained within the UST possessed a petrol odour but no evidence of free-phase L/DNAPL (light/dense non-aqueous phase liquid) product; a sample was taken for speciated hydrocarbon analysis to inform an options appraisal in terms of decommissioning and disposal.

Photograph **P5**: showing TP1

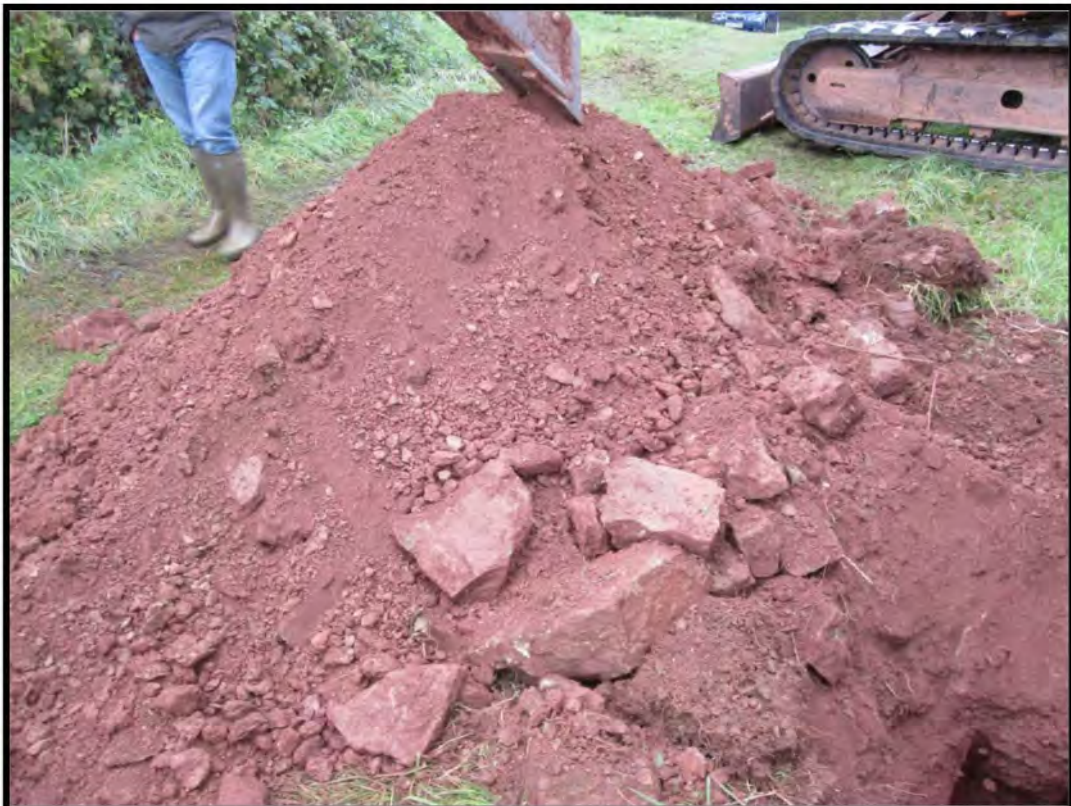
Photograph **P6**: showing TP1 arisings

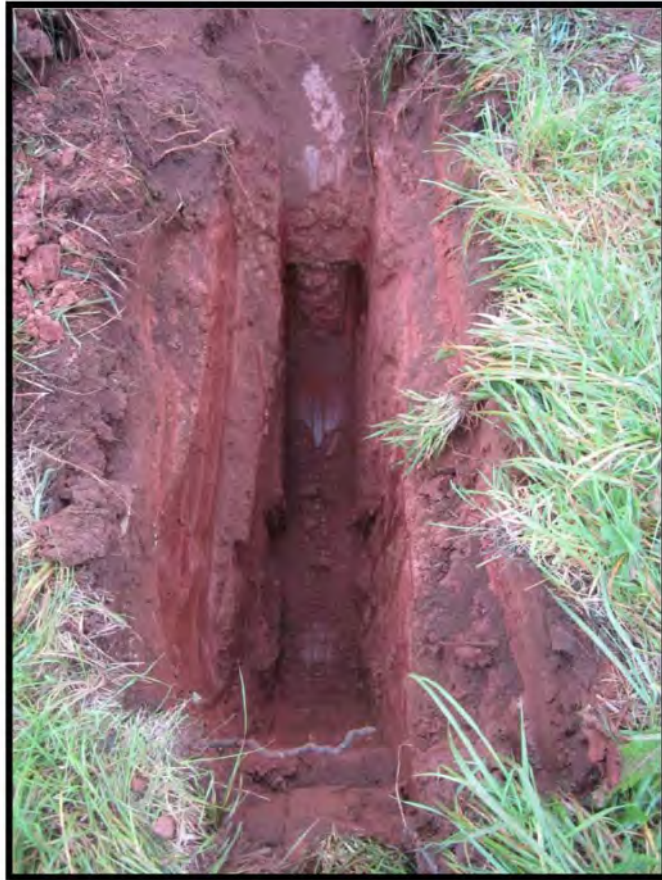
Photograph **P7**: showing TP2

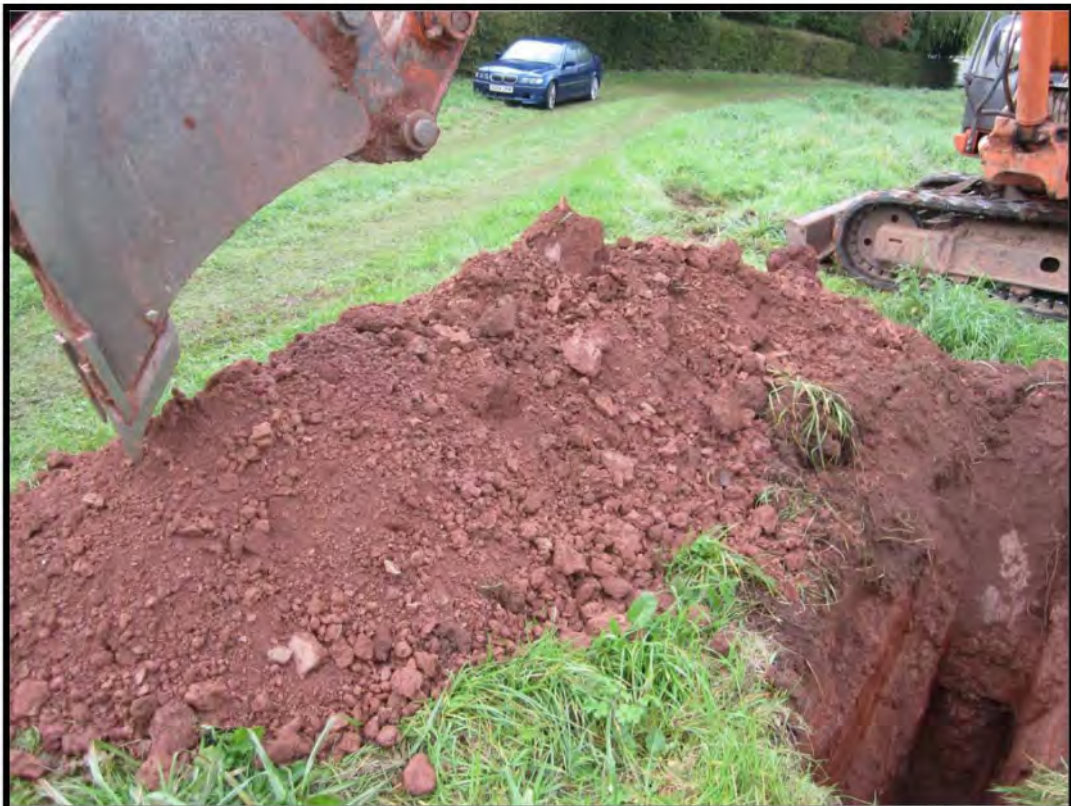
Photograph **P8**: showing TP2 arisings

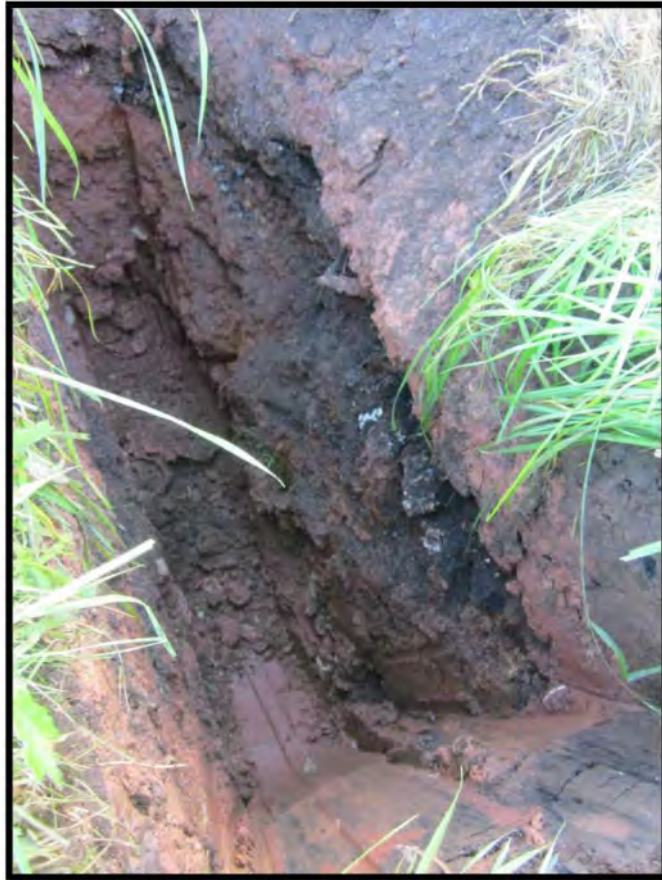
- 6.3 The former pond was marked out by reference to historic OS mapping and TP3 was excavated on that position. Beneath surface topsoil this encountered a layer of very loose made ground to 0.9-1.0m, comprising whole and broken bottles and pottery with occasional rusty metal all in a dark grey ash matrix. This is typical of pond backfill and probably comprises historic domestic waste from the adjacent cottages; there was no evidence of significant organic or any asbestos content, and none of a natural basal organic silt layer. Beneath the backfill natural ground comprised reddish-brown plastic clay, with no evidence of downward leaching of contaminants. Representative soil samples were taken for analysis.

Photograph **P9**: showing TP3 showing backfilled pond

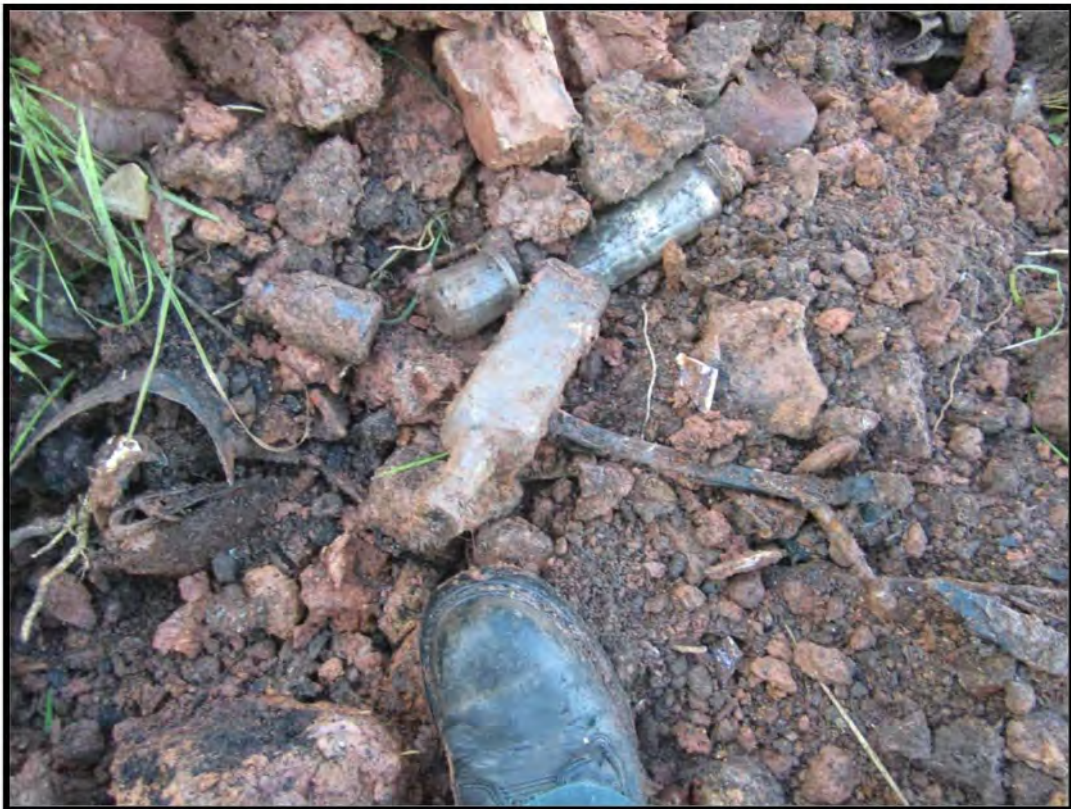
Photograph **P10**: showing pond backfill

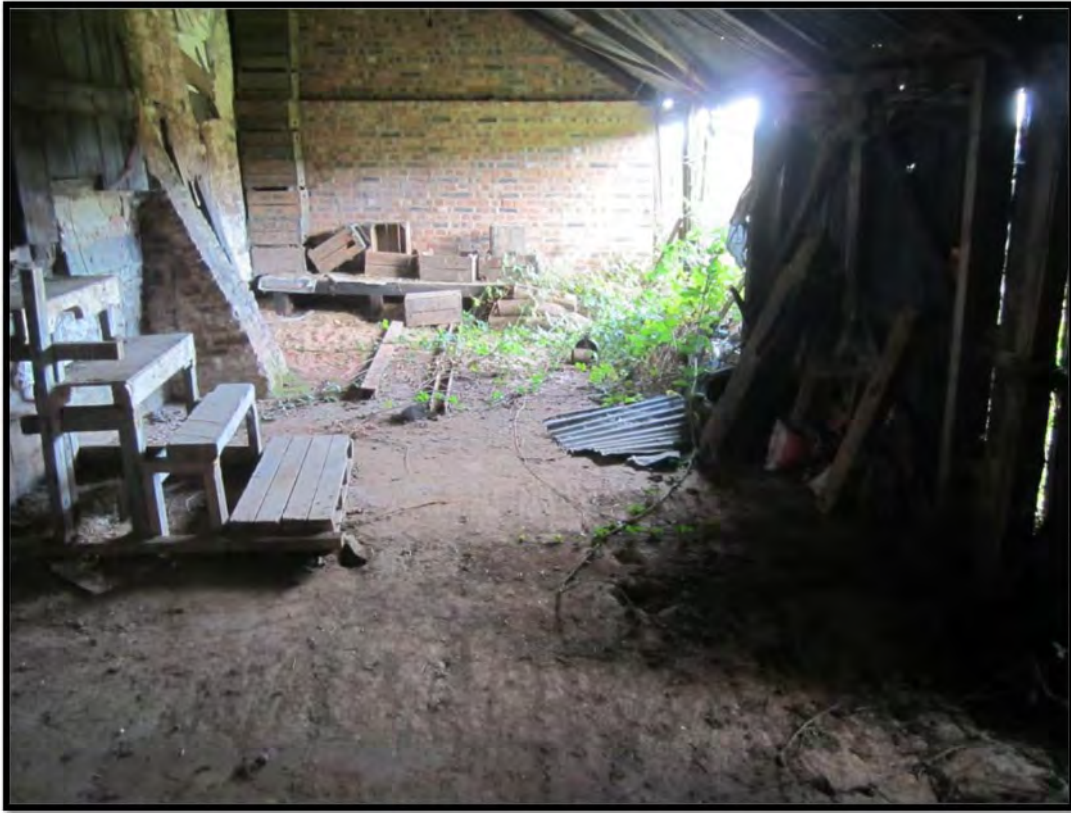
Photograph **P11**: showing internal south side

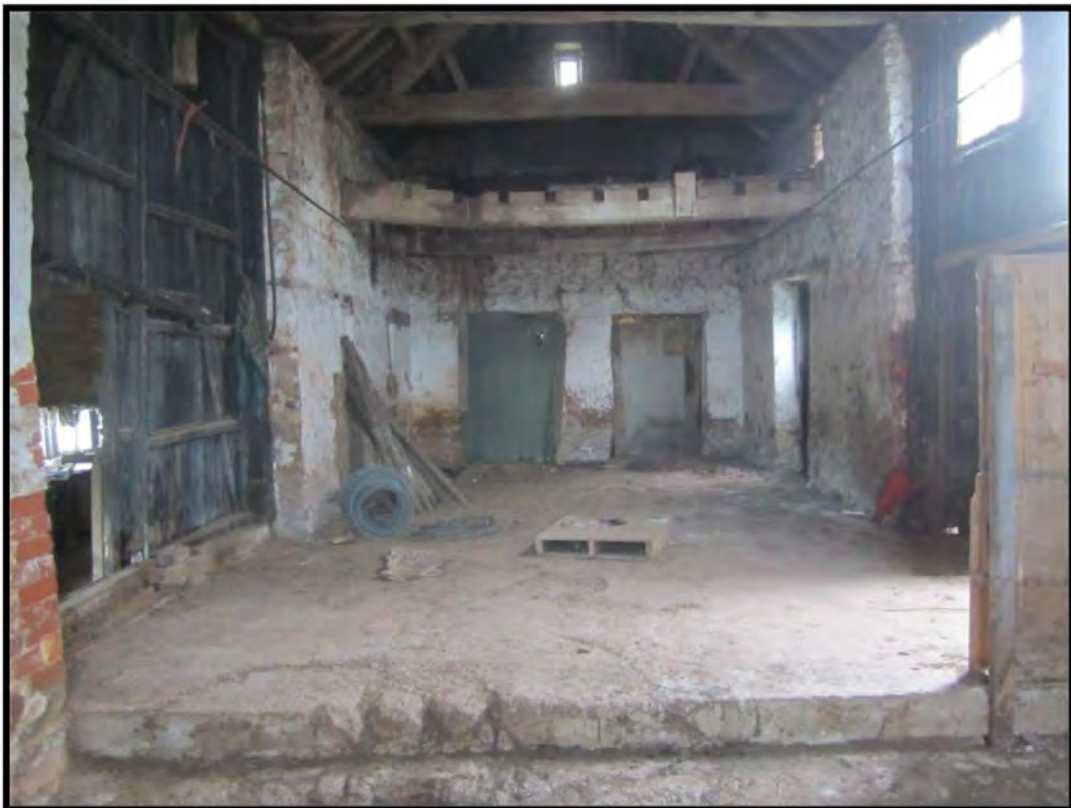
Photograph **P12**: showing internal north side

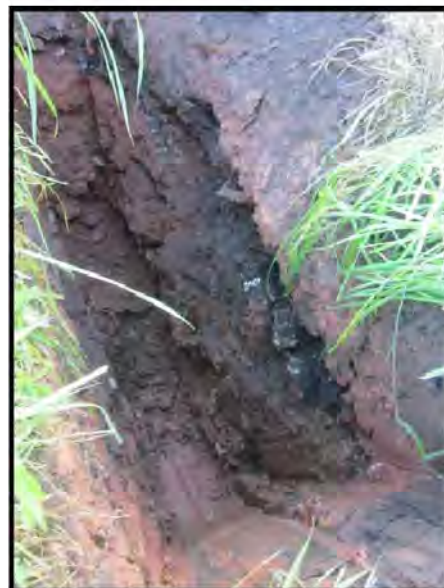
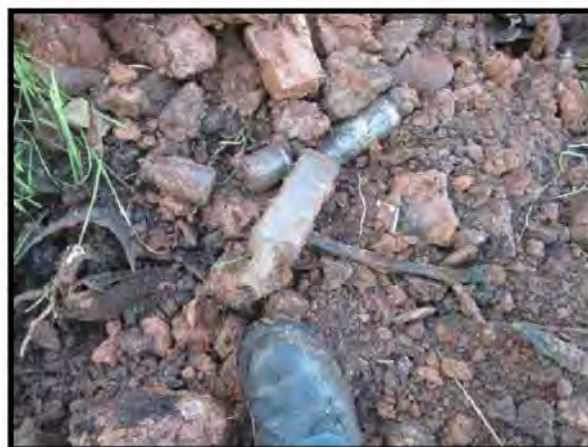
| Site: GLENLEITH BARN, ASTON COURT FARM, LITTLE GORSLEY, GL18 1PG | | | | TRIAL PIT No.<br><br><b>TP3</b> |

- A TOPSOIL: firm, dark brown, silty and organic CLAY
- B MADE GROUND: very loose, whole and broken bottles and broken pottery in dark grey ash matrix; occasional rusty metal and pottery (no significant organics)
- C CLAY: stiff, reddish brown, slightly silty and friable; no evidence of downward leaching of any contaminants

- 1 Pit logged from surface
- 2 Pit dry and stable
- 3 Soil samples taken at 0.1m, 0.2-0.9m, 1.0-1.2m and 1.2m depths
