GROUND INVESTIGATION REPORT FOR LAND AT THE OLD POTATO STORE, MILL LANE, FOWNHOPE, HEREFORDSHIRE, HR1 4NN

Report No. 4704

Report Production Record		
Report No	4704	
Site Name	Land at the old Potato Store, Mill Lane, Fownhope, Herefordshire, HR1 4NN	
Client	David Watkins (via M F Freeman Limited)	
Report on	Ground Investigation	
Prepared by	Richard J Stokes BSc (Hons) FGS

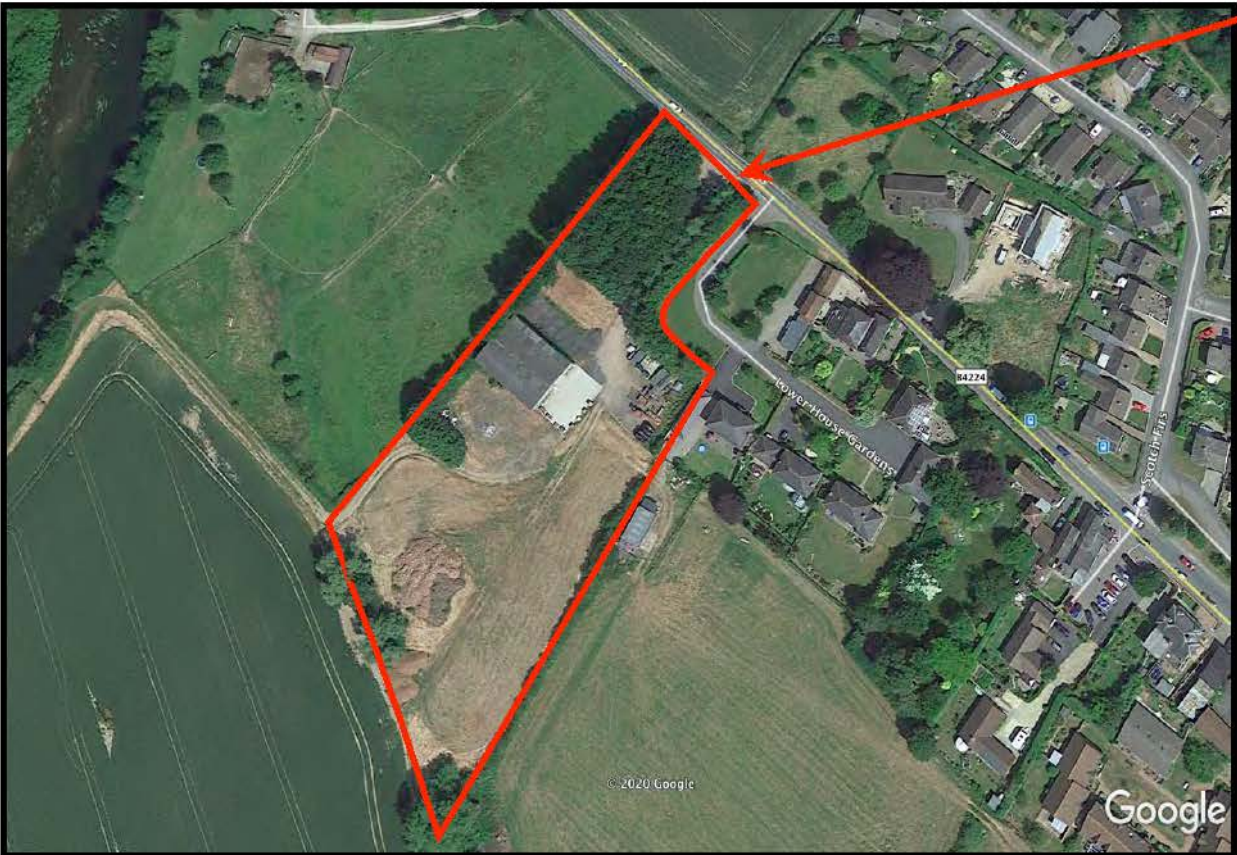
EXISTING SITE PLAN (based upon Andrew P Jones drg. 41-101-B, dated April '15) SHOWING SITE WALKOVER NOTES

THE SITE

- 2.3** A walkover survey was undertaken by this Practice prior to site investigation and representative photos are presented in Appendix 1. This identified the site to comprise a large agricultural barn/warehouse with a hardstand yard area, small woodland and access track to the north and open field to the south. The barn/warehouse is a typical (presumed) steel portal framed construction with steel cladding and roofing sheets of suspected possible Asbestos Containing Materials (pACM) which appeared to be in good unbroken condition. No internal access for inspection was possible. The yard area predominantly comprised packed gravel with an area of concrete immediately in front of the barn/warehouse. This area was locally strewn with glass and used for the storage of wooden pallets, with a wooden crate containing broken television sets, fridges and other miscellaneous items. To the immediate south of the warehouse were two small mounds of brick, wood and other miscellaneous items. The grassed areas appeared healthy with no evidence of contamination. There are a significant number of on and off-site trees including but not limited to ash, birch, conifer, hawthorn, maple, poplar and oak (refer to drawing 4704/2 for details).

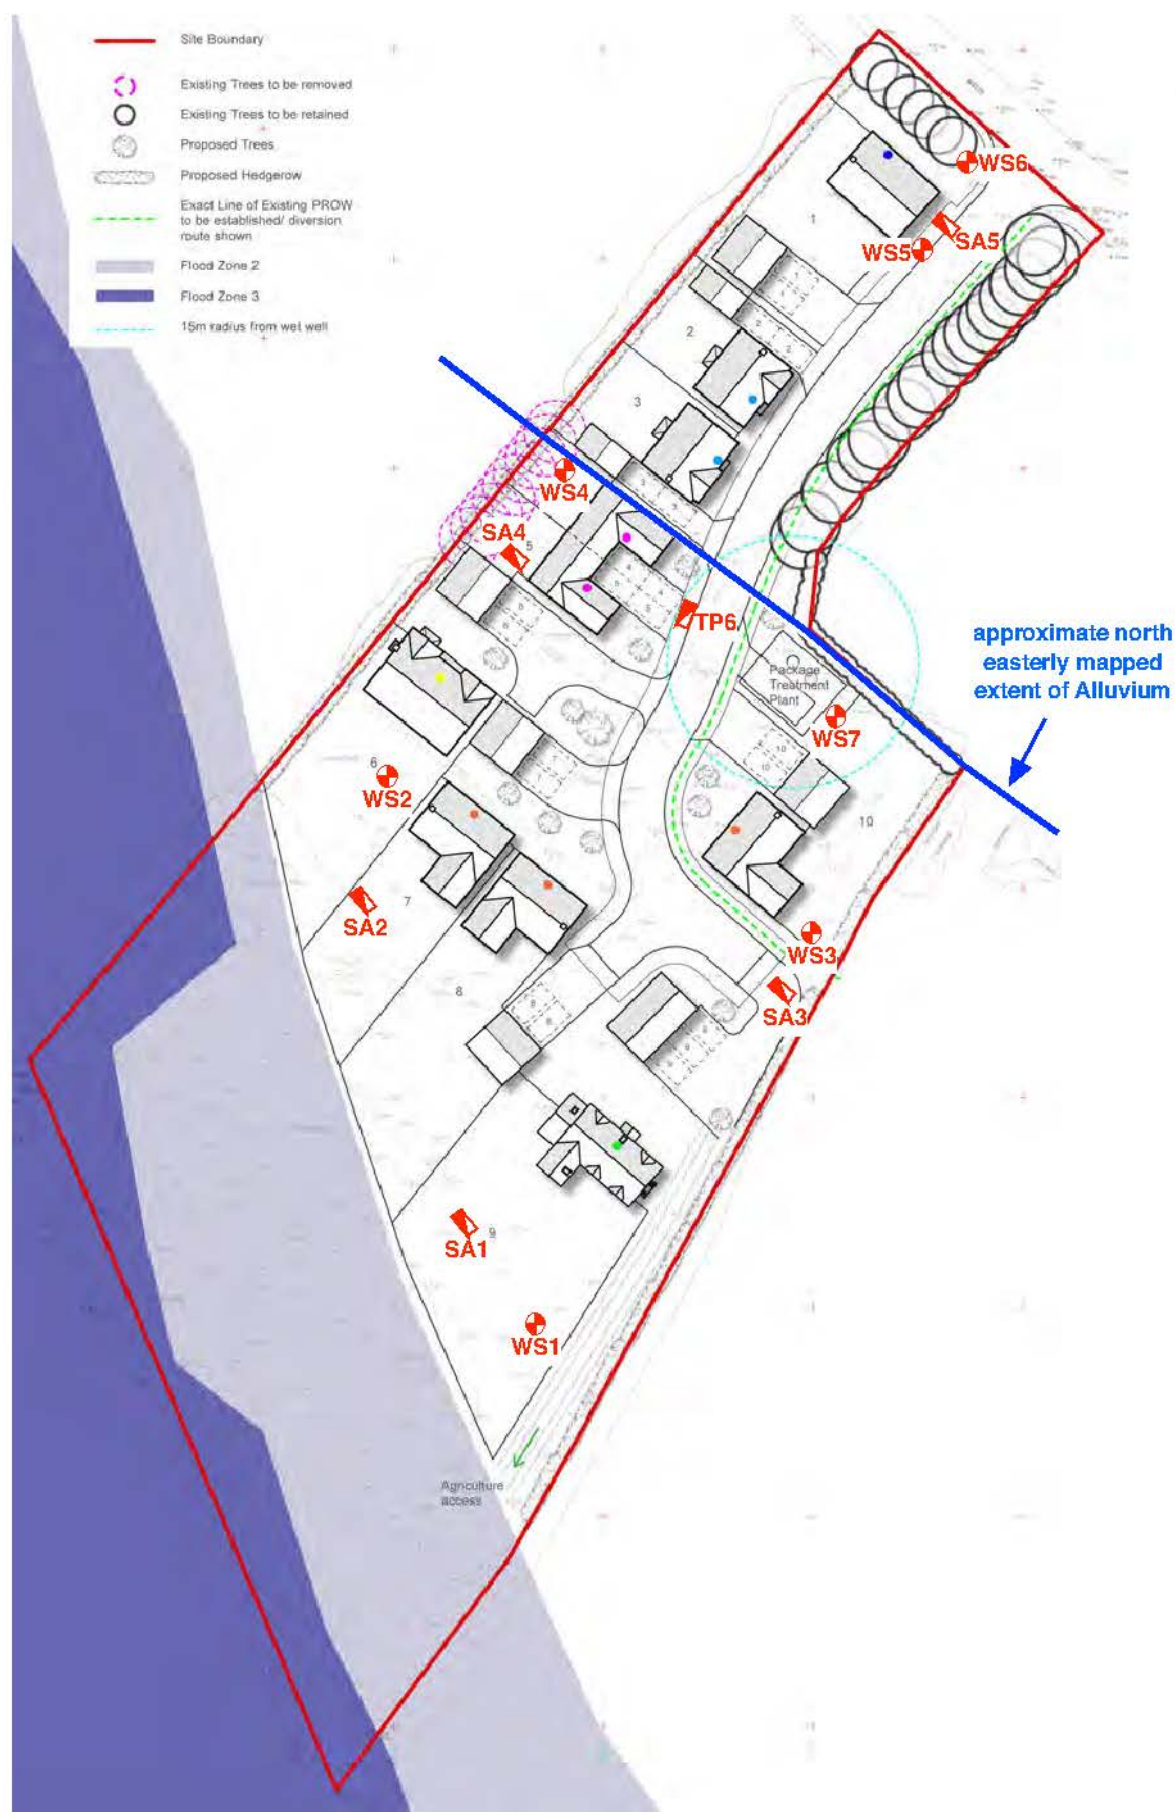
Job No. 4704	Drawing No. 4704/3	Scale: c1:1000@A4	Date: 21-08-20
-----------------	-----------------------	----------------------	-------------------

PROPOSED DEVELOPMENT LAYOUT (based upon Quattro drg. 6339-F-100 Rev D, dated May '20) SHOWING INVESTIGATION LOCATIONS

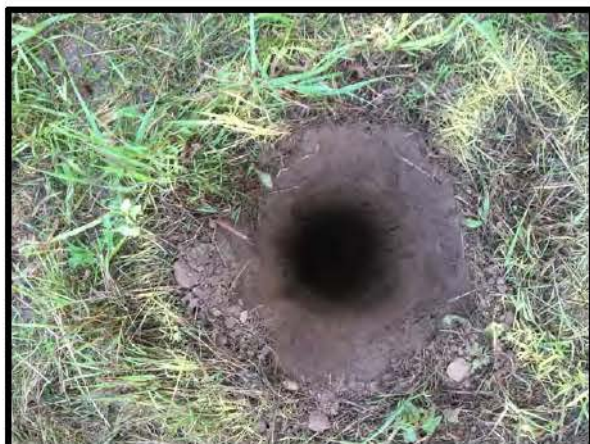
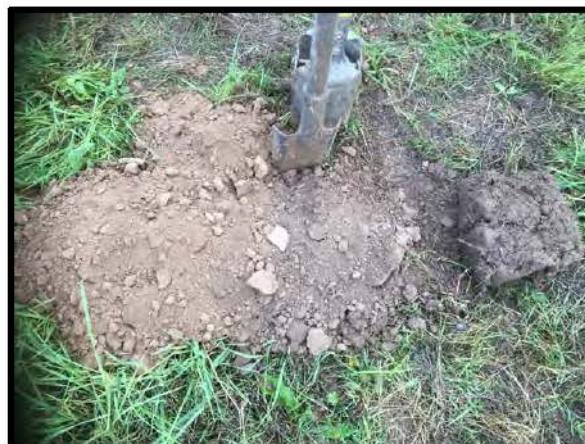
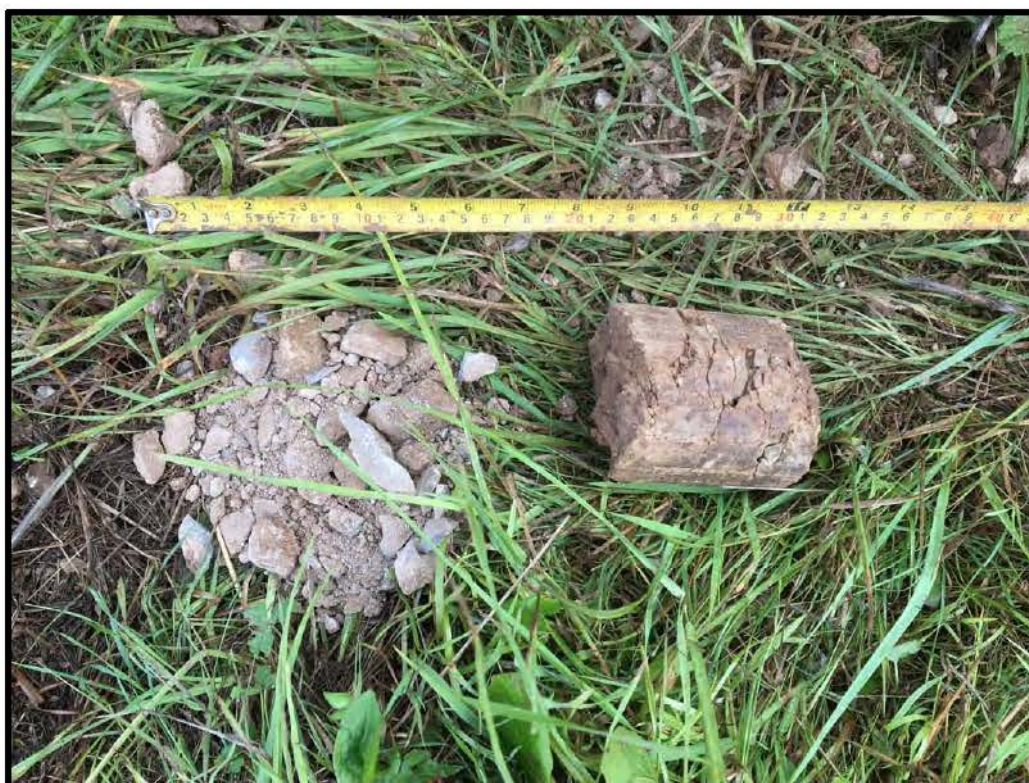
Project LAND AT OLD POTATO STORE, MILL LANE, FOWNHOPE, HEREFORDSHIRE HR1		Borehole No. WS1
Job No. 4704	Date: 20-08-20

Hand-dug starter pit

Hand-dug starter pit arisings

Borehole Core

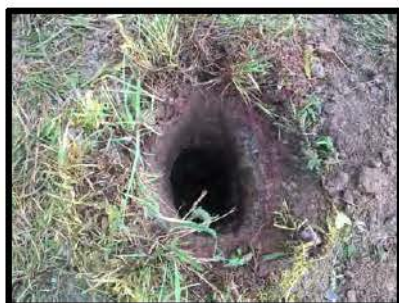
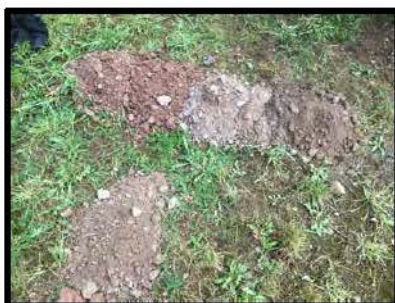
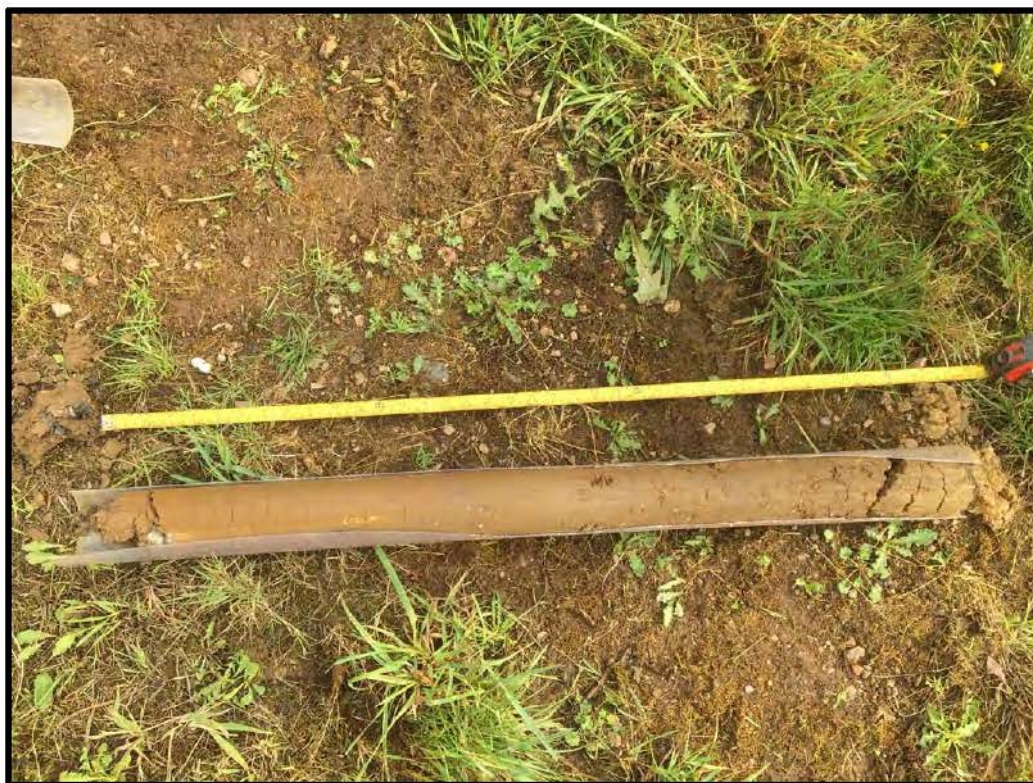
Project LAND AT OLD POTATO STORE, MILL LANE, FOWNHOPE, HEREFORDSHIRE HR1		Borehole No. WS2
Job No. 4704	Date: 20-08-20

Hand-dug starter pit

Hand-dug starter pit arisings

Borehole Core

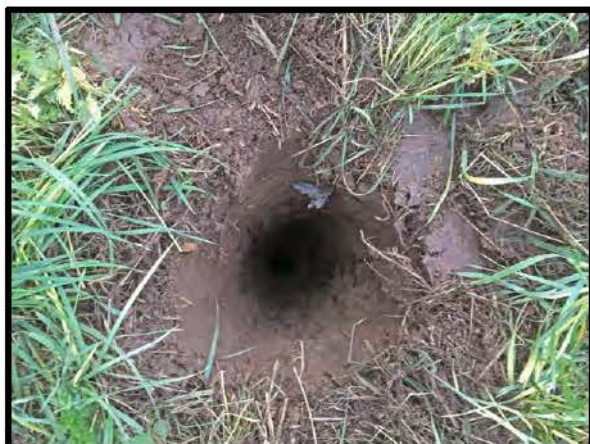
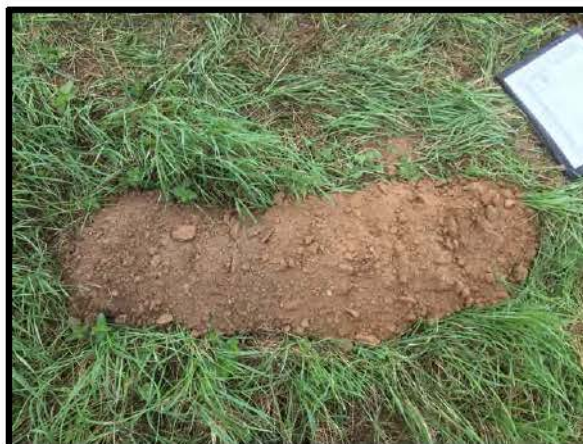
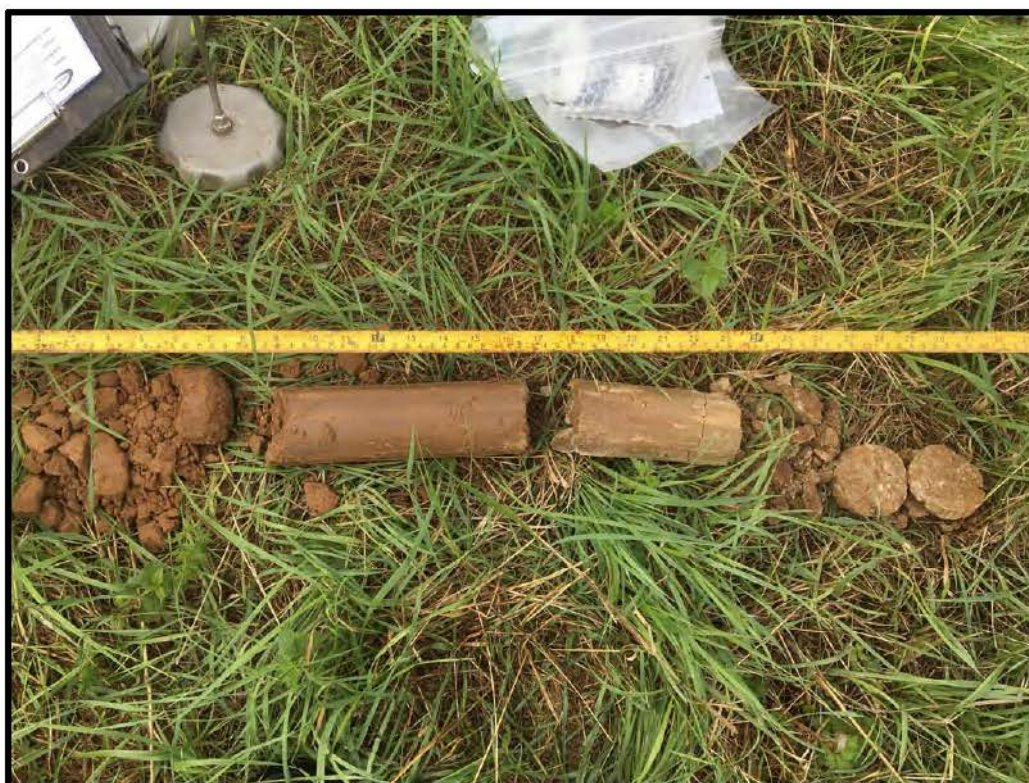
Project LAND AT OLD POTATO STORE, MILL LANE, FOWNHOPE, HEREFORDSHIRE HR1		Borehole No. WS3
Job No. 4704	Date: 20-08-20

Hand-dug starter pit

Hand-dug starter pit arisings

Borehole Core

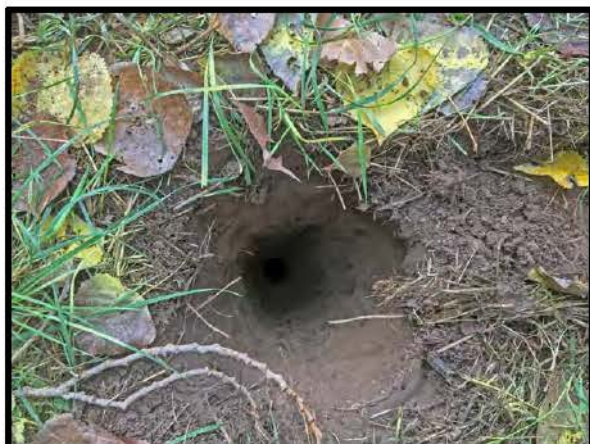
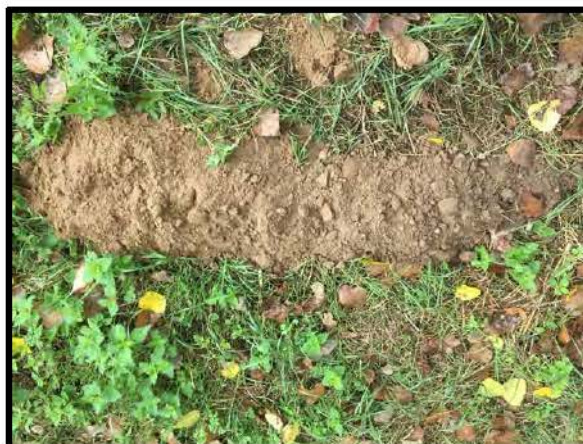
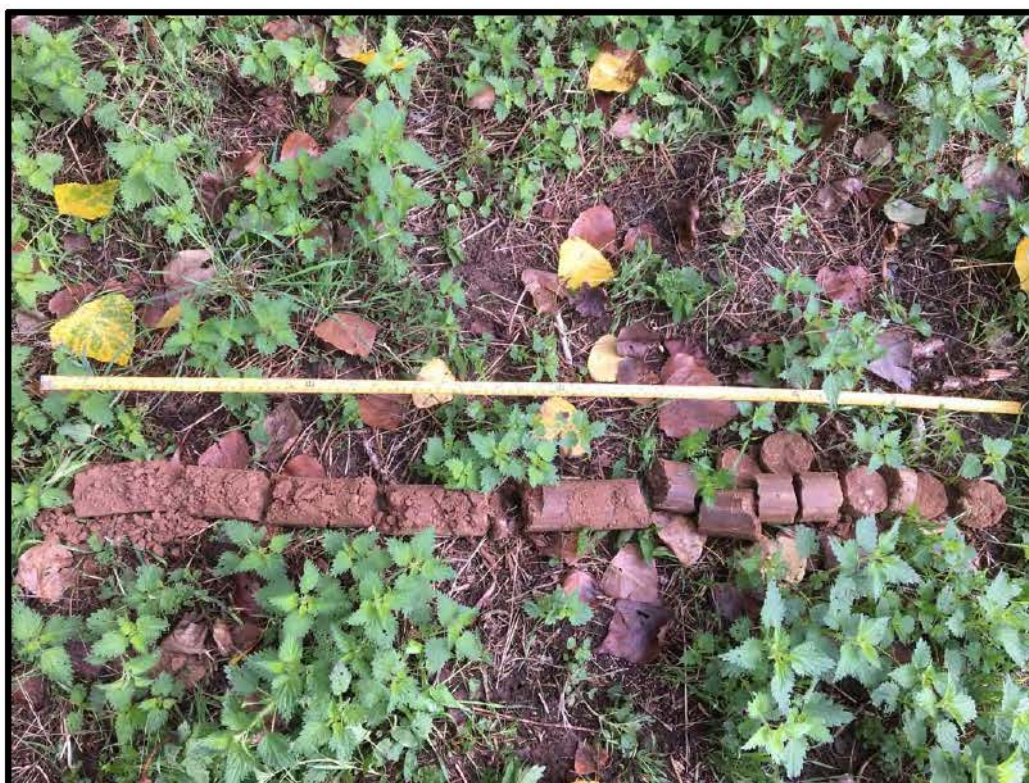
Project LAND AT OLD POTATO STORE, MILL LANE, FOWNHOPE, HEREFORDSHIRE HR1		Borehole No. WS4
Job No. 4704	Date: 20-08-20

Hand-dug starter pit

Hand-dug starter pit arisings

Borehole Core

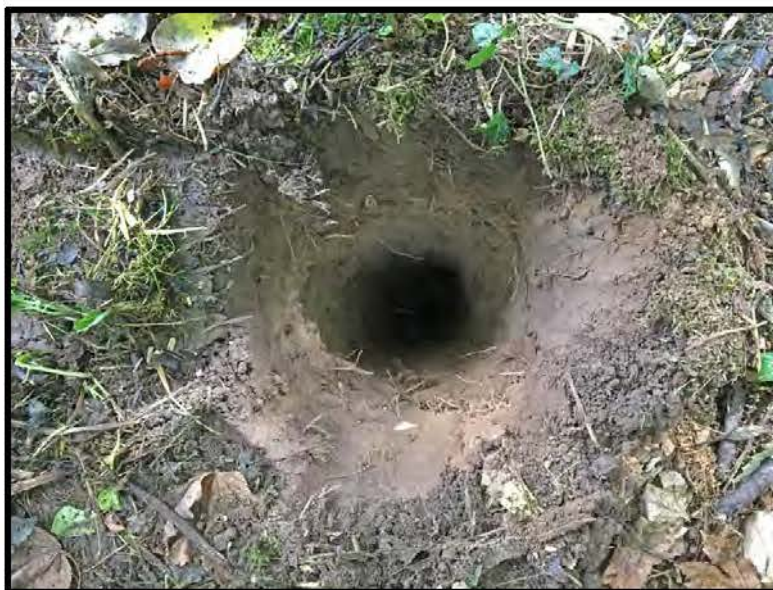
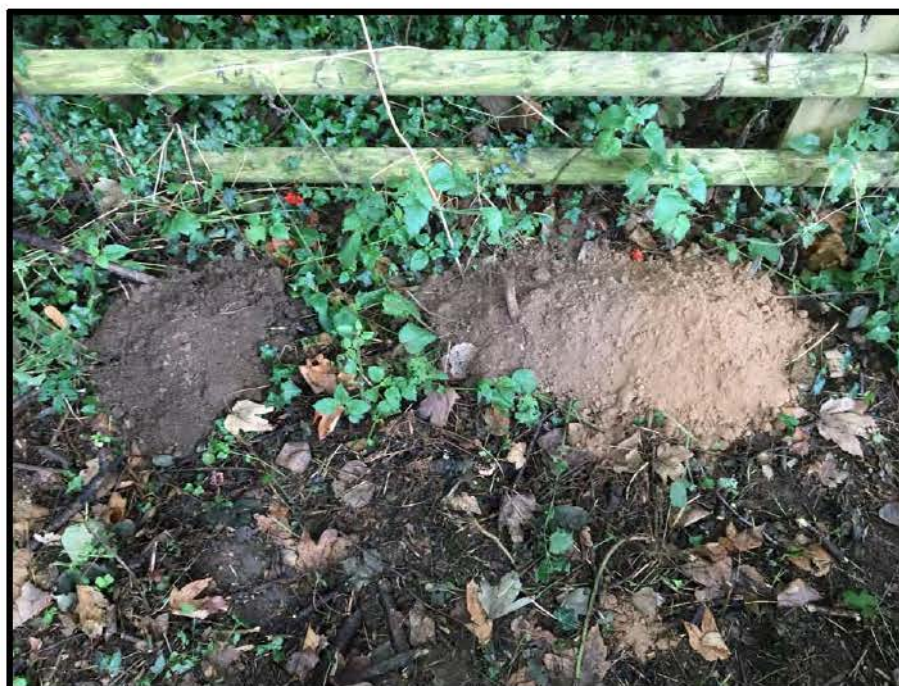
Project LAND AT OLD POTATO STORE, MILL LANE, FOWNHOPE, HEREFORDSHIRE HR1		Borehole No. WS5
Job No. 4704	Date: 20-08-20

Hand-dug starter pit

Hand-dug starter pit arisings

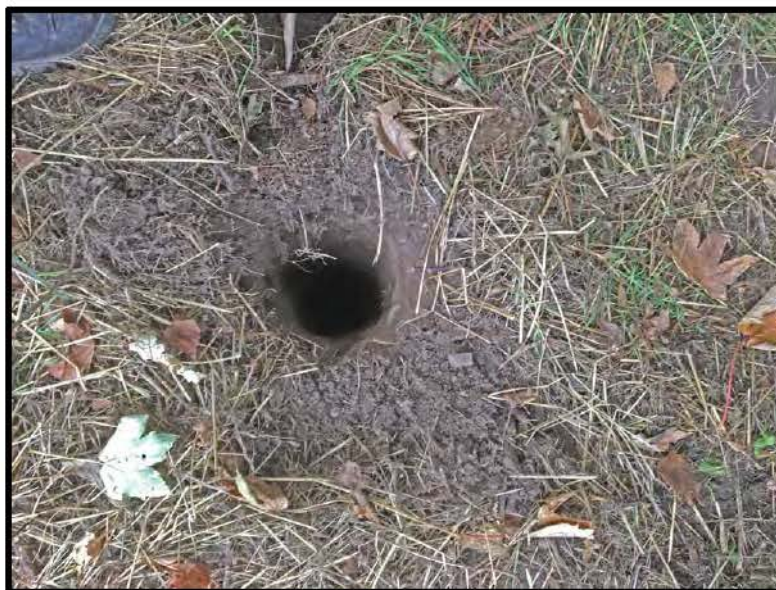
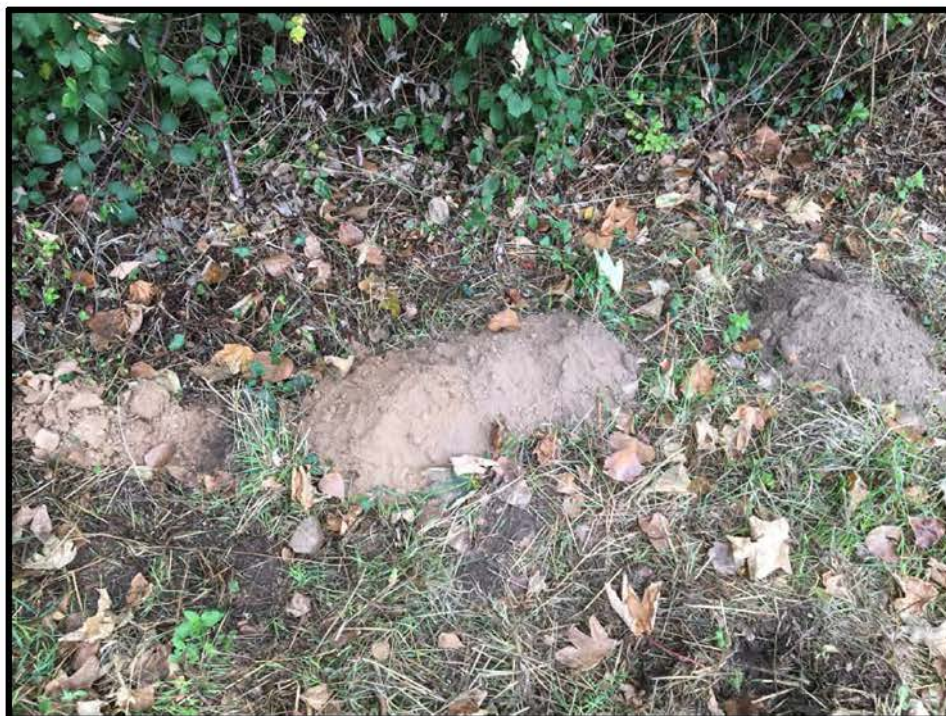
Project LAND AT OLD POTATO STORE, MILL LANE, FOWNHOPE, HEREFORDSHIRE HR1		Borehole No. WS6
Job No. 4704	Date: 20-08-20

Hand-dug starter pit

Hand-dug starter pit arisings

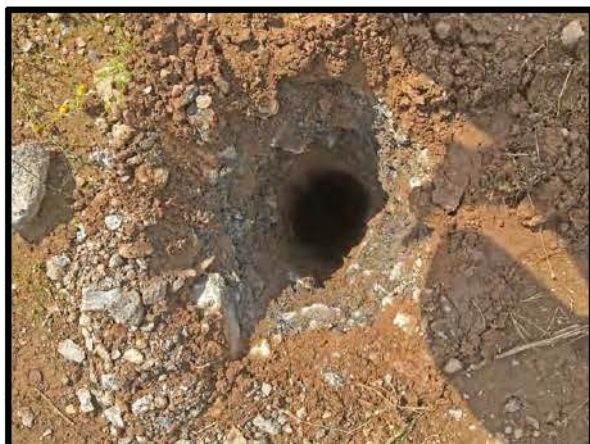
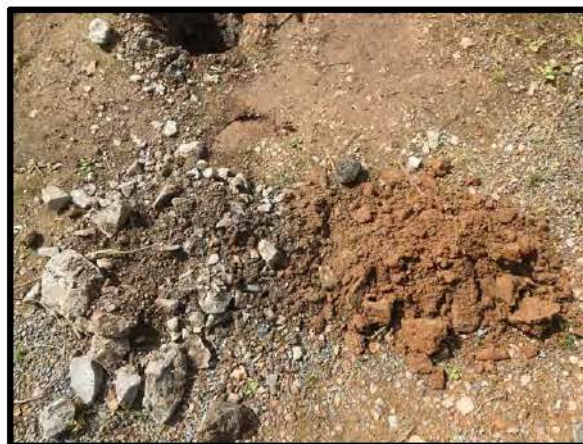
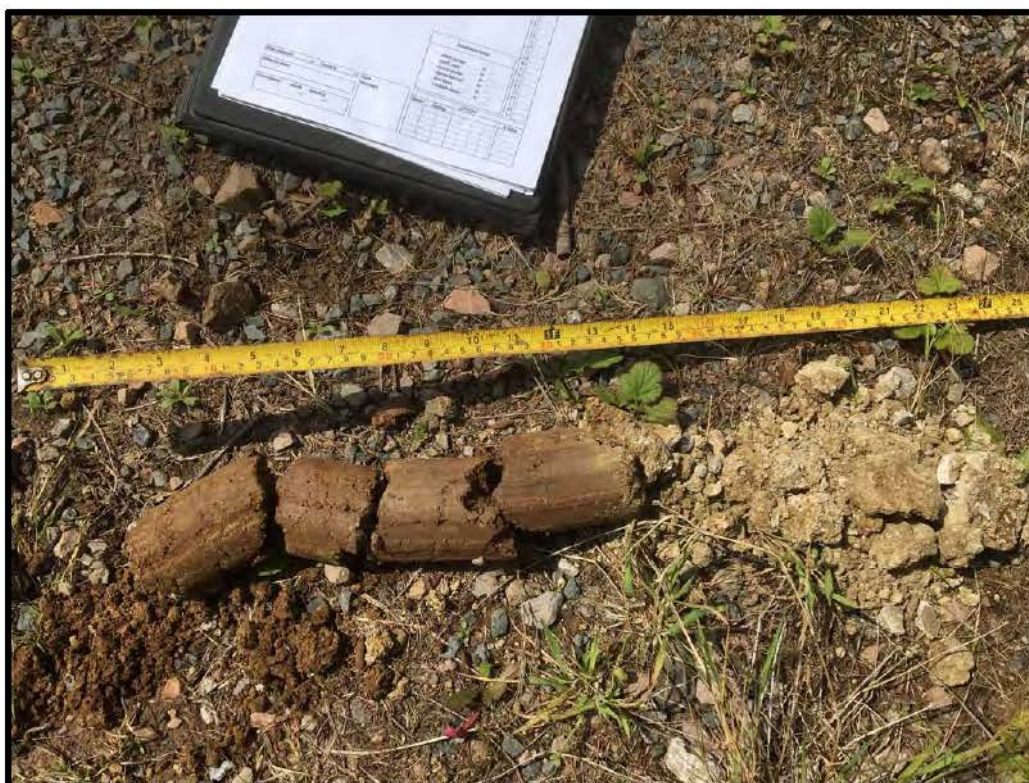
Project LAND AT OLD POTATO STORE, MILL LANE, FOWNHOPE, HEREFORDSHIRE HR1		Borehole No. WS7
Job No. 4704	Date: 20-08-20

Hand-dug starter pit

Hand-dug starter pit arisings

Borehole Core

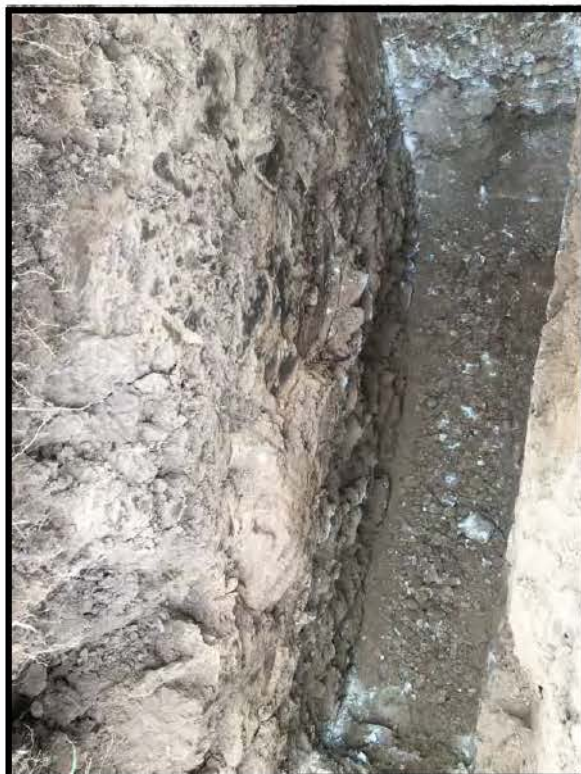
Site: LAND AT THE OLD POTATO STORE, MILL LANE, FOWNHOPE, HEREFORDSHIRE HR1 4NN				TRIAL PIT No. SA1
Job No. 4704	Date 17-08-20	Ground Level (c.m, AOD) 46m	Co-Ordinates (c.) E 357,479 N 234,664

- A TOPSOIL: probable soft, brown, organic, slightly silty, slightly sandy, plastic CLAY, with frequent roots from overlying grass
- B clayey SAND/sandy CLAY: probable medium dense, orangish-brown, slightly gravelly, clayey SAND/sandy CLAY
0.3m - becomes dense
- C GRAVEL: probable dense, reddish-brown, sandy, silty GRAVEL, with occasional cobbles

- 1 Pit logged from surface
- 2 Pit dry and stable
- 3 Soil sample taken at 0.1m depth
- 4 Falling head testing carried out
Pit dimensions 1.1m x 0.3m x 1.15m (LxWxD)

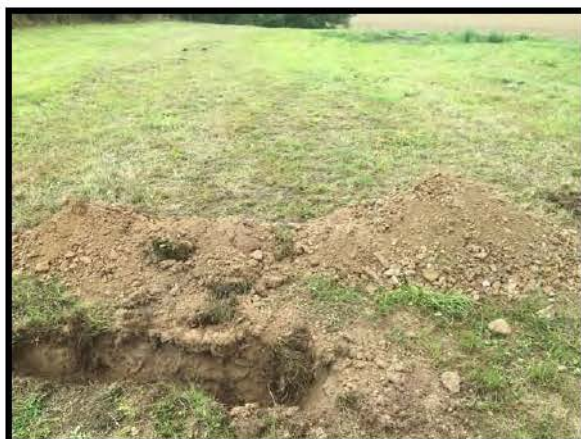
SA1	
Elapsed Time (mins)	Depth to Water (m)
0	0.43
9	0.48
96	0.64
213	0.76
276	0.81

- 6.16** Infiltration analysis, performed as full-scale soakaway tests were undertaken within five designated trial pits across the site, with infiltration rate calculations subsequently carried out, where possible, in general accordance with BRE 365 guidance; results are presented in Table 7 below.

SA No.	Test No. and Test Response Zone (m)	Geology	Calculated Soil Infiltration Rate (m/sec)	Time to drain to 50% storage (hours)
SA1	Test 1 (0.43 – 1.15)	AI?	2.60×10^{-6}	10
SA2	Test 1 (0.67 – 1.65)	MG/AI?	1.40×10^{-6}	19
SA3	Test 1 (0.47 – 1.50)	AI?	NA	NA
SA4	Test 1 (0.63 – 1.85)	MG/AI?	3.60×10^{-6}	8
SA5	Test 1 (0.37 – 1.00)	AI?	6.60×10^{-6}	4

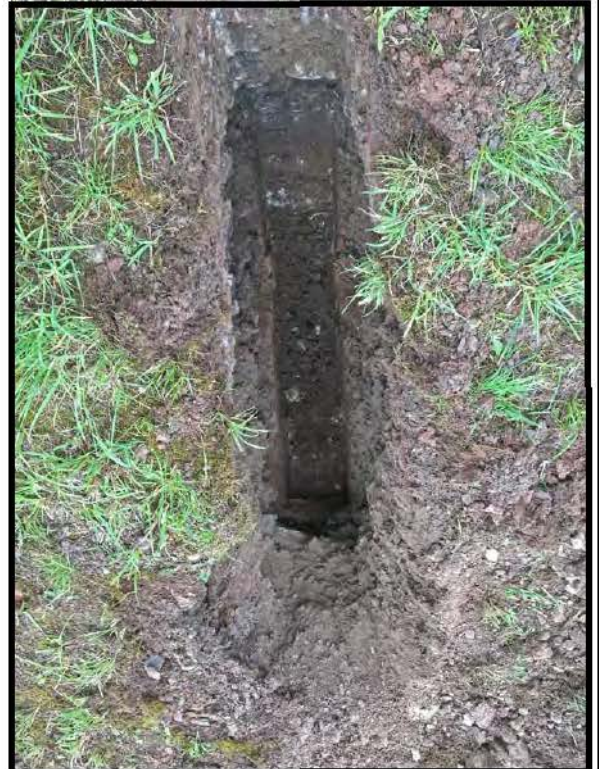
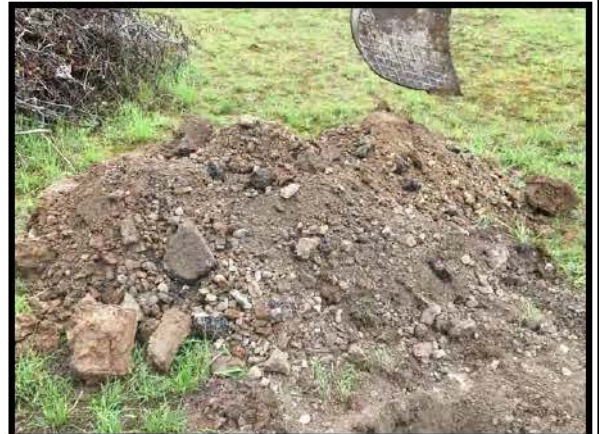
Site: LAND AT THE OLD POTATO STORE, MILL LANE, FOWNHOPE, HEREFORDSHIRE HR1 4NN				TRIAL PIT No. SA2
Job No. 4704	Date 17-08-20	Ground Level (c.m, AOD) 46m	Co-Ordinates (c.) E 357,465 N 234,694

- A MADE GROUND: probable loose, reddish-brown, organic, sandy GRAVEL, with vegetation and roots (gravel is fine to coarse, angular sandstone)
- B MADE GROUND: probable soft, mottled reddish-brown and light grey, slightly gravelly, silty CLAY (gravel is fine to coarse, angular concrete)
- C MADE GROUND: probable medium dense, mottled brown and light grey, slightly clayey, gravelly SAND (gravel is fine to coarse concrete) 0.50 - becomes black and ashy (buried tarmac)
- D CLAY: probable firm, mottled orangish brown and reddish-brown, slightly silty, gravelly, plastic CLAY; becomes very gravelly at base with occasional cobbles

- 1 Pit logged from surface
- 2 Pit dry and stable
- 3 Soil sample taken at 0.0m depth
- 4 Falling head testing carried out
Pit dimensions 1.3m x 0.3m x 1.65m (LxWxD)

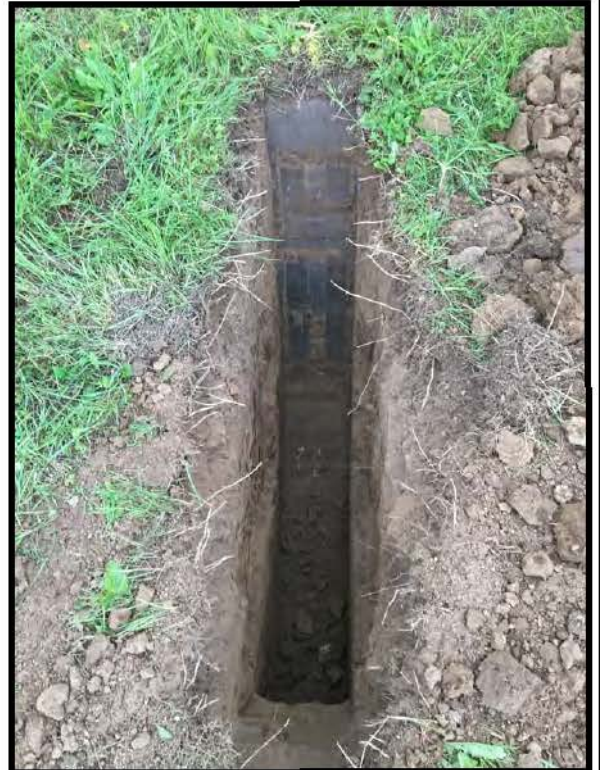
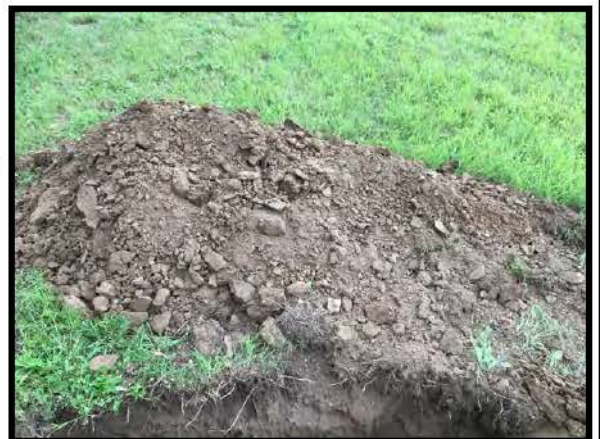
Site: LAND AT THE OLD POTATO STORE, MILL LANE, FOWNHOPE, HEREFORDSHIRE HR1 4NN				TRIAL PIT No. SA3
Job No. 4704	Date 17-08-20	Ground Level (c.m, AOD) 47m	Co-Ordinates (c.) E 357,513 N 234,686

- A TOPSOIL: probable soft, dark brown, organic, slightly silty, plastic CLAY, with frequent roots from overgrown grass
- B clayey SAND/sandy CLAY: probable medium dense, orangish-brown, slightly gravelly, clayey SAND/sandy CLAY 0.70 - becomes dense
- C GRAVEL: probable dense, cream, slightly sandy GRAVEL. Gravel is fine to coarse, angular sandstone with occasional cobbles

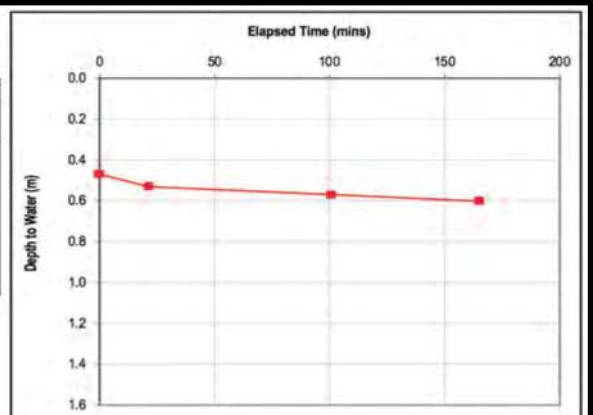
SA3	
Elapsed Time (mins)	Depth to Water (m)
0	0.47
21	0.53
101	0.57
165	0.60

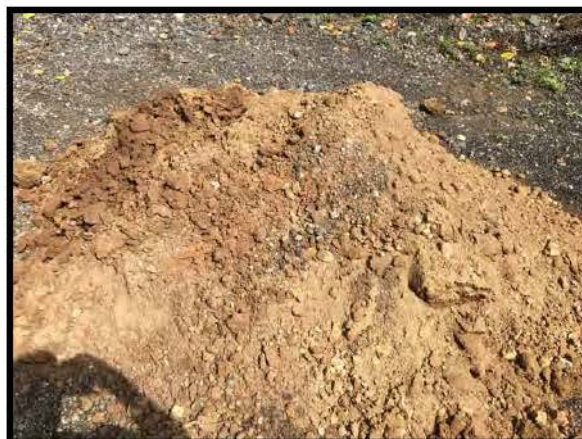
Site: LAND AT THE OLD POTATO STORE, MILL LANE, FOWNHOPE, HEREFORDSHIRE HR1 4NN				TRIAL PIT No. SA4
Job No. 4704	Date 17-08-20	Ground Level (c.m, AOD) 47m	Co-Ordinates (c.) E 357,485 N 234,737

- A MADE GROUND: probable loose, grey, fine to coarse, angular GRAVEL. Gravel is granite
- B clayey SAND/sandy CLAY: probable medium dense, orangish-brown, slightly gravelly, clayey SAND/sandy CLAY; frequent roots to 0.3m

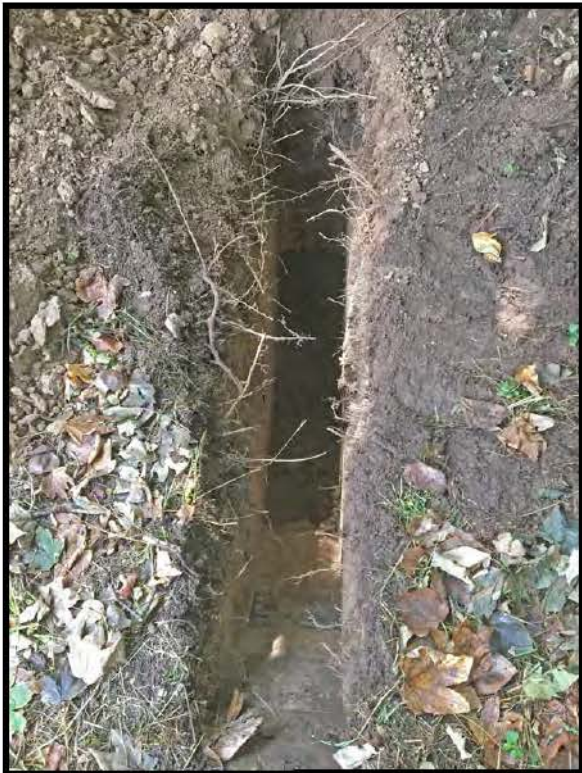
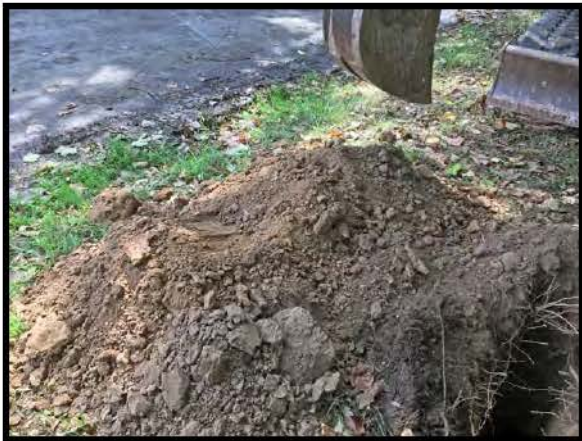
Site: LAND AT THE OLD POTATO STORE, MILL LANE, FOWNHOPE, HEREFORDSHIRE HR1 4NN				TRIAL PIT No. SA5
Job No. 4704	Date 17-08-20	Ground Level (c.m, AOD) 50m	Co-Ordinates (c.) E 357,536 N 234,781

A TOPSOIL: probable soft, dark brown, organic, slightly silty, plastic CLAY, with frequent roots from overgrown grass

- 1 Pit logged from surface
- 2 Pit dry and stable
- 3 No samples taken
- 4 Falling head testing carried out
Pit dimensions 1.4m x 0.3m x 1.0m (LxWxD)

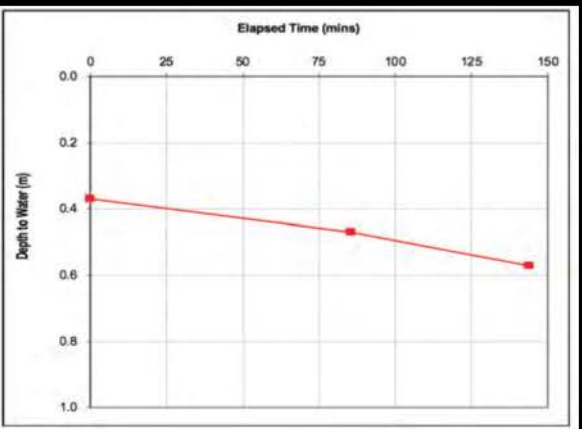
SA5	
Elapsed Time (mins)	Depth to Water (m)
0	0.37
86	0.47
144	0.57
