Preliminary Ecological Assessment Report

Survey Site: Wood House Farm,
Edwyn Ralph.
Hereford,
Herefordshire.
HR7 4LX

Report Reference: 048/19

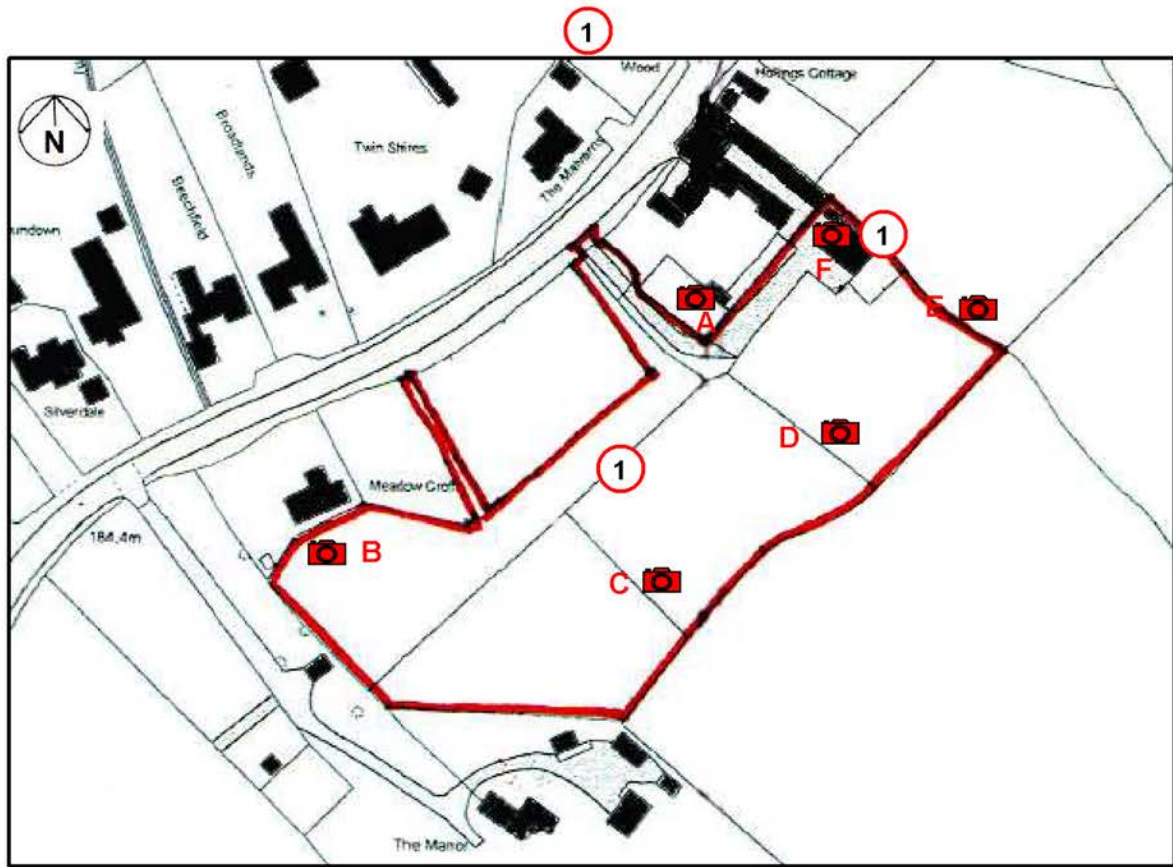
Target Points.

- ① = Temporary pile of overburden from their construction which has ruderal vegetation growing over it.
- ② = Remains of a midden heap and discarded farm machinery and rubbish. The area is overgrown with Ruderal vegetation with predominant species being Nettle and Bramble.

Indicate approximate camera positions for photographs at appendix.

A small section of ground to the rear of the new build houses contain a temporary pile of overburden from their construction which has ruderal vegetation growing over it. (Target point 1)

To the south of the barns is a small fenced enclosure with the remains of a midden heap and discarded farm machinery and rubbish. The area is overgrown with Ruderal vegetation with predominant species being Nettle and Bramble. (Target point 2)

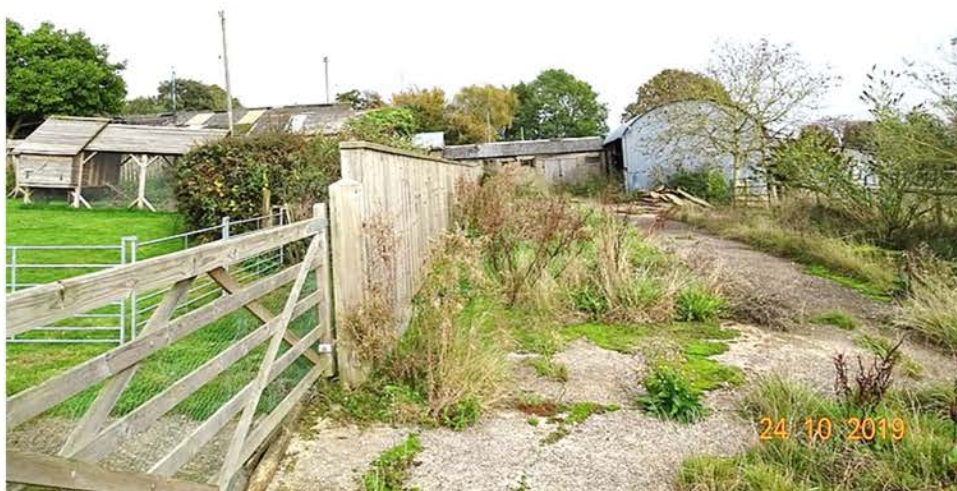
Fig 2. Describing access to barns to be demolished looking north east from CP(A)

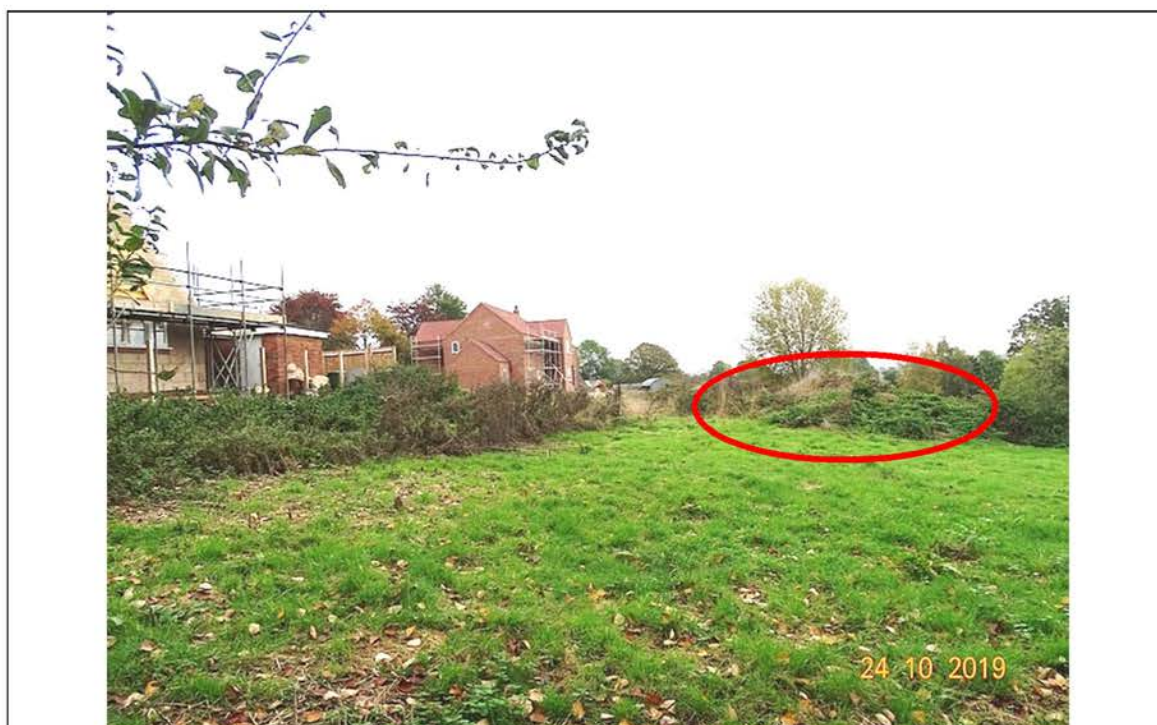
Fig 3. Looking north east from CP(B). Ringed area is overburden that has been temporarily moved during construction of housing which has become overgrown with ruderal vegetation.

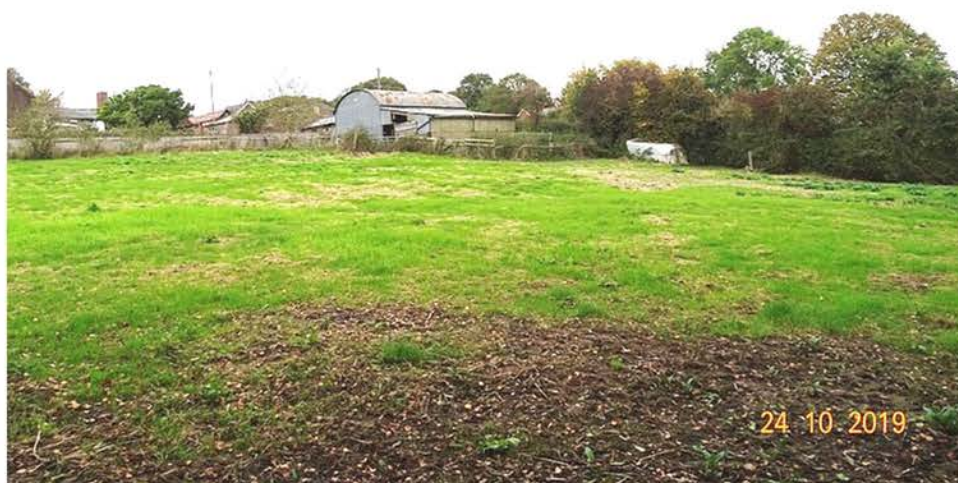
Fig 9. Looking in northerly direction from other side of fence to CP(D) towards barn to be demolished.

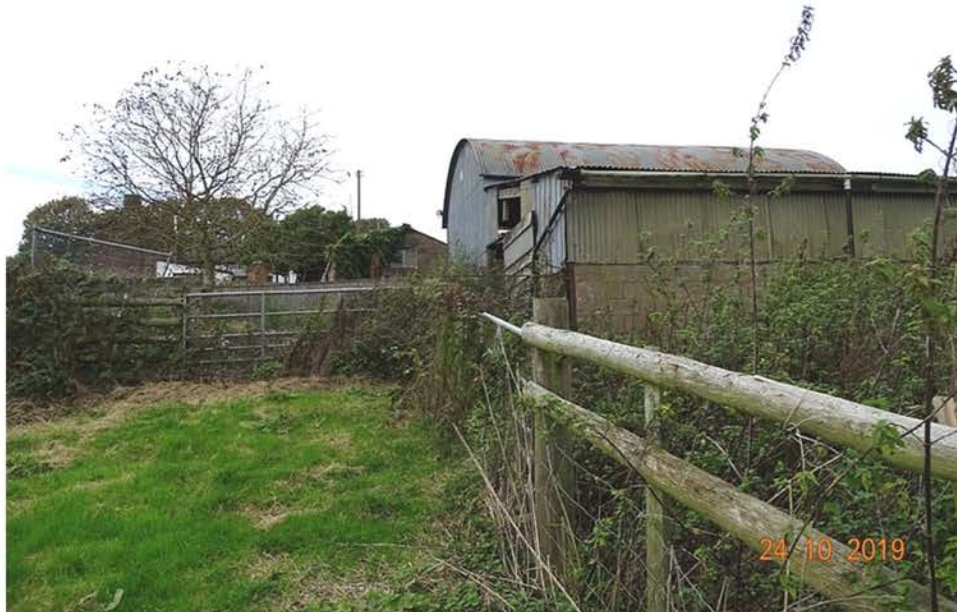
Fig 11. Describing barn from south. To south is enclosed area containing overgrown midden and discarded farm rubbish.

The barn subject to proposed demolition is a modified Dutch barn with curved roof and a lean too extension.

The structure is of a steel frame construction with corrugated iron, breeze block and slatted timber and corrugated fibreglass walls with corrugated iron roofs.

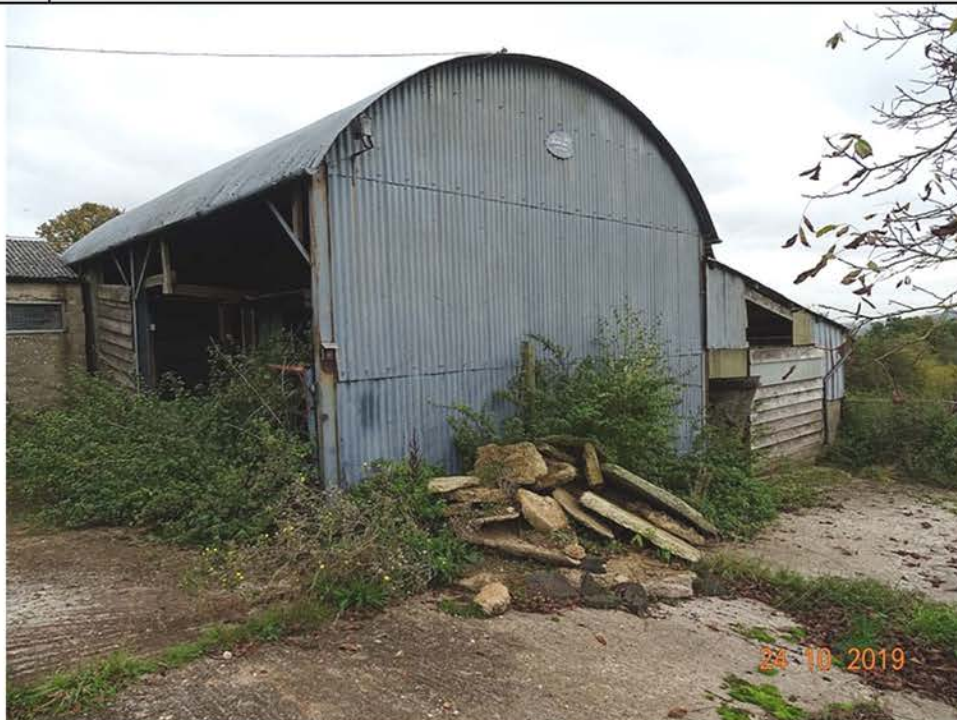
Fig 12. Describing west face of barn.

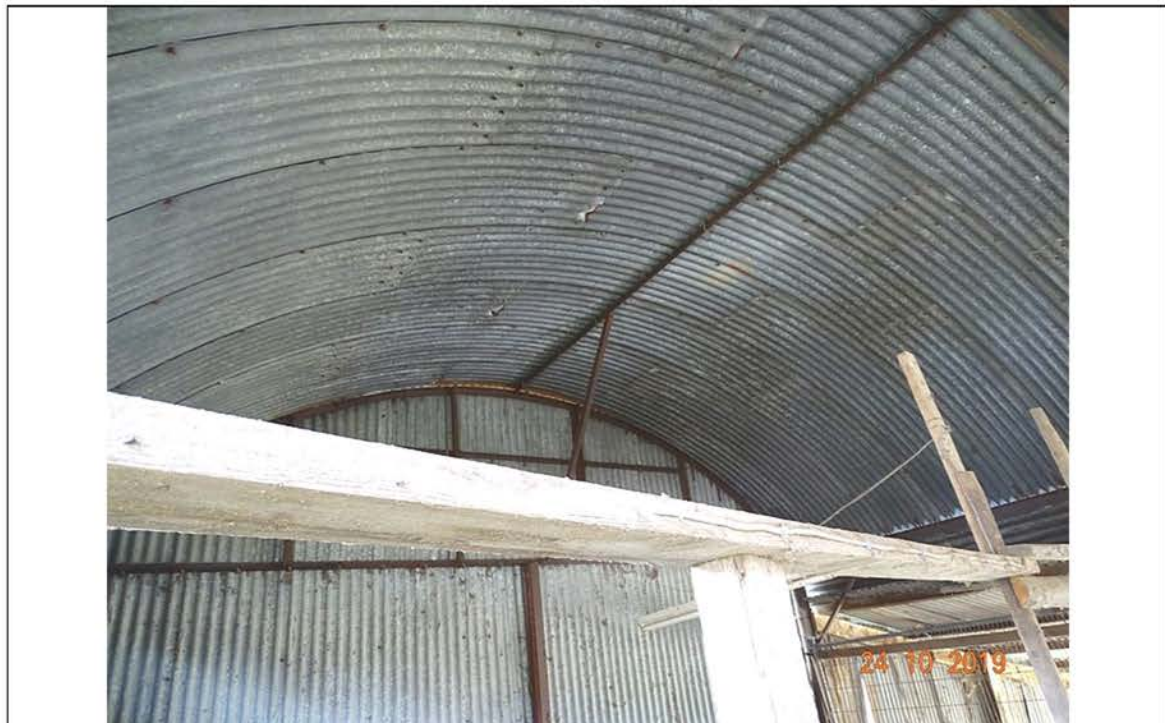
Fig 13. Internal view of main barn construction.

No evidence of bats was observed within the buildings. Because of the construction methods and building materials the barn was assessed as having negligible potential for roosting bats. The farm outbuilding had slightly more potential but with no flight route from the southern gable wall where there could be potential of bats roosting on the wall top and minimal crevices within the building it was assessed as very low potential for roosting bats.

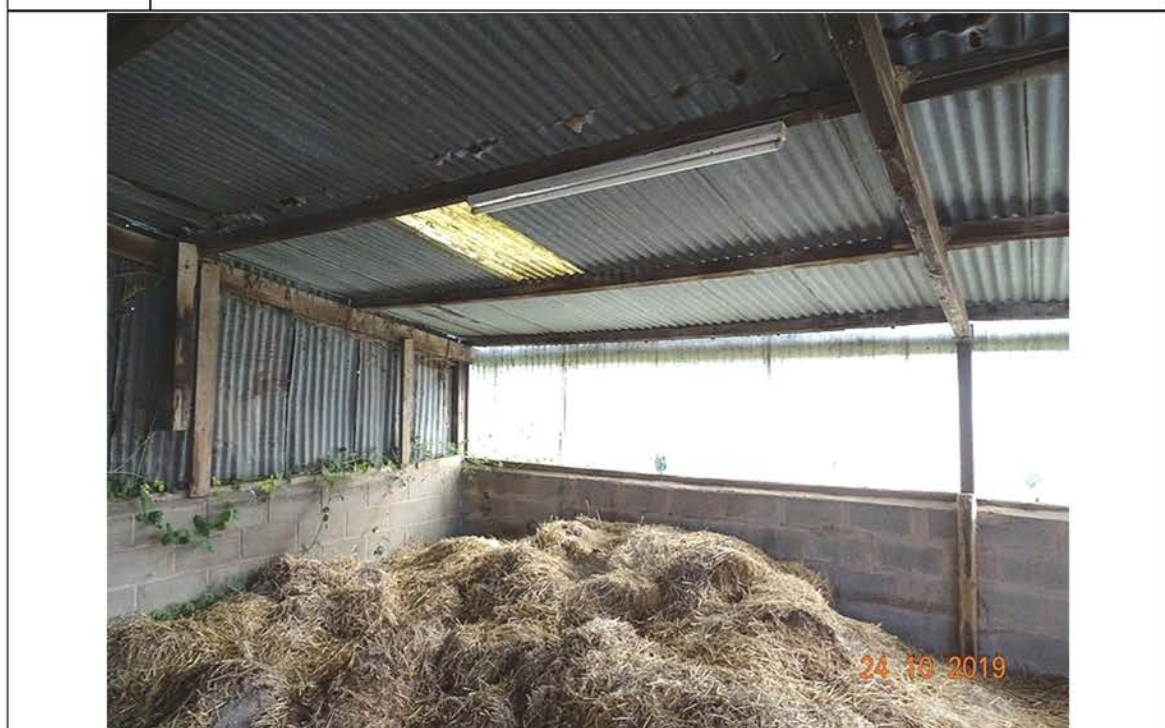
Fig 14. Internal view of lean too attached to south side of barn.

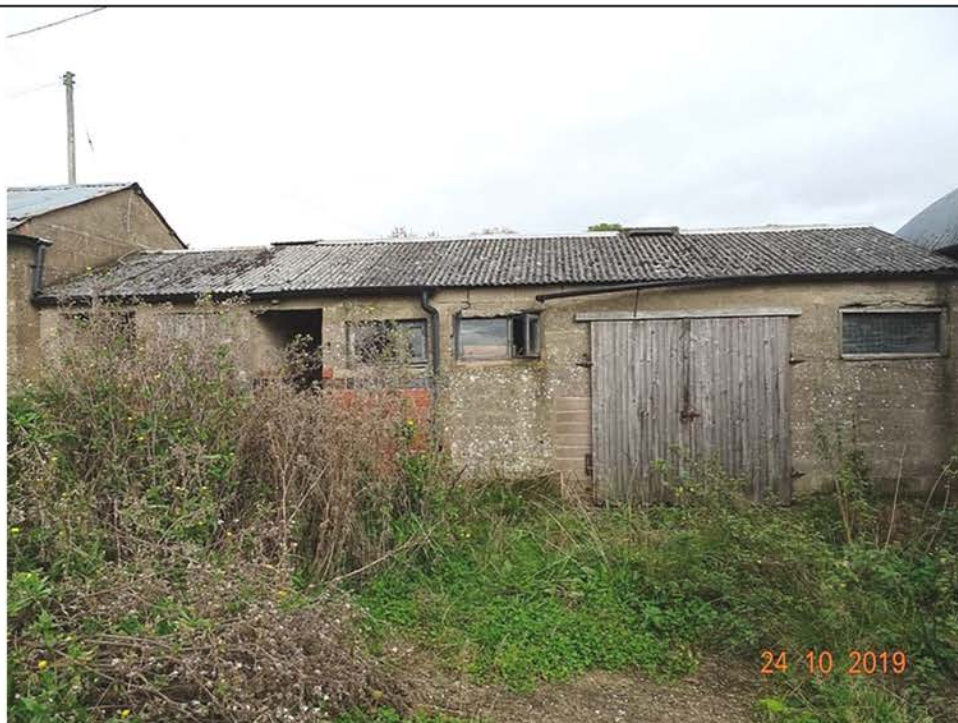
Fig 15. Describing section of original range of farm building included within the curtilage of the site and earmarked for demolition.

The farm outbuilding is a single storey shed with brick and concrete block walls with a pitched timber truss and purlin roof covered with corrugated fibre cement panels.

A single, very old (older than 2 seasons) Barn Swallow nest was observed within the farm outbuilding. No other evidence of nesting birds was observed.

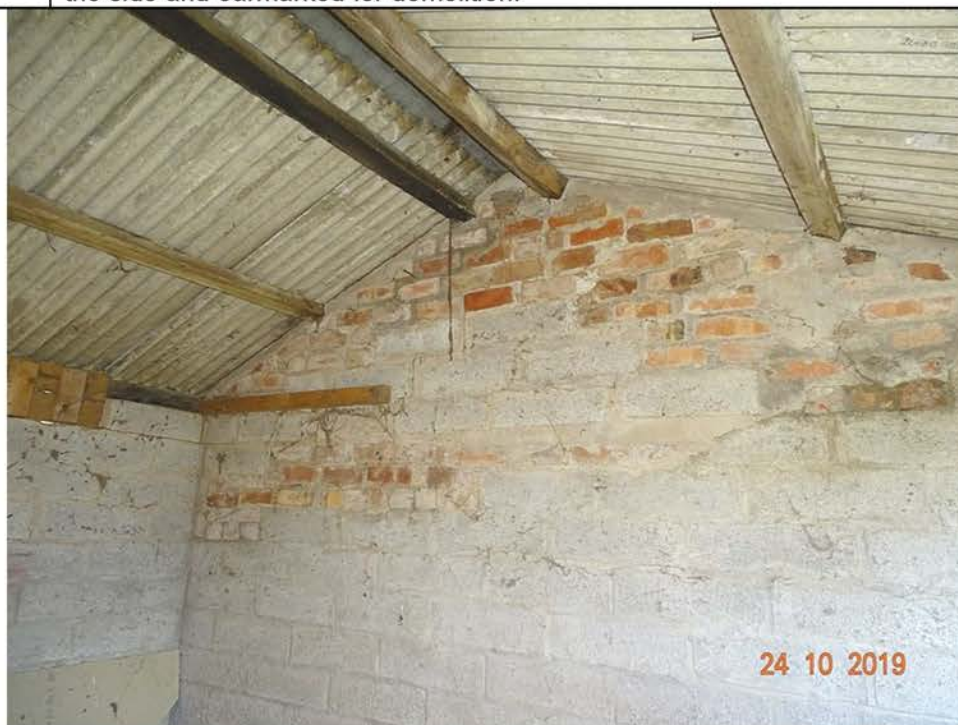
Fig 16. Describing internal construction of building.
