# BAT SURVEY REPORT

**Barn at Three Acres**  
**Garway Hill**  
**Herefordshire**  
**HR2 8HD**

**July 2021**

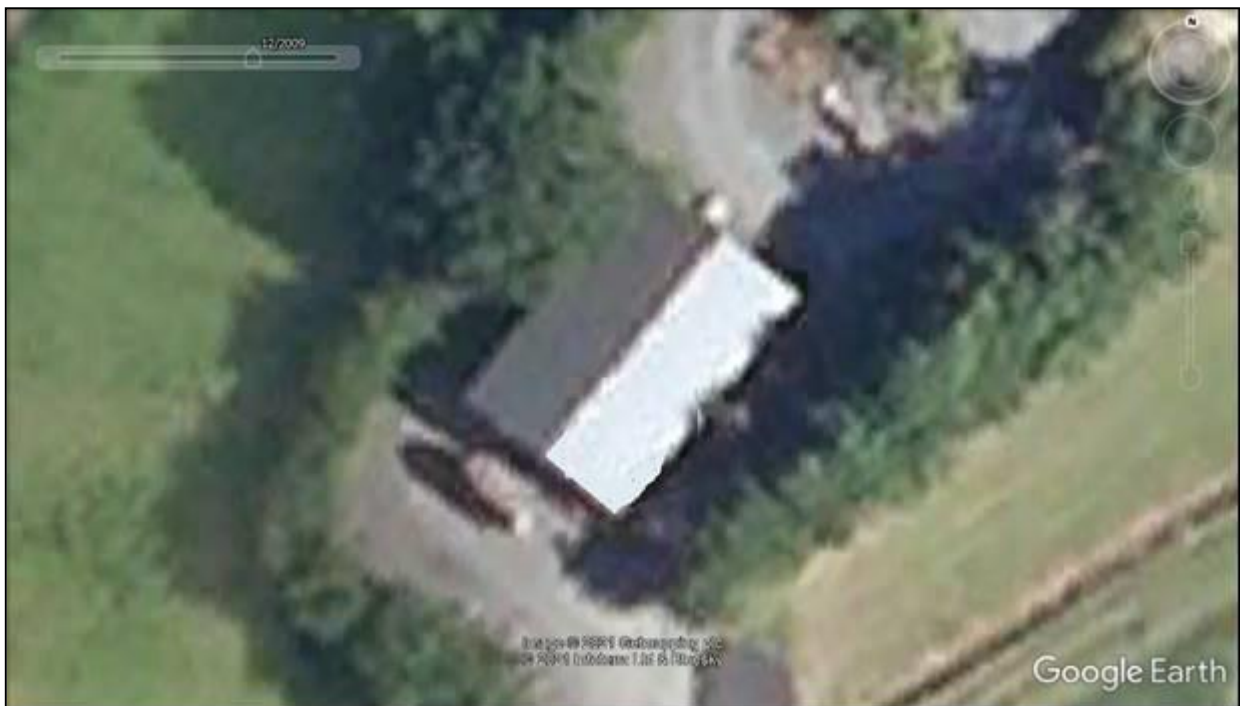
*Figure 1 – Aerial view of the barn*

The building sits detached within a residential curtilage. The surrounding landscape comprises pasture fields, tree lines, hedgerows and nearby mostly broad-leaved woodland.

The landscape is well connected, with surrounding habitat of high quality for supporting bats.

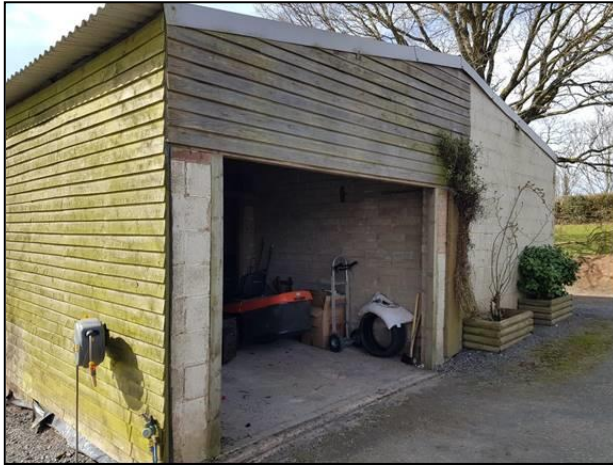
**Photo 1** – North-east gable view

The building is of relatively modern concrete block construction, comprising garaging, stables and general storage. The external walls are bare pointed, with the southern façade timber clad. The roof is covered with corrugated steel sheeting.

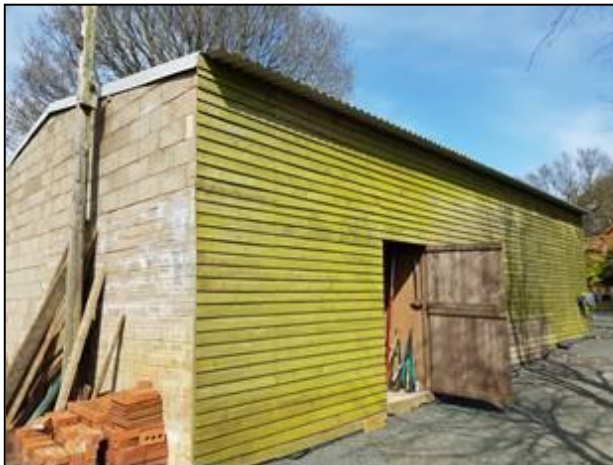
**Photo 3** – South aspect

There are various gaps and crevices within the timber cladding, and at the roof-wall junctions.

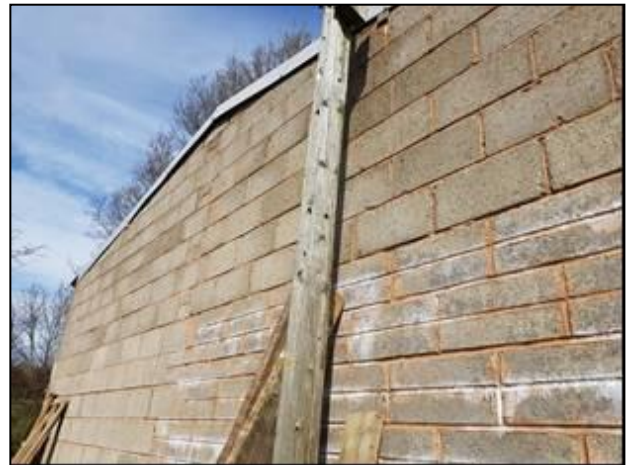
**Photo 4** – Gaps at south roof-wall junction verge

The surveying confirmed that **one common pipistrelle bat** is using an area of the metal cladding on the south gable roof verge for roosting. It was present on only one of the survey sessions.

This study confirmed that **one common pipistrelle bat** is using an area of the metal cladding on the south west gable roof verge as an **occasional summer day roost**.

The roof-wall junction at the south-west verge hosts the bat roost. The roof is due to be dismantled as part of the conversion.

1. Immediately prior to the dismantling, the licensed ECW will carefully inspect the relevant areas containing the bat roost with an endoscope if necessary to ensure that there are no bats present. If any are found, where necessary and appropriate they will be captured by hand or with a hand-net and safely removed for temporary safekeeping and later released or transferred to a new roost box in accordance with the BDAP below.

2. All roofing sheets, timber elements etc within 2m of the bat roost location will be removed by hand as a controlled strip under direct supervision of the ECW. Sheets and fascia boards etc will be gently lifted away by hand and hand tools and inspected underneath to prevent injuring or killing any bats that might be present. If any are found, they will be captured by hand as detailed above.

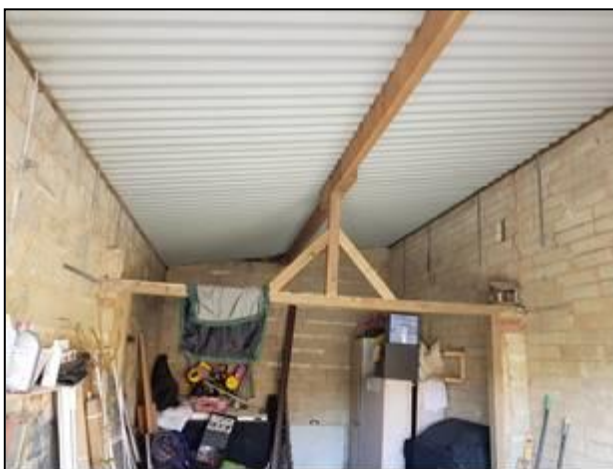
**Photo 5** – Example interior room view

The interior walls are bare pointed blockwork. The ceilings are unlined and open to the corrugated sheets.

Close inspection revealed no bat droppings or other sign of use by bats (e.g. butterfly or moth wing feeding remains).

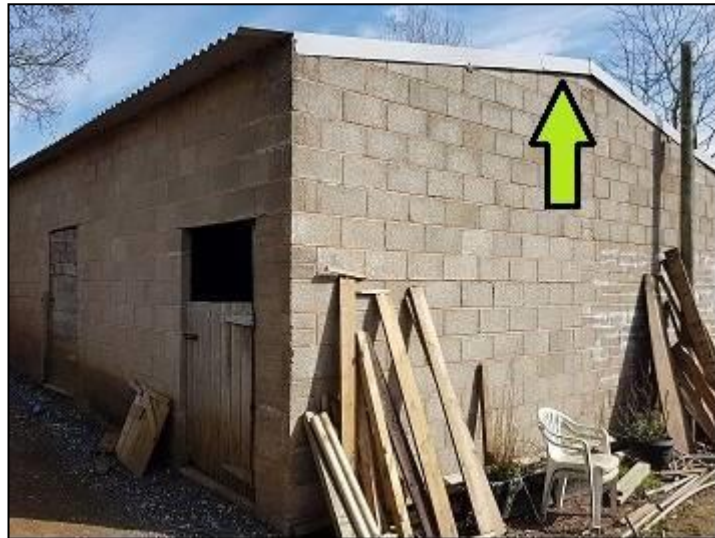
SUMMARY OF BAT ACTIVITY SURVEY RESULTS	
Survey date and conditions	Observations
<b><u>1<sup>st</sup> June 2021</u></b>  <b>21:05 to 22:35hrs</b>  Sunset 21:20hrs  <b>Start temp:</b> 20°C <b>Fin temp:</b> 18°C <b>Cloud:</b> 1/8 <b>BFT:</b> 6 <b>Precip:</b> Nil	<b>Dusk survey</b>  Bat activity was surveyed from 15 minutes before sunset.  Common pipistrelles briefly commuted and foraged through the site, but there was no activity directly associated with the building.
<b><u>21<sup>st</sup> July 2021</u></b>  <b>21:05 to 22:35hrs</b>  Sunset 21:20hrs  <b>Start temp:</b> 23°C <b>Fin temp:</b> 20°C <b>Cloud:</b> 0/8 <b>BFT:</b> 3 <b>Precip:</b> Nil	<b>Dusk survey</b>  At 21:45hrs, a common pipistrelle emerged from a gap under the metal verge covering on the south gable at the position shown below.  Common and soprano pipistrelles commuted and foraged through the site intermittently.
