Heritage Statement

**Threshing Barn
Upper Hill Farm
Breinton
Hereford
HR4 7PQ**

**Solomon Property
Developments Ltd**

August 2020

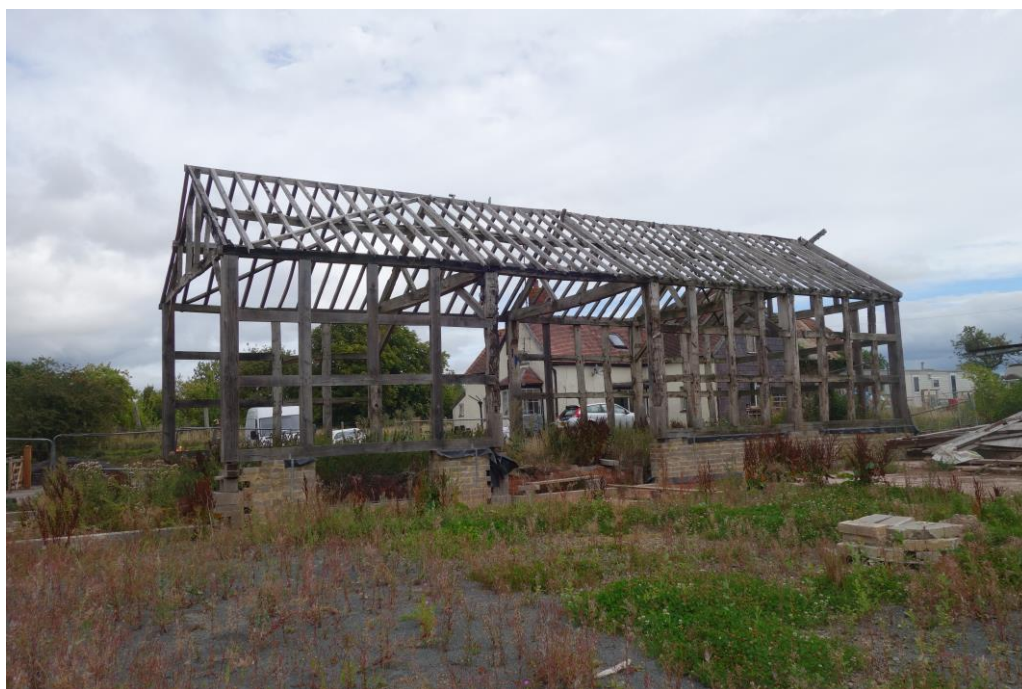
Plate 1: View looking NE towards threshing barn showing reconstructed plinth and sill plates, with farmhouse to rear

It is evident that since this listing description was produced in 2009, significant remedial works have been carried out to the threshing barn (following building surveys undertaken in 2018 and 2019) to urgently address its poor structural condition, including the complete replacement of the masonry plinth upon which the timber framing of the barn formerly rested with sections of concrete breeze block walling and replacement of the timber sill plates which appear to have rotted away. However, the upper portions of the framing of the N and S walls, particularly within the eastern two bays, have survived mostly intact (*Plate 3*) although there is more evidence of the replacement of framing with new rails and studs towards the W end of the barn (*Plate 4*). Some of the older timbers appeared to display evidence of fire damage.

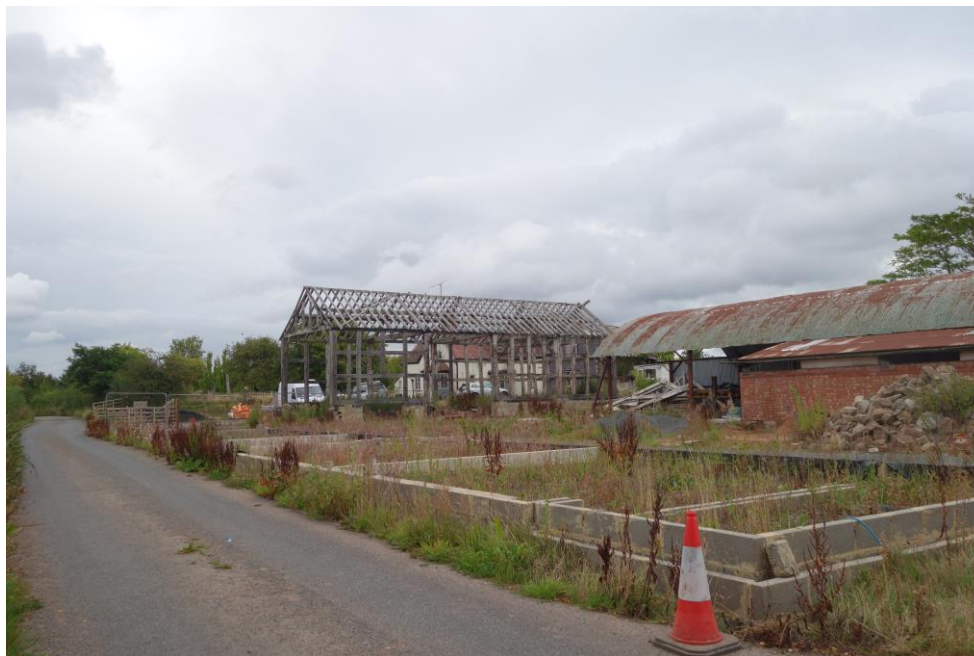
Plate 2: View looking NE towards Upper Hill Farm showing footings of new structure on footprint of former cattle shed, with steel-framed Dutch Barn to right of picture

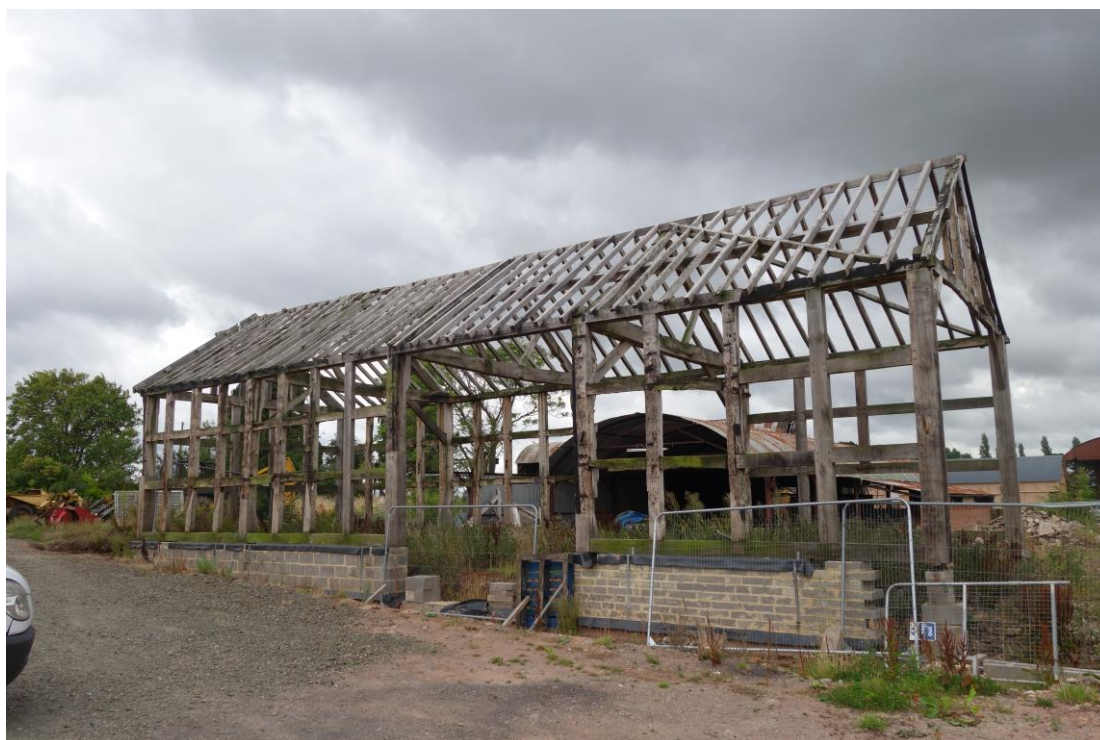
Plate 3: View SE showing N elevation of threshing barn showing intact upper portions of box-framing with reconstructed plinth and sill plates beneath

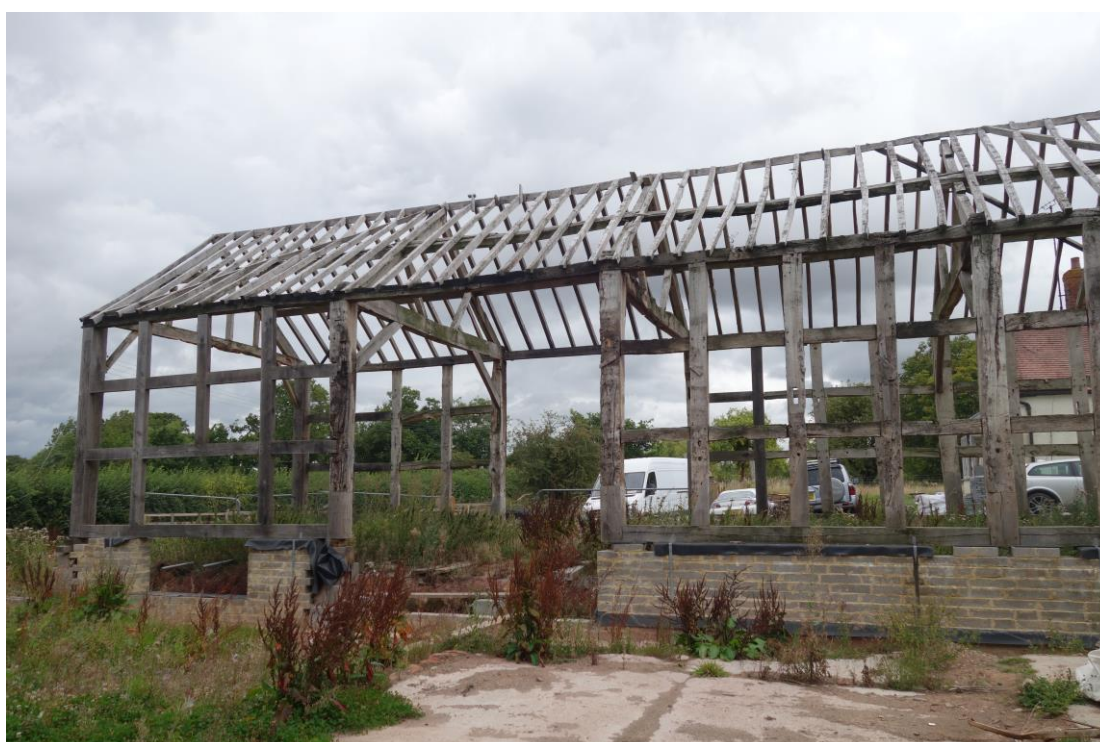
Plate 4: View looking N showing S elevation of threshing barn with farmhouse to rear

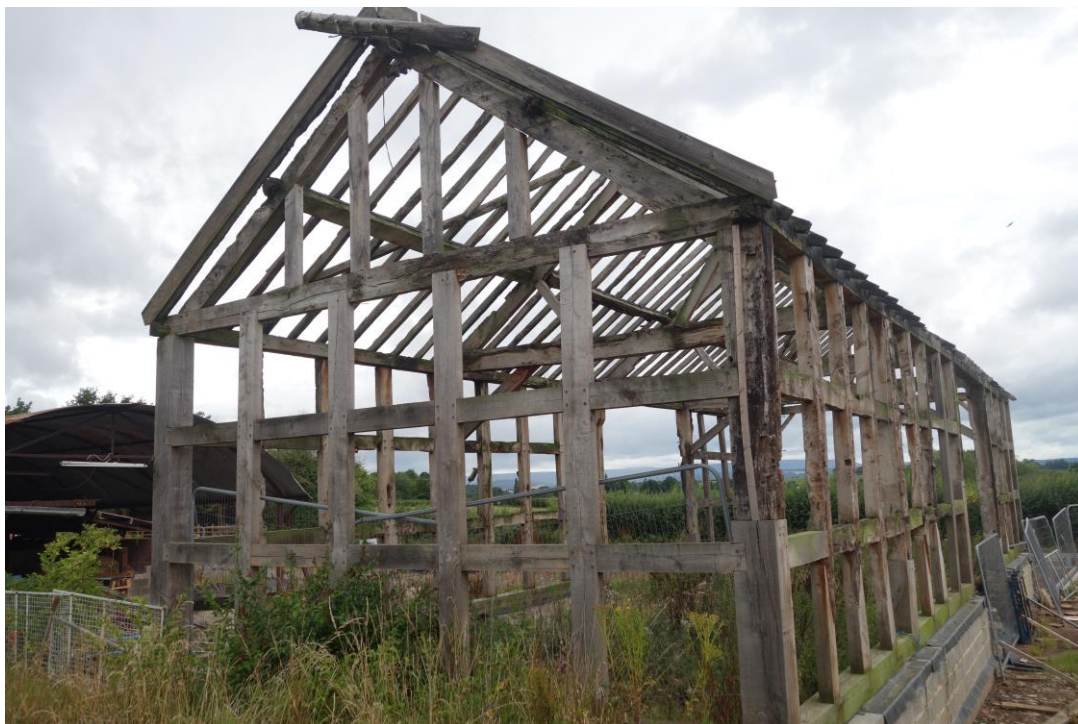
Plate 5: View SW showing E gable end of threshing barn with reconstructed box framing and original framing in the apex of the gable consisting of four vertical struts

The framing at the E gable end (which appears to have consisted of a series of vertical studs) appears to have been largely reconstructed with square panel framing up to tie-beam level (*Plate 5*) except for the apex of the E gable which has four vertical struts connecting the tie-beam to the principal rafters which appear to be original fabric. The W-gable end of the barn has had almost all the framing removed except for the apex of the W gable which has a similar configuration of four vertical struts connecting the tie-beam to the principal rafters (*Plate 6*).

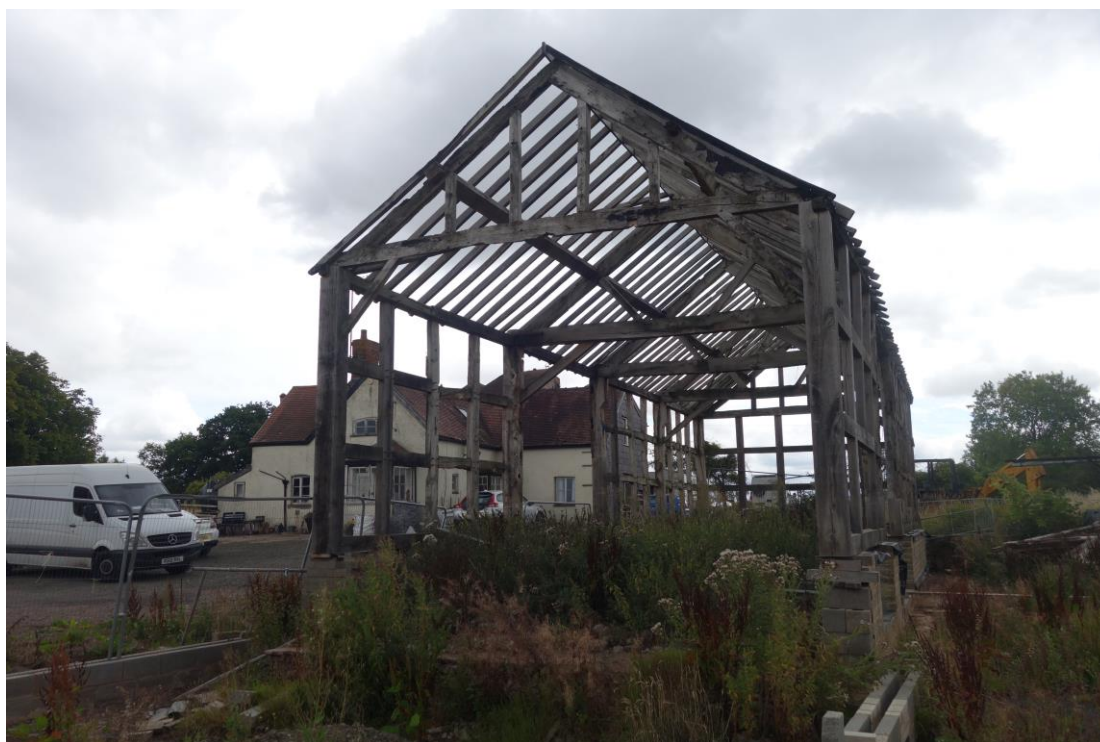
Plate 6: View looking NE showing extant framing in apex of W gable end of the threshing barn comprising four vertical struts, with the remaining framing removed

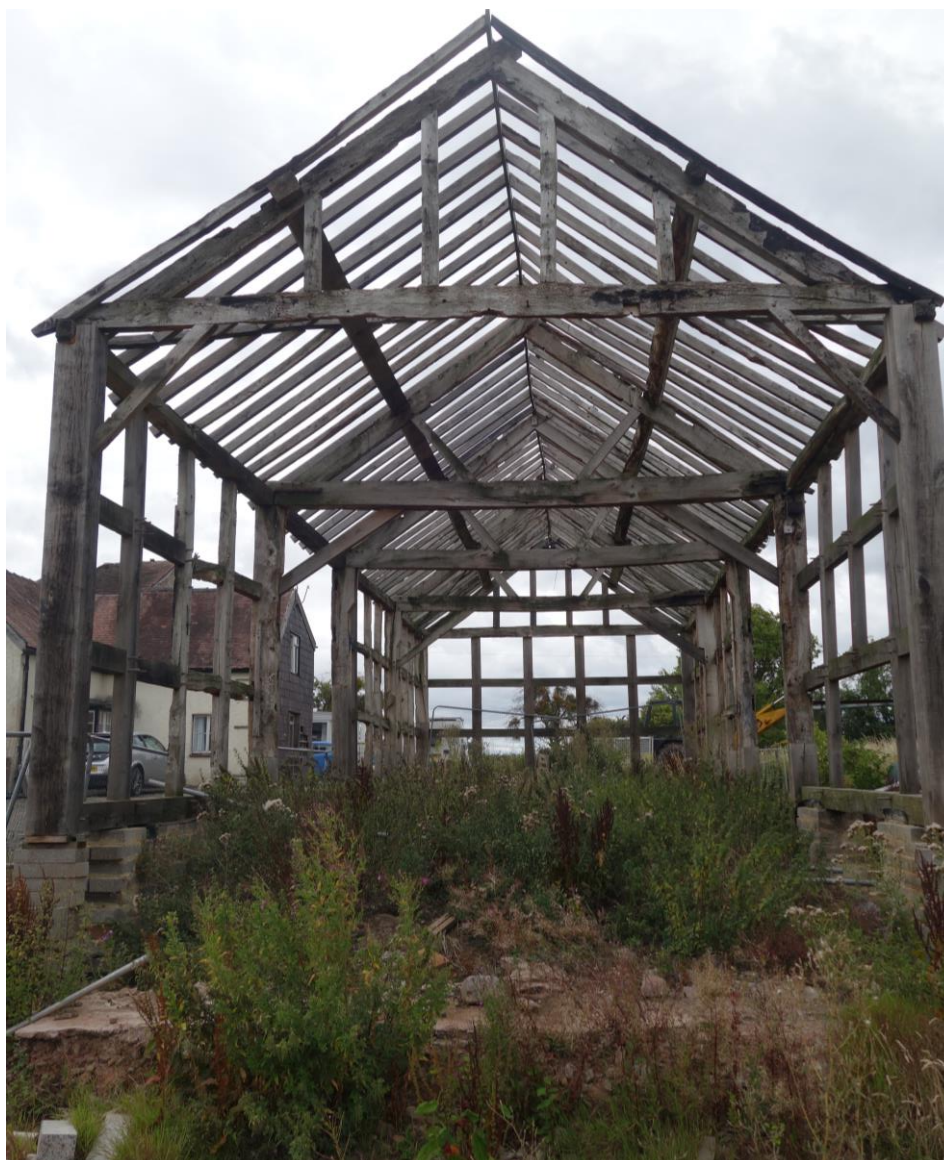
Plate 7: View looking E showing interior of threshing barn as viewed from the W end, showing its current heavily overgrown state

The interior of the barn is heavily overgrown and few internal features of interest were noted at ground level. The wattled wall panels mentioned in the listing description have clearly been removed. Due to the dense undergrowth within the barn, it is not entirely clear whether the flagstone threshing floor has also been removed, which would have occupied the space between the two double-doors within the central bay of the barn, where the winnowing of the crops would have taken place (*Plate 7*). It is possible that the flagstones may have been removed to be reinstated as part of the residential conversion of the barn as shown on the proposal plan.

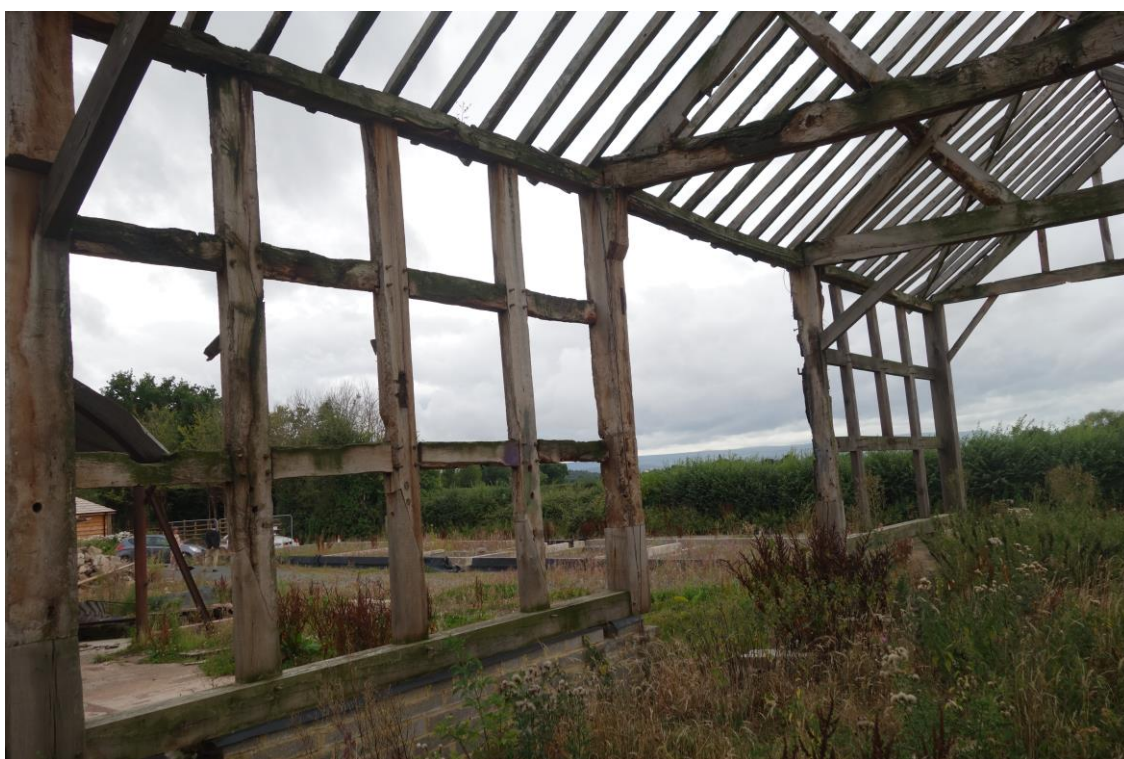
Plate 8: Oblique view looking SW showing detail of framing in S elevation of threshing barn with stave holes for wattled panels and slots for internal partitions

Evidence of stave holes for wattled panels was noted in the framing of the N and S walls, as well as limited evidence of stave holes and slots for internal sub-divisions between the bays of the barn, where the unthreshed and processed crop and straw would have been stored separately (*Plate 8*)

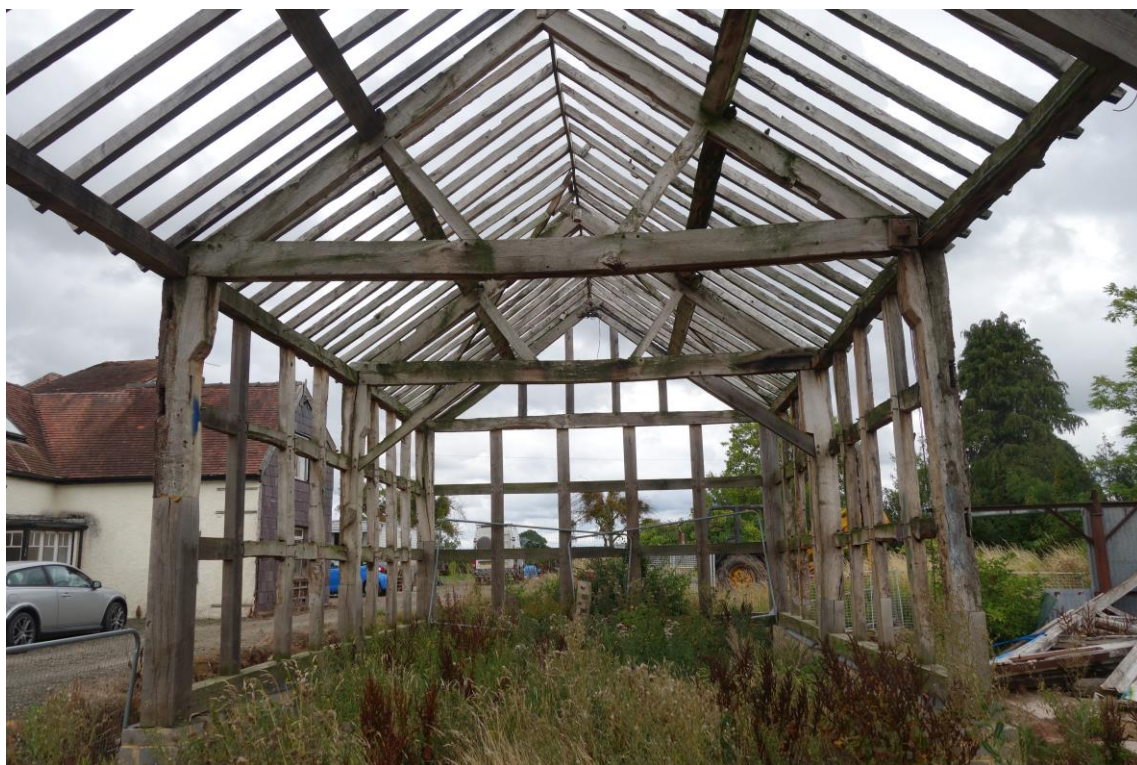
Plate 9: View looking E showing interior of central and easternmost two bays of threshing barn with open-truss roof structure and trenched purlins

The most notable internal feature within the barn is the roof structure, consisting of two pairs of simple roof trusses with four vertical struts connecting the tie-beam to the principal rafters at the E and W gable ends and three open trusses subdividing the four internal bays which have angled struts connecting the tie-beam to the principal rafters which in turn are linked by a pair of substantial trenched side purlins. The central truss is carried on straight chamfered braces which are tied into the wall posts while the two flanking trusses have angled struts linking the tie beams to the wall posts (*Plate 9*).

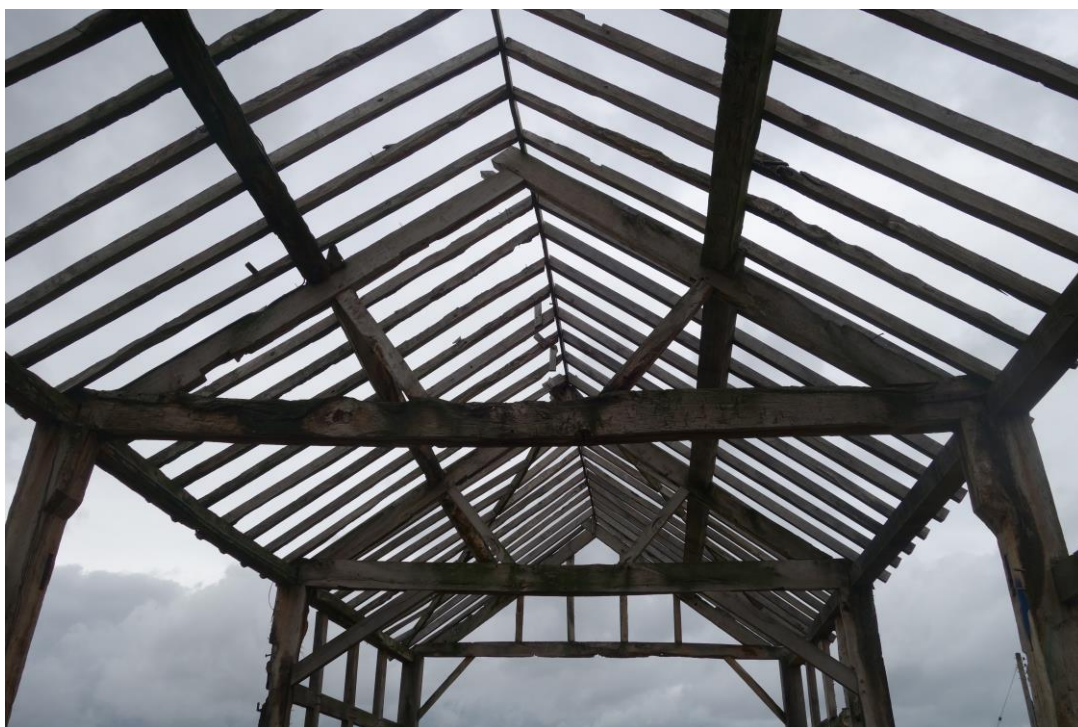
Plate 10: View looking W showing detail of roof trusses in central and westernmost bays of barn with carpenter's marks

The carpentry of the roof trusses is of especial interest, exhibiting a series of carpenters' marks which occur towards the end of the tie-beam on each truss; these include a cross and two 'flags' (*Plates 10 & 11*). The common rafters appear to be machine-cut and are therefore presumably later than the trusses and purlins.

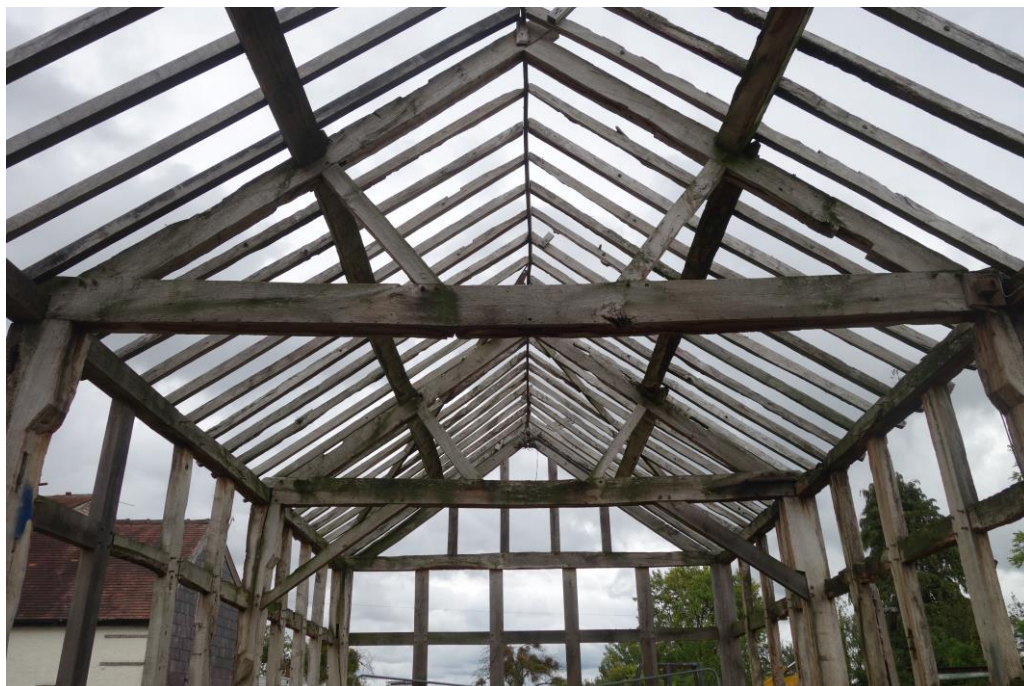
Plate 11: View looking E showing detail of roof trusses in easternmost two bays of threshing barn with carpenter's marks

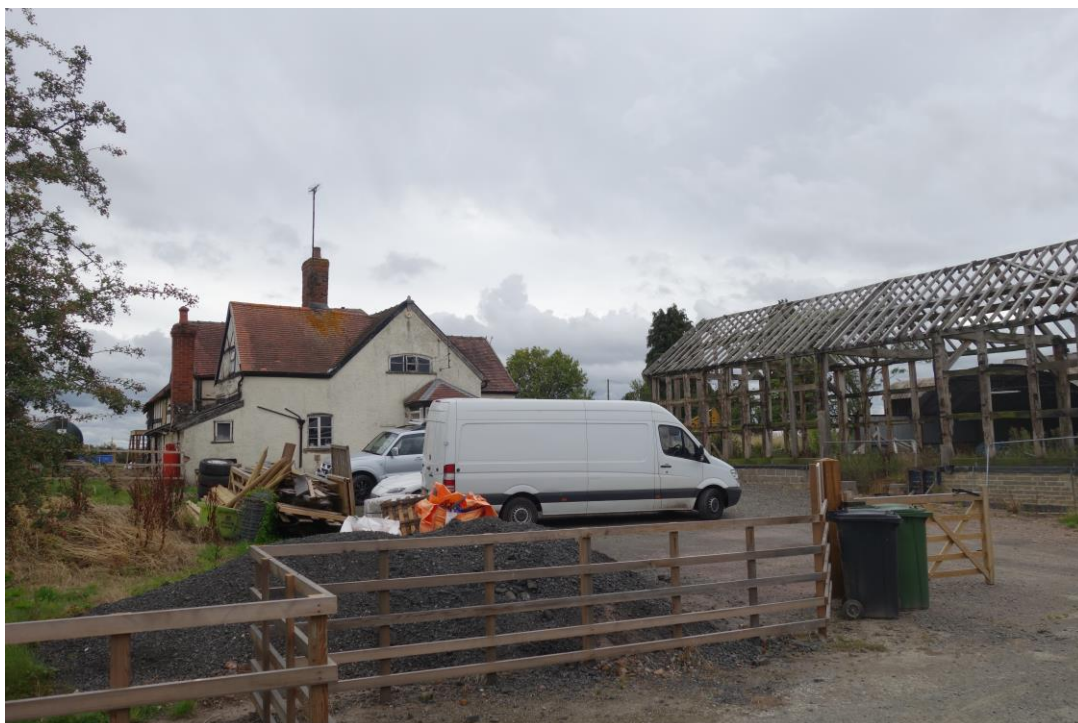
Plate 12: View looking W from lane towards Upper Hill Farmhouse, with the threshing barn visible to right of picture

listed farmhouse, which can be particularly appreciated in views from the lane adjoining the property which is also a public footpath (*Plate 12*).

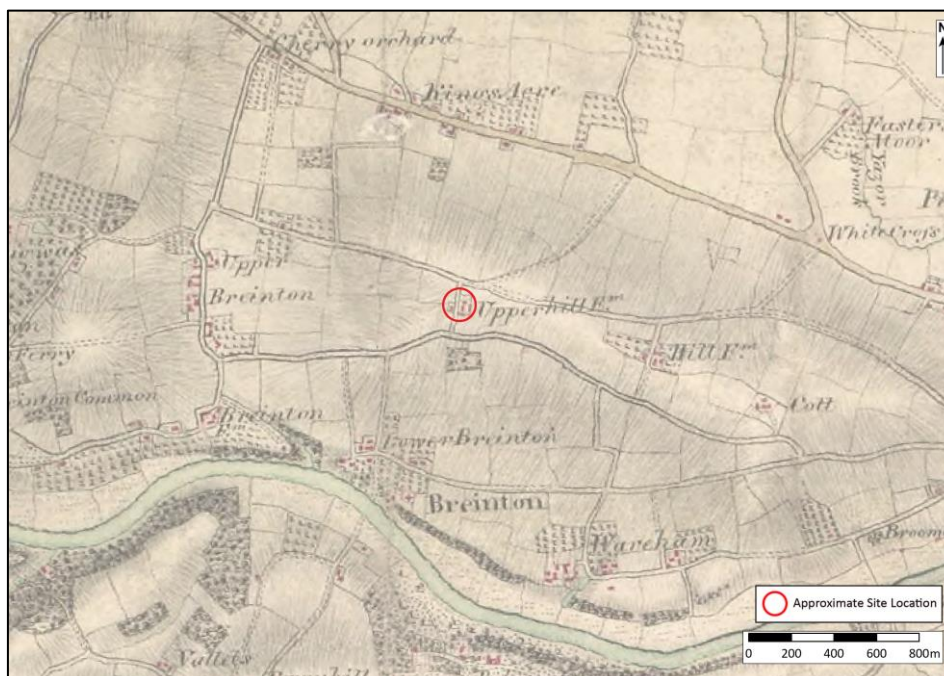
Fig. 7: Extract from the OS Surveyor's Drawing of 1815 (site marked in red)
(Reproduced by courtesy of the British Library)

The earliest available cartographic depiction of the site is provided by an Ordnance Survey drawing of Hereford and its environs dated 1815 (*fig. 7*). This map shows the farmhouse and threshing barn to the S, situated on the N side of a courtyard flanked to the E and W by two detached oblong ranges aligned N-S. Another range aligned E-W is depicted on the S side of the courtyard, directly abutting the roadway to the W.

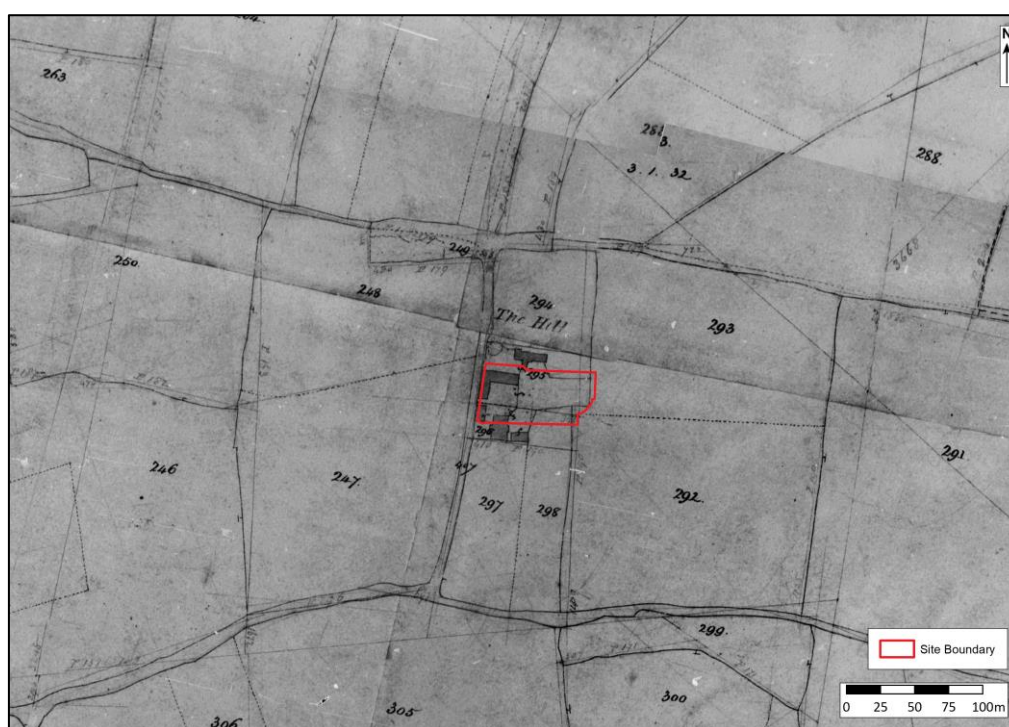
Fig. 8: Extract from the Breinton tithe map of 1839
(Reproduced by courtesy of the National Archives)

Significant changes to the layout of the outbuildings S of Upper Hill Farm is depicted on the Breinton tithe map of 1839 (*fig. 8*) at which time the farmstead (then marked as 'The Hill') was owned by the Vicars Choral of Hereford Cathedral and occupied by a tenant farmer named John Jones. An extension had been added at the W end of the threshing barn and two oblong ranges aligned N-S are shown as having been erected along the W side of the courtyard, immediately abutting the lane to the W. The building on the E side of the courtyard shown on the 1815 OS map had been demolished by 1839, while the barn to the S had been enlarged and was in separate ownership.
