BS5837:2012 ARBORICULTURAL METHOD STATEMENT

**SOUTH MARCHES DISTRICT SCOUT GROUP
(SCOUTS CORNER), HEREFORD, HR1 2RX**

SOUTH MARCHES DISTRICT SCOUTS

South Marches District Scouts
South Marches District Scout Group (Scouts Corner), Hereford, HR1 2RX
BS5837:2012 Arboricultural Method Statement

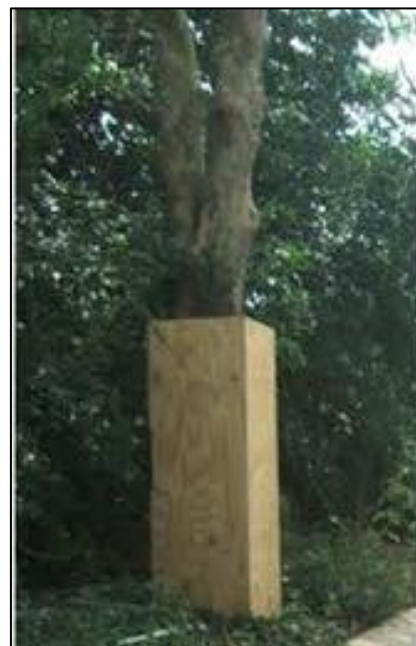
Plate 1: Example of plywood hoarding used as tree protection. ©Google.

With the shipping containers being in close proximity to T2, T10 and T11's stem, there is a risk of damage being caused whilst moving the shipping containers. Solid plywood hoarding tree protective stem boxes will be installed around T2, T10 and T11's stem to prevent damage being caused.

The plywood hoarding should be securely attached onto a lightweight timber frame that is secured to the ground. The frame will be installed around the stem, maintaining a gap between the stem and the plywood hoarding. The plywood hoarding will be a minimum of 2.5m high. No materials will be attached/nailed to the tree.

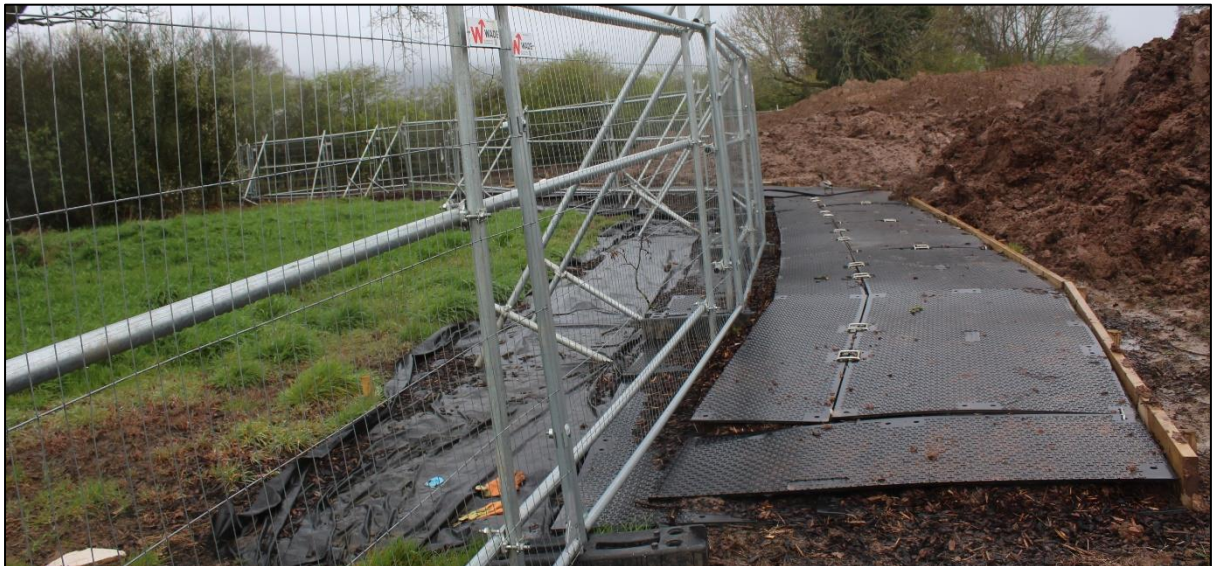
Plate 2: An example of temporary ground protection laid up against the tree protection fencing. This protects the RPA whilst also providing adequate space between the fencing and the development footprint.

Temporary ground protection matting will be laid within T11 and H14's RPA, between the tree protection fencing / boundary fencing and the footprint of the proposed scouts hall. This helps to safeguard tree roots and minimise soil compaction, whilst also providing enough space for the development to be carried out without being constrained by tree protection fencing. The temporary ground protection will be installed as follows:

Pedestrian-operated plant up to a gross weight of 2t – proprietary, inter-linked ground protection boards placed on top of a compression-resistant layer (e.g. 150mm depth of woodchip), laid onto a geotextile membrane (Plate 2).

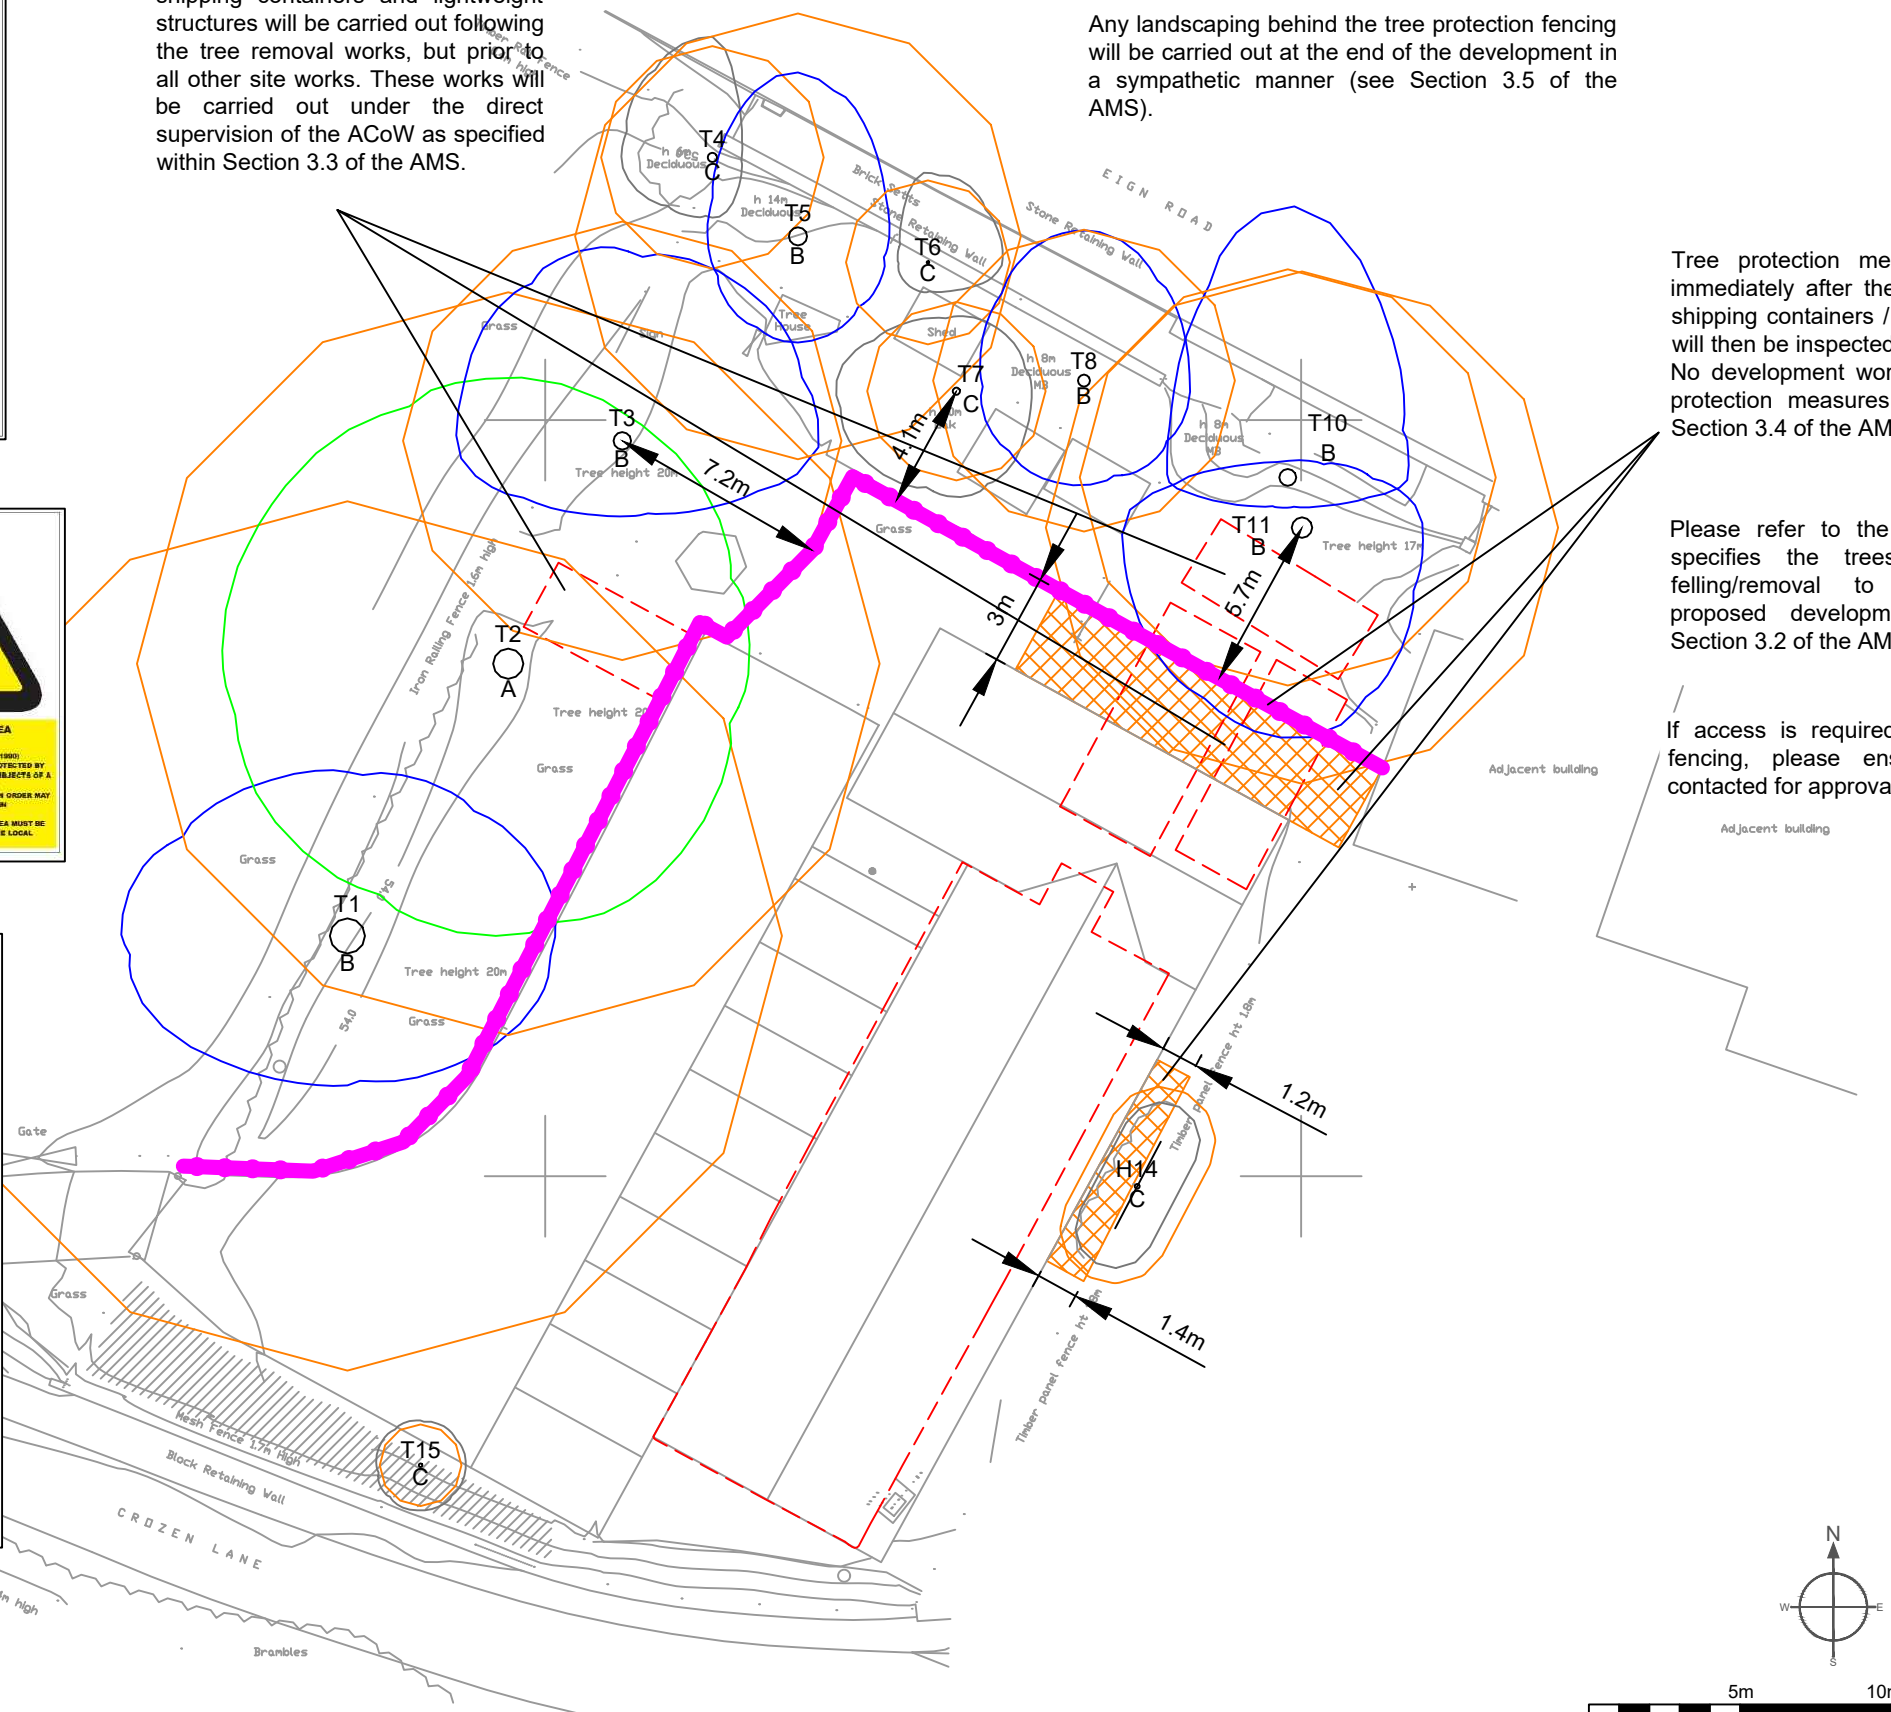
4.3.2 Tree Protection Plan

Any landscaping behind the tree protection fencing will be carried out at the end of the development in a sympathetic manner (see Section 3.5 of the AMS).

The diagram shows a cross-section of the temporary ground protection system. It is installed on a paved surface. A wooden edgerail is secured to the ground with stakes. Inside the edgerail, a layer of woodchips is placed on top of a geotextile membrane. Proprietary ground protection boards are laid on top of the woodchips, secured together with metal couplers. The diagram is labeled with numbers 1 through 6 corresponding to the components: 1. Timber Edgerails, 2. Geotextile Membrane, 3. Woodchip, 4. Proprietary ground protection, 5. Metal couplers, and 6. Timber Stakes.

Please refer to the AIA plan that specifies the trees that require felling/removal to facilitate the proposed development (also see Section 3.2 of the AMS).

If access is required behind the tree protection / fencing, please ensure the ACoW is firstly / contacted for approval and / or guidance.

A tree protection fence will be erected to the correct specification and positioned as specified by the dimensions on the TPP (Annex 4.3). The tree protection fencing will only be dismantled and removed from site following the completion of all works and the removal of machinery and vehicles from site.

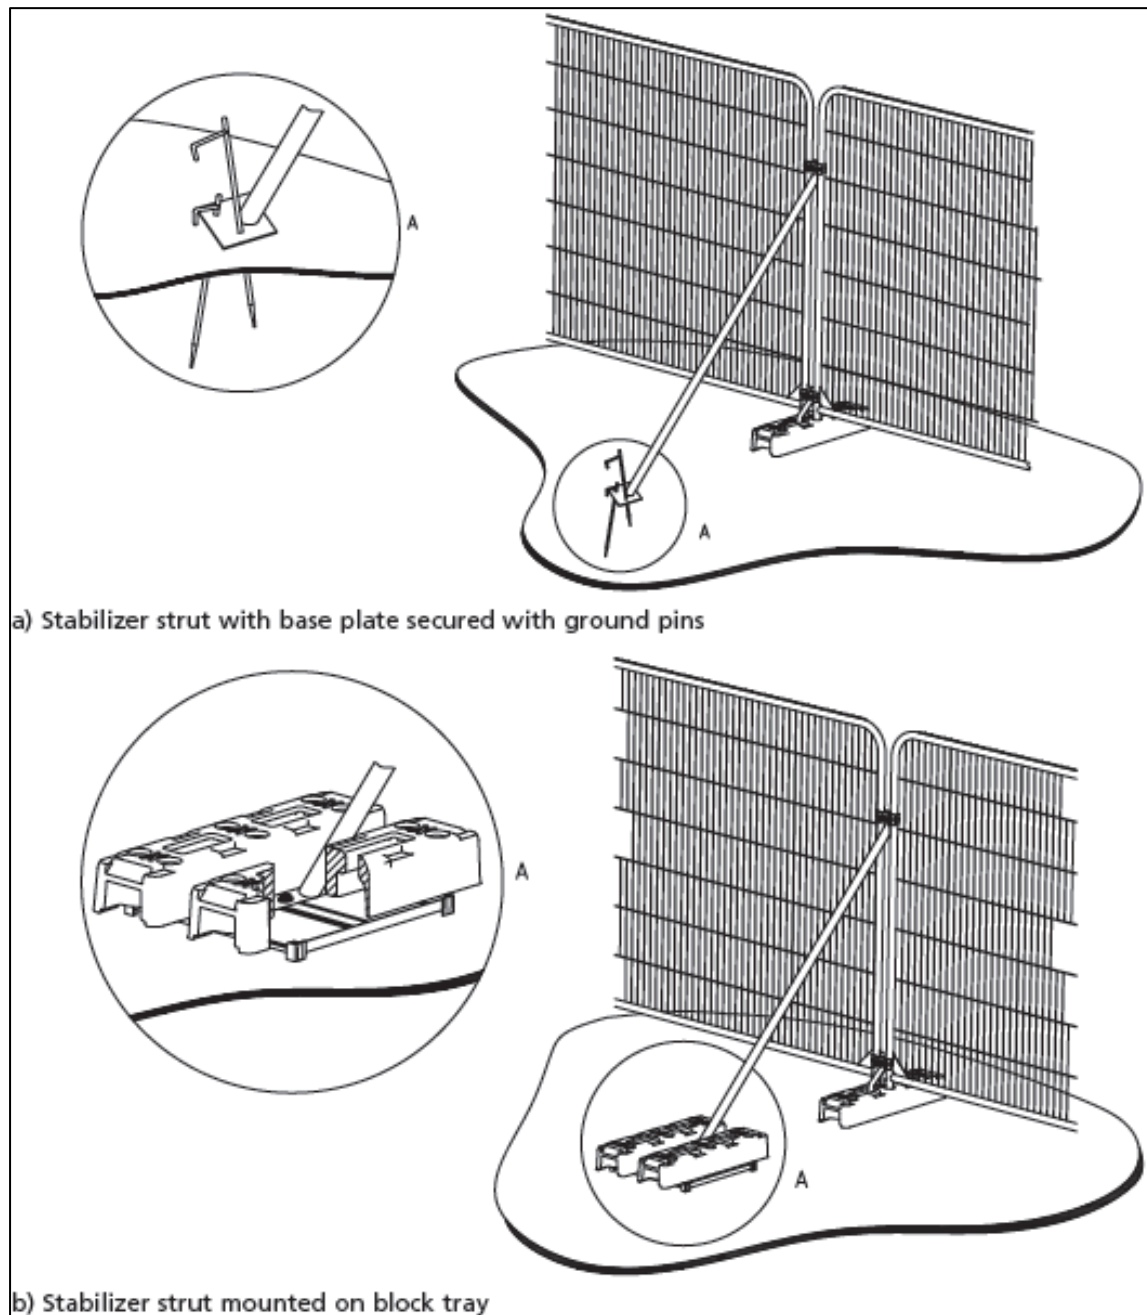
4.4.1 Tree Protection Fencing Design

a) Stabilizer strut with plate secured with ground pins

b) Stabilizer strut mounted on block tray

The tree protection fencing will comprise of **2 metre high welded mesh panels on rubber feet**. The fence panels will be joined together using a **minimum of two anti-tamper couplers**, installed so that they can only be removed from inside (tree side) the fence. The distance of the fence couplers will be at least 1 metre and should be uniform through the fence. The panels will be supported on the inner side by **stabilizer struts** (one installed between each fencing panel), which will be attached to a **base plate** secured with **ground pins** (Annex 4.4).

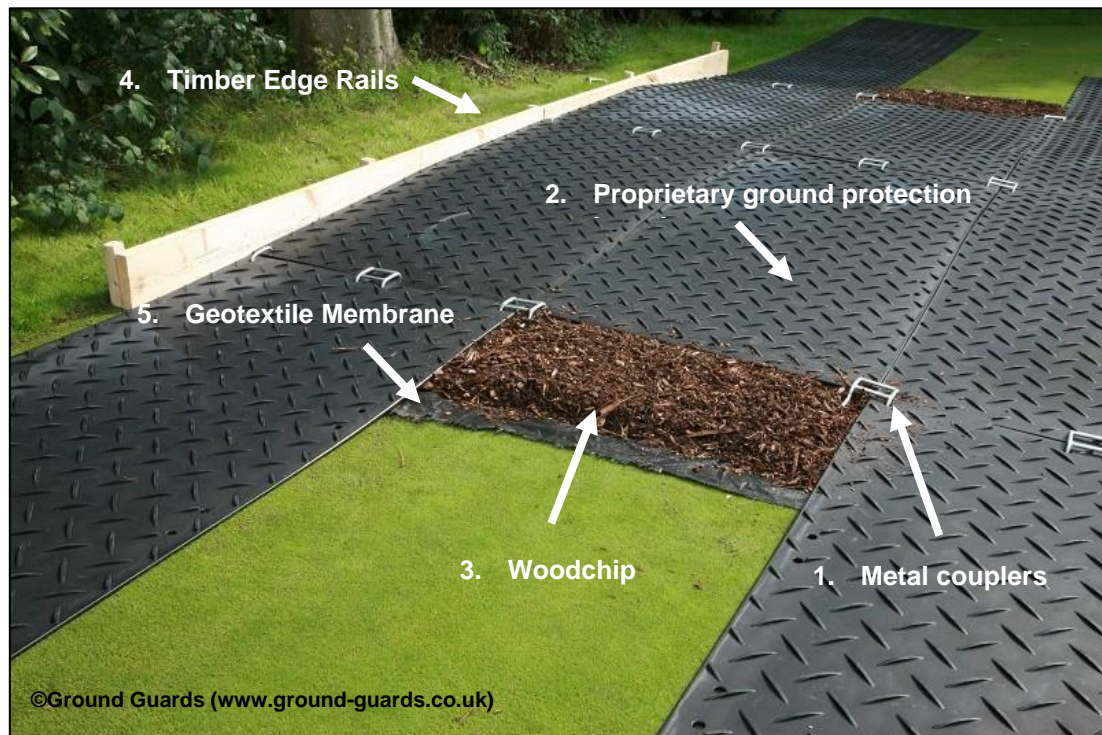
4.4.2 Temporary Ground Protection

1. Timber edge rails at 200 mm high x 50 mm wide will be secured to the ground with timber stakes. Timber stake dimensions will be 50 x 50 x 500 mm and will be positioned at 1 m spacings. Timber edge rails will be installed at both sides of the ground protection's specified position.
2. A geotextile membrane will be laid on the ground between the timber edge rails.
3. A layer of woodchip at a depth of 150 mm will be laid upon the geotextile membrane.
4. Proprietary ground protection boards at 1200 mm wide x 2400 mm long will be laid upon the woodchip. A single row of boards will be used to cover the areas specified for 1.2 m wide temporary ground protection. Two rows of boards laid next to each other with no gaps between will be required in areas specified for 2.4 m wide temporary ground protection.
5. The ground protection boards will be secured together using metal couplers.

Temporary ground protection will be capable of tolerating pedestrian-operated plant up to a gross weight of 2 t. Machinery of a weight greater than 2 t will be removed from moving over these areas.
