## BS5837 Tree Survey, Arboricultural Impact Assessment and Method Statement.

Deepmoor Yatton Herefordshire HR6 9TN

20/11/20

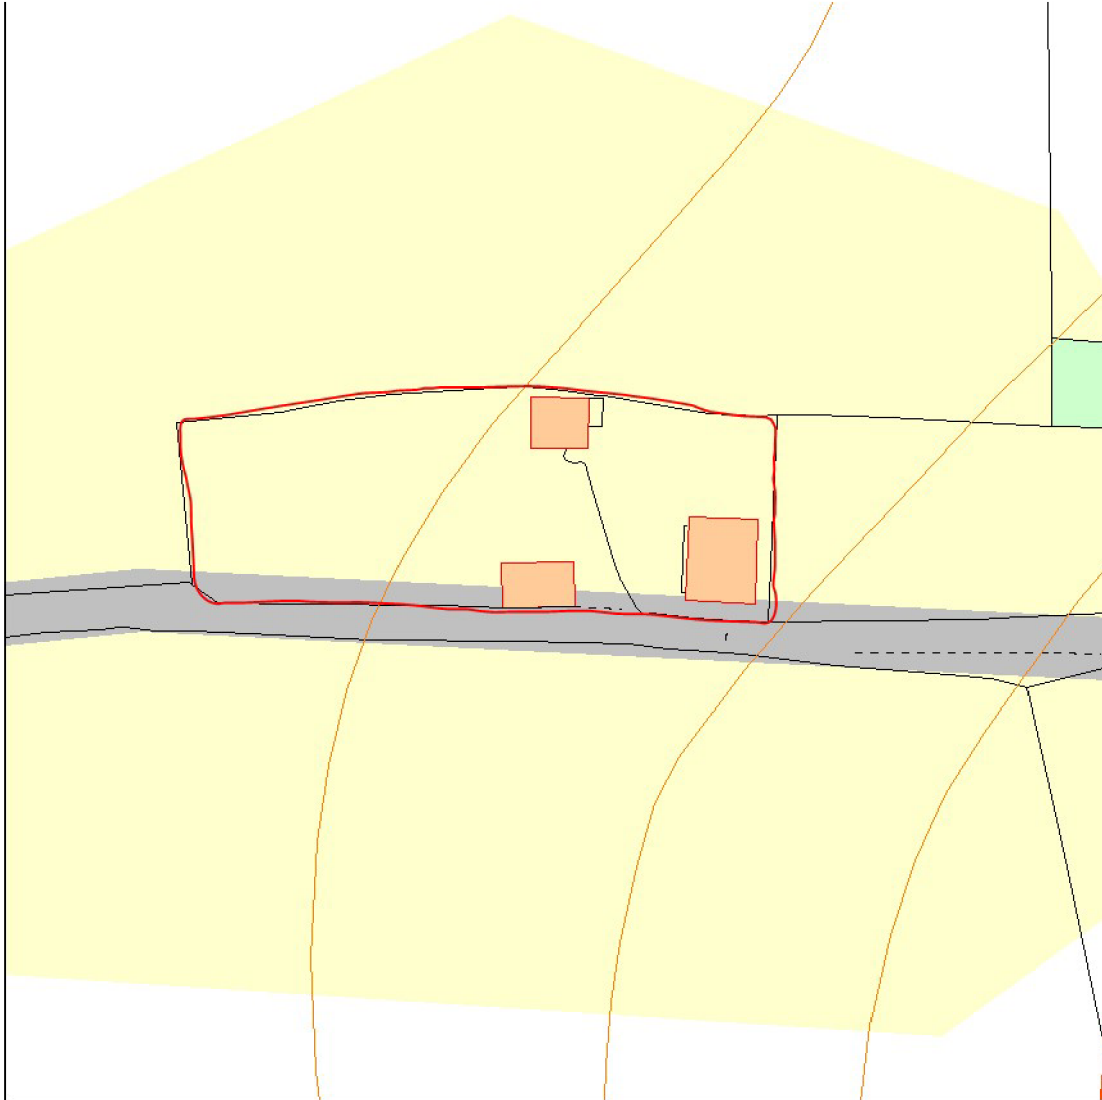
#### 4. Location of survey:

5. Tree survey site parameters are highlighted in red above.

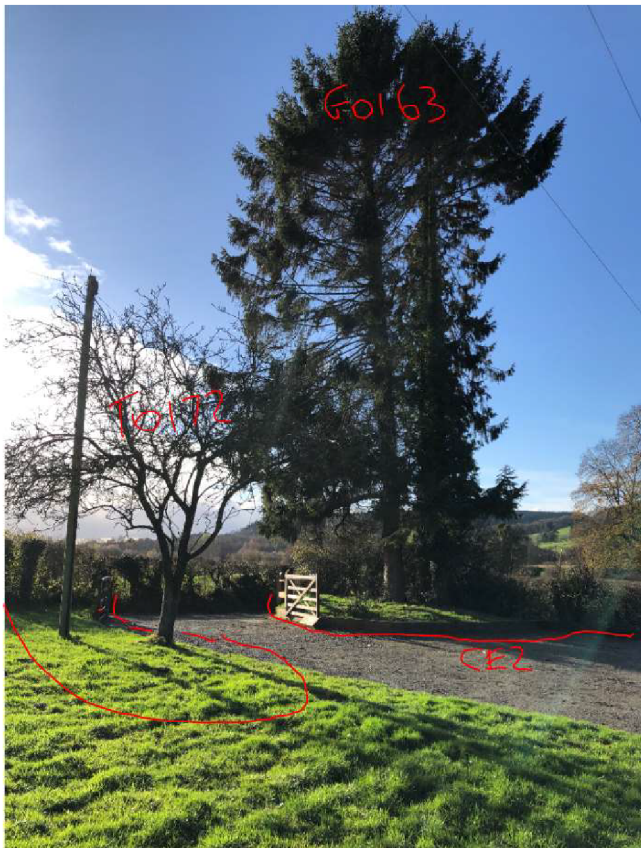
8.3 Group G0163, and Tree 0172 have an historic stone driveway within the root protection areas. The BS5837 root protection area calculations are based by calculating an area equivalent to a circle radius 12 times the stem diameter. This is a standard format for all trees and does not take into account pre-existing site conditions or other factors that indicate rooting has occurred asymmetrically. BS5837 allows for modifications to the Root Protection Area (RPA) based on the positions of roots when influenced by historic site features e.g. roads buildings, drains. In this case as shown by the tree protection plan the RPA are aligned with the pre existing stone driveway access. See photo below.

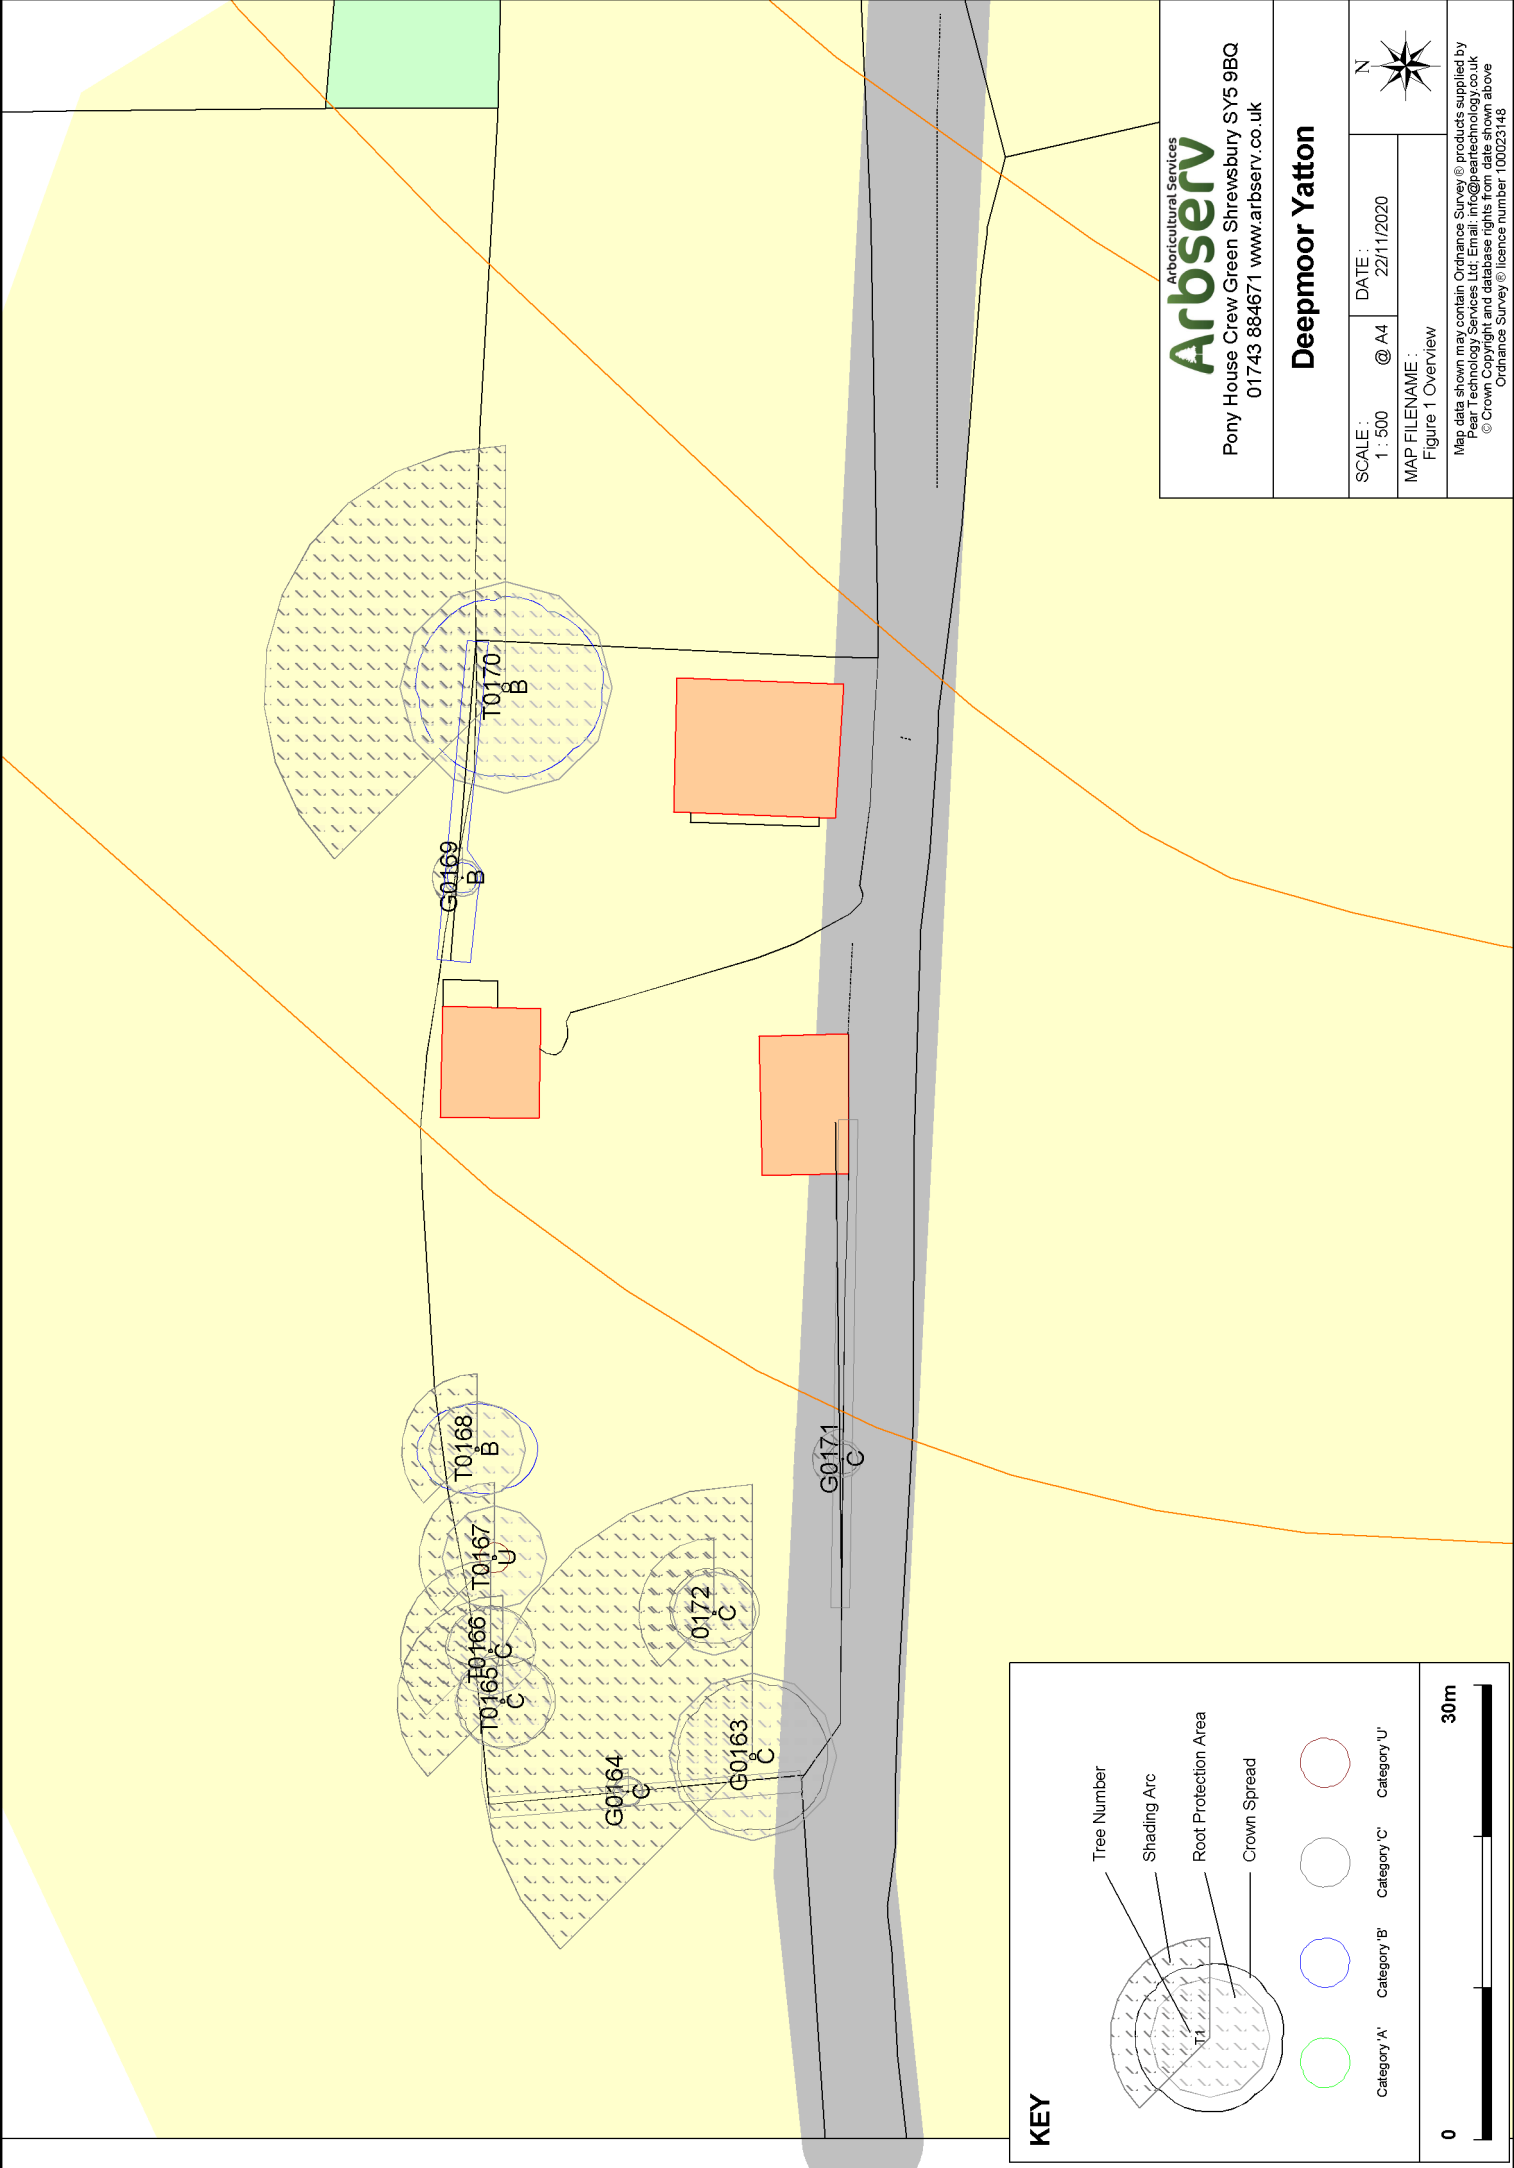
## Appendix 1 figure 1 Tree Location Plan.

6.1 The survey was carried out on 20/11/20 by Matthew Owen, the weather at the time was clear and with good visibility. Figure 1 shows the general layout of the site and the locations of all trees. The full results are tabulated in BS5837 tree survey schedule table (appendix 3) and should be read in conjunction with the tree protection plan Figure 2

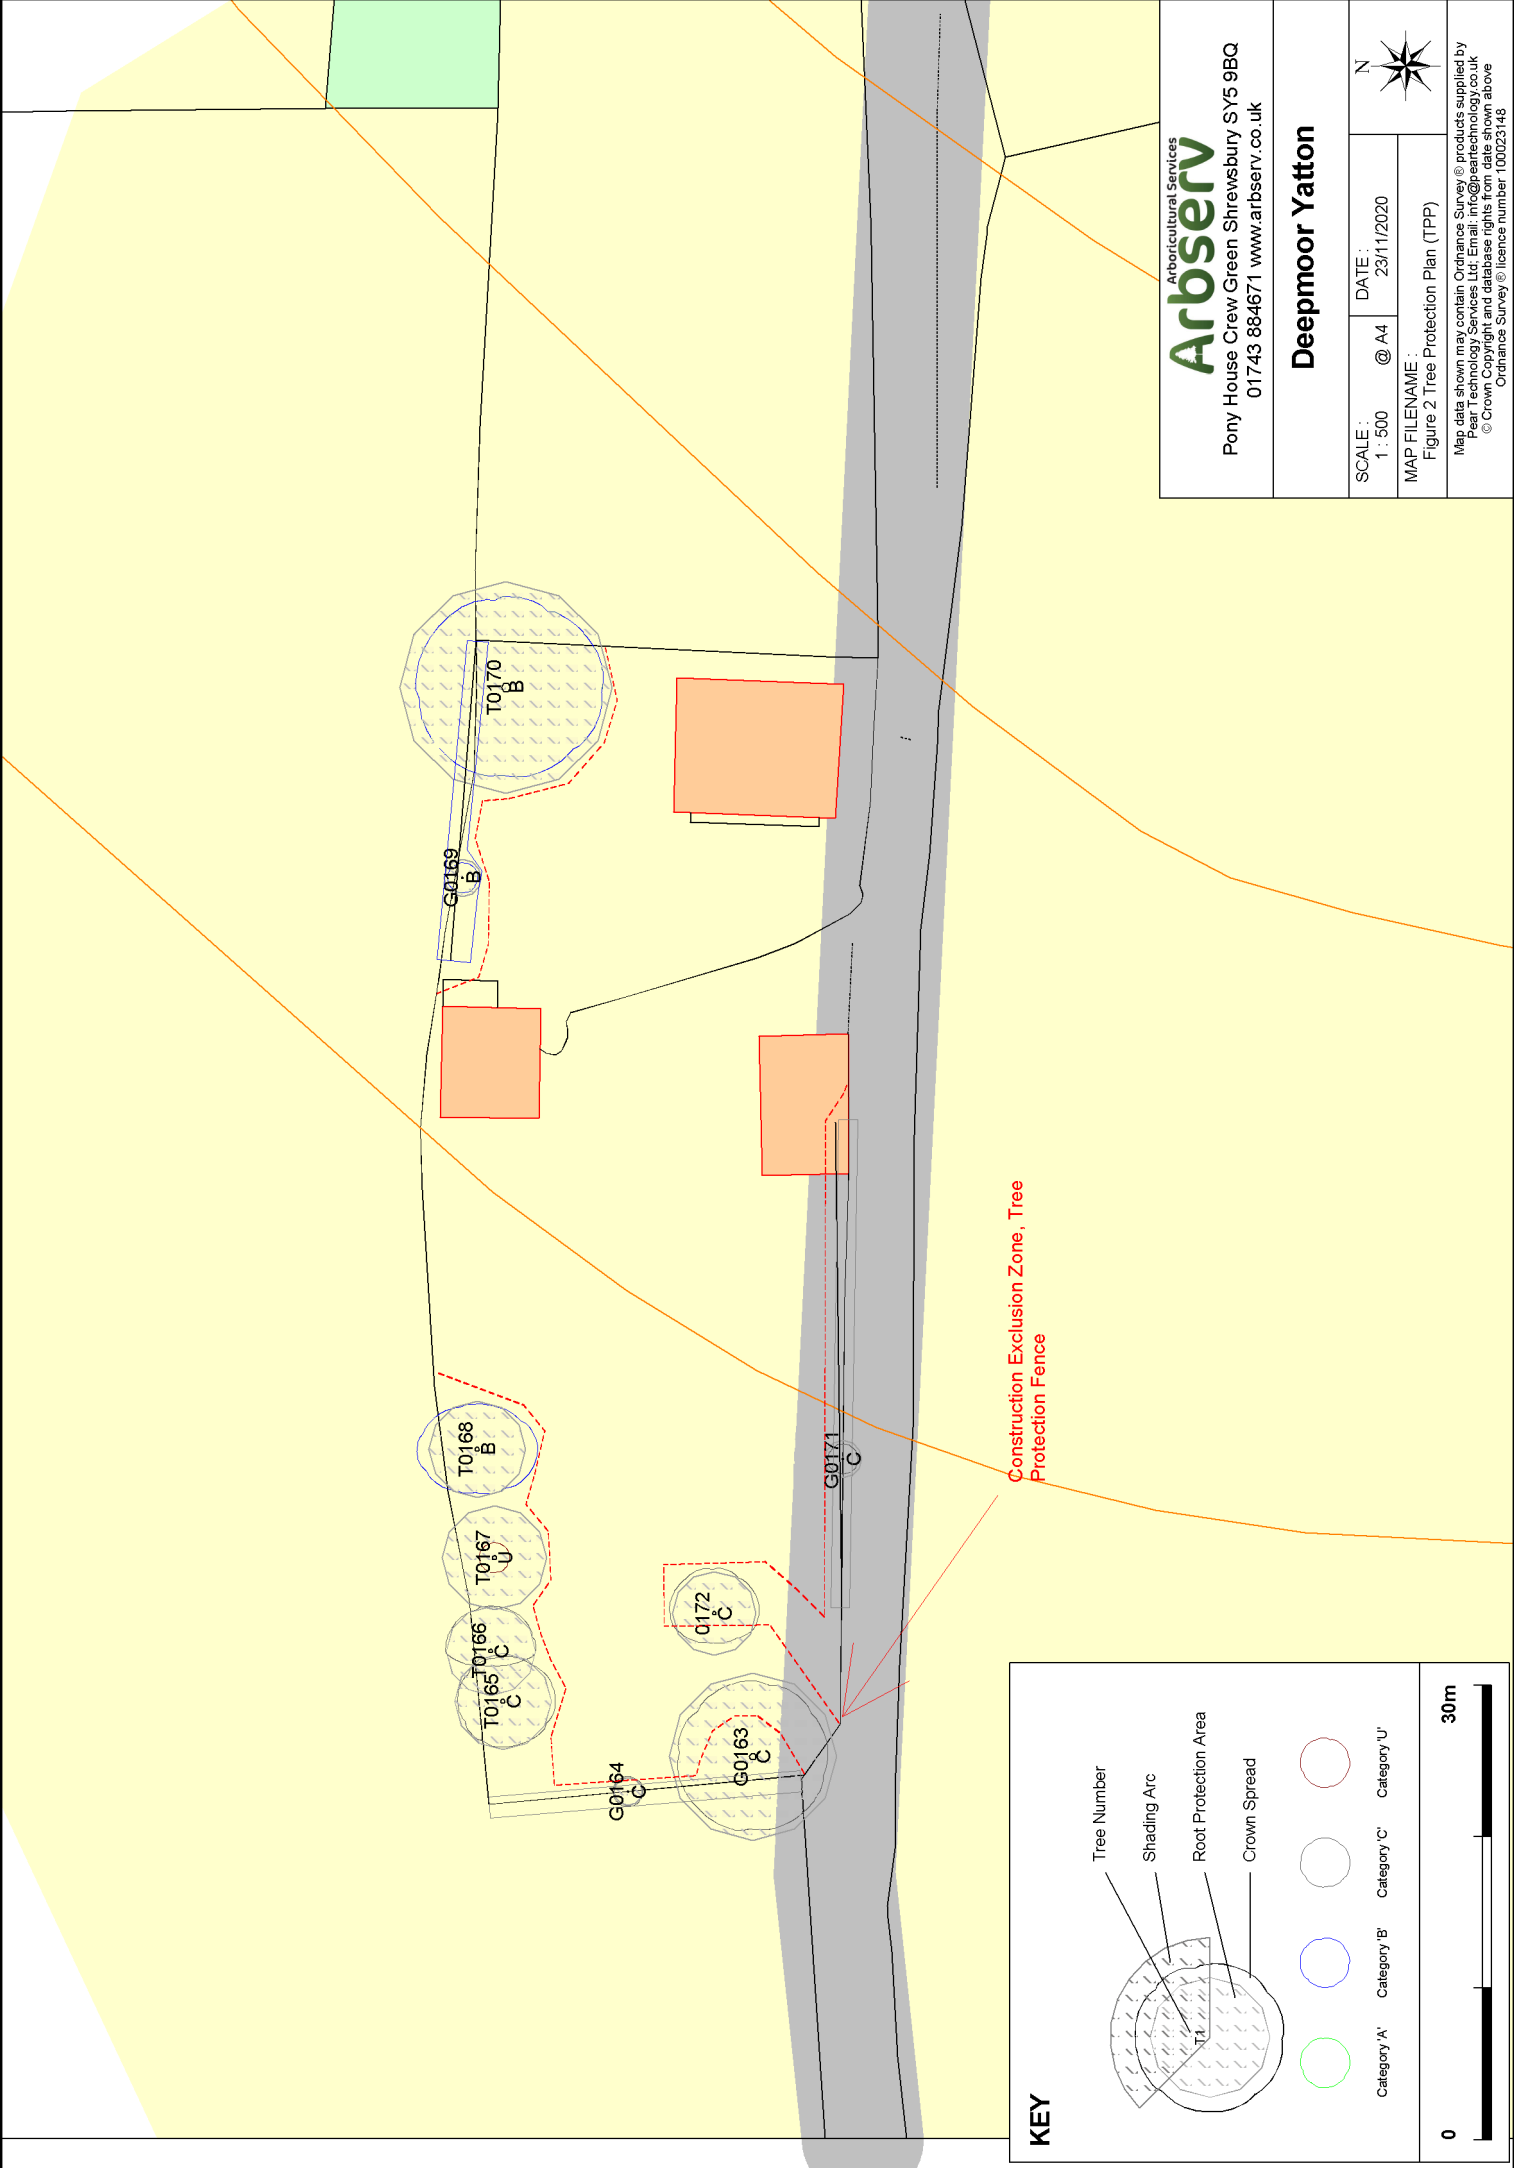
## Appendix 2 figure 2 Tree Protection Plan.

7.3 The below ground constraints are marked as Root Protection Areas (RPA'S) on the tree protection plan figures 2. The concise arboricultural impact assessments and method statements are displayed in the survey comment of the tree survey table for each tree. This is to provide uncomplicated use by operatives along with the tree protection plan on site. The arboricultural impact assessment and method statement in this report provide more detailed information.

8.4 The proposed building and parking areas fall out-side the RPA'S of all other trees and hedges in the site parameter. (see Figure 2 Tree Protection Plan) The Arboricultural impact on these trees can be mitigated by following the Arboricultural Method statement out-side RPA. The existing sites has open areas of lawn in the centre and existing trees and hedges around the perimeter. All trees and hedges on this site can be successfully protected with a tree protection fence (CEZ) with no Arboricultural Impact.

9.2 **Method out-side RPA** for all trees retained. The RPA shall be measured and clearly marked on site with the use of ground pins or marker spray. All relevant personnel should be briefed to ensure they are fully aware of the location and extent of the RPA'S Construction Exclusion Zone (CEZ). Install the section of Heras fence or similar barrier positioned as indicated on the tree protection plan to form a construction exclusion zone (CEZ).

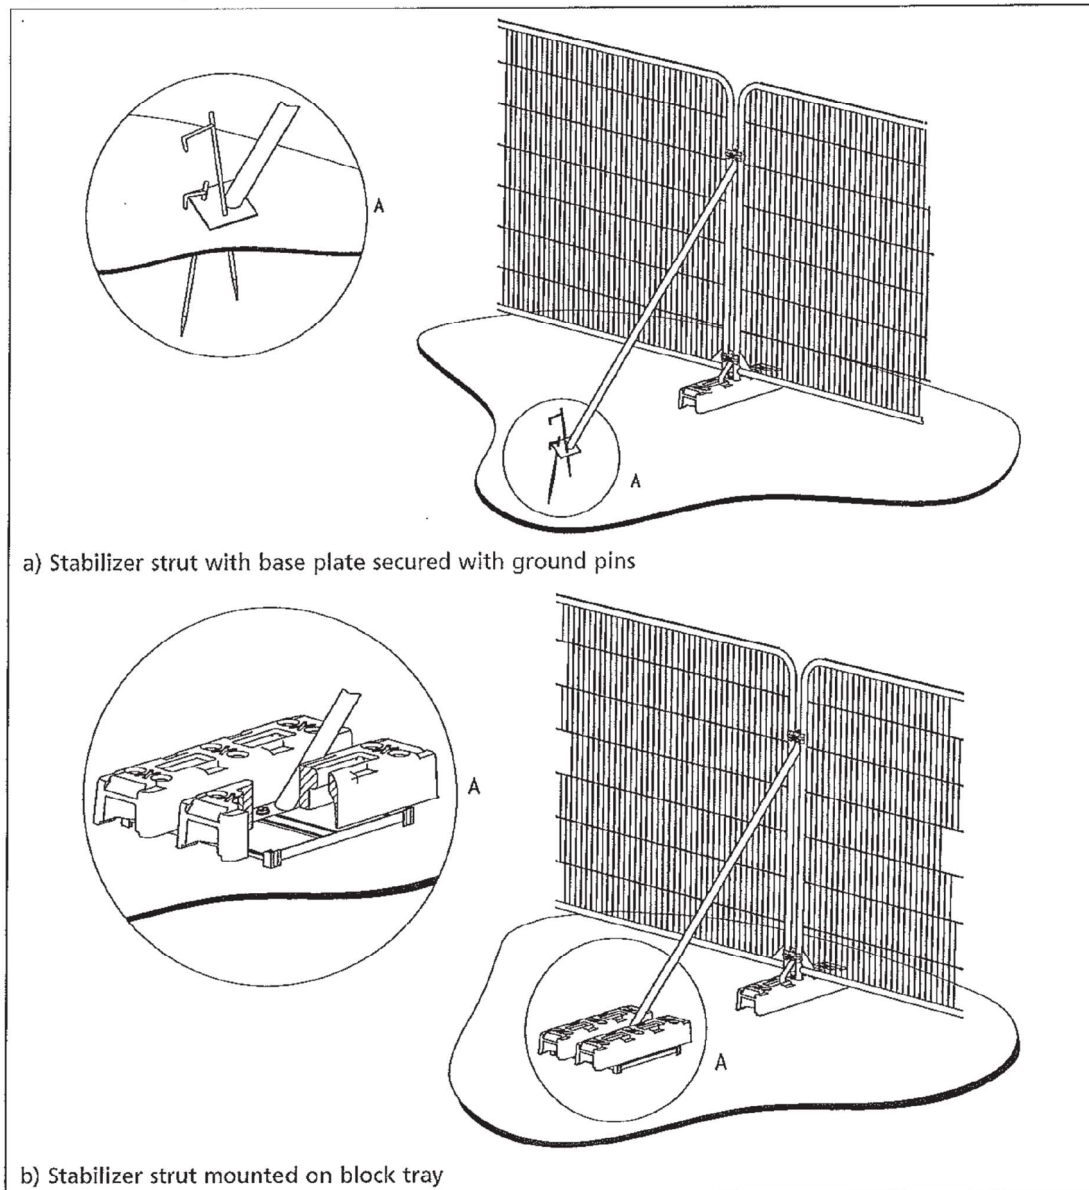
Figure 3 Examples of above-ground stabilizing systems

**6.2.2.3** Where the site circumstances and associated risk of damaging incursion into the RPA do not necessitate the default level of protection, an alternative specification should be prepared by the project arboriculturist and, where relevant, agreed with the local planning authority. For example, 2 m tall welded mesh panels on rubber or concrete feet might provide an adequate level of protection from cars, vans, pedestrians and manually operated plant. In such cases, the fence panels should be joined together using a minimum of two anti-tamper couplers, installed so that they can only be removed from inside the fence. The distance between the fence couplers should be at least 1 m and should be uniform throughout the fence. The panels should be supported on the inner side by stabilizer struts, which should normally be attached to a base plate secured with ground pins (Figure 3a). Where the fencing is to be erected

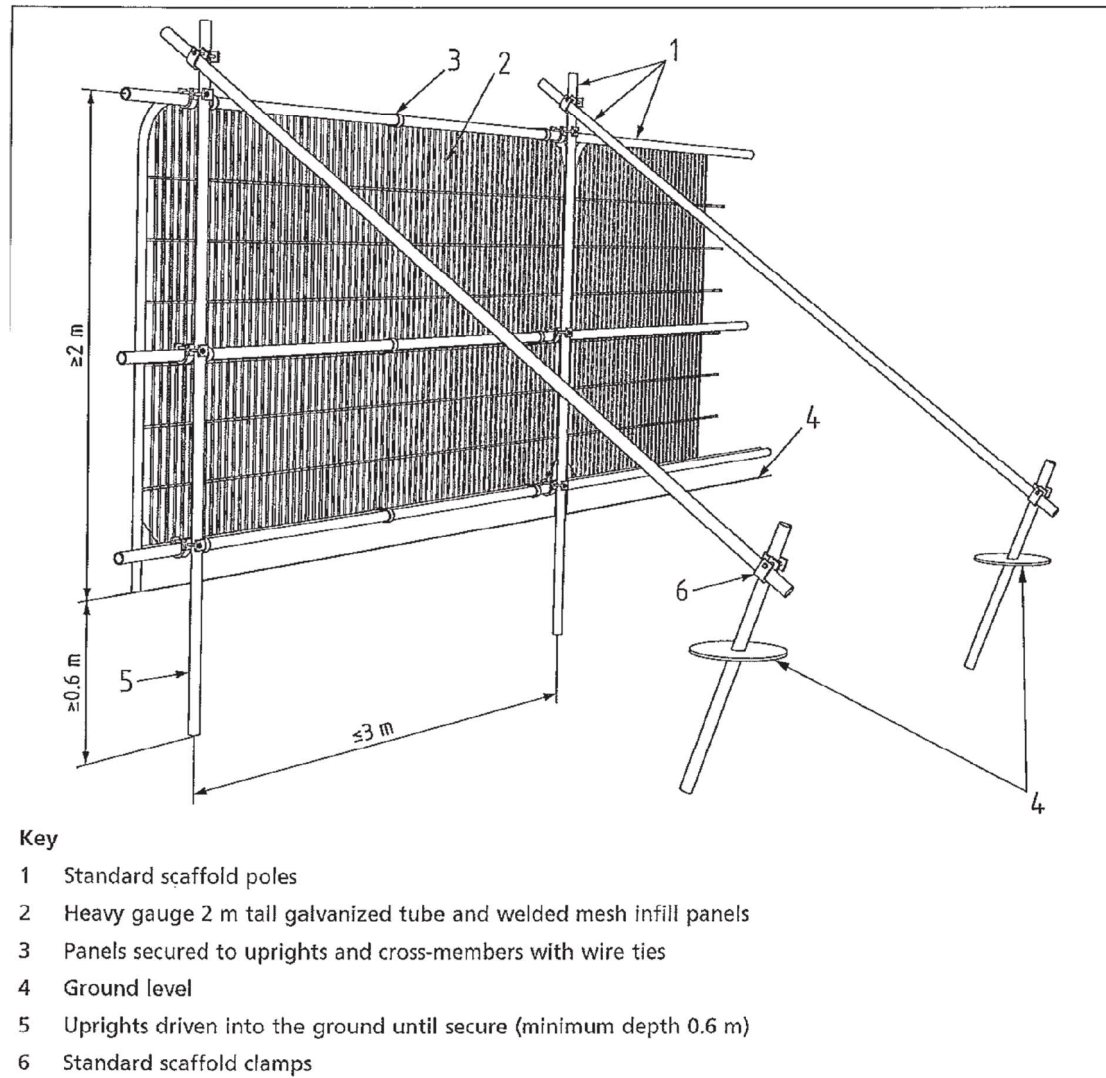
Figure 2 Default specification for protective barrier

**6.2.2.2** The default specification should consist of a vertical and horizontal scaffold framework, well braced to resist impacts, as illustrated in Figure 2. The vertical tubes should be spaced at a maximum interval of 3 m and driven securely into the ground. Onto this framework, welded mesh panels should be securely fixed. Care should be exercised when locating the vertical poles to avoid underground services and, in the case of the bracing poles, also to avoid contact with structural roots. If the presence of underground services precludes the use of driven poles, an alternative specification should be prepared in conjunction with the project arboriculturist that provides an equal level of protection. Such alternatives could include the attachment of the panels to a free-standing scaffold support framework.
