# 228 - BANK HOUSE

Structural Report -

15/06/2021

JAKE SMITH ENGINEERING

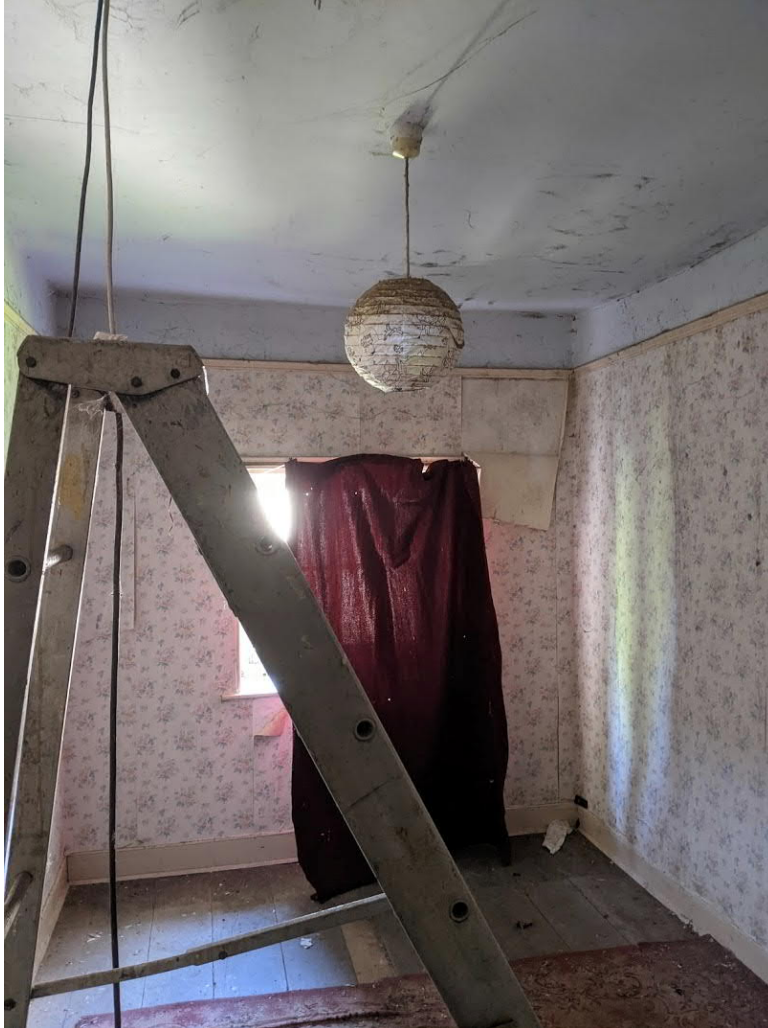
- 7.7. The roof construction is a cut roof supported off a series of trusses (mainly kingpost). The roof has a hidden central valley.
- 7.8. The roof space above the first floor is accessible via small hatch in northern bedroom:

- 7.9. Viewing was limited to the direct vicinity of the roof hatch as entering the roof space would be dangerous given its condition. The roof timbers are assumed as oak.

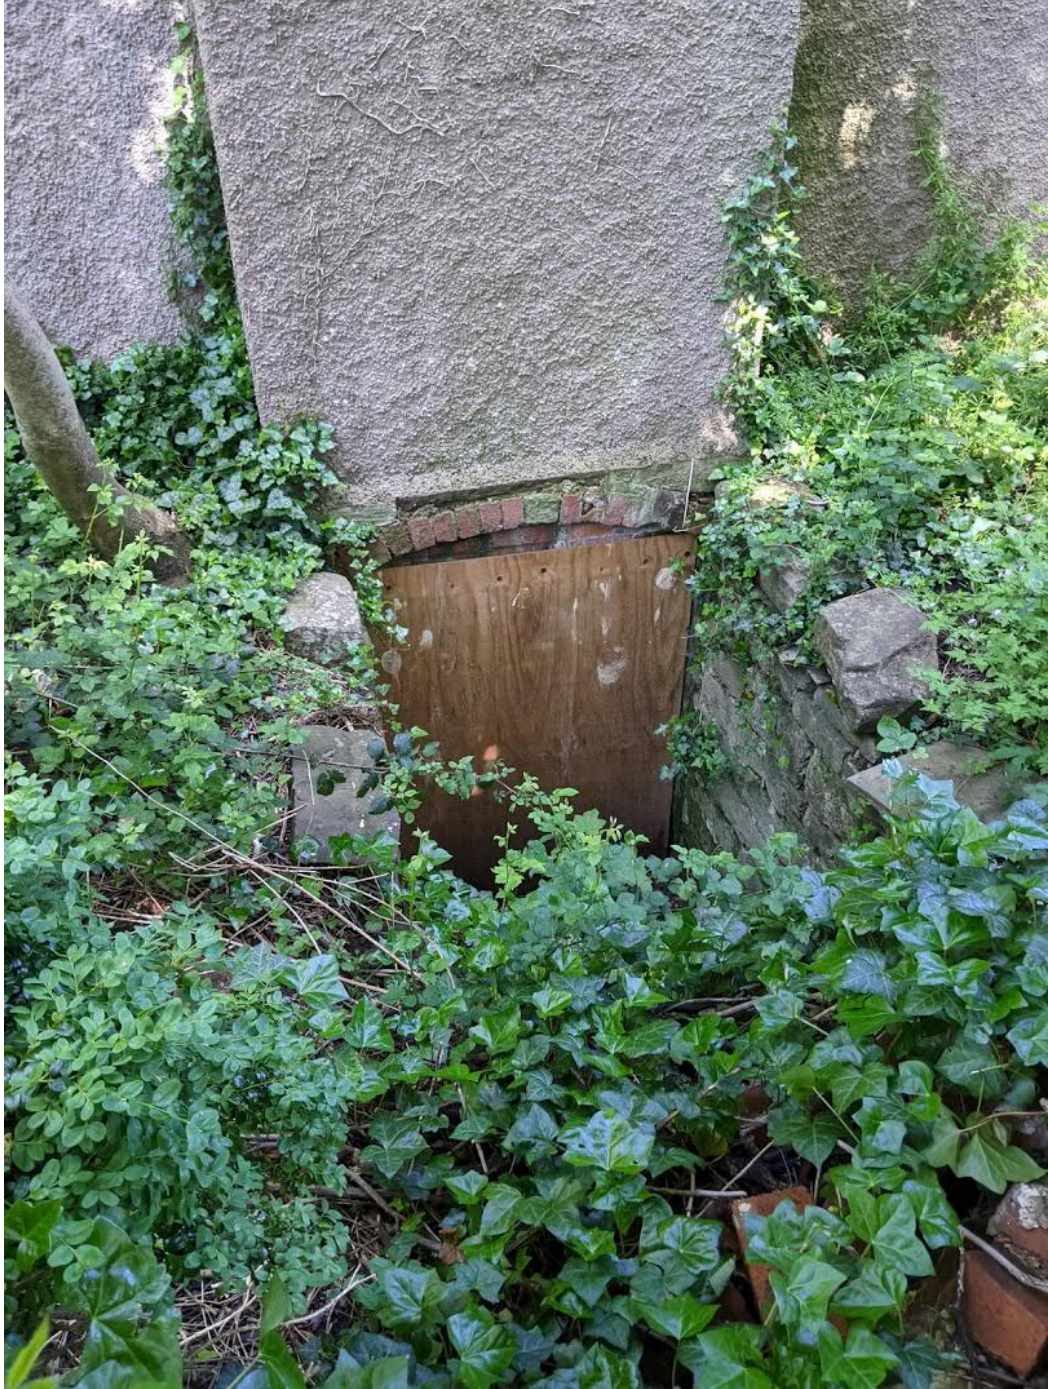
South Elevation

7.20. The brickwork front is in fair condition. Some plant growth is evident which will be causing damage. There is extensive ivy growth visible at the eaves which has damaged the gutters and roof.

7.21. Ventilation for the raised floor void is evident around the building perimeter

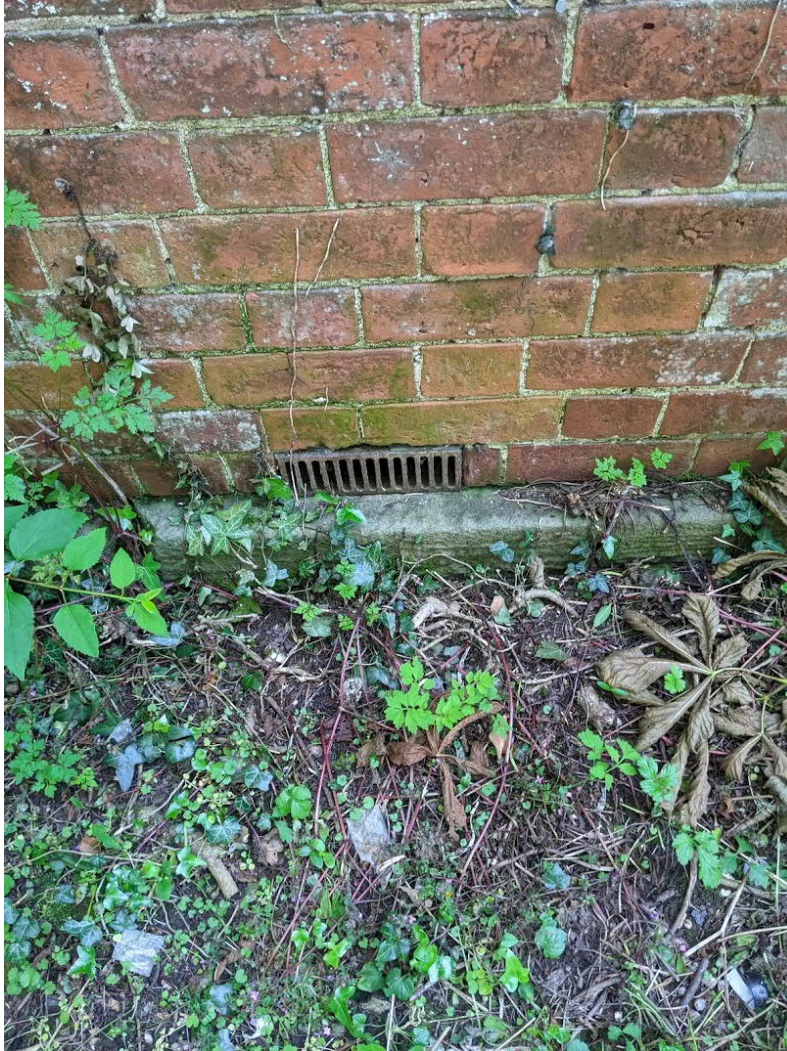
7.22. There is no significant bow or lean to this wall.

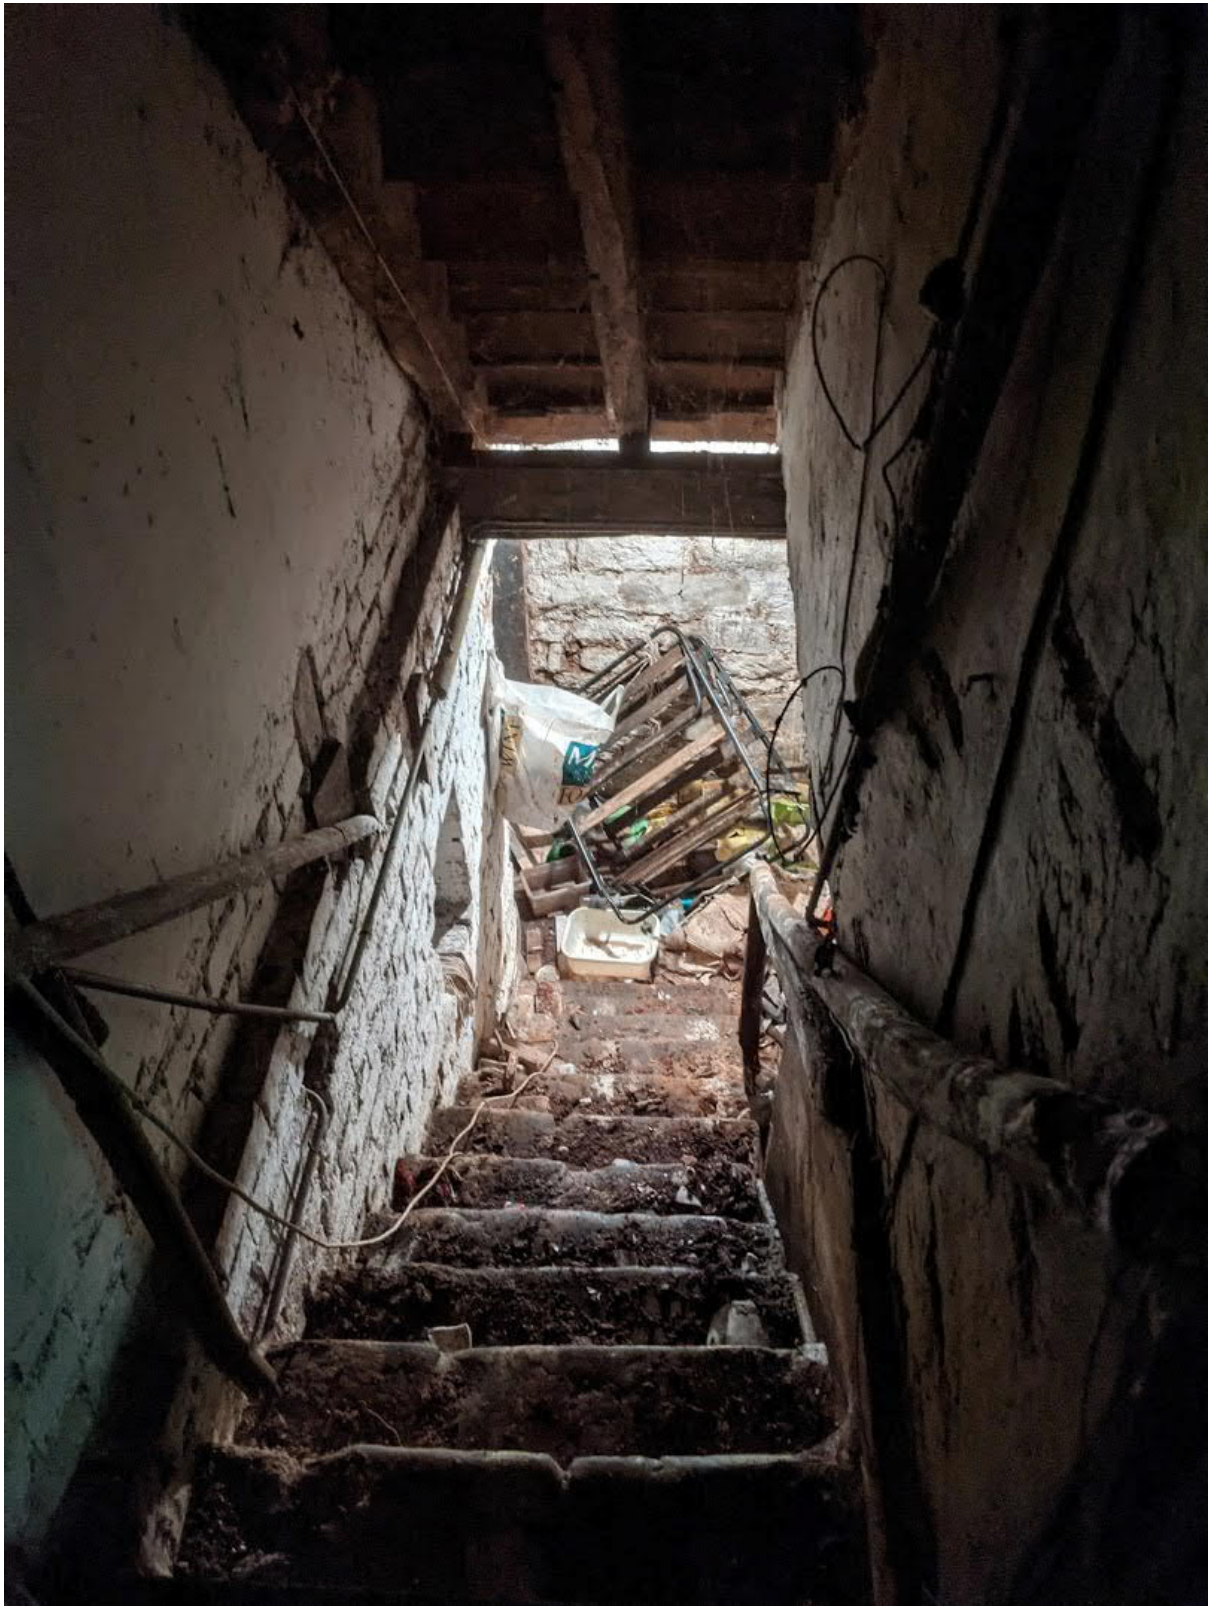
- 7.26. The property has a basement under part of the southern side of the building. The floor of which appears to be formed of compact soil. The walls are formed of brick and stone. There is an internal brick wall which appears to form support for the floor joists above.

7.27. The floor is supported by a series of oak beams and joists. These are in varying condition as the humidity is very high. Water from the roof is coming through the building to the basement. Whilst some beams may be salvageable, there is quite impressive mould growth on some of the beams.
