# **Preliminary Structural Appraisal**

- Project: Lower Barns St Michaels Tenbury Wells
- Client: Mr & Mrs Yapp
- Ref: 17168
- Date: May 2017

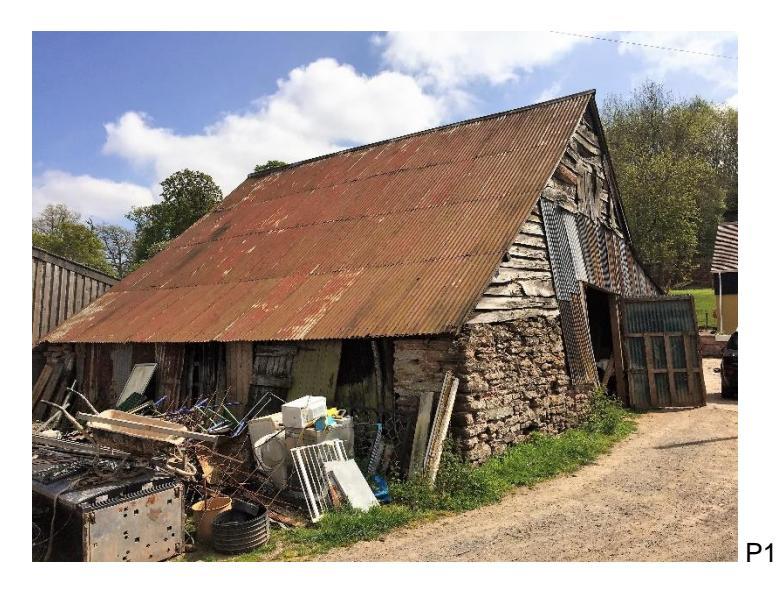
**Barn** – Rectangular and gabled timber framed building supported off stone plinth. Framing organisation consistent with period practise. Building length divided into three equal bays defined by cross frames incorporating dual pitched roof trusses supporting side purlins. External elevations are completed with infill framing.

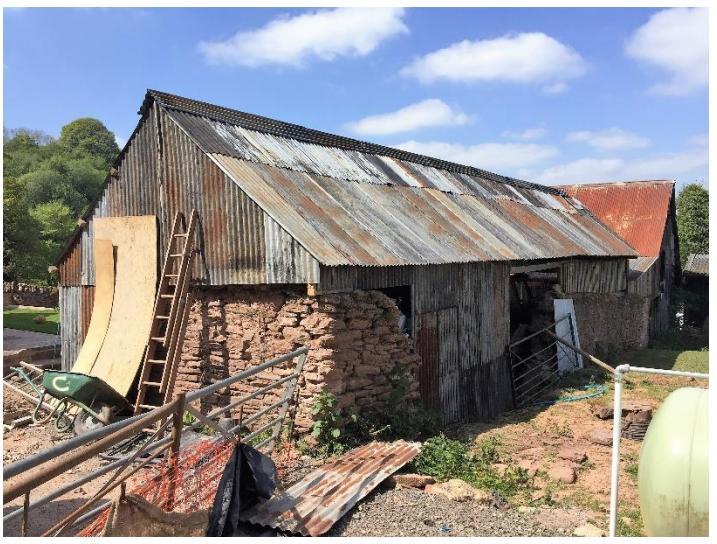
**Cart Shed** – Rectangular and gabled single storey building. Open almost entirely on the yard side and enclosed on two elevations by stone walling. Lightweight timber framed roof structure.

<u>Comment:</u> Like the barn, the stone is in adequate condition, it lacks an effective mortar to bond the construction. Masonry walling requires careful consolidation and repairs. Some section may need to be taken and rebuilt.
