Design & Access and Heritage Statement

Newton Farm, Stoke Lacy, Bromyard, HR7 4QY

Repairs and alterations to existing farm buildings

August 2022

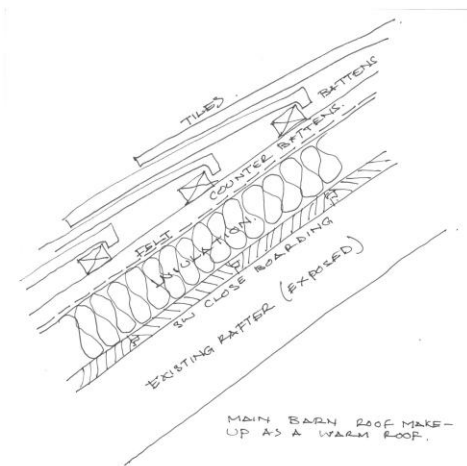
New roof build up.

To improve usability of the barn and to future proof its use, it is proposed to incorporate insulation and roof windows into the roof slopes. The roof will be recovered in the salvaged tiles.

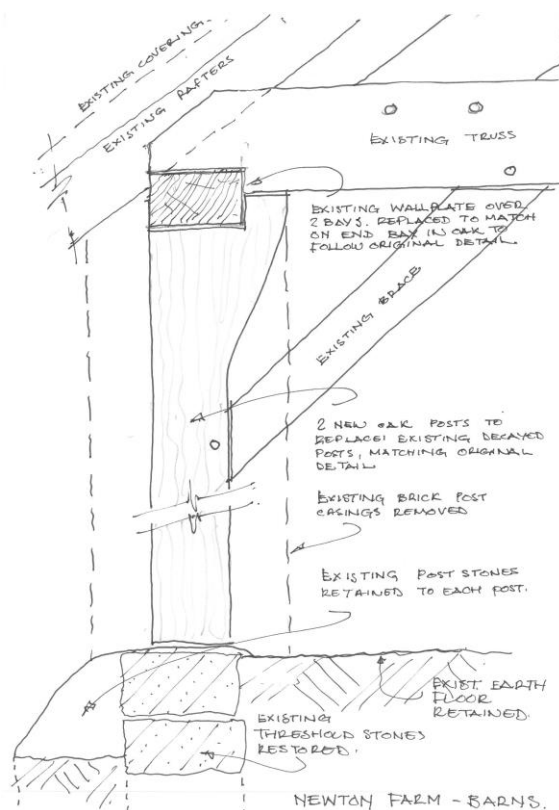
Post and truss detail.

The existing later brick infill and brick casings to the posts will be removed. The rotten oak posts will be replaced in oak to match the original detail.

The temporary post and roof support beam will be removed and a new oak wall plate inserted to match the original detail.
