Structural Appraisal Report

Proposed Barn Conversion

Parkmill,
Llangarron,
Herefordshire,
HR9 6NH

Davidson John Ltd.
Ref.No. 900/37/01/TJ

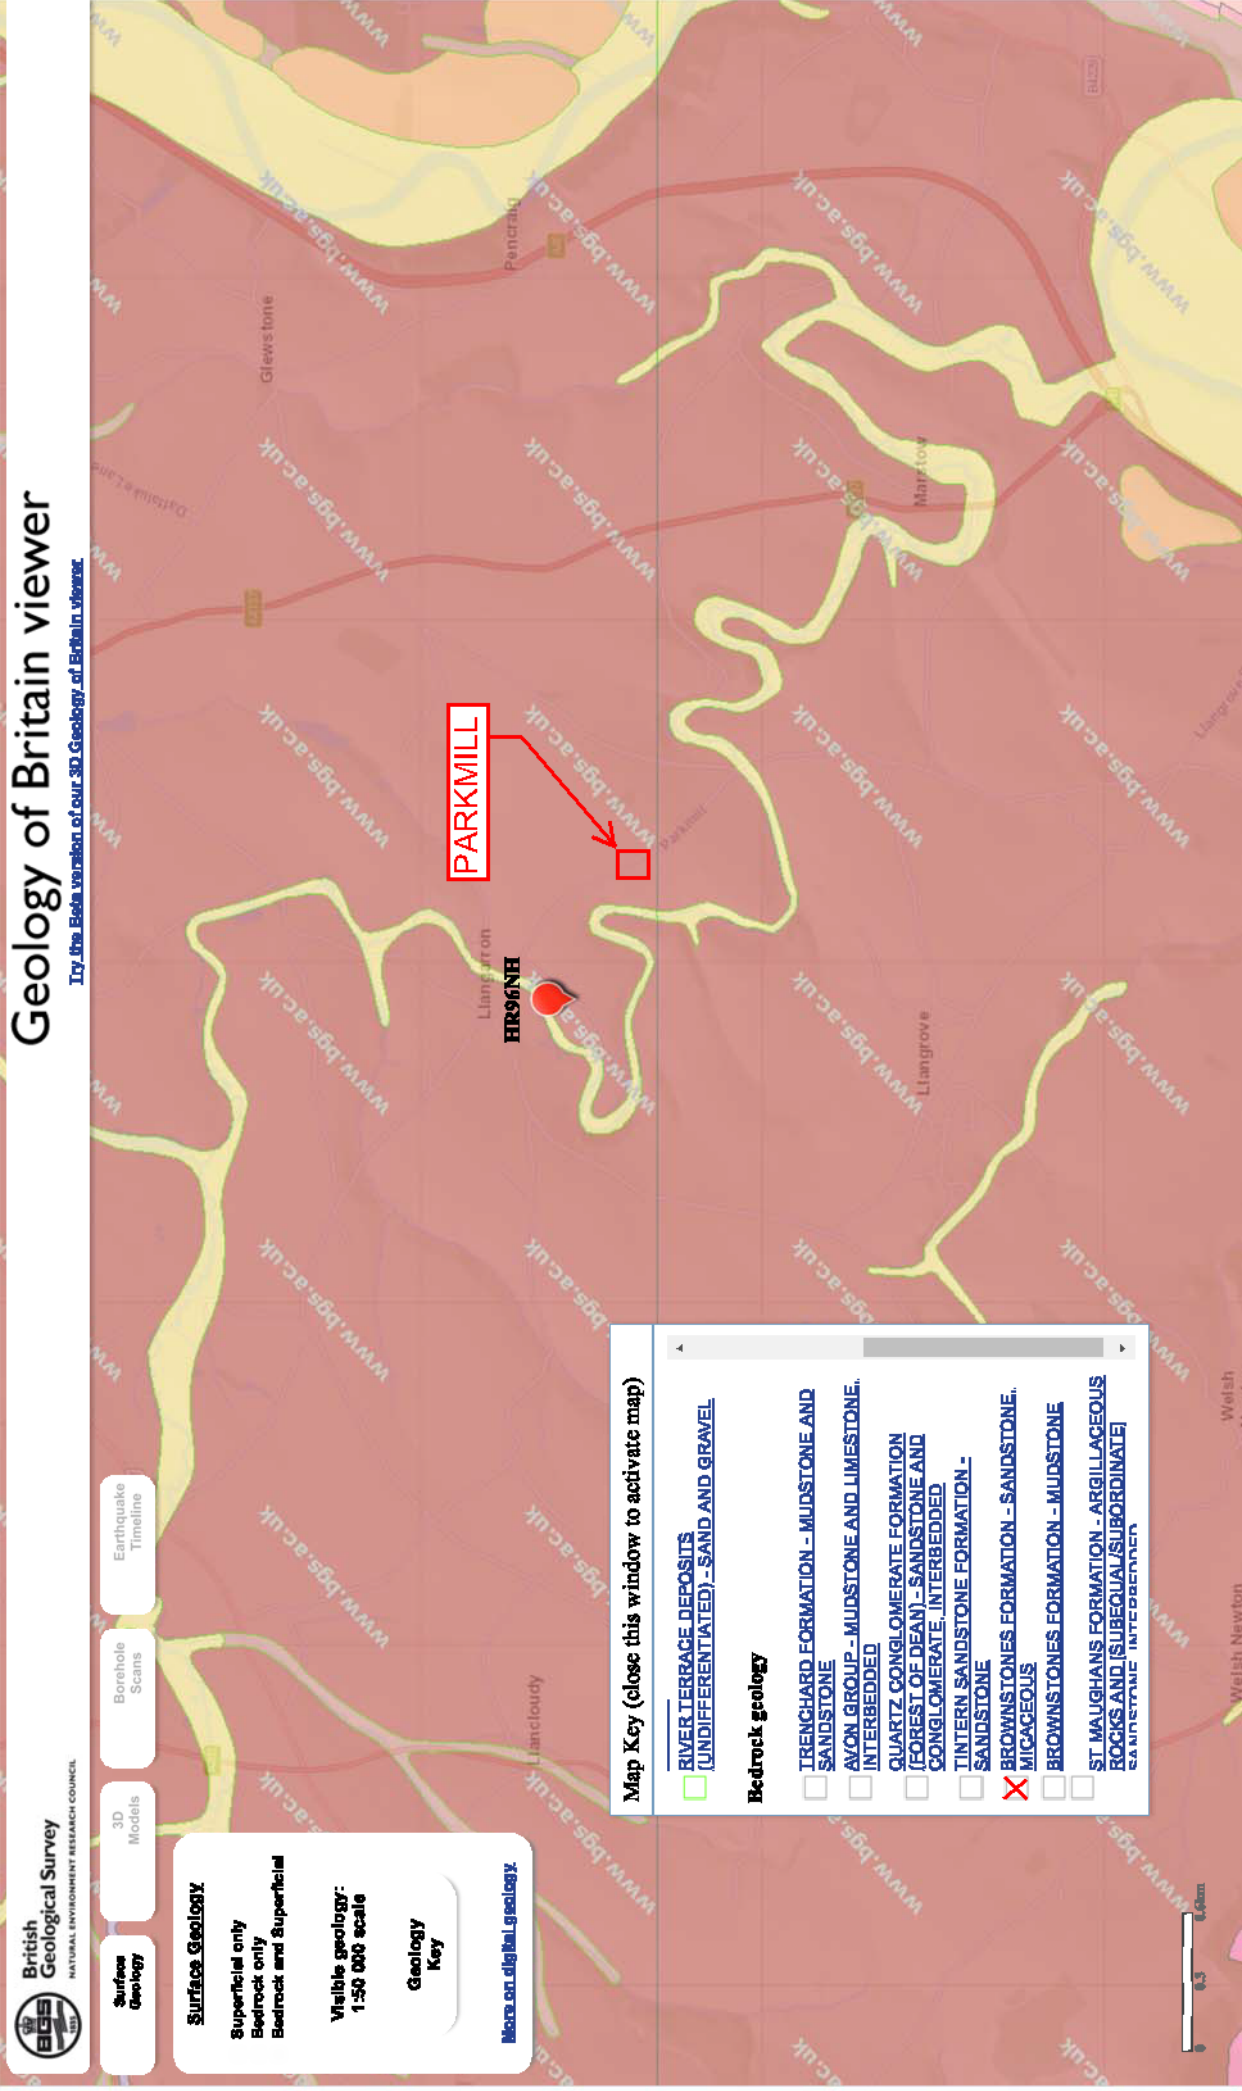
Fig.1- Site Geology

Our appraisal took the form of internal and external visual inspections carried out on 7th August 2018, together with a study of the Architect's drawings showing the basic proposals. At this stage trial pits have not been excavated to explore the foundations to the building, but our study of the local geological map would suggest that the underlying ground conditions should be the Brownstones Formation (Sandstone) overlying the St. Maughans formation (Mudstone). The Garron brook runs at the foot of the slope to the West of the site, approximately 200m away, and it is anticipated that ground conditions will change to Alluvium nearer to the brook. Please refer to Fig. 1.

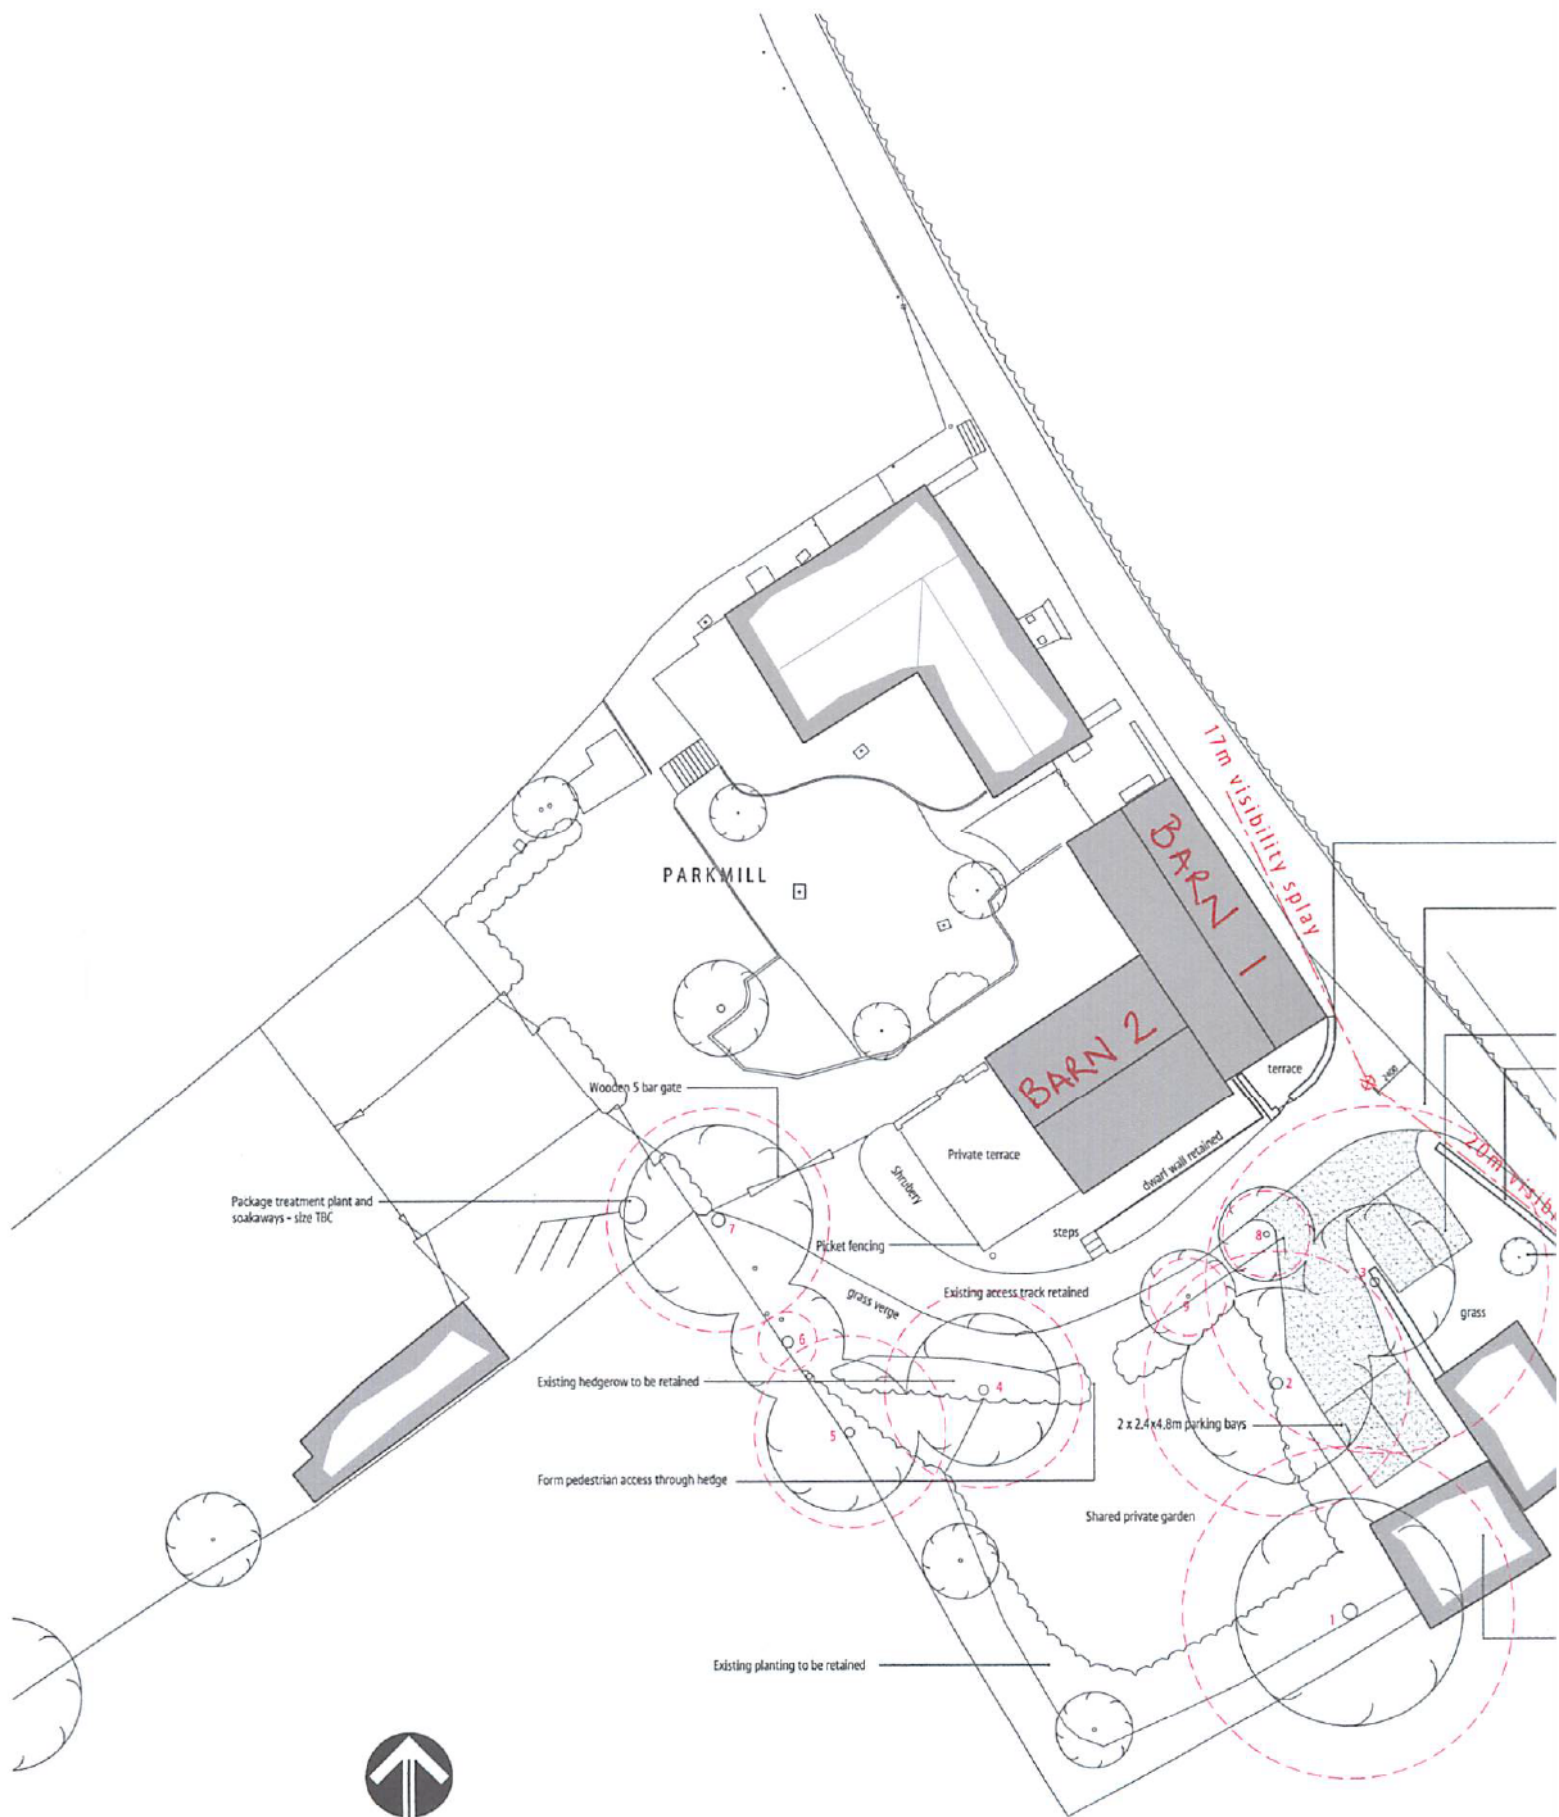
Fig. 2 -
SITE PLAN

The buildings with which we are concerned in this application are outbuildings located to the South East side of the main farmhouse as shown in the Site Plan appended to this report as Fig. 2.
