# Asbestos Pre-Demolition Survey Report

## Former Broadlands Primary School, Prospect Walk, HR1 1NZ

**Title:** Full Demolition of property , **Including:** All properties on site

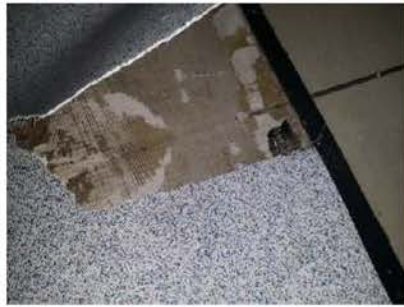
Former Broadlands Primary School - Infant Block	0	004/ lobby	Floor covering	256902-44	Asbestos-containing floor tile with bitumen adhesive	Chrysotile	3	20 Sqm	R3	Remove

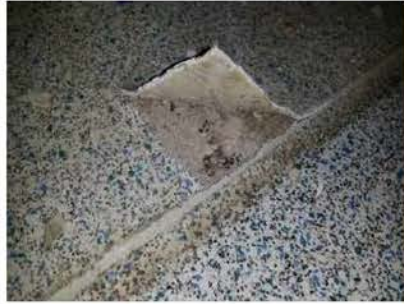
Former Broadlands Primary School - Infant Block	0	005/ tank cupboard	Floor covering	256902-44	Asbestos-containing floor tile with bitumen adhesive	Chrysotile	3	2 Sqm	R3	Remove

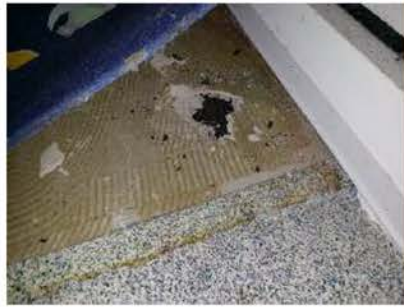
Former Broadlands Primary School - Infant Block	0	006/ classroom	Floor covering	256902-42	Asbestos-containing floor tile with bitumen adhesive	Chrysotile	3	60 Sqm	R3	Remove

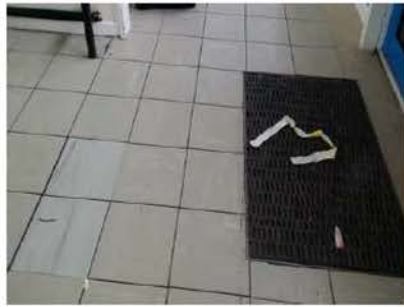
Former Broadlands Primary School - Infant Block	0	009/ lobby including timber cupboards	Floor covering	256902-44	Asbestos-containing floor tile with bitumen adhesive	Chrysotile	3	30 Sqm	R3	Remove

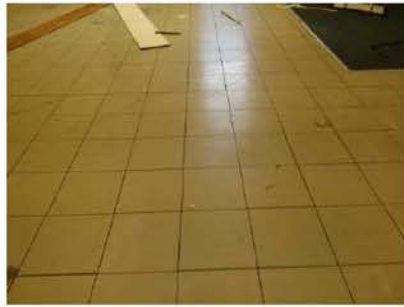
Former Broadlands Primary School - Infant Block	0	011/ classroom	Floor covering	256902-44	Asbestos-containing floor tile with bitumen adhesive	Chrysotile	3	40 Sqm	R3	Remove

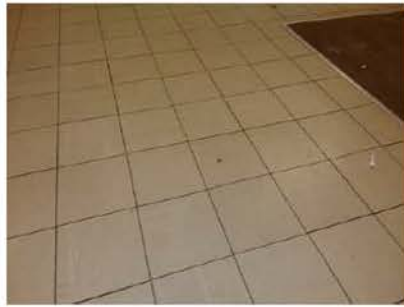
Former Broadlands Primary School - Infant Block	0	012/ classroom	Floor covering	256902-44	Asbestos-containing floor tile with bitumen adhesive	Chrysotile	3	40 Sqm	R3	Remove

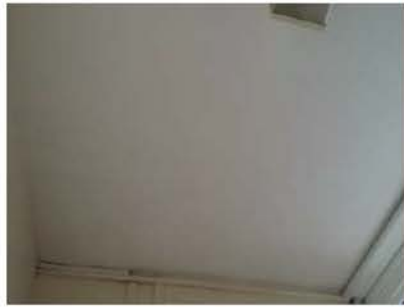
Building	Level	Location	Item / Product Examined	Sample No.	Material Description	Fibre Type	Material Score	Extent	Risk Level Assessment	Initial Control Recommendation	Photograph
Former Broadlands Primary School - Infant Block	0	013/ reprographics room	Floor covering	256902-44	Asbestos-containing floor tile with bitumen adhesive	Chrysotile	3	3 Sqm	R3	Remove	 
Former Broadlands Primary School - Infant Block	0	013/ reprographics room	Ceiling	256902-40	Asbestos-containing textured coating	Chrysotile	3	3 Sqm	R3	Remove

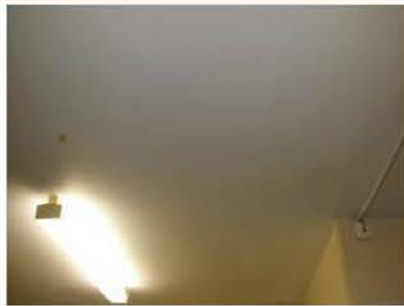
Building	Level	Location	Item / Product Examined	Sample No.	Material Description	Fibre Type	Material Score	Extent	Risk Level Assessment	Initial Control Recommendation	Photograph
Former Broadlands Primary School - Infant Block	0	015/ classroom	Ceiling	256902-49	Asbestos-containing textured coating	Chrysotile	3	20 Sqm	R3	Remove

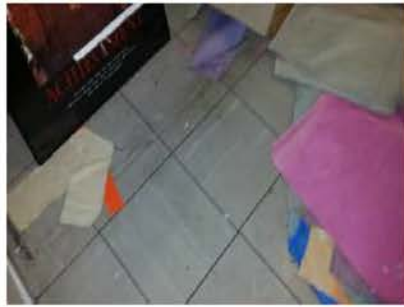
Former Broadlands Primary School - Infant Block	0	017/ lobby	Floor covering	256902-44	Asbestos-containing floor tile with bitumen adhesive	Chrysotile	3	6 Sqm	R3	Remove

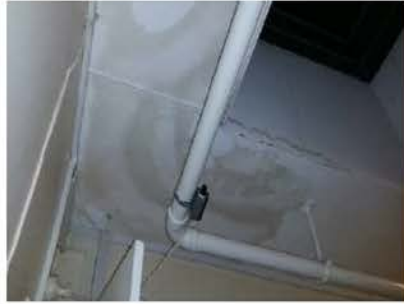
Former Broadlands Primary School - Infant Block	0	017/ lobby	Ceiling	256902-49	Asbestos-containing textured coating	Chrysotile	3	6 Sqm	R3	Remove

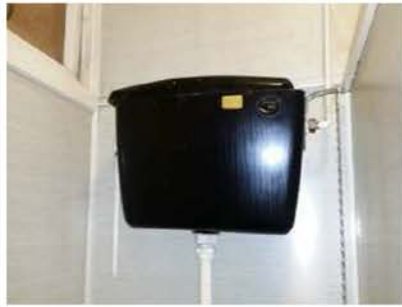
Former Broadlands Primary School - Infant Block	0	019/ toilet	Toilet cistern	256902-52	Asbestos-containing composite	Amosite	4	1 No	R3	Remove

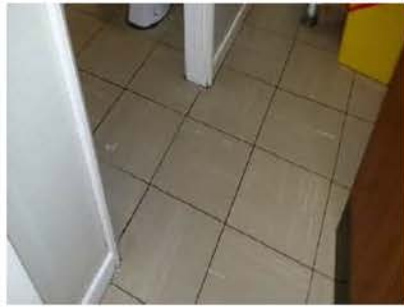
Former Broadlands Primary School - Infant Block	0	019/ toilet	Floor covering	256902-44	Asbestos-containing floor tile with bitumen adhesive	Chrysotile	3	2 Sqm	R3	Remove

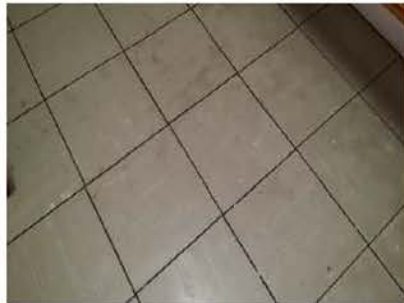
Former Broadlands Primary School - Infant Block	0	028/ lobby including timber cupboards	Floor covering	256902-44	Asbestos-containing floor tile with bitumen adhesive	Chrysotile	3	10 Sqm	R3	Remove

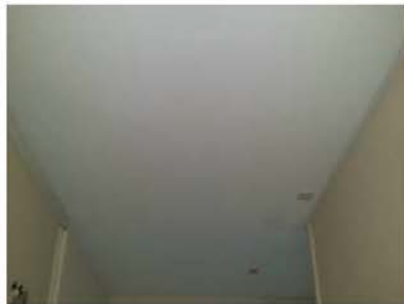
Former Broadlands Primary School - Infant Block	0	028/ lobby including timber cupboards	Ceiling	256902-49	Asbestos-containing textured coating	Chrysotile	3	10 Sqm	R3	Remove

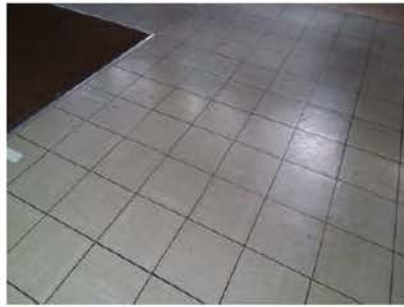
Former Broadlands Primary School - Infant Block	0	030/ classroom	Floor covering	256902-44	Asbestos-containing floor tile with bitumen adhesive	Chrysotile	3	40 Sqm	R3	Remove

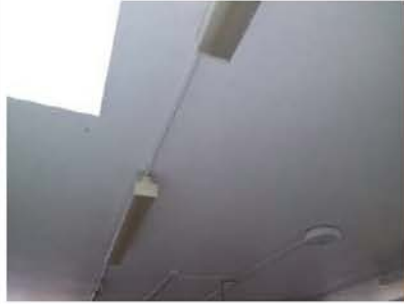
Former Broadlands Primary School - Infant Block	0	030/ classroom	Ceiling	256902-49	Asbestos-containing textured coating	Chrysotile	3	60 Sqm	R3	Remove

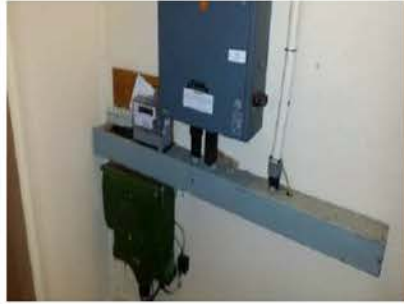
Former Broadlands Primary School - Infant Block	0	037/ electric cupboard	Electrics		Asbestos-containing woven	Presume Chrysotile	5	Extent Indiscernible	R3	Remove

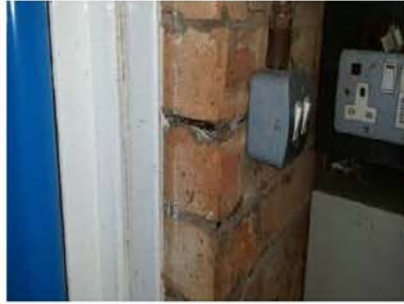
Former Broadlands Primary School - Infant Block	0	043/ boiler room	Packer to brickwork adjacent door	256902-80	Asbestos-containing bituminous felt	Chrysotile	3	Significant Quantity Observed	R3	Remove

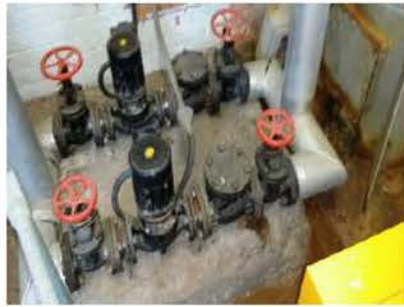
Former Broadlands Primary School - Infant Block	0	043/ boiler room	Gaskets to pipework	256902-66	Asbestos-containing gaskets	Chrysotile	4	Throughout Location	R3	Remove

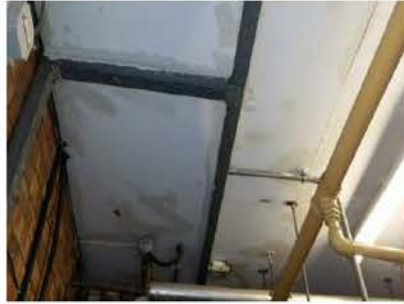
Former Broadlands Primary School - Infant Block	0	043/ boiler room	Ceiling	256902-63	Asbestos-containing Insulating board	Amosite, Chrysotile	6	12 Sqm	R3	Remove

Item / Product Examined	Material Description	Sampling Strategy	Sample No.	Extent	Product Score	Material Condition	Surface Treatment	Fibre Id.	Material Score	Accessibility Score	Risk Level Assessment
Ceiling	Asbestos-containing Insulating board	Sample	256902-63	12 Sqm	2	1	1	Amosite, Chrysotile	6	1

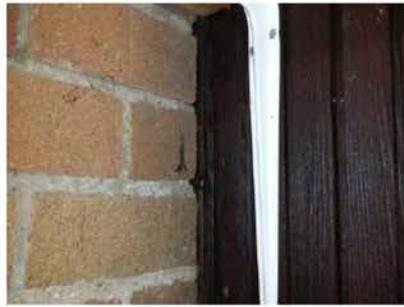
Former Broadlands Primary School - Infant Block	0	045/ external store	Damp proof course	256902-81	Asbestos-containing bituminous product	Chrysotile	3	Throughout Location	R3	Remove

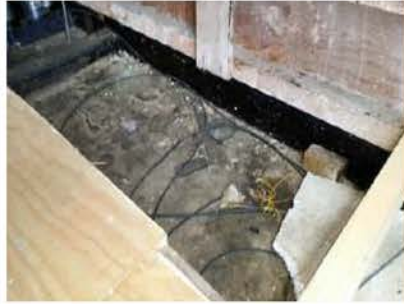
Former Broadlands Primary School - Infant Block	1	001/ roof top tank room	Floor and wall covering	256902-71	Asbestos-containing bituminous felt	Chrysotile	3	8 Sqm	R3	Remove

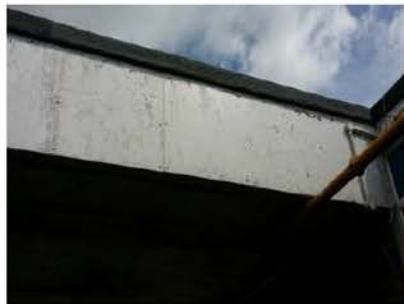
Former Broadlands Primary School - Infant Block	9	999/externals	Fascia panels to canopies and building	256902-77	Asbestos-containing cement	Chrysotile	4	Throughout Location	R3	Remove

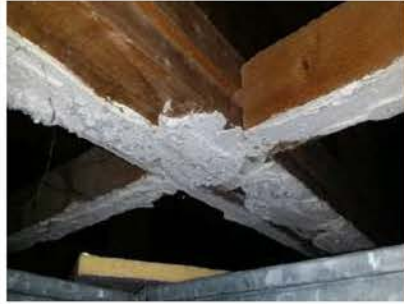
Former Broadlands Primary School - Junior Block	0	008/ lobby	Floor covering	256902-6	Asbestos-containing floor tile with bitumen adhesive	Chrysotile	3	15 Sqm	R3	Remove	 
Former Broadlands Primary School - Junior Block	0	014/ classroom	Sealant to timber framework within ceiling void	256902-3	Asbestos-containing mastic	Chrysotile	3	Throughout Location	R3	Remove

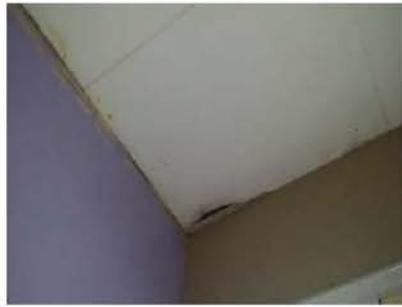
Former Broadlands Primary School - Junior Block	0	024/ nursery store	Sealant to polystyrene tiles	256902-3	Asbestos-containing mastic	Chrysotile	3	Throughout Location	R3	Remove

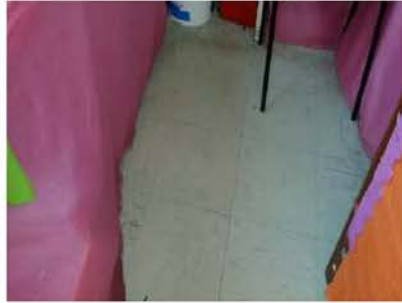
Former Broadlands Primary School - Junior Block	0	024/ nursery store	Floor covering	256902-6	Asbestos-containing floor tile with bitumen adhesive	Chrysotile	3	2 Sqm	R3	Remove

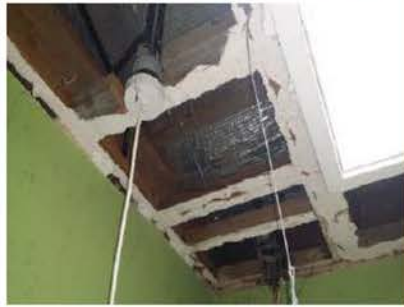
Former Broadlands Primary School - Junior Block	0	027/ nursery toilets	Sealant to timber framework within ceiling void	256902-3	Asbestos-containing mastic	Chrysotile	3	Throughout Location	R3	Remove

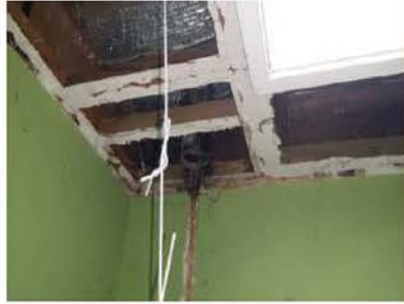
Former Broadlands Primary School - Junior Block	0	027/ nursery toilets	Pipe within ceiling void	256902-11	Asbestos-containing cement	Chrysotile	4	1 Lm	R3	Remove

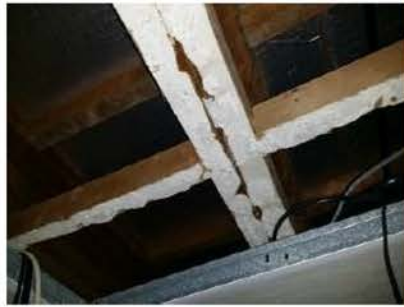
Former Broadlands Primary School - Junior Block	0	034/ classroom	Sealant to timber framework within ceiling void	256902-3	Asbestos-containing mastic	Chrysotile	3	Throughout Location	R3	Remove

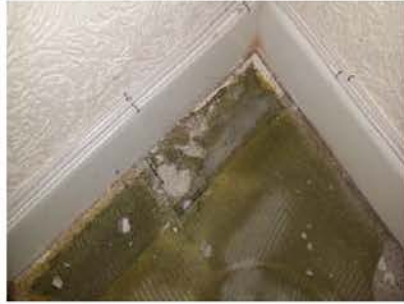
Former Broadlands Primary School - Junior Block	0	040/ staff room	Floor covering	256902-6	Asbestos-containing floor tile with bitumen adhesive	Chrysotile	3	12 Sqm	R3	Remove

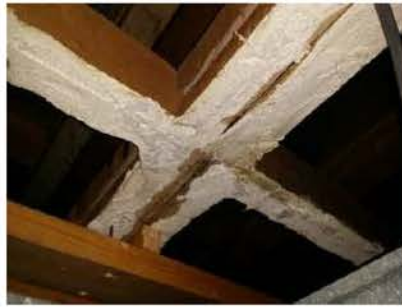
Former Broadlands Primary School - Junior Block	0	049/ classroom	Sealant to timber framework within ceiling void	256902-3	Asbestos-containing mastic	Chrysotile	3	Throughout Location	R3	Remove

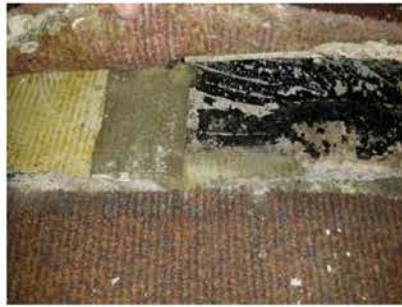
Former Broadlands Primary School - Junior Block	0	050/ classroom	Floor covering	256902-6	Asbestos-containing floor tile with bitumen adhesive	Chrysotile	3	60 Sqm	R3	Remove

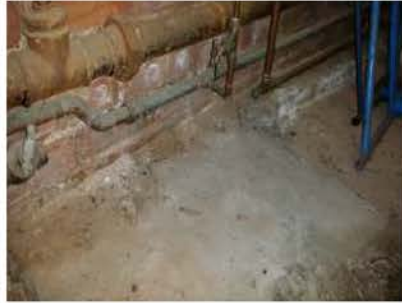
Former Broadlands Primary School - Junior Block	0	051/ boiler room	Debris to floor	256902-29	Asbestos-containing thermal	Amosite, Chrysotile	11	Throughout Location	R1	Remove

Building: Former Broadlands Primary School - Junior Block				Level: 0		Location: 051/ boiler room					
Item / Product Examined	Material Description	Sampling Strategy	Sample No.	Extent	Product Score	Material Condition	Surface Treatment	Fibre Id.	Material Score	Accessibility Score	Risk Level Assessment
Debris to floor	Asbestos-containing thermal	Sample	256902-29	Throughout Location	3	3	3	Amosite, Chrysotile	11	3

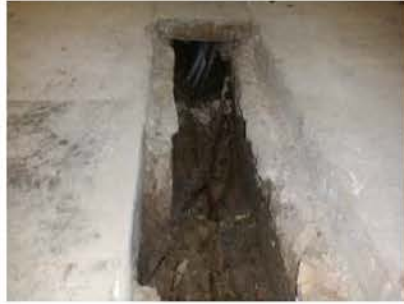
Former Broadlands Primary School - Junior Block	0	051/ boiler room	Ceiling including fascia panels	256902-26	Asbestos-containing insulating board	Amosite, Chrysotile	6	40 Sqm	R3	Remove	 
Former Broadlands Primary School - Junior Block	0	051/ boiler room	Floor duct	256902-31	Asbestos-containing debris	Amosite, Chrysotile	11	Throughout Location	R1	Remove

Building: Former Broadlands Primary School - Junior Block				Level: 0		Location: 051/ boiler room					
Item / Product Examined	Material Description	Sampling Strategy	Sample No.	Extent	Product Score	Material Condition	Surface Treatment	Fibre Id.	Material Score	Accessibility Score	Risk Level Assessment
Ceiling including fascia panels	Asbestos-containing insulating board	Sample	256902-26	40 Sqm	2	1	1	Amosite, Chrysotile	6	1

NAD
Boilers	Modern										
Boiler flues	Metal										
Floor duct	Asbestos-containing debris	Sample	256902-31	Throughout Location	3	3	3	Amosite, Chrysotile	11	2

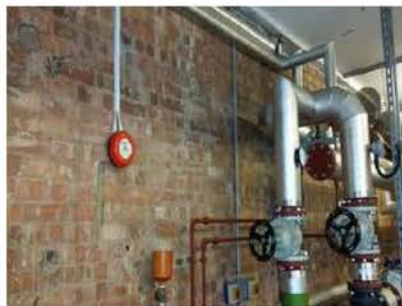
Former Broadlands Primary School - Junior Block	0	051/ boiler room	Residues to walls	256902-27	Asbestos-containing thermal	Amosite, Chrysotile	11	Throughout Location	R1	Remove

R3
Residues to walls	Asbestos-containing thermal	Sample	256902-27	Throughout Location	3	3	3	Amosite, Chrysotile	11	2

R1
		🗨️ Thermal residues to all walls adjacent pipework									
Residues to pipework	Asbestos-containing thermal	Sample	256902-28	Throughout Location	3	3	3	Amosite, Chrysotile	11	2

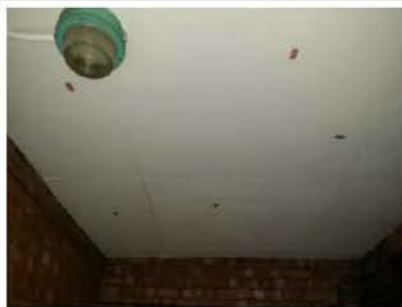
Former Broadlands Primary School - Junior Block	0	052/ external store	Ceiling	256902-26	Asbestos-containing insulating board	Amosite, Chrysotile	6	6 Sqm	R3	Remove

Building: Former Broadlands Primary School - Junior Block				Level: 0		Location: 052/ external store					
Item / Product Examined	Material Description	Sampling Strategy	Sample No.	Extent	Product Score	Material Condition	Surface Treatment	Fibre Id.	Material Score	Accessibility Score	Risk Level Assessment
Ceiling	Asbestos-containing insulating board	Cross Reference	256902-26	6 Sqm	2	1	1	Amosite, Chrysotile	6	1

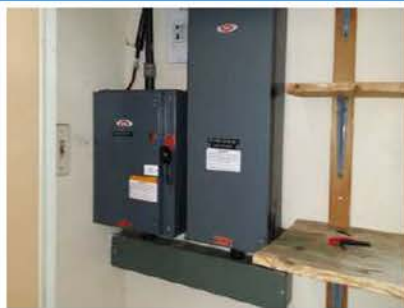
Building	Level	Location	Item / Product Examined	Accessibility	Surveyor Additional Comments At Time Of Survey	Photograph
Former Broadlands Primary School - Infant Block	0	027/ electric cupboard	Electrics	Limited Access	Live service supply

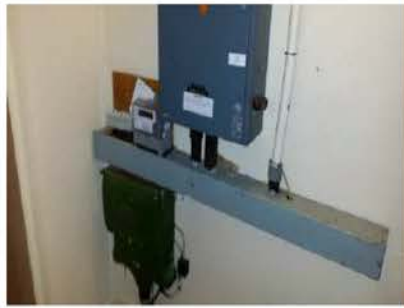
Former Broadlands Primary School - Infant Block	0	037/ electric cupboard	Electrics	Limited Access	Live service supply

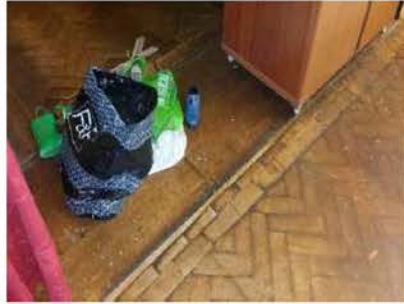
Former Broadlands Primary School - Junior Block	0	021/ hall including stores to side of stage	Floor void	Limited Access	Continually occupied

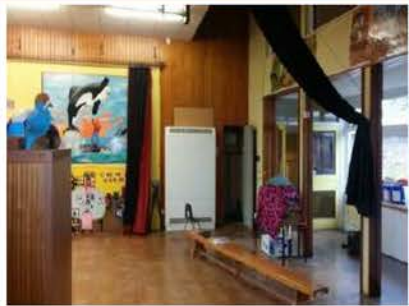
Building	Level	Location	Item / Product Examined	Accessibility	Surveyor Additional Comments At Time Of Survey	Photograph
Former Broadlands Primary School - Junior Block	0	021/ hall including stores to side of stage	<b>Entire Location</b>	Limited Access	continually occupied

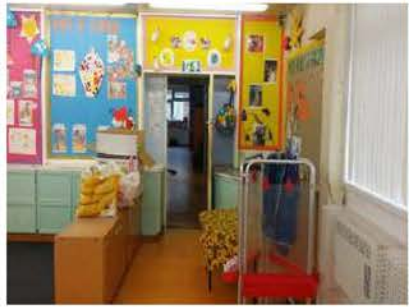
Former Broadlands Primary School - Junior Block	0	022/ nursery	<b>Entire Location</b>	Limited Access	continually occupied

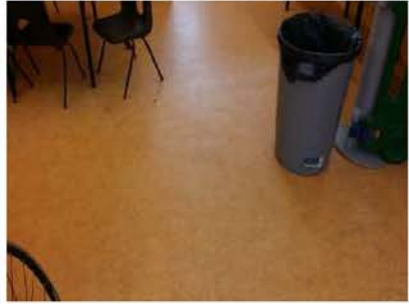
Former Broadlands Primary School - Junior Block	0	022/ nursery	Floor covering	Limited Access	Continually occupied

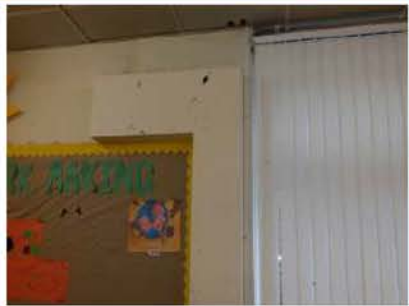
Building	Level	Location	Item / Product Examined	Accessibility	Surveyor Additional Comments At Time Of Survey	Photograph
Former Broadlands Primary School - Junior Block	0	022/ nursery	Boxing	Limited Access	Continually occupied

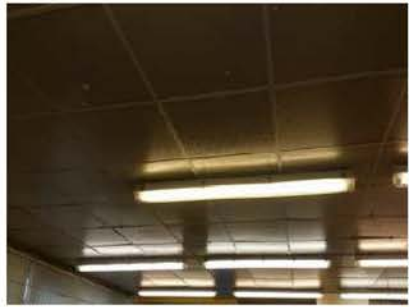
Former Broadlands Primary School - Junior Block	0	022/ nursery	Ceiling void	Limited Access	Continually occupied

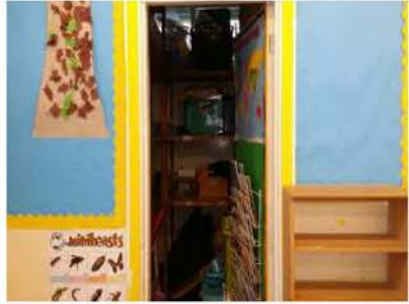
Former Broadlands Primary School - Junior Block	0	023/ nursery store	<b>Entire Location</b>	Limited Access	continually occupied

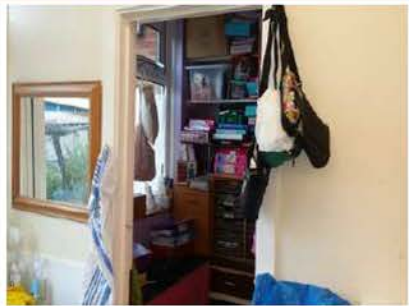
Building	Level	Location	Item / Product Examined	Accessibility	Surveyor Additional Comments At Time Of Survey	Photograph
Former Broadlands Primary School - Junior Block	0	024/ nursery store	<b>Entire Location</b>	Limited Access	continually occupied

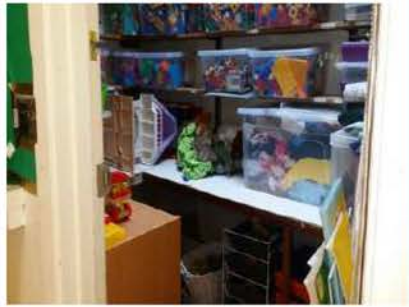
Former Broadlands Primary School - Junior Block	0	025/ nursery store	<b>Entire Location</b>	Limited Access	continually occupied

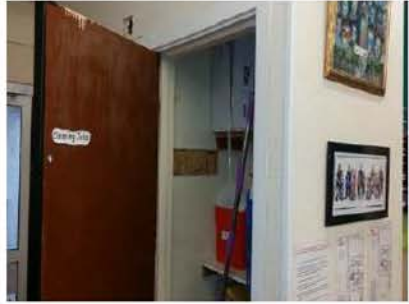
Former Broadlands Primary School - Junior Block	0	026/ cleaners cupboard	<b>Entire Location</b>	Limited Access	continually occupied

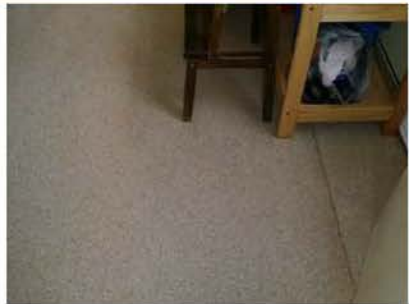
Building	Level	Location	Item / Product Examined	Accessibility	Surveyor Additional Comments At Time Of Survey	Photograph
Former Broadlands Primary School - Junior Block	0	027/ nursery toilets	Floor covering	Limited Access	Continually occupied

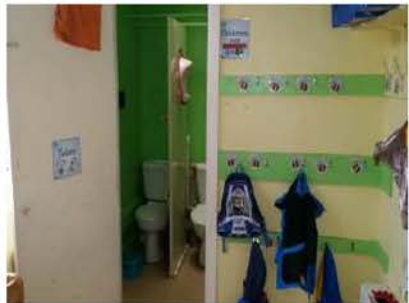
Former Broadlands Primary School - Junior Block	0	027/ nursery toilets	<b>Entire Location</b>	Limited Access	continually occupied

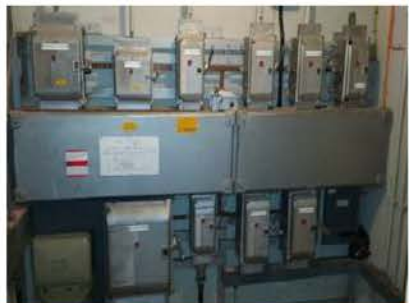
Former Broadlands Primary School - Junior Block	0	032/ electric cupboard	Electrics	Limited Access	Live service supply
