**STRUCTURAL INSPECTION OF  
BARNs AT GANNAH FARM  
BOLSTONE, HOLME LACY  
HEREFORDSHIRE, HR2 6NA**

Project Number: S-15-019  
Originator: Richard Hartshorne

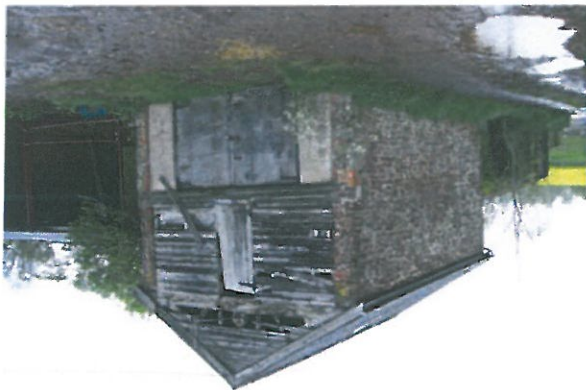
2.1 The two storey stone store barn is located to the left hand side of the main farmhouse directly adjacent to a steel framed barn.

2.2 The building is constructed in load bearing solid bonded random coursed stonework with a pitched asbestos cement sheeted roof supported on softwood rafters and oak trusses. The first floor is constructed of oak joists spanning between substantial oak beams.

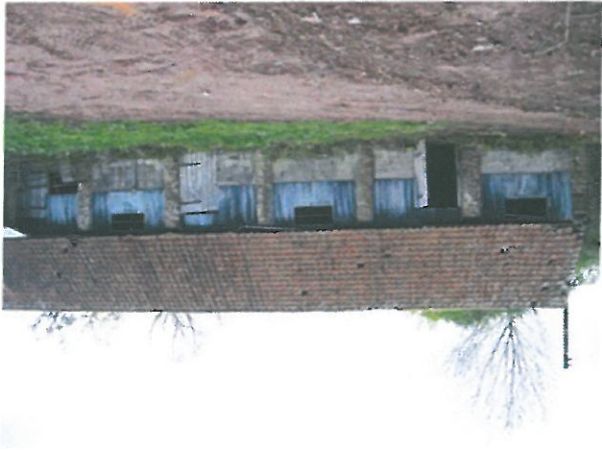
3.1 The single storey stone barn is located at the rear of the main farmhouse running parallel to a steel framed barn.

3.2 The building is constructed in load bearing stonework with a pitched pantile roof over. There is a small section of first floor located at the Eastern end of the barn.

3.3 The front elevation of the barn has been infilled with a combination of blockwork and corrugated iron sheeting.
