House Elevation Key:

ARBOR

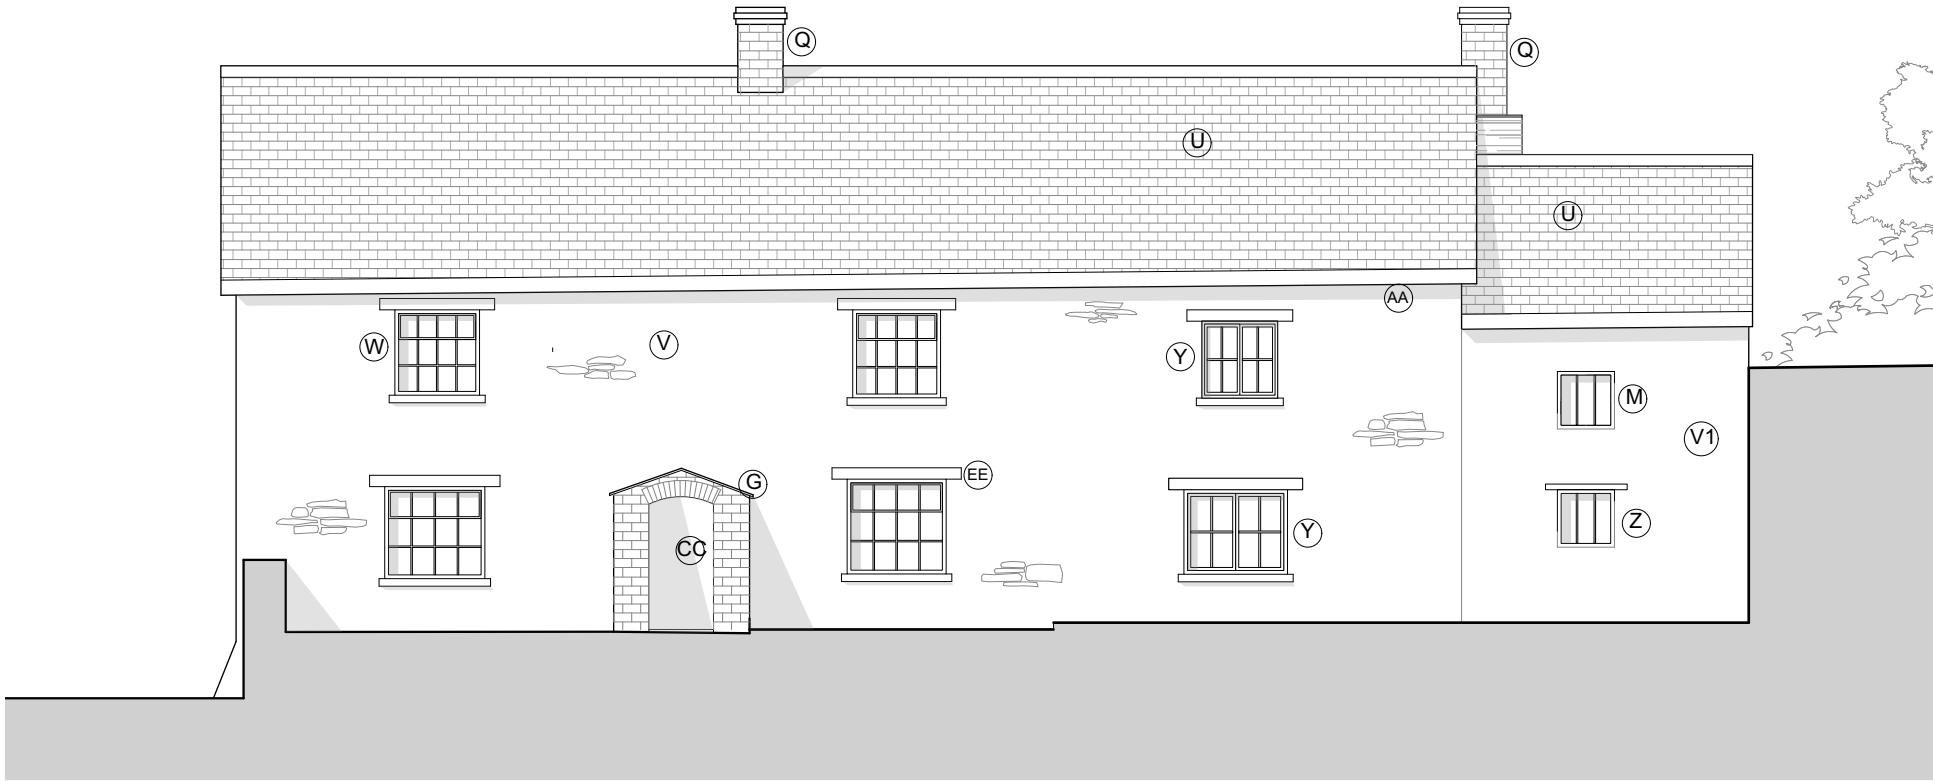
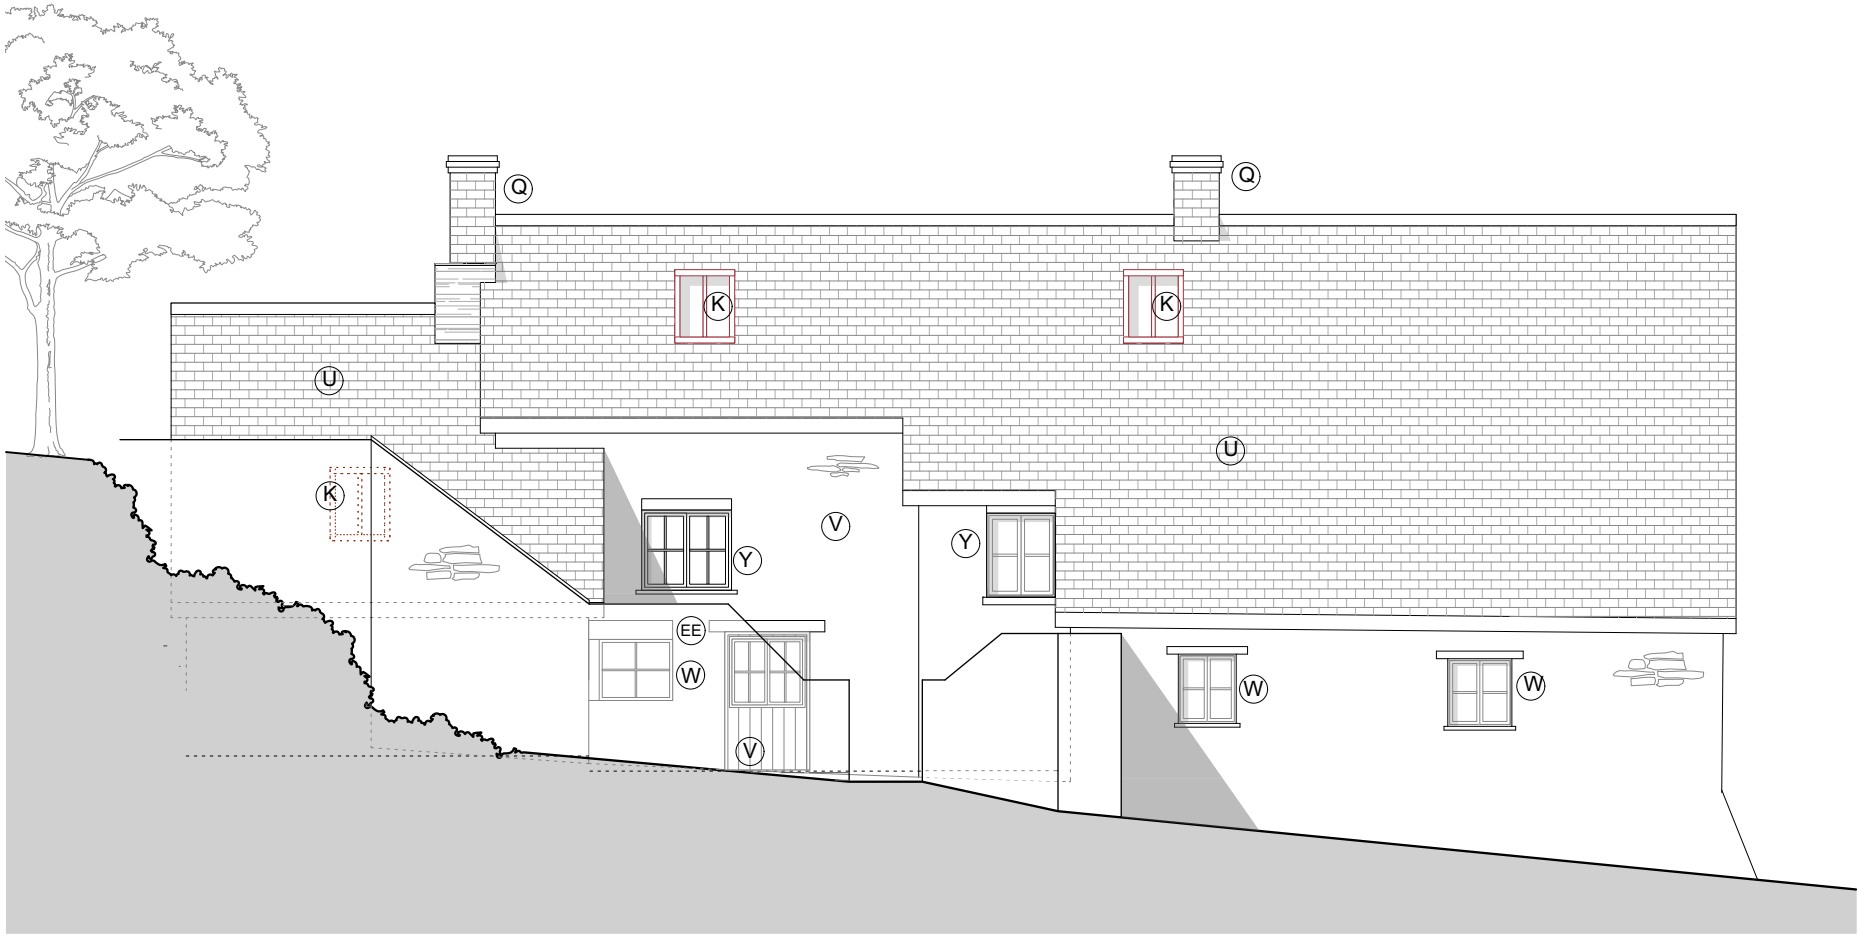
- G** - Existing porch repaired in accordance with structural engineers guidance and tied in main house front wall.
- K** - Conservation, flush fitting aluminium conservation rooflights

- M** - Replace modern infil with sympathetic glazing to reveal diamond mullions.
- Q** - Stone chimney breast repointed and repaired where necessary
- S** - Existing window replaced in repaired gable wall

- T** - New window formed in gable wall
- U** - Roof repaired with reclaimed slate to match existing.
- V** - All stonework repaired using lime mortar to match existing. White limewash to all elevations

- V1** - As above (V) without limewash
- W** - Restore original timber windows to original operation
- X** - Gable end wall rebuilt in accordance with Structural Engineer's guidance. Stonework re-used and laid to match existing coursing, limewashed.

- Y** - Replace existing modern window with new frame to match original window configuration.
- Z** - Reinstate window opening
- AA** - Powder coated black aluminium rainwater goods.

- BB** - New oak plank door to match existing
- CC** - Existing door sympathetically repaired where necessary
- DD** - Pod materials to be timber clad to replicate simple wood

- EE** - Replace failed oak lintel
