## House Plan Key:

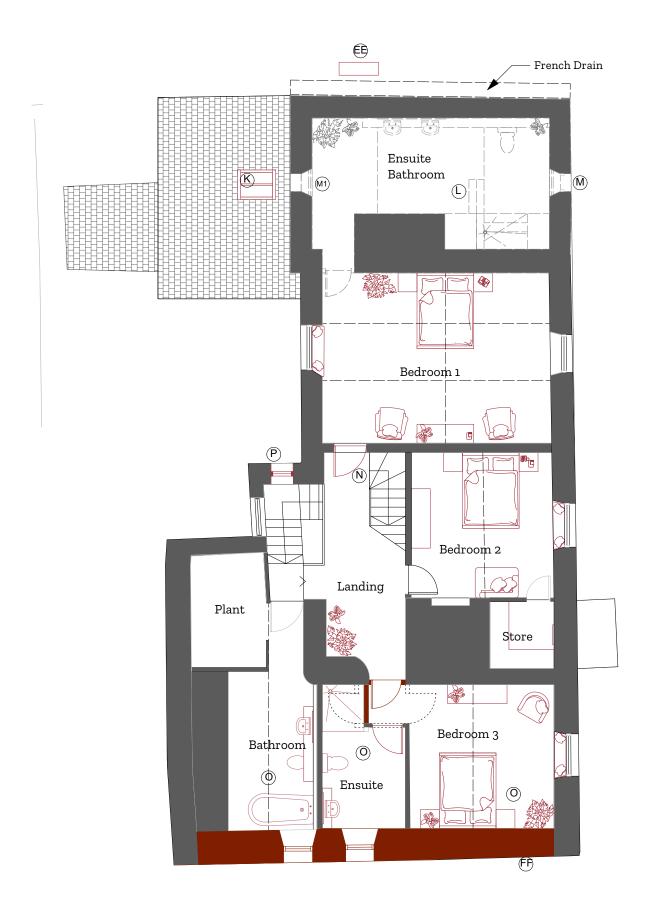
- **A** Remove inserted landing to reveal original room
- **B** Flagstone floor restored
- **B1** Flagstone floor restored lowered to match dining room
- C Restore original chimney breast

- **D** Timber frame partition and listed bench
- **E** Existing fire place, evidence of original fire place behind
- **F** Restore 19th century staircase

- **G** Existing porch repaired in accordance with structural engineers guidance and tied in main house front wall.
- H Underground drainage chanel installed to capture and channel water currenty flowing though house to be linked in with the repaired existing underground drainage system. under the floors running north to south.

- J Storage
- **K** Conservation, flush fitting aluminium conservation rooflights
- L Reinstate floor at first floor level
- **M** Replace modern infil with sypathethic glazing to reveal diamond mullions.

- **M1** Remove Modern infill and reinstate diamond mullions with glazed window internally
- N New door to bedroom
- O Timber floors connecting to gable wall repaired and supported on new gable end wall

- **P** New fire escape window
- **Q** Chimney breast repointed and repaired where necessary
- R Timber rafters restored where necessary
  S- Existing window replaced in repaired gable

- **S-** Existing window replaced in repaired gable wall
- T New window formed in gable wall
- **U-** Roof repaired with reclaimed slate to match existing.

- ${\bf BB}$  New oak plank door to match existing
- **CC** Existing door sypathetically repaired where necessary
- **DD** Pod materials to be timber clad to replicate simple wood
