no.5 south west elevation

no.6 south east elevation

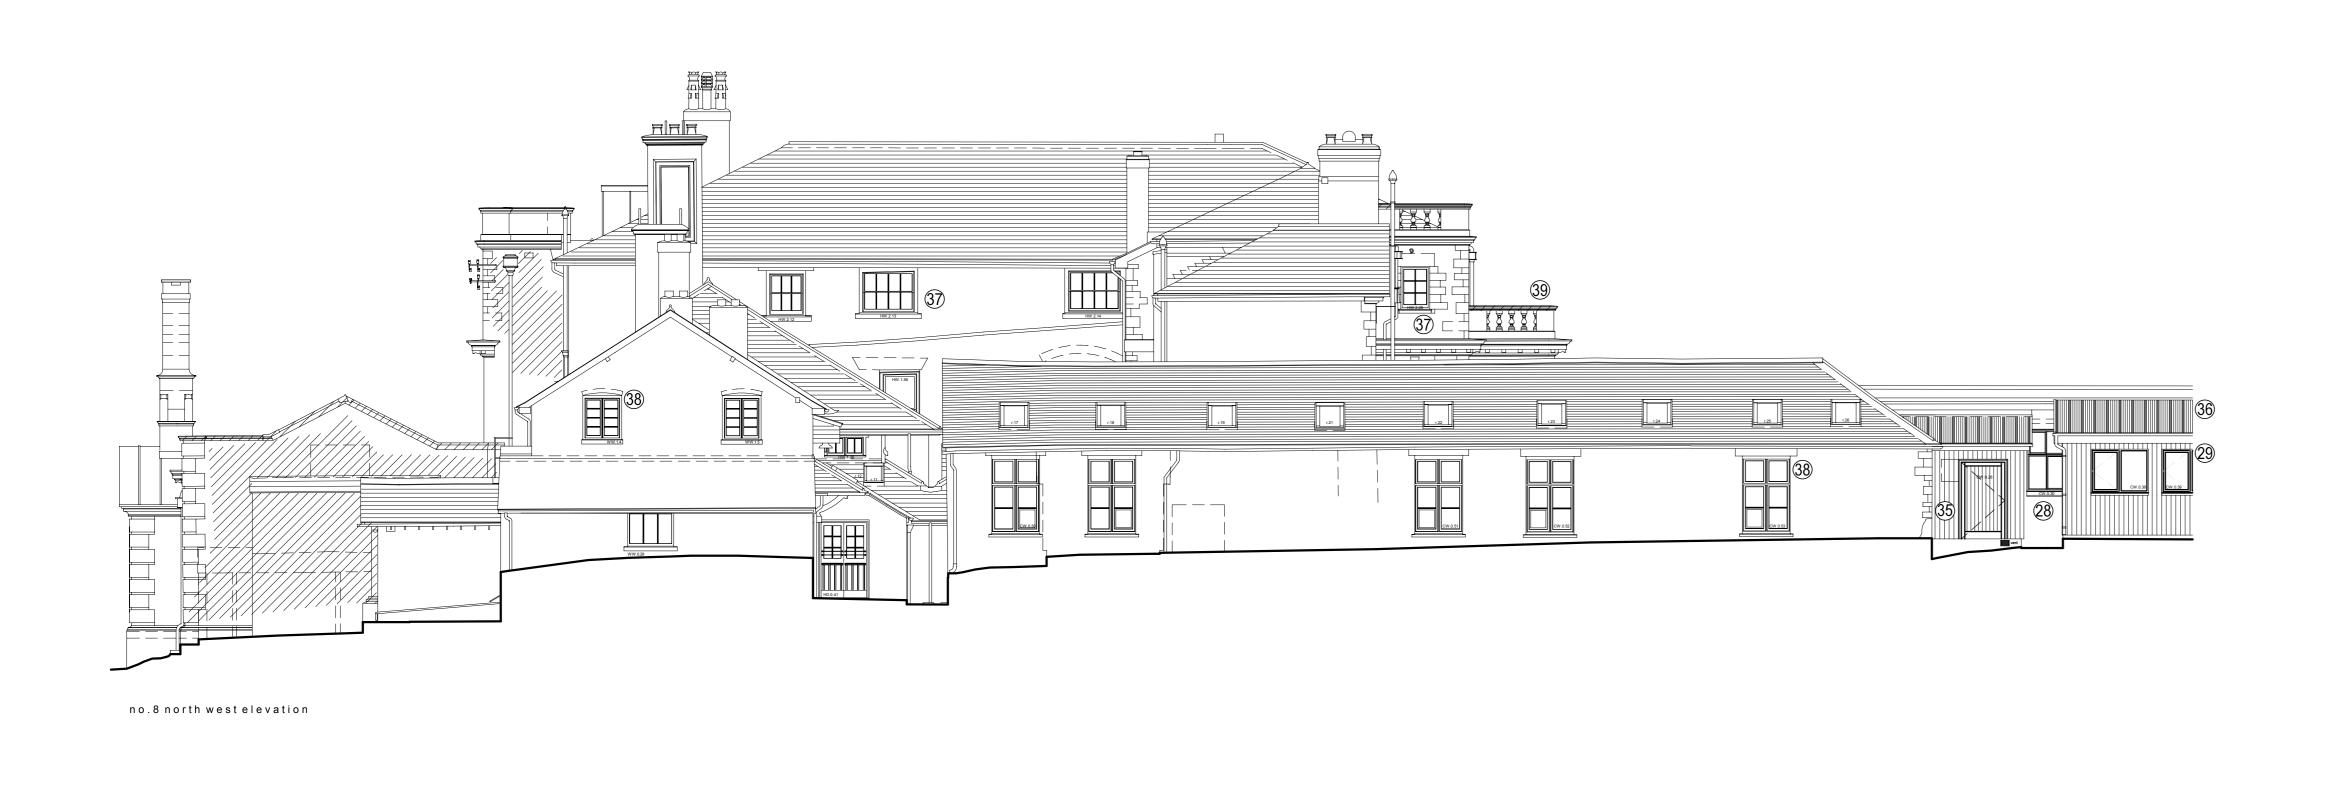
- new low profile metal rooflights over (The Rooflight Company web: http://www.the rooflightcompany.co.uk/the-conservation-(21 rooflight-product)
- 28 existing prefab classroom extension to be reclad using a planed vertical board

- (29) existing windows replaced with new double-glazed, powder-coated aluminium frame windows
- (36) existing roof finish replaced with corugated/ profiled metal sheet roofing system

- existing single-glazed, sliding sash timber
  windows to be repaired, overhauled and
  upgraded to full working order and redecorated
- single glazed timber casement windows to be repaired, overhauled and upgraded to full working order and redecorated all ledges and projections to decorative cornice, balustrading and copers etc. to be cleaned to remove lichen and moss growth by specialist cleaning contractor using DOFF/JOSS/TORC

- cleaning system 56 new 100mm Ø cast iron/ uPVC soil vent pipes, colour: black
- isolated patch repointing, using a 1:2.5 NHL 2.5 naturally hydraulic lime mortar mix using purpose made / proper pointing tools that fit the joint width to ensure good compaction and remove all mortar droppings immediately

- plaster repair to decorative cornice using a 1:2.5 NHL 2.5 naturally hydraulic lime mortar mix
- masonry to be cleaned by specialist contractor to remove organic growth following removal of dead creepers/ root systems using DOFF/JOSS/TORC cleaning system

- ★ all roofs, ledges, gutters and valleys to be cleaned and all moss/ lichen growth to be removed and area treated using ROUNDUP PRO VANTAGE
