A BAT EMERGENCE SURVEY AT THE GRANARY/TRACTOR

SHED BUILDING, WALLHEAD FARM, ST WEONARDS,

HEREFORDSHIRE, HR2 8PY

Report Number: ASW/PP/053/17/2013 September 2013

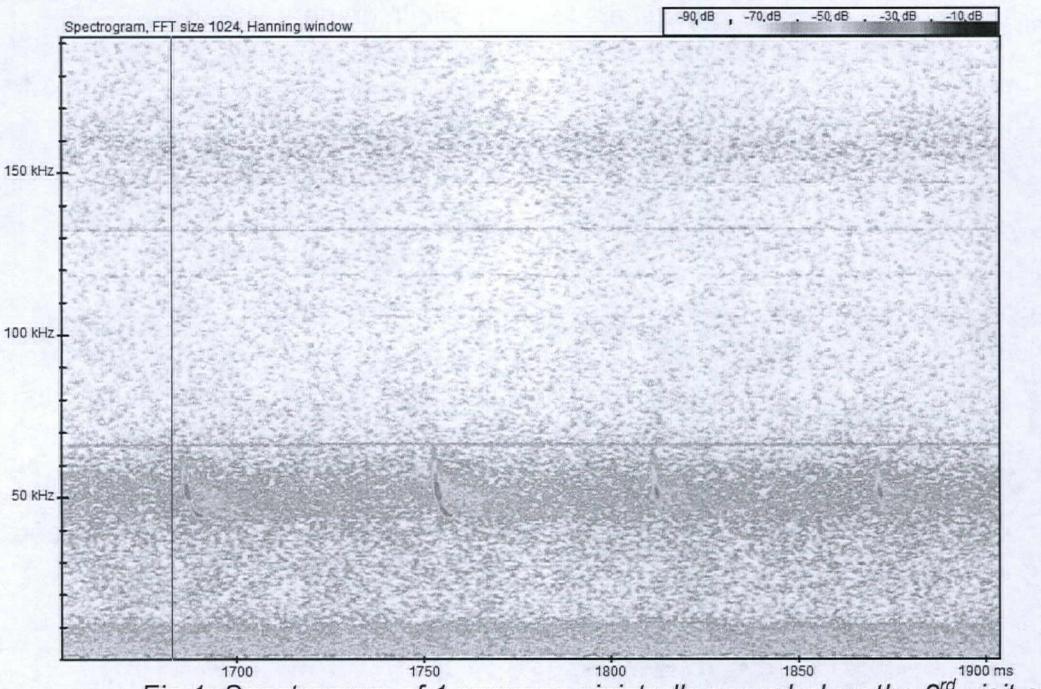
Fig 1: Spectrogram of 1 common pipistrelle recorded on the 3rd visit of bat near granary building

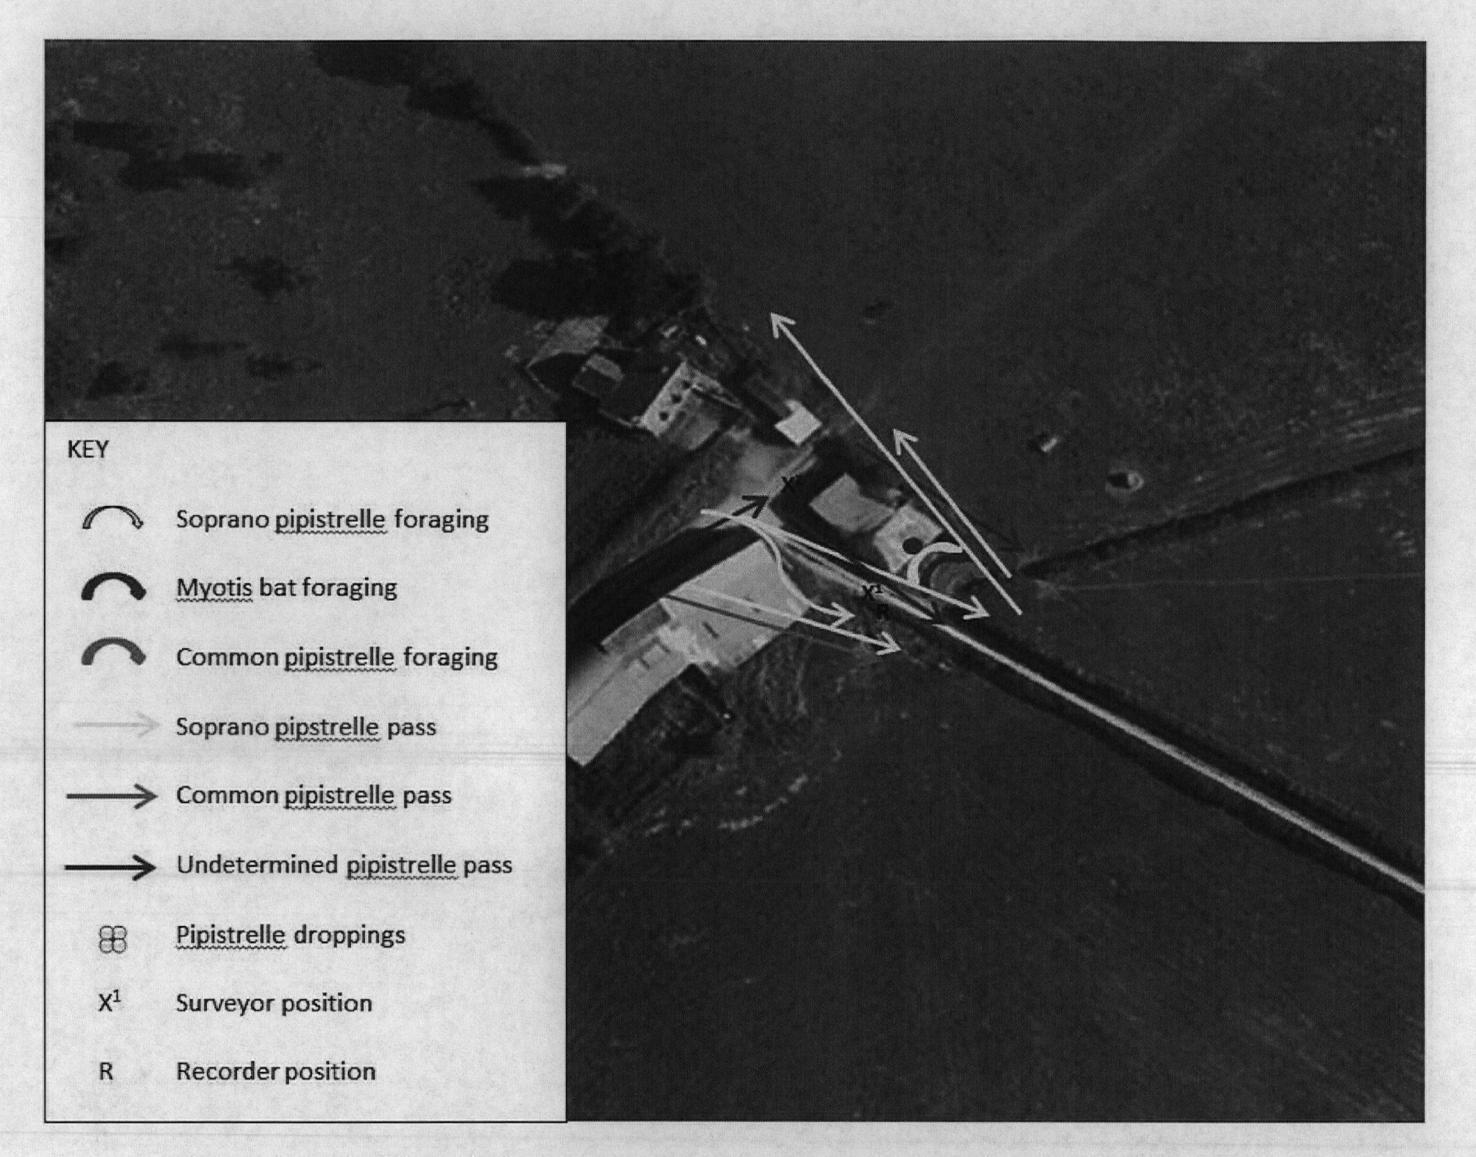
Appendix 1: Map A - Location of bat sightings at the Granary/Tractor Shed building at Wallhead Farm, St Weonards, Herefordshire – August/September 2013

Note – A total of three bat emergence surveys were conducted at the Wallhead Farm site. On all three visits the Tractor shed/Granary Building was covered to establish whether this building and its associated features were being used by roosting bats. All bat activity was recorded including behaviour and direction of flight.

On all three visits no emergence was noted and therefore it was concluded based on evidence gathered that no bats were roosting within this particular building on this occasion.

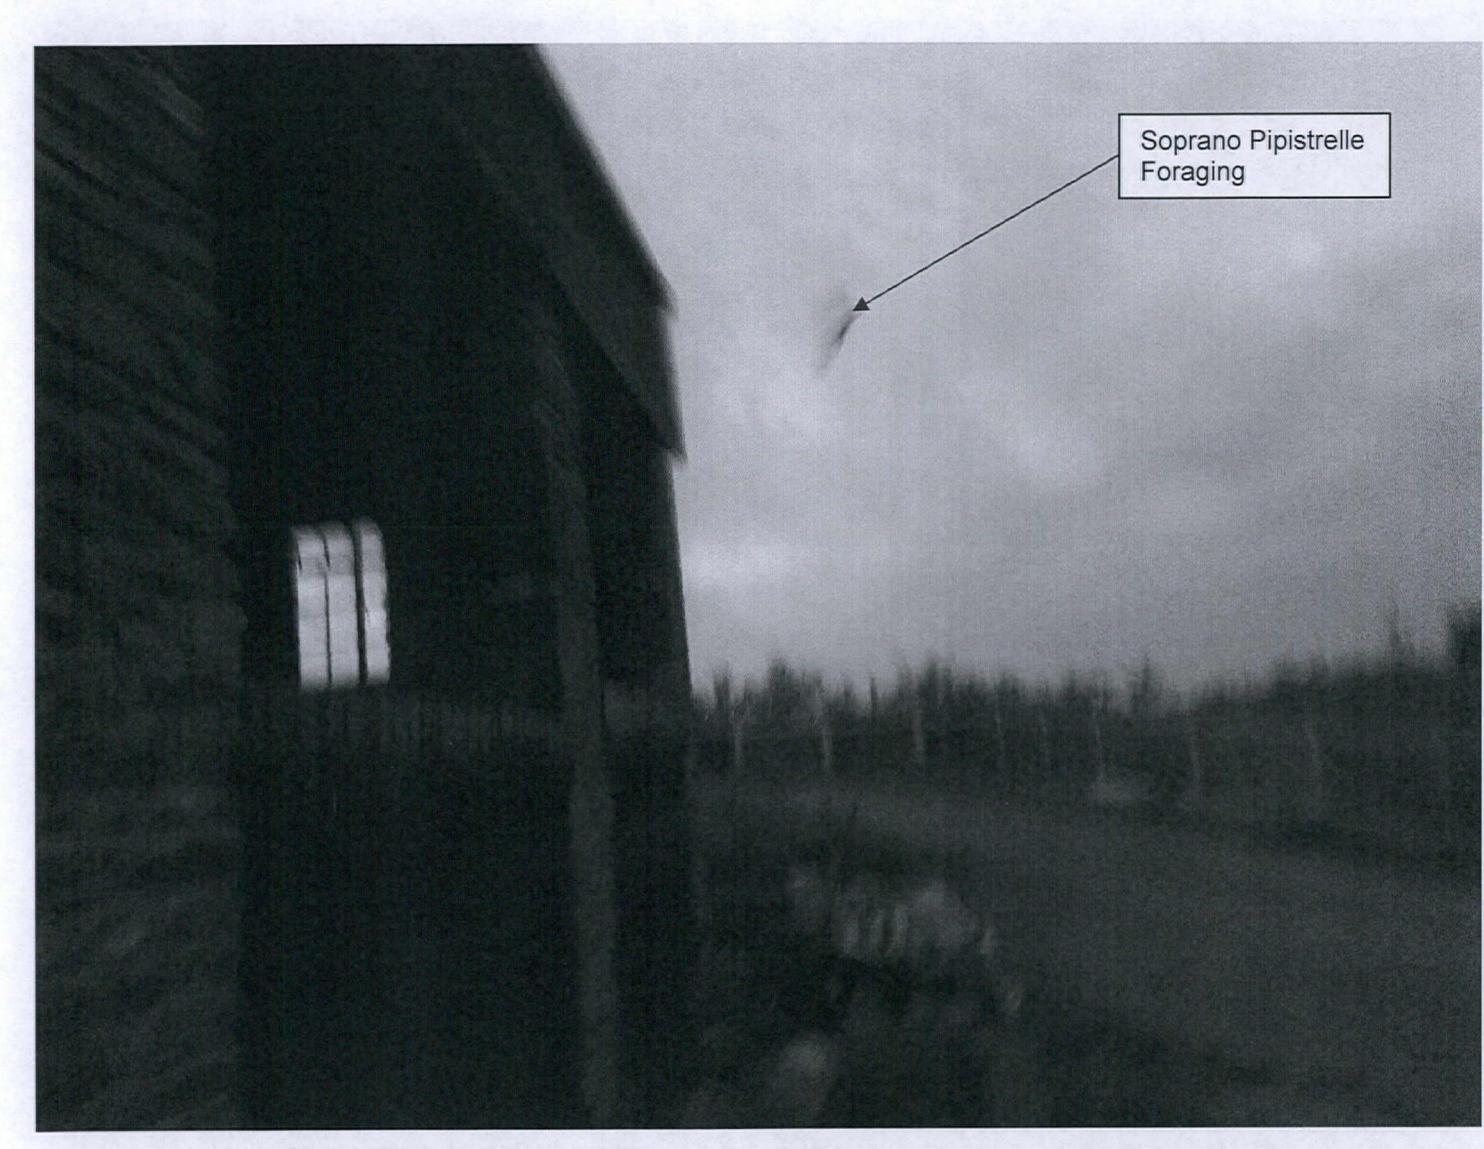
Photograph A

Note: Picture taken of a soprano pipistrelle foraging near Granary/Tractor Shed building on the 2nd bat emergence survey visit.

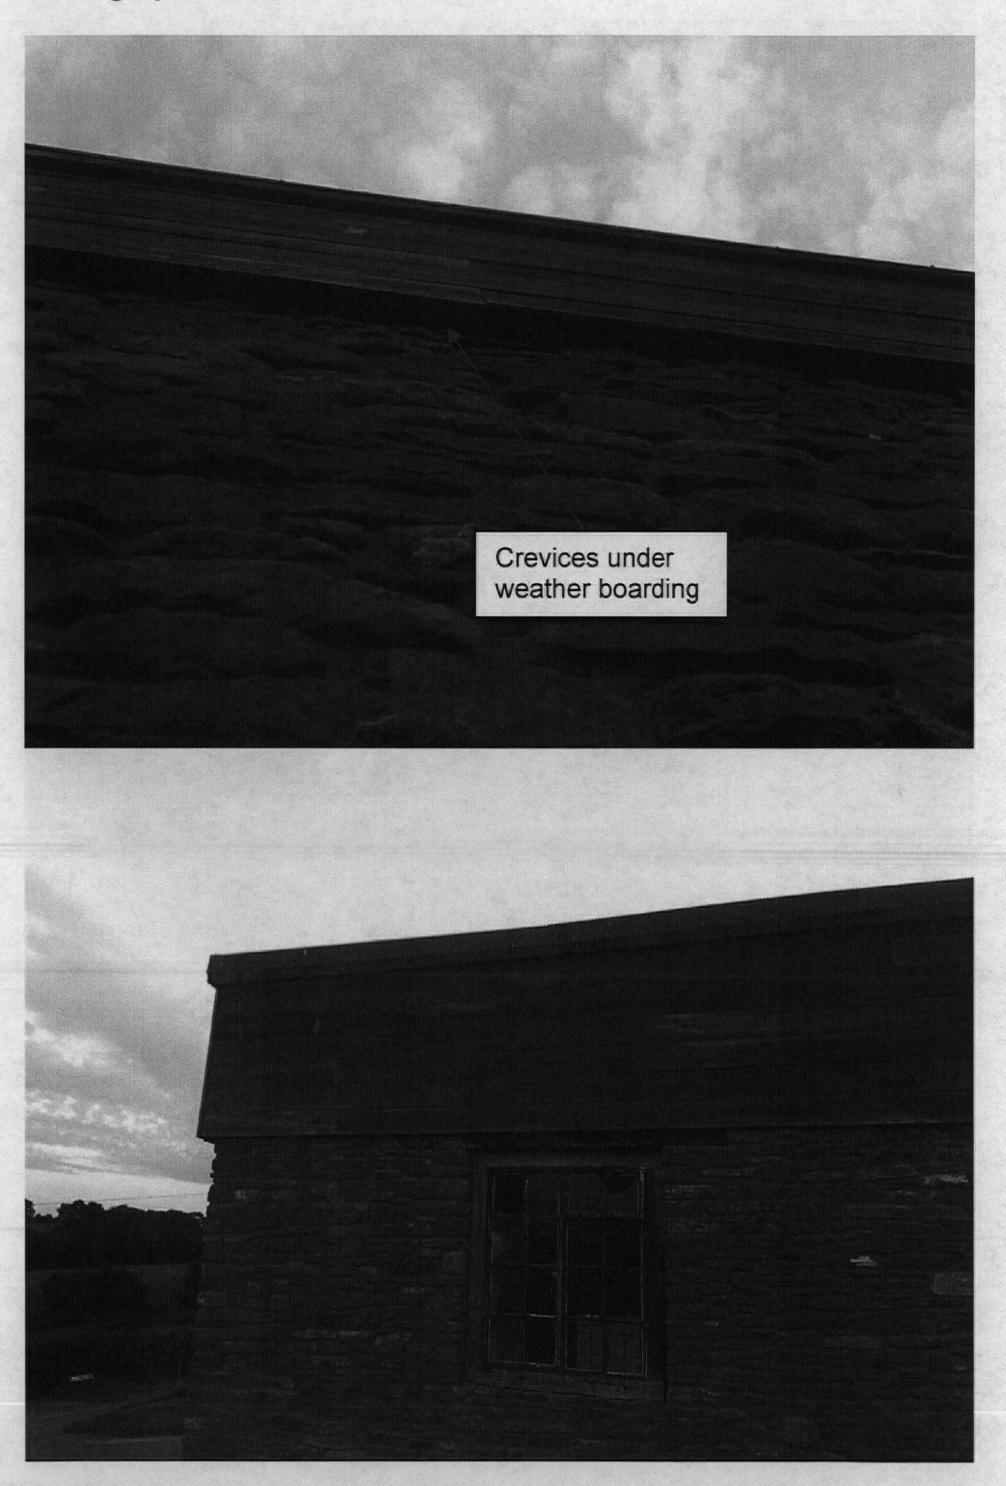
Photograph B & C

Note: External features which may be exploited in theory by bats for roosting, although no evidence was present of this

- Overall, the Granary/Tractor Shed was found to have Low/Medium bat roost potential, with a number of roost features noted within the building both externally and internally. However there were a number of more suitable features noted in adjacent buildings i.e. bat boxes and bat loft.

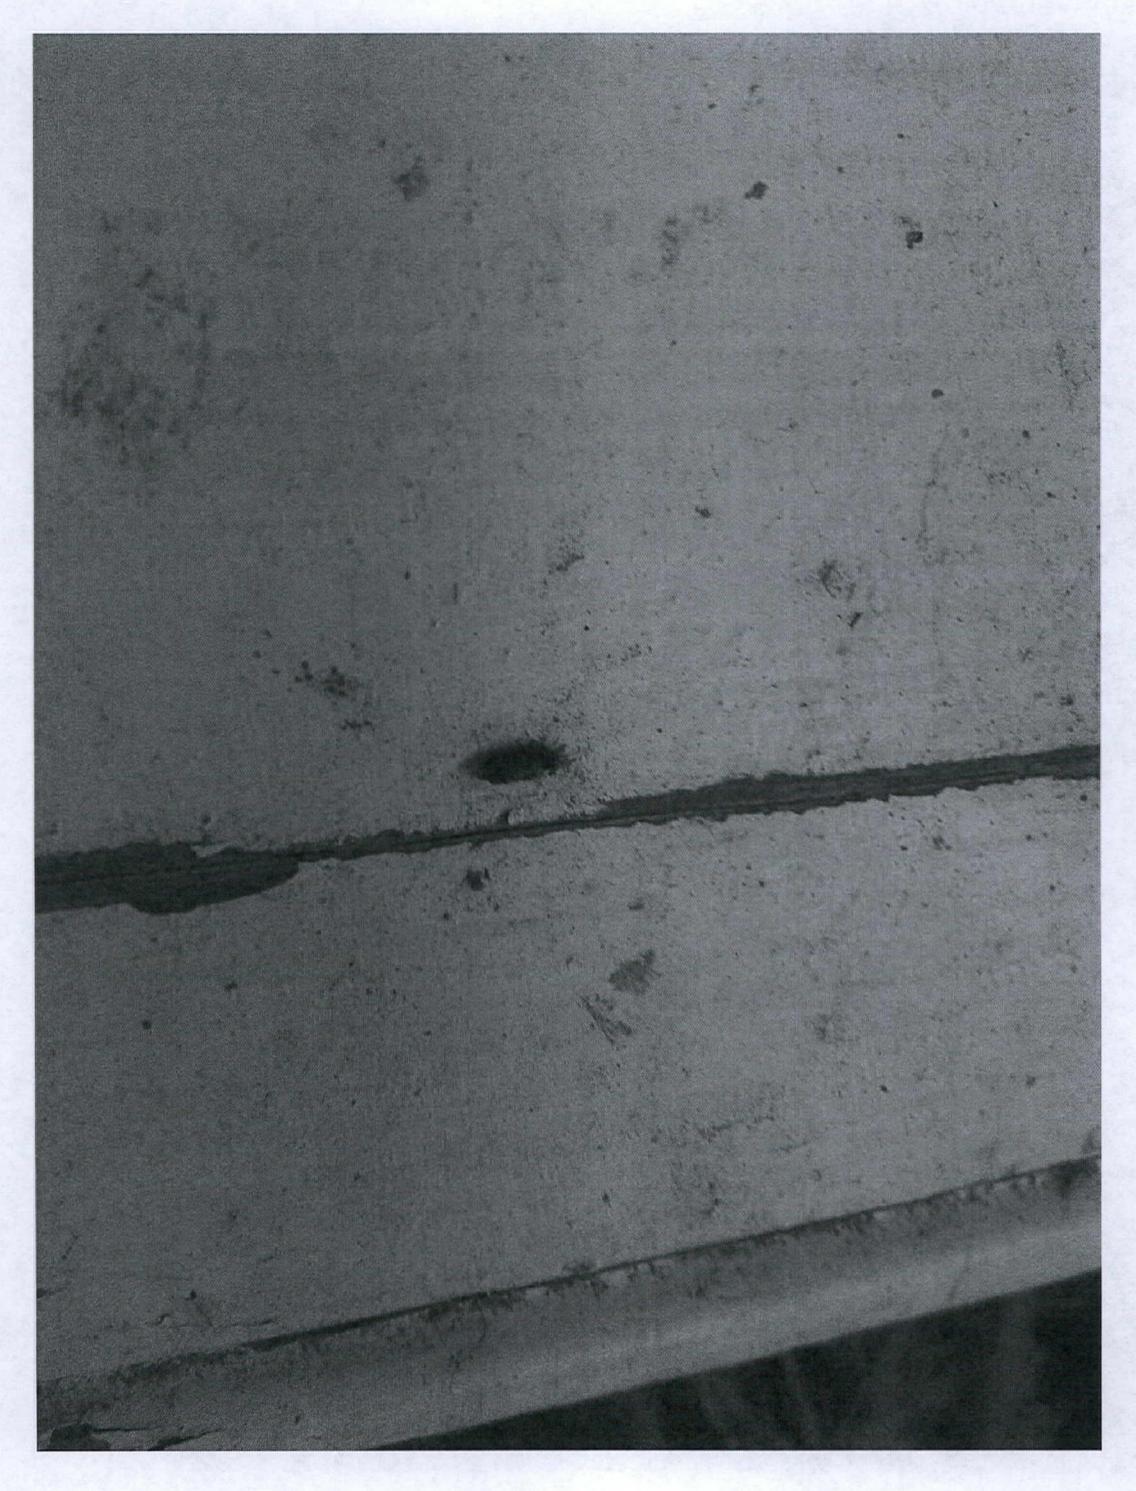
Photograph D

Note: An old pipistrelle dropping found within Granary/Tractor Shed Building, where a bat had ejected this during flying in and out of part of the structure at night

- Good foraging behaviour was noted in part of this stone building by pipistrelle bats, hence why two old droppings had been deposited during flight on objects at ground level. This is typical behaviour by these bats as they will eject numerous droppings whilst catching and eating small insects on the wing.
