<u>Trees and Construction</u> BS5837 Tree Survey Assessment

Site:	The Graftonbury Garden Hotel, Grafton, Herefordshire, HR2 8BN
Ref:	14553/A1
Client:	Procuro Planning Services Ltd

- February 2015 -

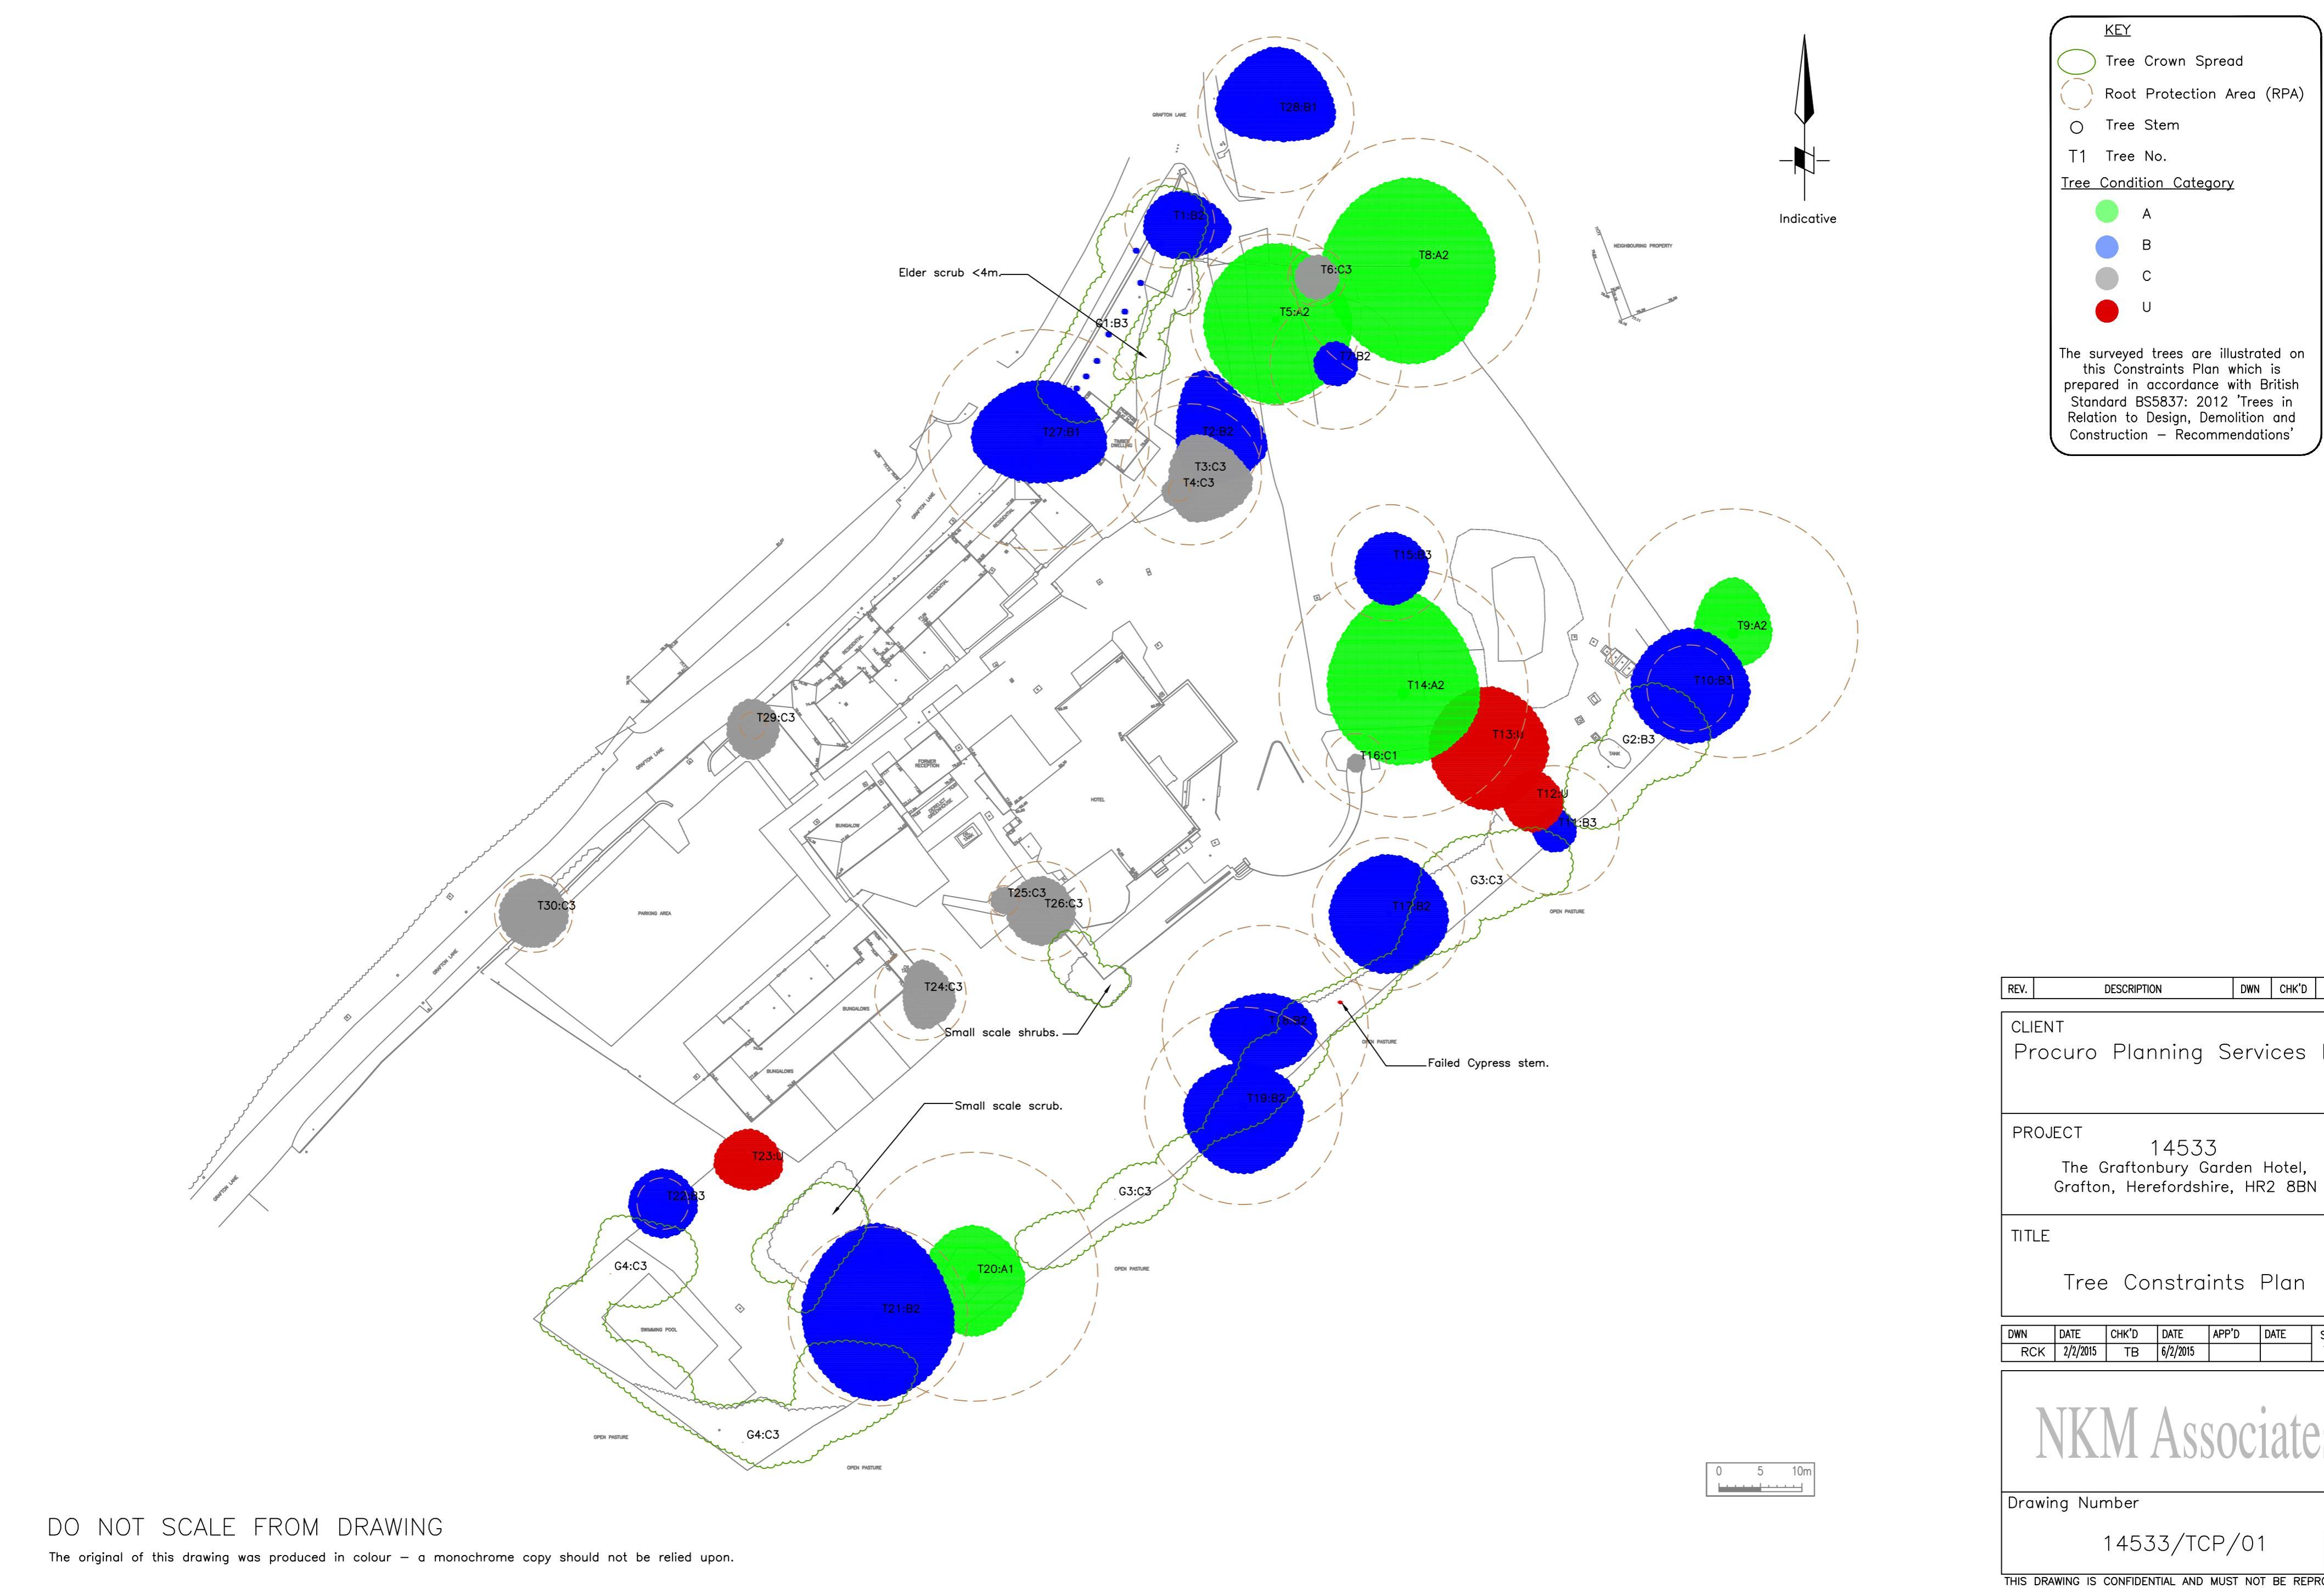
- 1.6 The survey data and site observations use the supplied topographical survey to illustrate the surveyed trees in plan format as a 'Tree Constraints Plan' (hereafter; TCP); the TCP and the tree survey data table are at Appendix III.

- 3.1 The following information, as with the prior contents of this report, should be read with the appended tree data table and tree constraints plan (14553/TCP/01).
