E4 Environment Limited

Ledbury Road, Hereford

# **Arboricultural Assessment**

September 2015

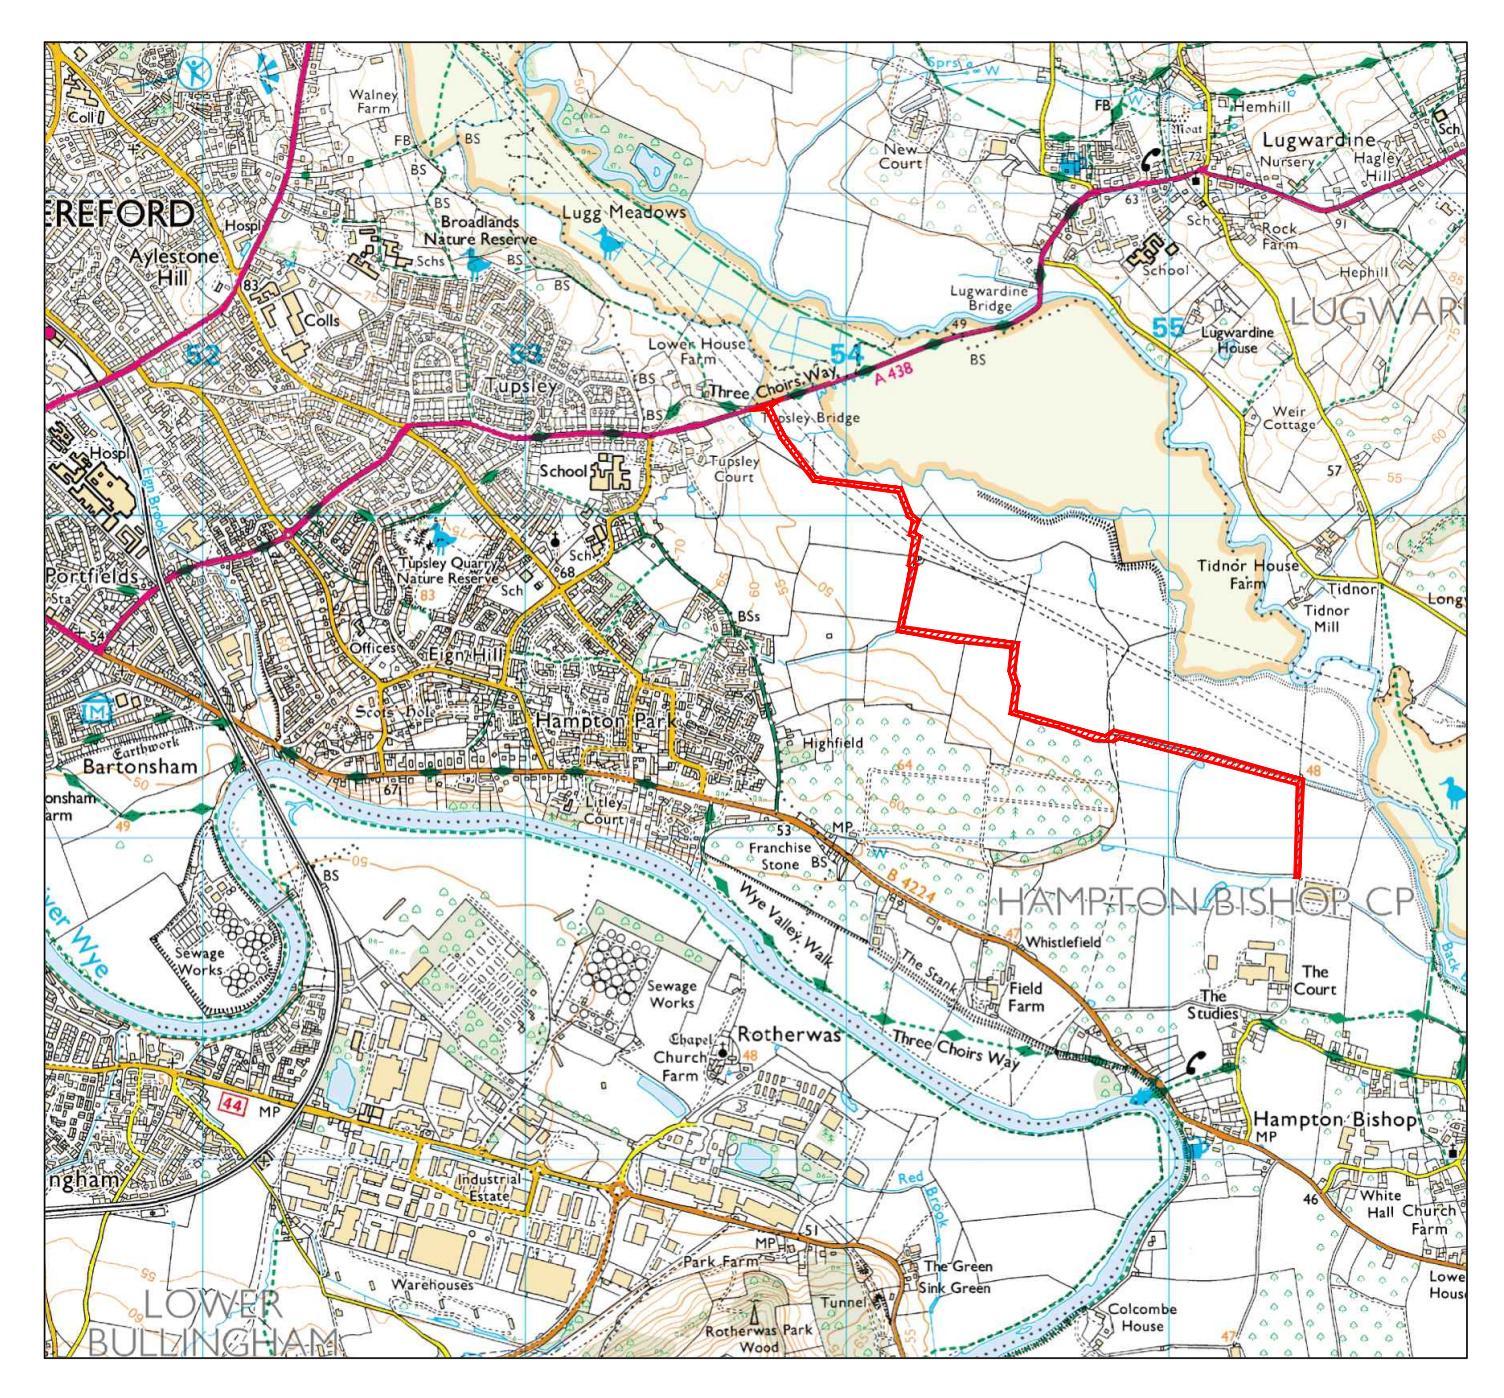
Assessment Boundary

- 2.14 Figure 1 (drawing no. 6873-A-01) identifies the assessment area including trees beyond the application boundary that may be affected by future development of the site and should not be considered as the application boundary.

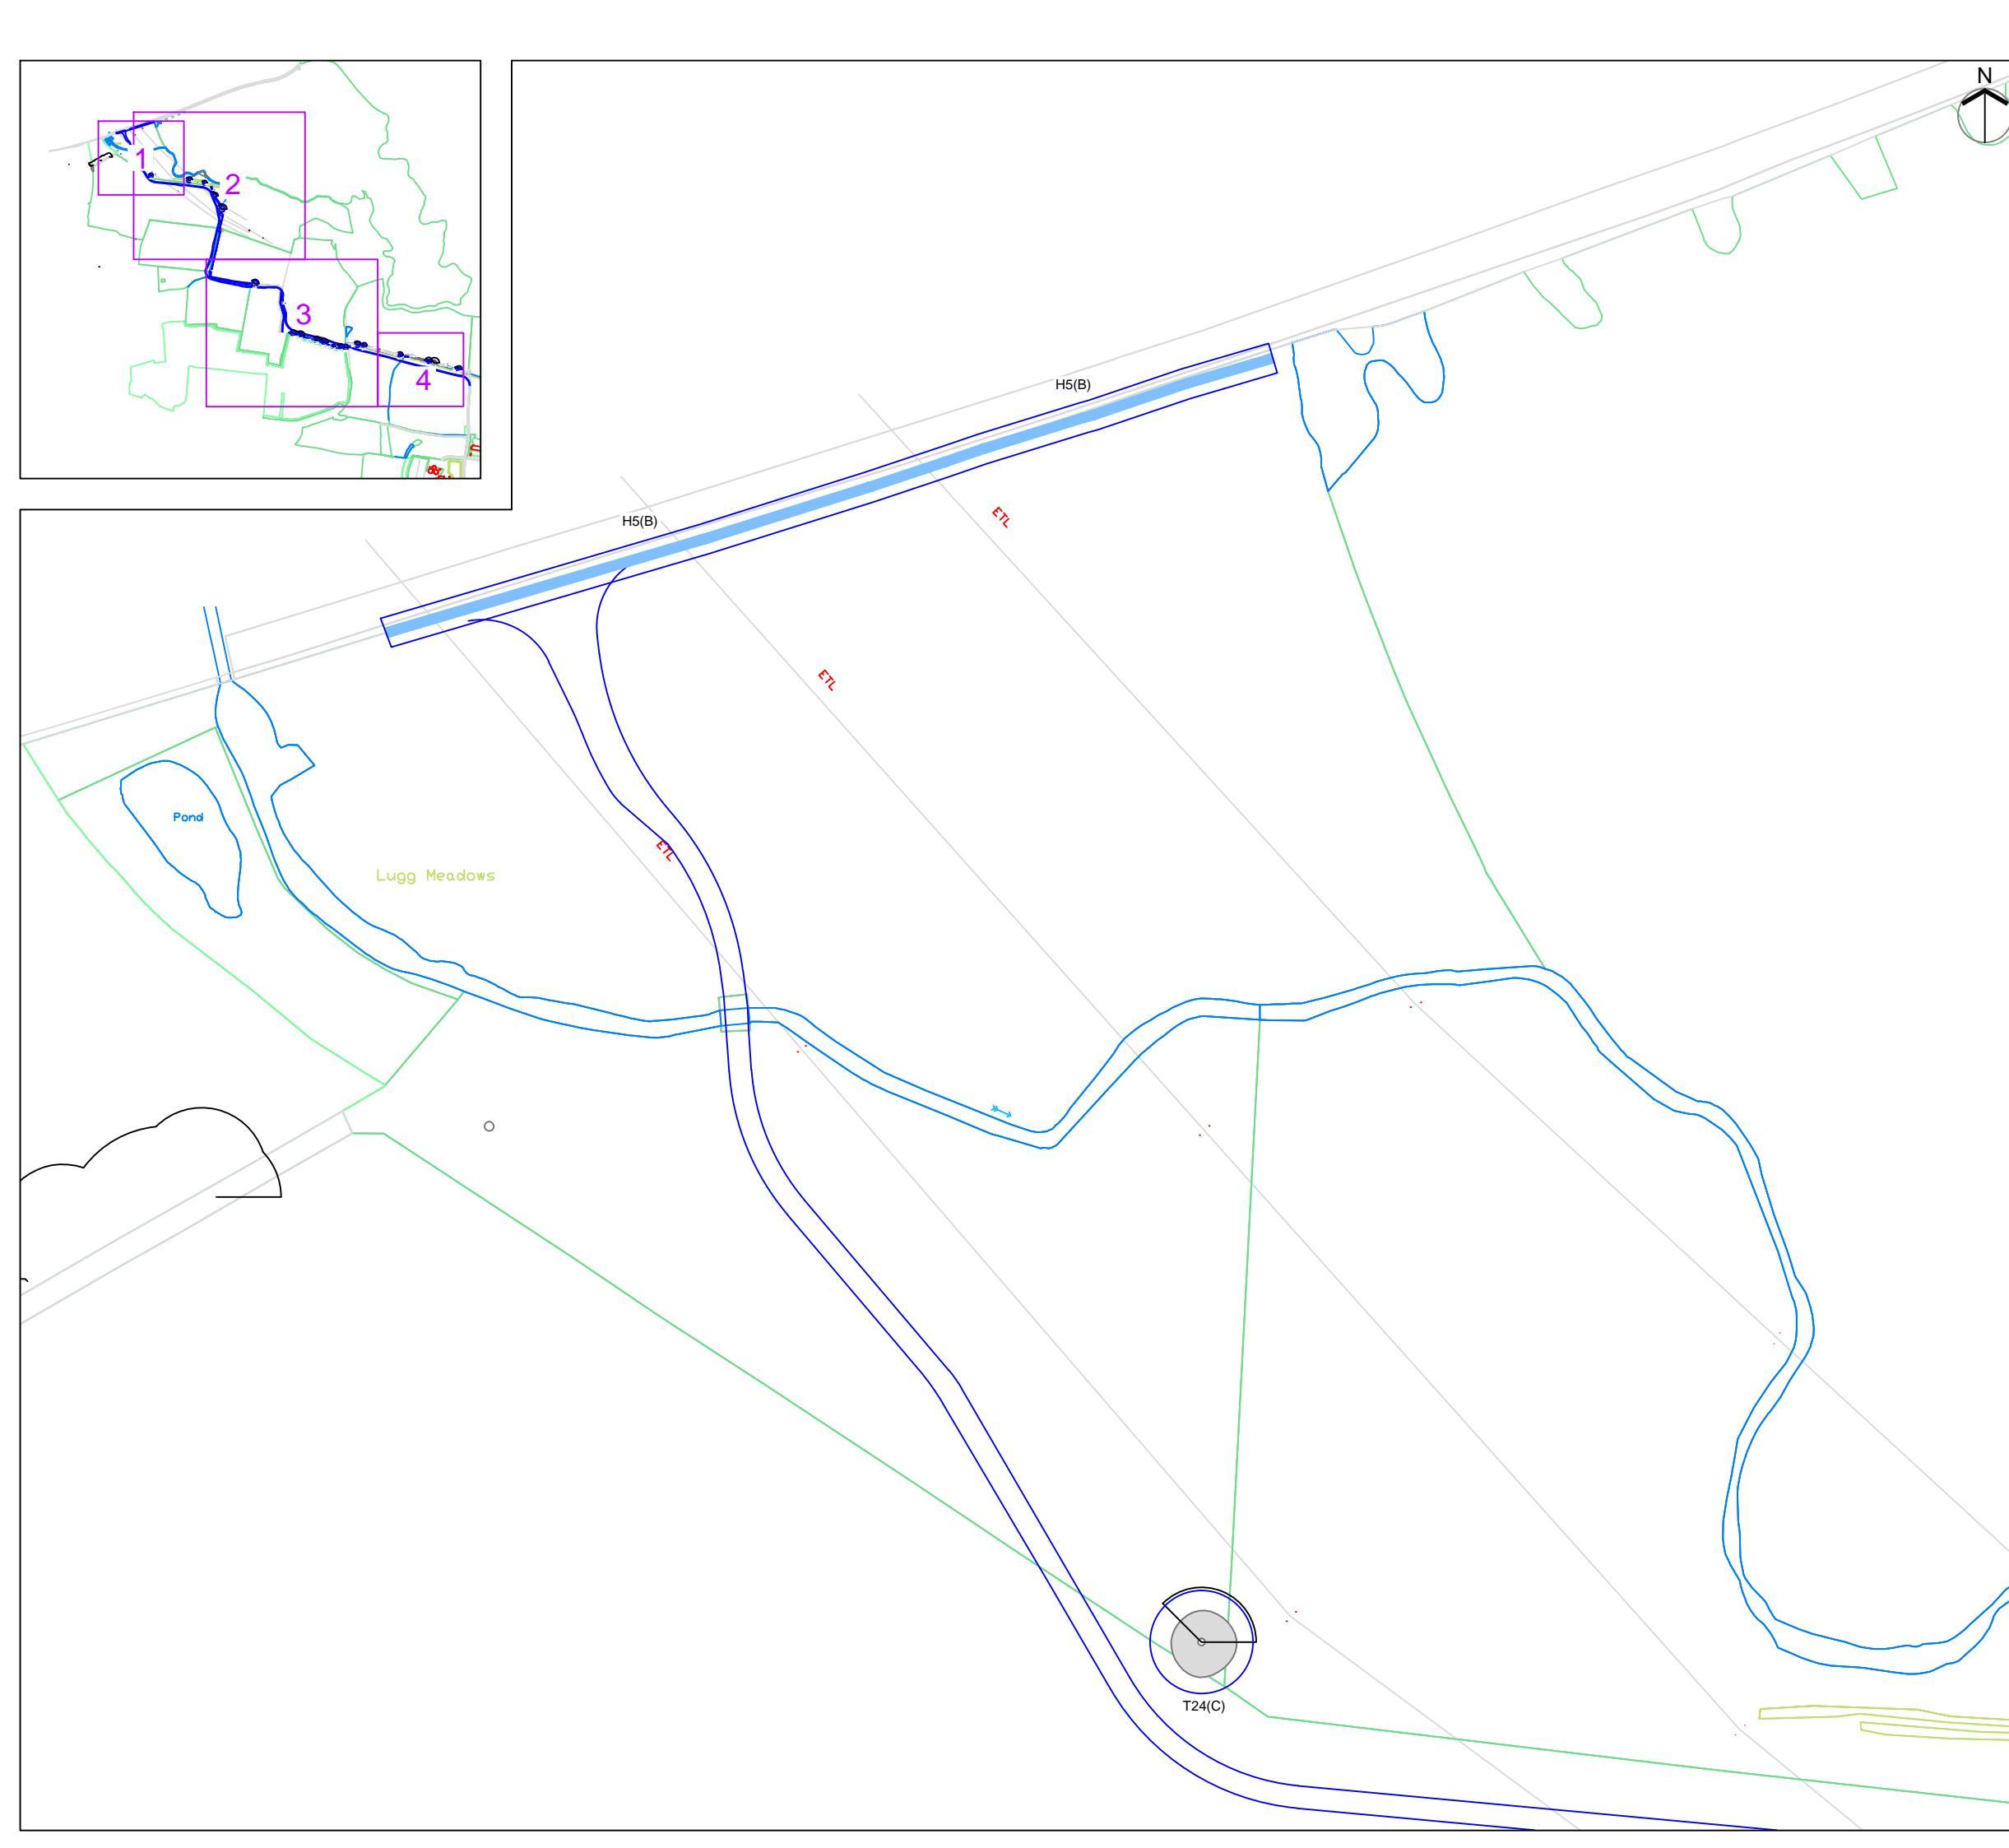
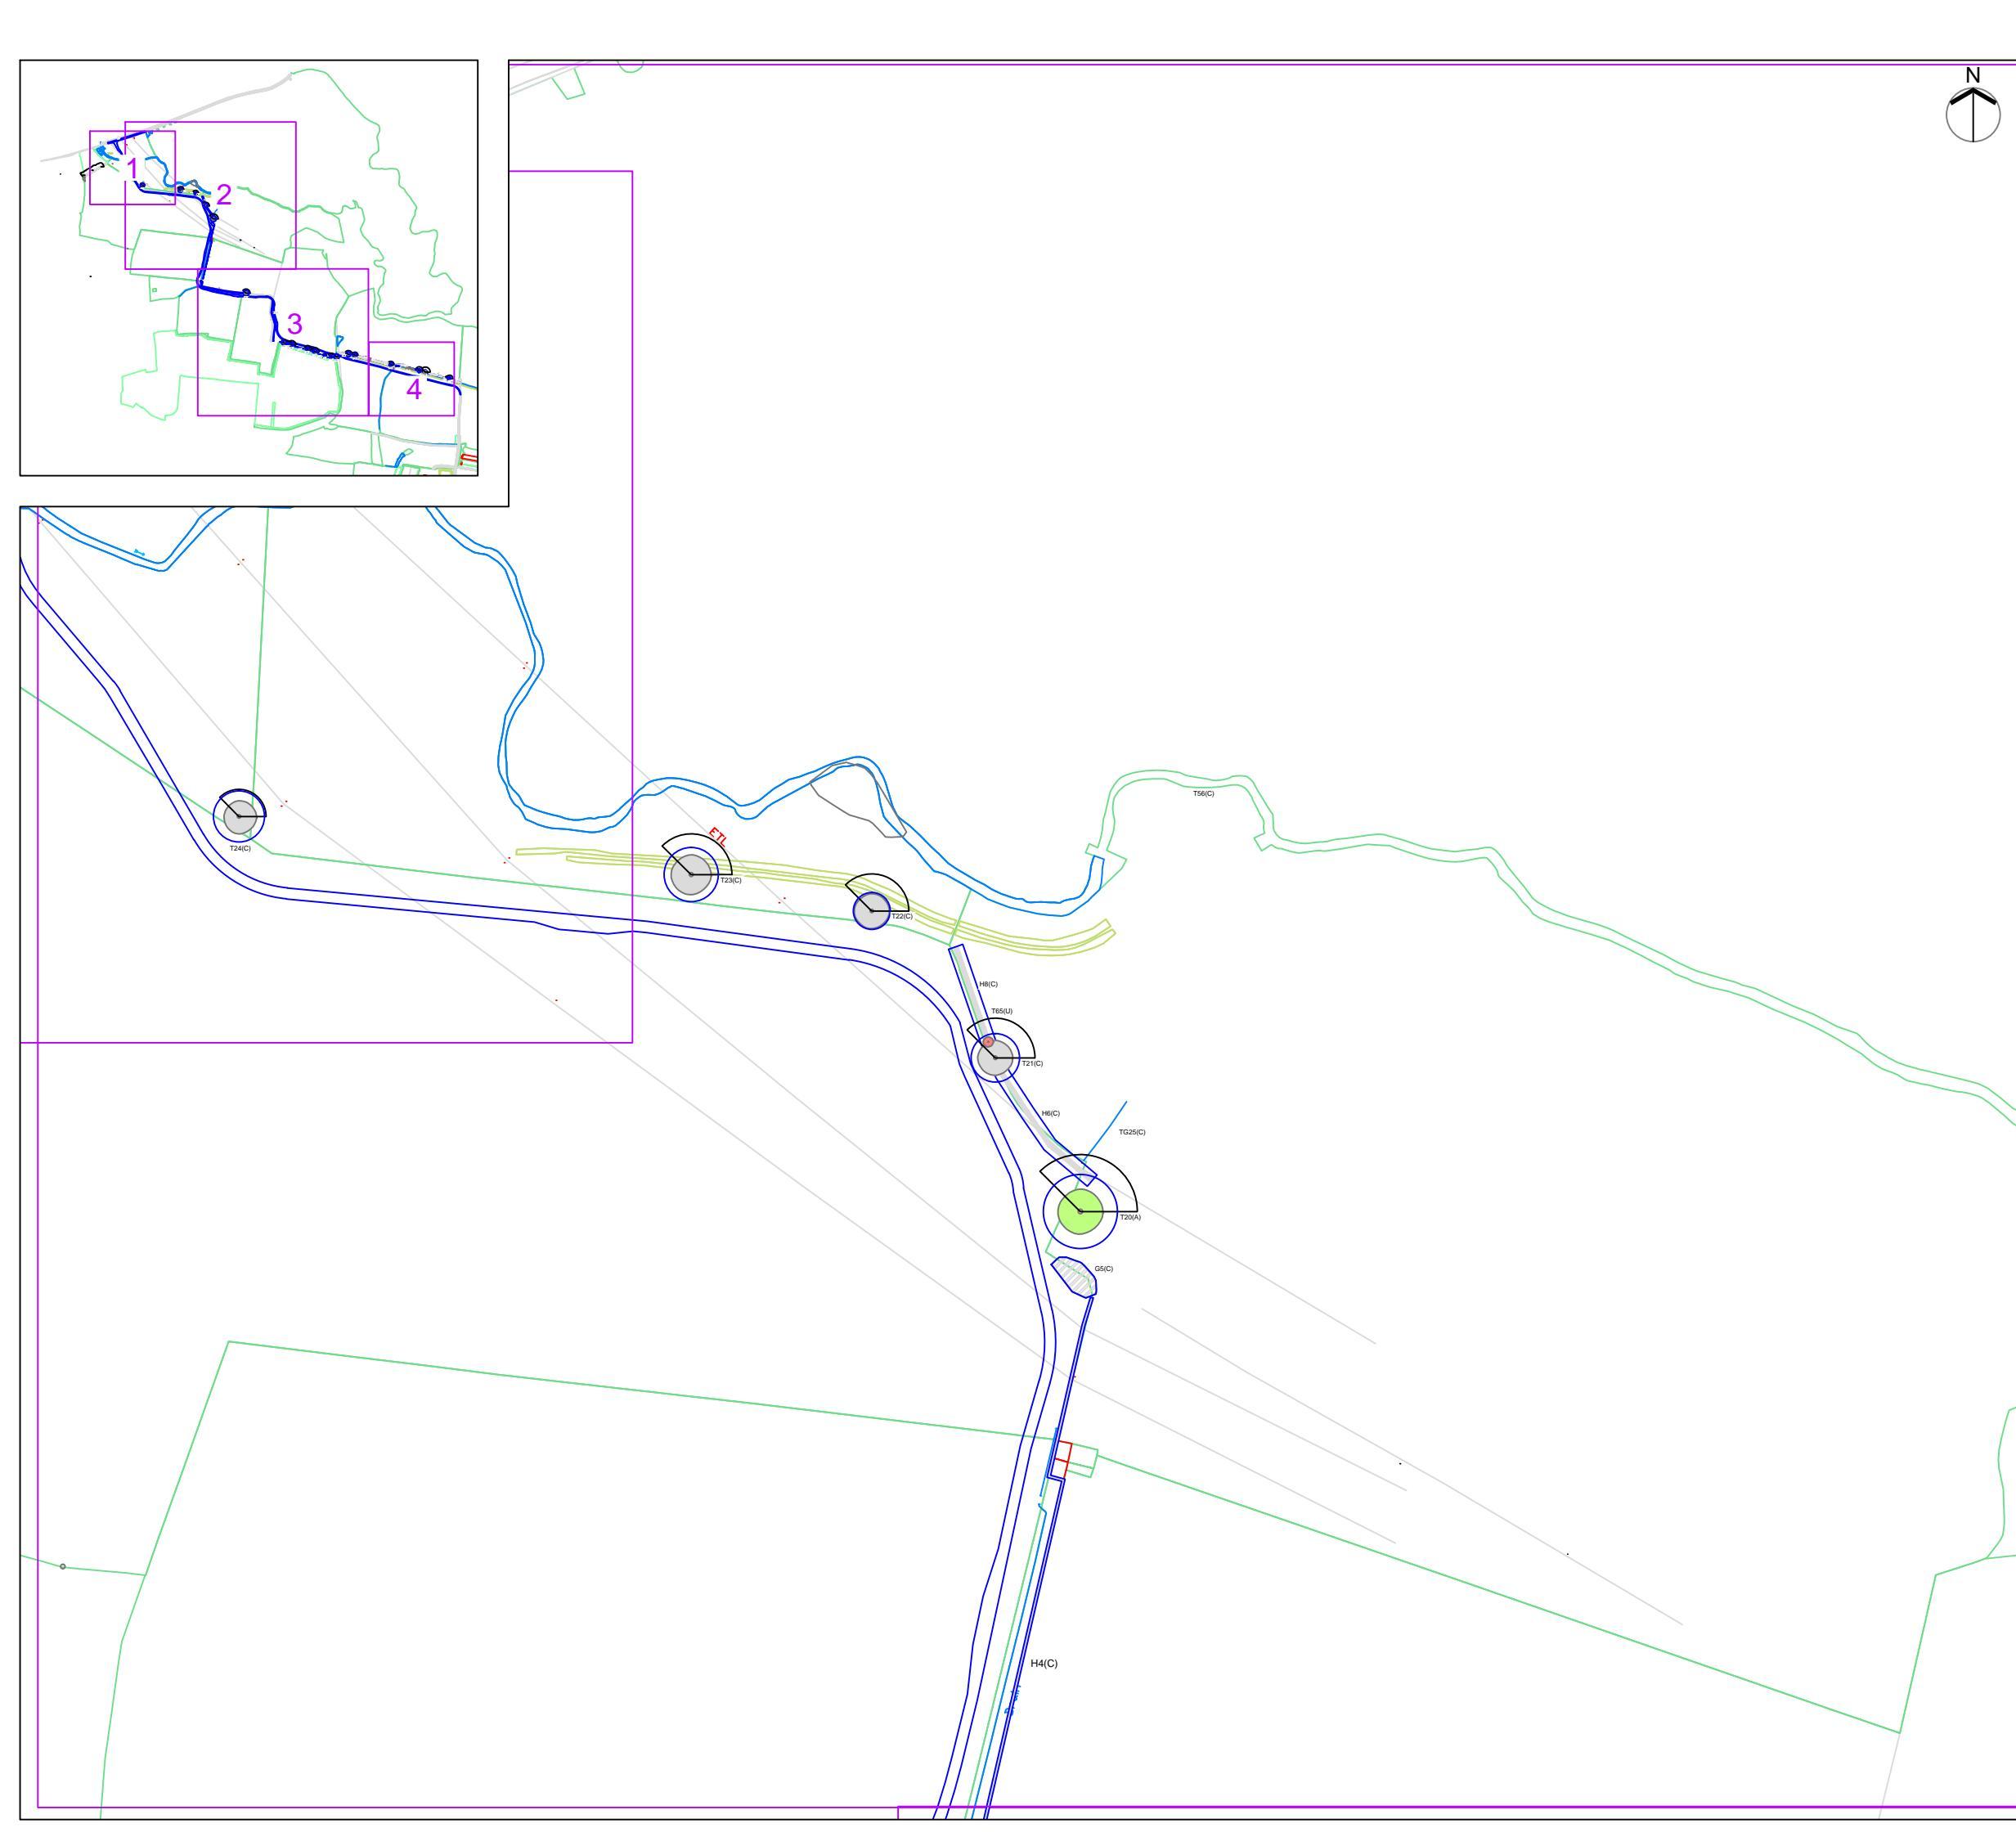
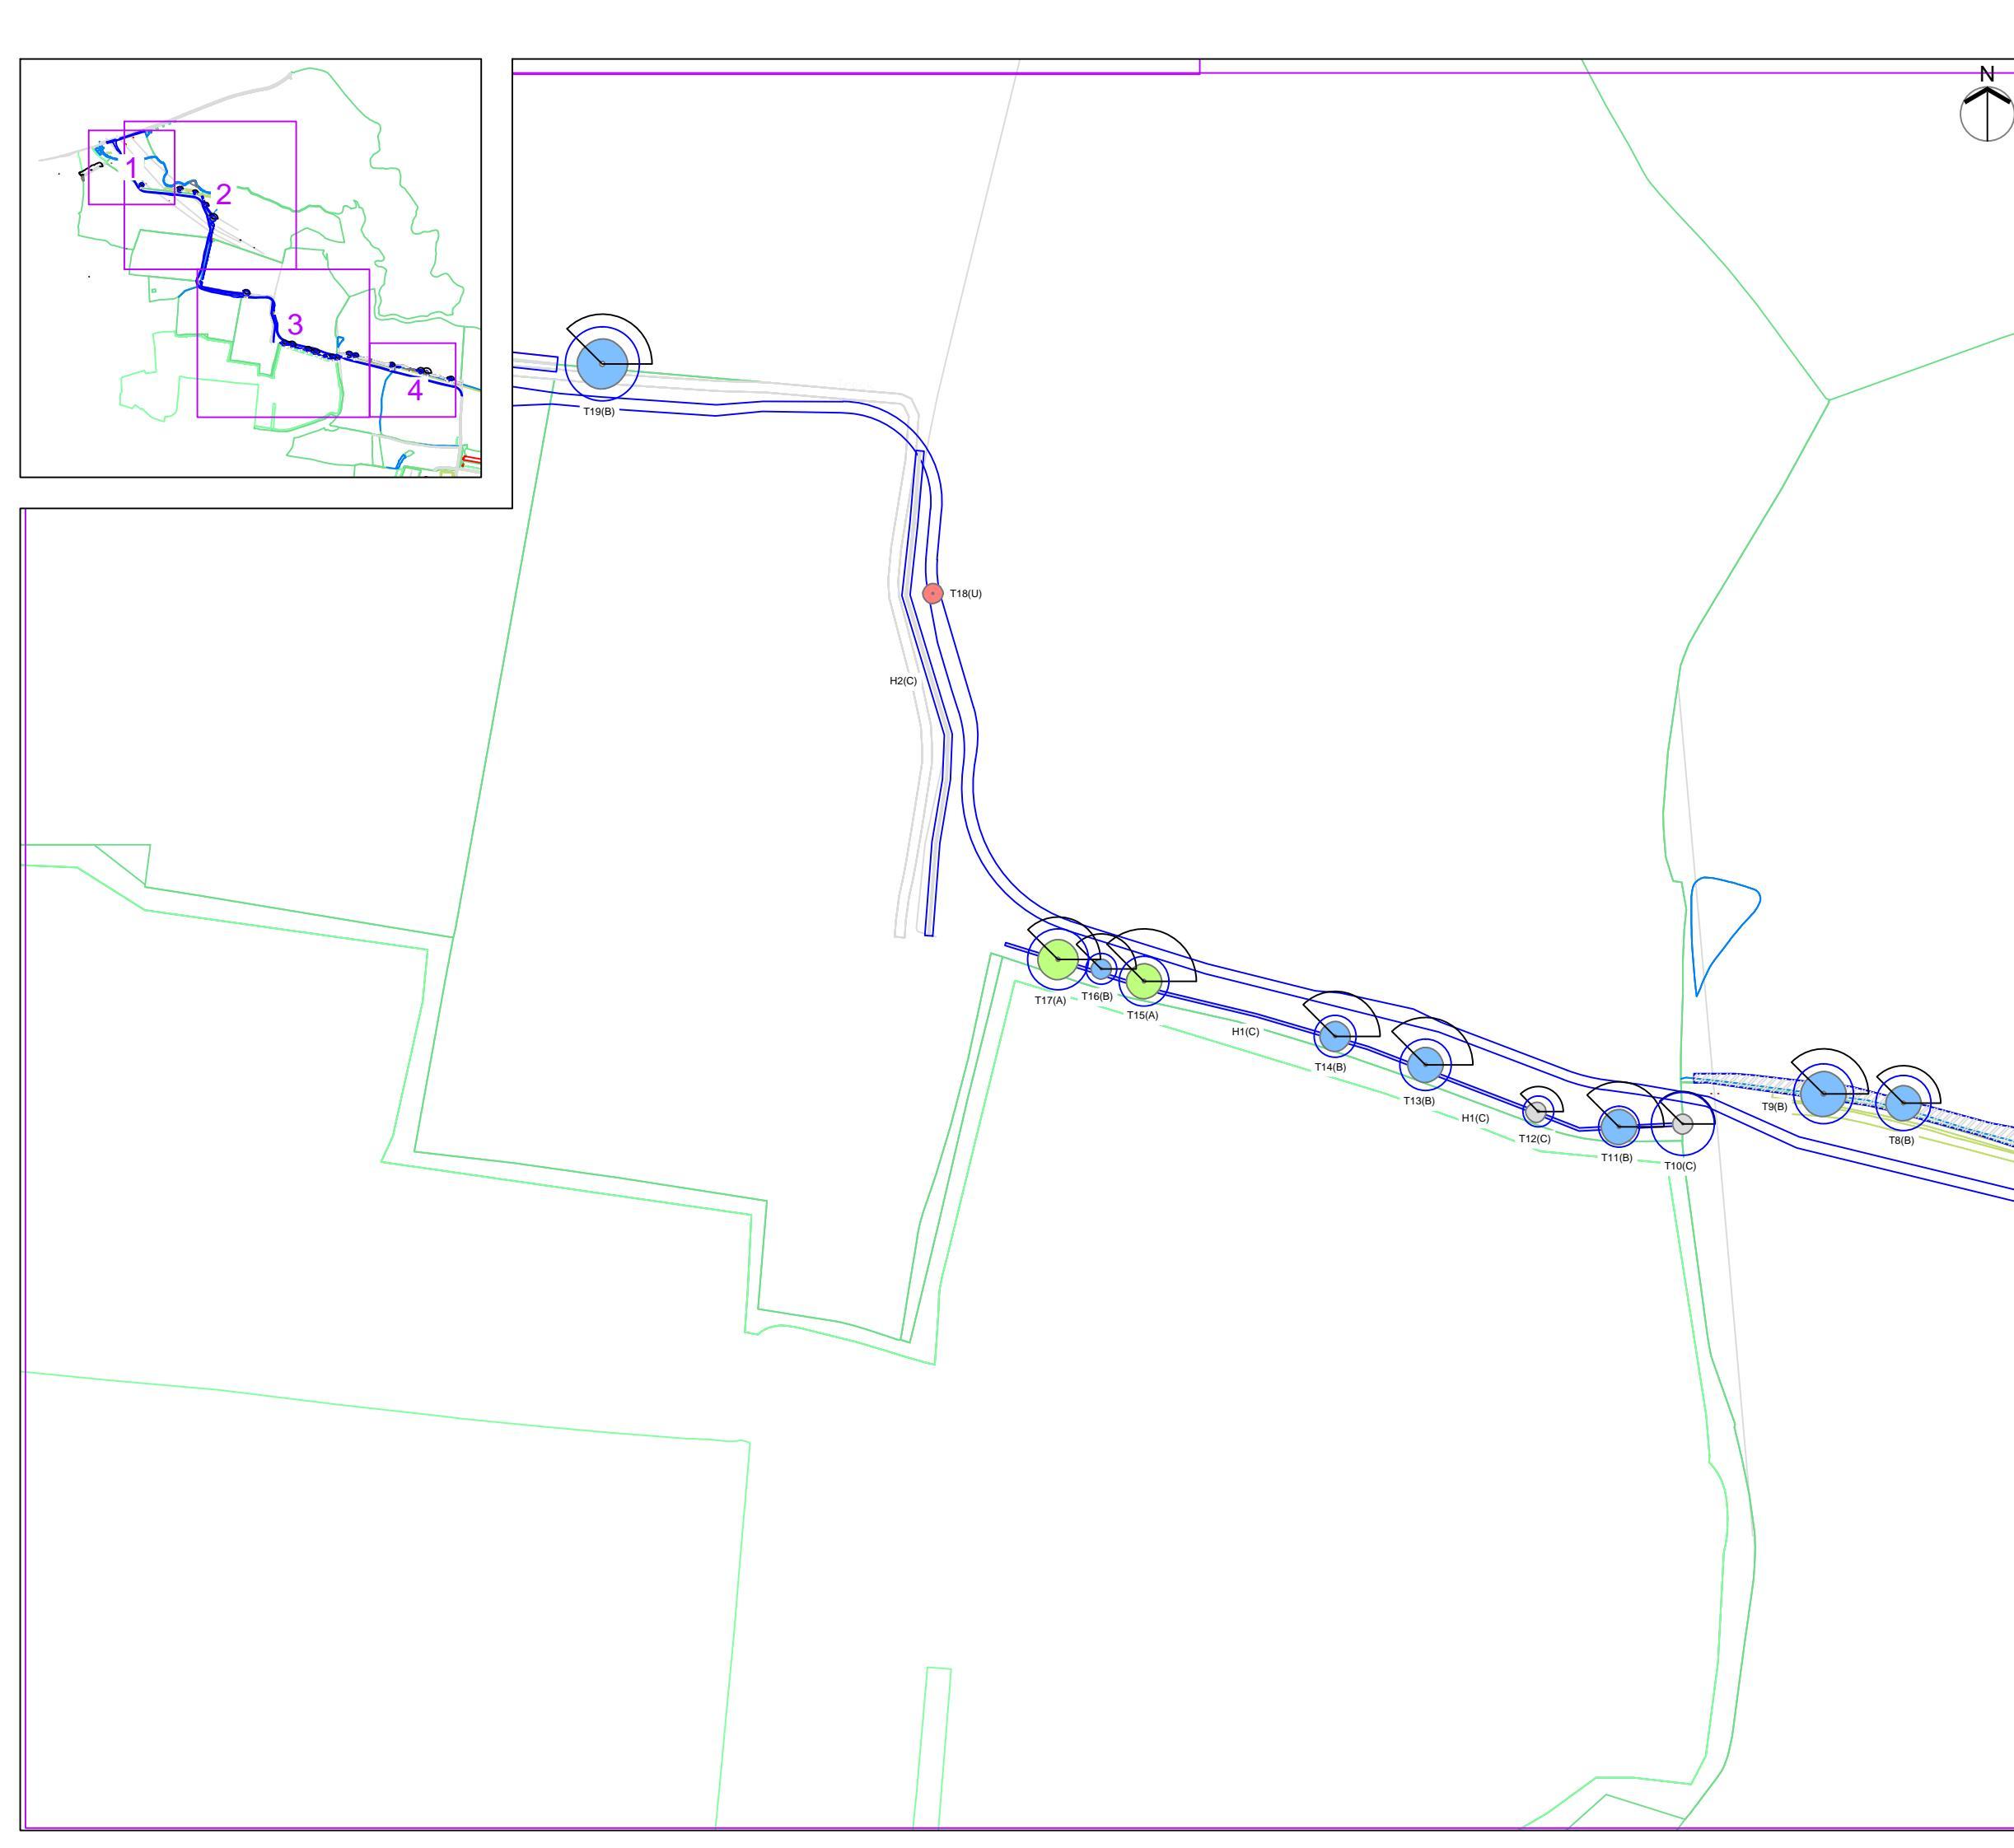
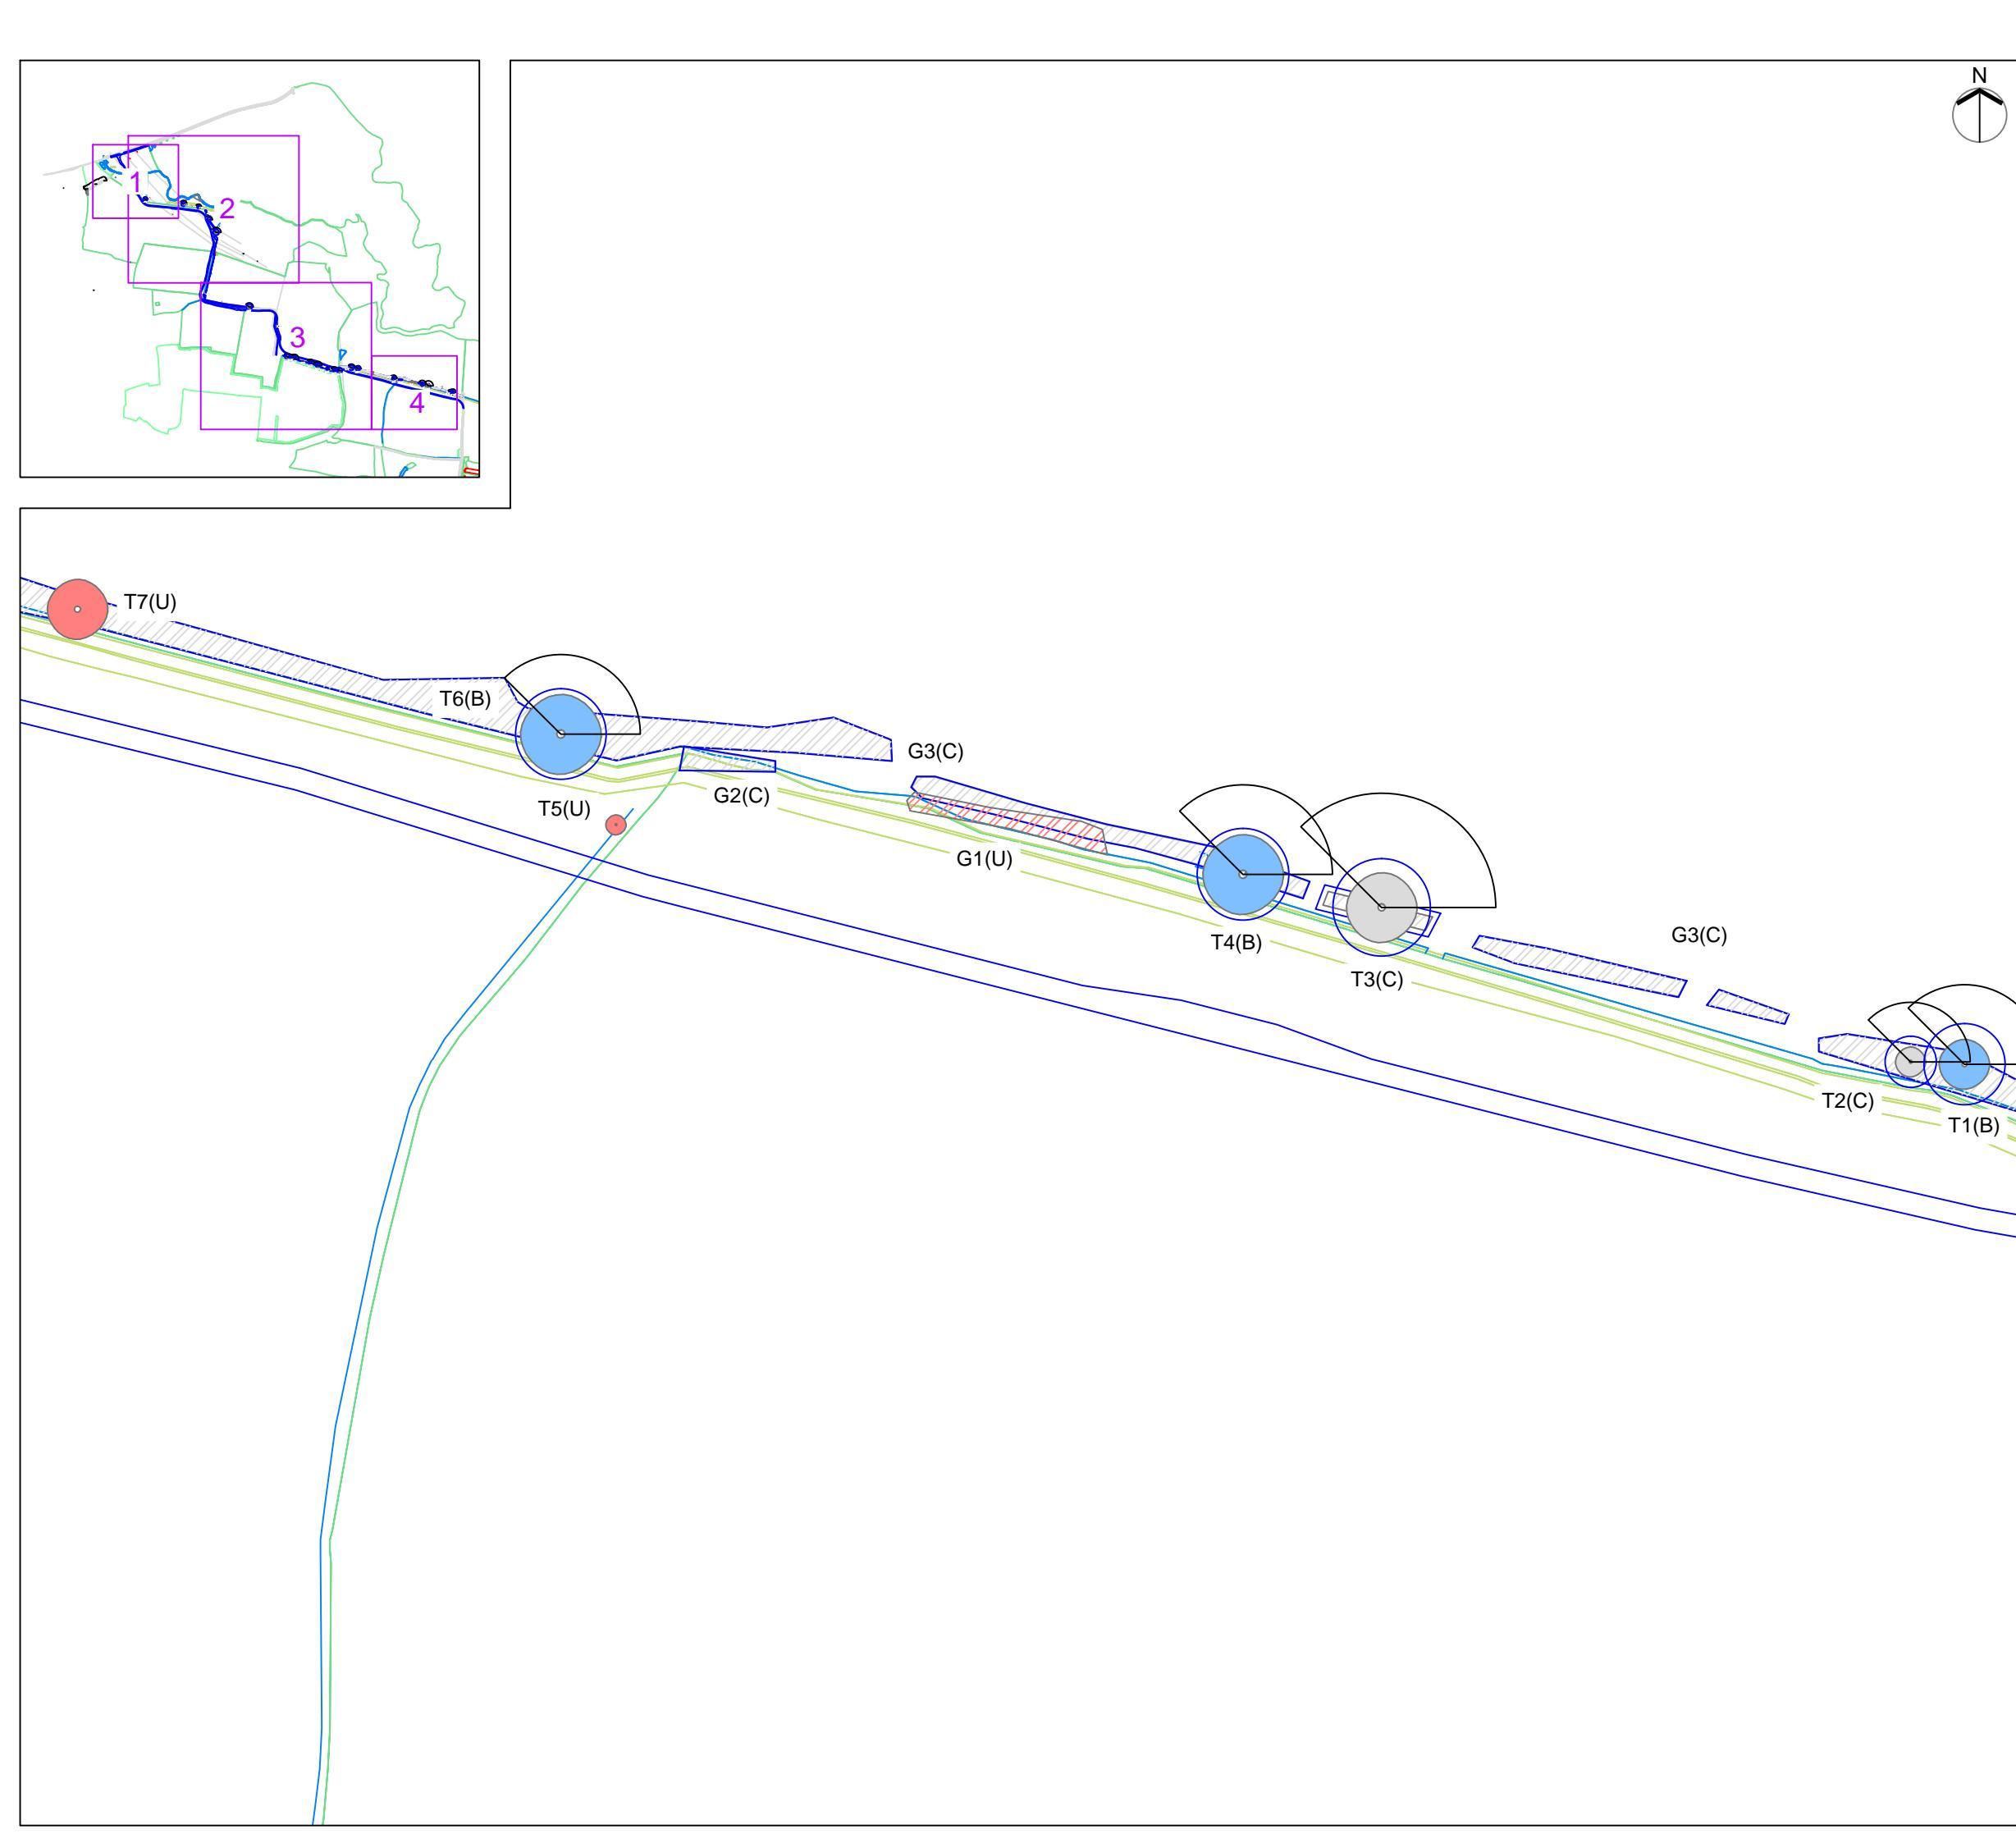
Figure 2: Tree Survey Plan (6873-A-02.01, 6873-A-02.02, 6873-A-02.03, 6873-A-02.04)

- 2.15 The individual positions of trees and groups have been shown on the Tree Survey Plan, Figure 2 (drawing no. 6873-A-02.01, 6873-A-02.02, 6873-A-02.03, 6873-A-02.04). The positions of trees are based on a topographical / land survey, as far as possible, supplied by the client. Where topographical information has not identified the position of trees and hedgerows, their relation to any existing surrounding features has been plotted using a global positioning system and aerial photography to provide approximate locations. The crown spread, root protection area and shade pattern (where appropriate) are also indicated on this plan.
